Profile/Photo Observation Report

| | | • | | | ROBOTICS | |
|---|---|---|---|---|---|--|
| Pipe Length (ft): | 201.2 | Owner: | City of Hobart | Pre Clean: | Heavy Cleaning | |
| Street: | South Colorado Street | | Flow Control: | Not Controlle | Not Controlled | |
| US MH: M | -506-010 | DS MH: | M-506-011 | Total Length Surveyed (| ft): 201.2 | |

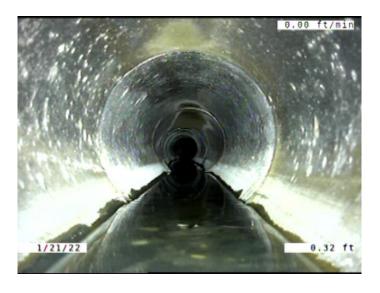
Code: **DSF**

Description: Deposits Settled Fine

Distance (ft): .3
Structural Grade: 0
O&M Grade: 2
Clock Start/From: 5
Clock To: 7
1st Value:

Value Percent: 5.000
Continuous Index: S01
Within 8" of Joint: YES

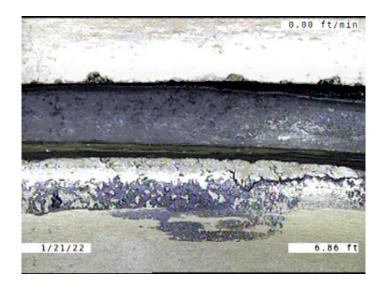
Code: JAM

Description: Joint Angular Medium

Distance (ft): 6.9
Structural Grade: 3
O&M Grade: 0

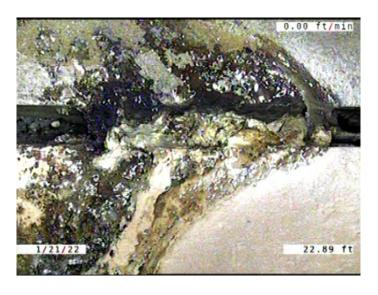
Code: IWJ

Description: Infiltration Weeper Joint

Distance (ft): 22.9
Structural Grade: 0
O&M Grade: 2
Clock Start/From: 4
Clock To: 5
1st Value:
2nd Value:
Value Percent:
Continuous Index:

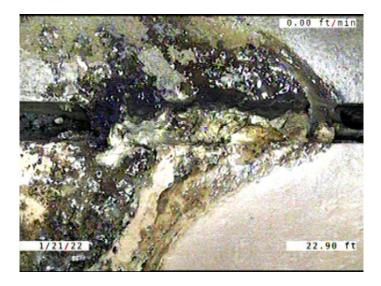
Code: DAE

Description: Deposits Attached Encrustation

Distance (ft): 22.9
Structural Grade: 0
O&M Grade: 2
Clock Start/From: 4
Clock To: 5

Value Percent: 5.000

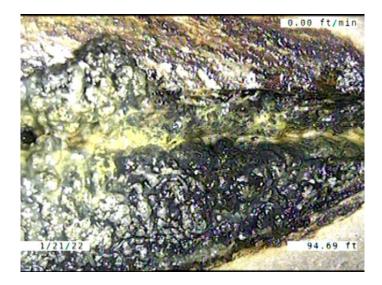
Code: DAE

Description: **Deposits Attached Encrustation**

Distance (ft): 94.7 Structural Grade: 0 O&M Grade: 2 Clock Start/From: 8 Clock To: 10

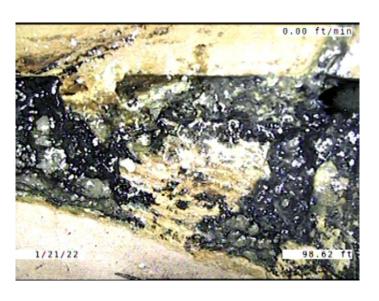
Code: DAE

Description: **Deposits Attached Encrustation**

Distance (ft): 98.6 Structural Grade: 0 O&M Grade: 2 Clock Start/From: 2 5 Clock To: 1st Value:

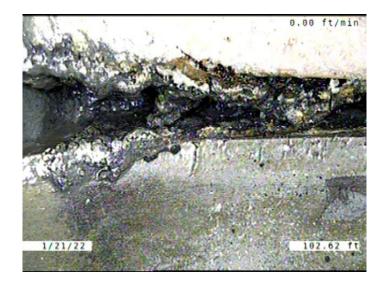
Code: DAE

Description: Deposits Attached Encrustation

Distance (ft): 102.6
Structural Grade: 0
O&M Grade: 2
Clock Start/From: 7
Clock To: 5

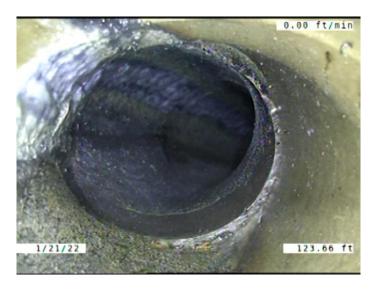
Code: TF

Description: Tap Factory

Distance (ft): 123.7
Structural Grade: 0
O&M Grade: 0
Clock Start/From: 11

Remarks: ENCUSTATION COMING FROM THE TAP TO MAIN CONNECTION. ALSO H

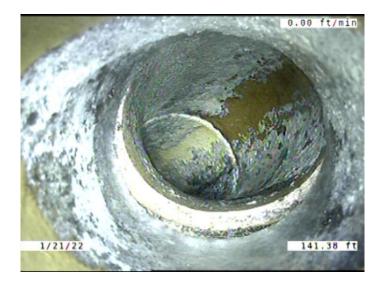
Code: **TF**

Description: Tap Factory

Distance (ft): 141.4
Structural Grade: 0

Remarks: ENCUSTATION COMING FROM THE TAP TO MAIN CONNECTION. ALSO H

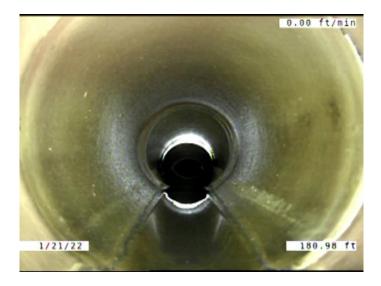
Code: MWLS

Description: Miscellaneous Water Level Sag

Distance (ft): 181.0
Structural Grade: 2
O&M Grade: 0

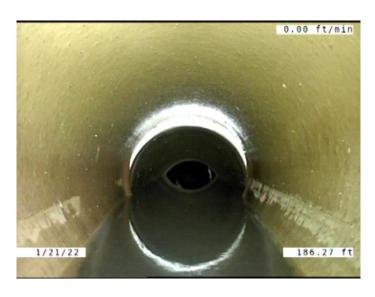
Code: MWLS

Description: Miscellaneous Water Level Sag

Distance (ft): 186.3
Structural Grade: 4
O&M Grade: 0

Value Percent: 65.000
Continuous Index: S04
Within 8" of Joint: NO

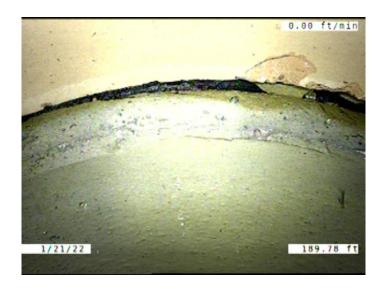
Code: **JOM**

Description: Joint Offset Medium

Distance (ft): 189.8
Structural Grade: 3
O&M Grade: 0

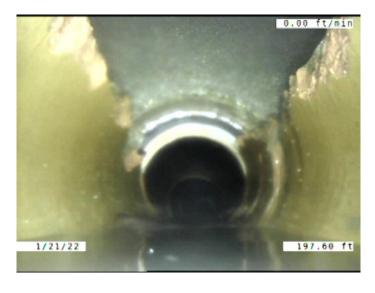
Code: **MWLS**

Description: **Miscellaneous Water Level Sag**

Distance (ft): 197.6 Structural Grade: 4 O&M Grade: 0

Value Percent: 65.000 Continuous Index: F04 Within 8" of Joint: NO

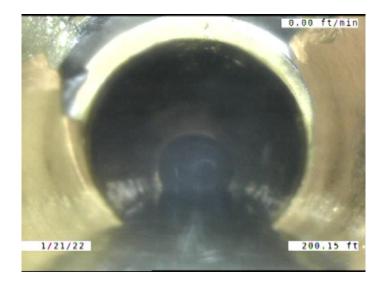
Code: **DSF**

Description: **Deposits Settled Fine**

Distance (ft): 200.2 Structural Grade: 0 2 O&M Grade: Clock Start/From: 5 Clock To: 7

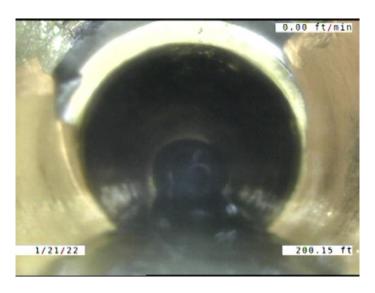
Code: DAE

Description: **Deposits Attached Encrustation**

Distance (ft): 200.2 Structural Grade: 0 O&M Grade: 2 Clock Start/From: 7 5 Clock To: 1st Value:
