## Profile/Photo Observation Report

Date:	<b>04/06/2018</b>	Weather:		Coding:	<b>PACP 6.0</b>
Pipe Length (ft):	<b>204.9</b>	Owner:	<b>NA</b>	Pre Clean:	<b>No Pre-Cleaning</b>
P.O.#:		Surveyor:	<b>Mark Ruby</b>	PSR:	<b>P-506-012-011</b>
Customer:		Clean Date:	<b>01/01/1900</b>	Shape:	<b>C</b>

Street:	<b>S COLORADO ST &amp; W 7TH PL</b>	Flow Control:	<b>Not Controlled</b>
City:	<b>Hobart, IN</b>	Year Renewed:	
Location:	<b>Yard</b>	Tape/Media #:	
Purpose:	<b>Routine Assessment</b>	Dia/Height:	<b>10"</b>
Use:	<b>Sanitary</b>	Material:	<b>VCP</b>
Drain Area:	<b>NA</b>	Lining:	
Category:	<b>NA</b>		
Comment:	<b>Flow direction is marked wrong.</b>		
Location Details:		Direction of Survey:	<b>Upstream</b>
US MH:	<b>M-506-011</b>	DS MH:	<b>M-506-012</b>
		Total Length Surveyed (ft):	<b>129.9</b>

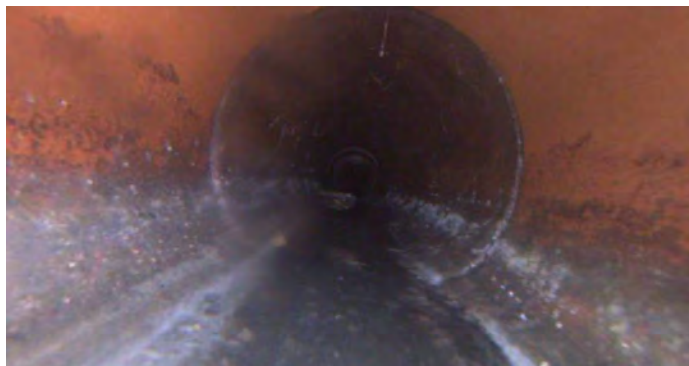
Code: **AMH**  
 Description: **Manhole**  
 Distance (ft): **.0**  
 Structural Grade: **0**  
 O&M Grade: **0**  
 Clock Start/From:  
 Clock To:  
 1st Value:  
 2nd Value:  
 Value Percent:  
 Continuous Index:  
 Within 8" of Joint: **NO**  
 Remarks: **M-506-012**

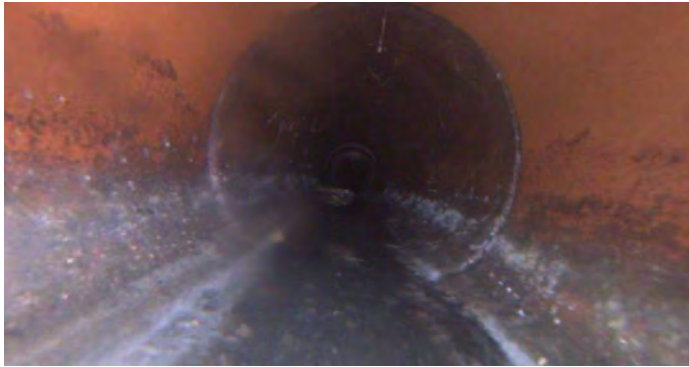
Code: **MWL**  
Description: **Water Level**

Distance (ft): **.0**  
Structural Grade: **0**  
O&M Grade: **0**  
Clock Start/From:  
Clock To:  
1st Value:  
2nd Value:  
Value Percent: **10.000**  
Continuous Index:  
Within 8" of Joint: **NO**  
Remarks:

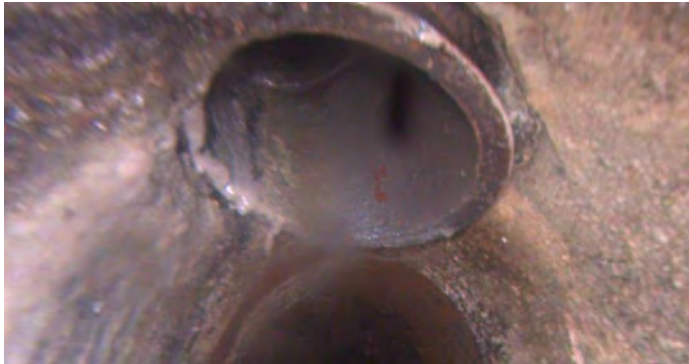
Code: **TB**  
Description: **Tap Break-in**

Distance (ft): **6.4**  
Structural Grade: **0**  
O&M Grade: **0**  
Clock Start/From: **12**  
Clock To:  
1st Value: **4.000**  
2nd Value:  
Value Percent:  
Continuous Index:  
Within 8" of Joint:  
Remarks:

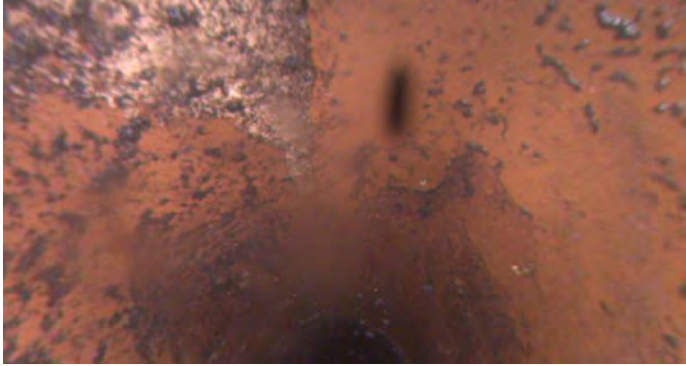
Code: **CL**  
Description: **Crack Longitudinal**

Distance (ft): **7.5**  
Structural Grade: **2**  
O&M Grade: **0**  
Clock Start/From: **12**  
Clock To:  
1st Value:  
2nd Value:  
Value Percent:  
Continuous Index:  
Within 8" of Joint:  
Remarks:

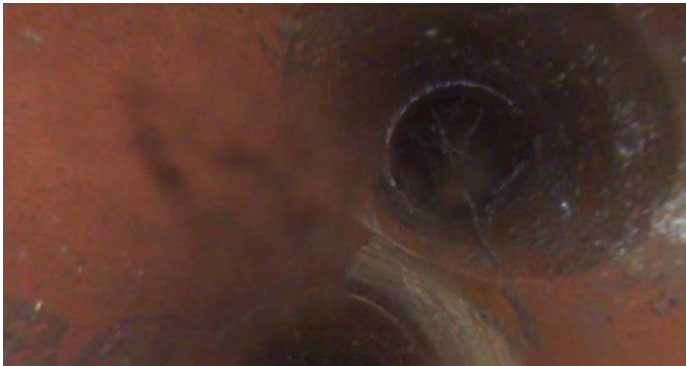
Code: **TF**  
Description: **Tap Factory**

Distance (ft): **14.7**  
Structural Grade: **0**  
O&M Grade: **0**  
Clock Start/From: **10**  
Clock To:  
1st Value: **4.000**  
2nd Value:  
Value Percent:  
Continuous Index:  
Within 8" of Joint:  
Remarks:

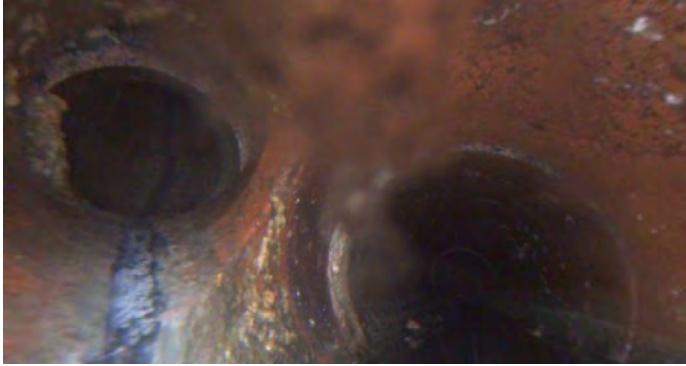
Code: **TF**  
Description: **Tap Factory**

Distance (ft): **28.2**  
Structural Grade: **0**  
O&M Grade: **0**  
Clock Start/From: **2**  
Clock To:  
1st Value: **4.000**  
2nd Value:  
Value Percent:  
Continuous Index:  
Within 8" of Joint:  
Remarks:

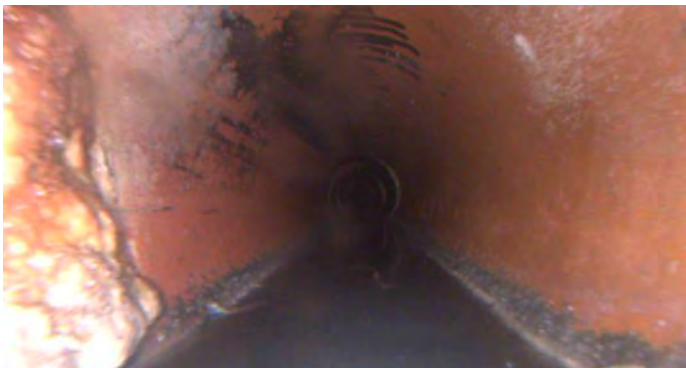
Code: **DAGS**  
Description: **Deposits Attached Grease**

Distance (ft): **49.6**  
Structural Grade: **0**  
O&M Grade: **2**  
Clock Start/From: **7**  
Clock To: **9**  
1st Value:  
2nd Value:  
Value Percent: **5.000**  
Continuous Index:  
Within 8" of Joint: **YES**  
Remarks:

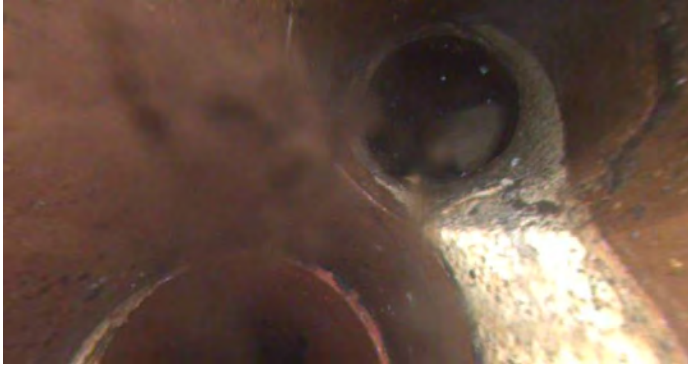
Code: **TF**  
Description: **Tap Factory**

Distance (ft): **53.9**  
Structural Grade: **0**  
O&M Grade: **0**  
Clock Start/From: **10**  
Clock To:  
1st Value: **4.000**  
2nd Value:  
Value Percent:  
Continuous Index:  
Within 8" of Joint:  
Remarks:

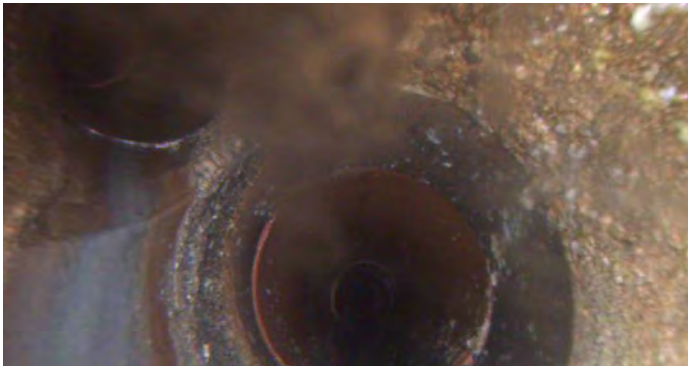
Code: **TF**  
Description: **Tap Factory**

Distance (ft): **59.0**  
Structural Grade: **0**  
O&M Grade: **0**  
Clock Start/From: **2**  
Clock To:  
1st Value: **4.000**  
2nd Value:  
Value Percent:  
Continuous Index:  
Within 8" of Joint:  
Remarks:

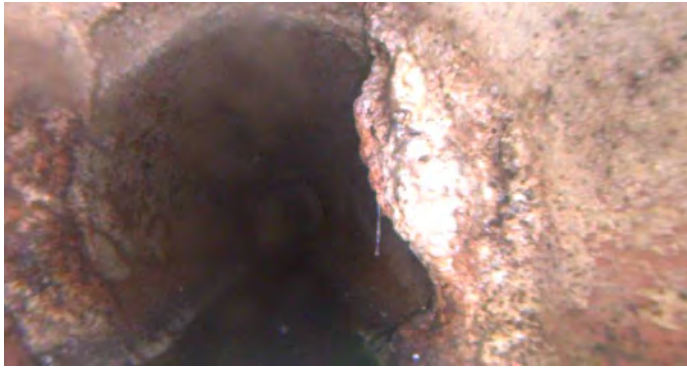
Code: **DAGS**  
Description: **Deposits Attached Grease**

Distance (ft): **71.2**  
Structural Grade: **0**  
O&M Grade: **2**  
Clock Start/From: **1**  
Clock To: **5**  
1st Value:  
2nd Value:  
Value Percent: **5.000**  
Continuous Index:  
Within 8" of Joint: **NO**  
Remarks:

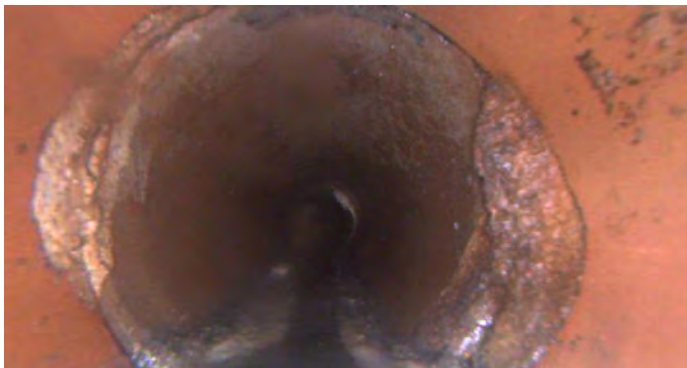
Code: **DAE**  
Description: **Deposits Attached Encrustation**

Distance (ft): **86.0**  
Structural Grade: **0**  
O&M Grade: **2**  
Clock Start/From: **7**  
Clock To: **5**  
1st Value:  
2nd Value:  
Value Percent: **5.000**  
Continuous Index: **S01**  
Within 8" of Joint: **YES**  
Remarks:

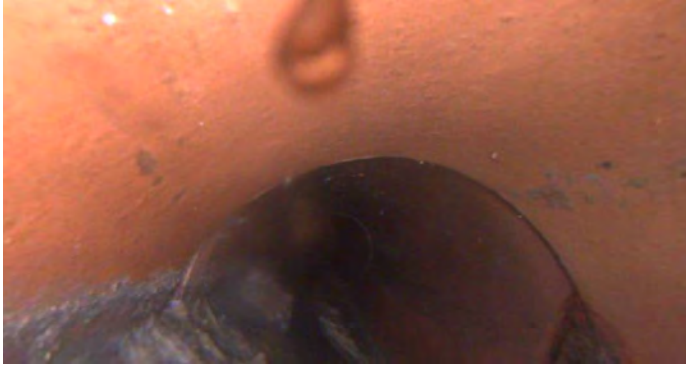
Code: **DAE**  
Description: **Deposits Attached Encrustation**

Distance (ft): **129.9**  
Structural Grade: **0**  
O&M Grade: **2**  
Clock Start/From: **7**  
Clock To: **5**  
1st Value:  
2nd Value:  
Value Percent: **5.000**  
Continuous Index: **F01**  
Within 8" of Joint: **YES**  
Remarks:

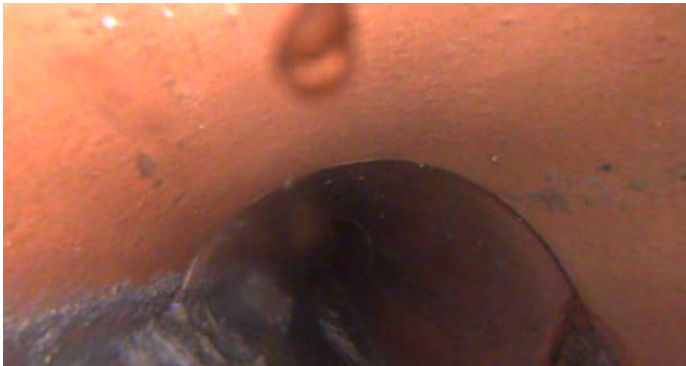
Code: **MSA**  
Description: **Abandoned Survey**

Distance (ft): **129.9**  
Structural Grade: **0**  
O&M Grade: **0**  
Clock Start/From:  
Clock To:  
1st Value:  
2nd Value:  
Value Percent:  
Continuous Index:  
Within 8" of Joint: **NO**  
Remarks: **Roll max**
