## Profile/Photo Observation Report

Date:	01/21/2022	Weather:		Coding:	PACP 7.0
Pipe Length (ft):	205.0	Owner:	City of Hobart	Pre Clean:	Heavy Cleaning
P.O.#:	YES502259	Surveyor:	S. Bucklin	PSR:	P-506-012-011
Customer:	City of Hobart	Clean Date:	01/17/2022	Shape:	C

Street:	West 7th Place	Flow Control:	Not Controlled
City:	Hobart, IN	Year Renewed:	
Location:	Local rural streets with light traffic, t	Tape/Media #:	
Purpose:	Routine Assessment	Dia/Height:	10"
Use:	Sanitary Sewage Pipe	Material:	VCP
Drain Area:		Lining:	None
Category:	NA		
Comment:			
Location Details:		Direction of Survey:	Upstream
US MH:	M-506-011	DS MH:	M-506-012
		Total Length Surveyed (ft):	9.2

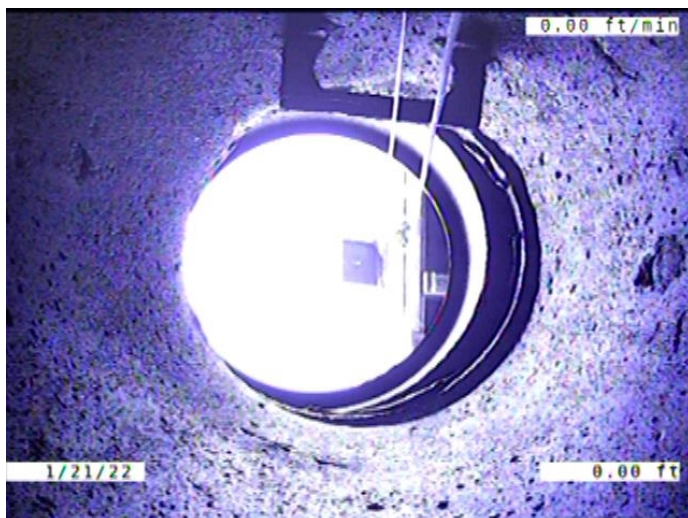
Code: **AMH**  
 Description: **Manhole**

Distance (ft): **.0**  
 Structural Grade: **0**  
 O&M Grade: **0**  
 Clock Start/From:  
 Clock To:  
 1st Value:  
 2nd Value:  
 Value Percent:  
 Continuous Index:  
 Within 8" of Joint: **NO**  
 Remarks: **M-506-012**

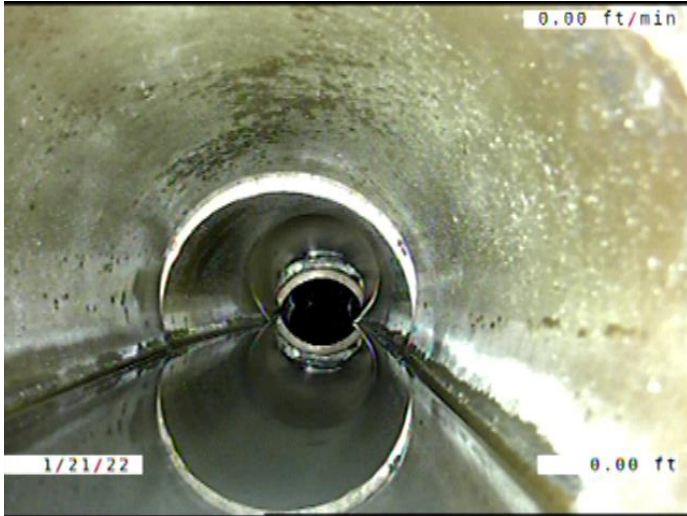
Code: **MWL**  
Description: **Miscellaneous Water Level**

Distance (ft): **.0**  
Structural Grade: **0**  
O&M Grade: **0**  
Clock Start/From:  
Clock To:  
1st Value:  
2nd Value:  
Value Percent: **10.000**  
Continuous Index:  
Within 8" of Joint: **NO**  
Remarks:

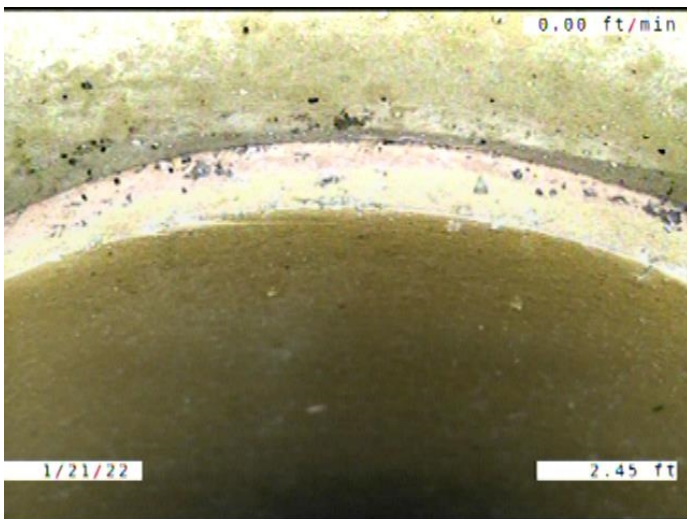
Code: **JOM**  
Description: **Joint Offset Medium**

Distance (ft): **2.5**  
Structural Grade: **3**  
O&M Grade: **0**  
Clock Start/From:  
Clock To:  
1st Value:  
2nd Value:  
Value Percent:  
Continuous Index:  
Within 8" of Joint: **NO**  
Remarks:

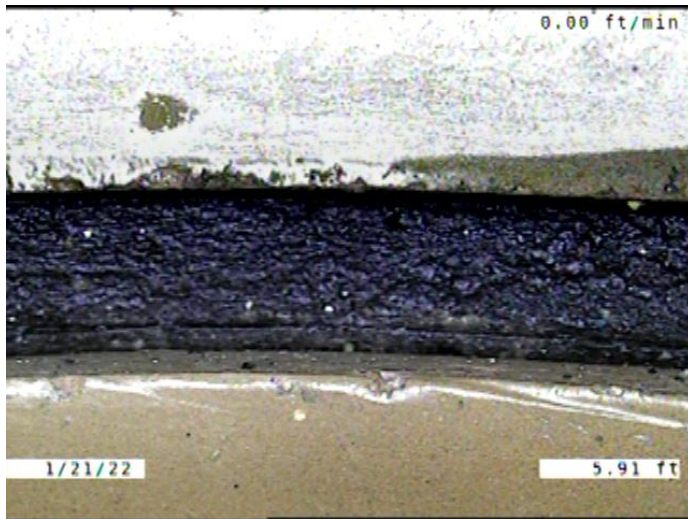
Code: **JAL**  
 Description: **Joint Angular Large**

Distance (ft): **5.9**  
 Structural Grade: **4**  
 O&M Grade: **0**  
 Clock Start/From:  
 Clock To:  
 1st Value:  
 2nd Value:  
 Value Percent:  
 Continuous Index:  
 Within 8" of Joint: **NO**  
 Remarks:

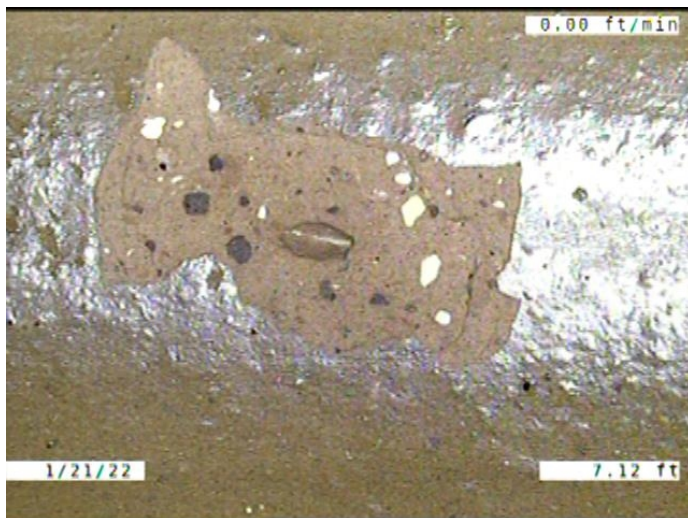
Code: **SSS**  
 Description: **Surface Damage Surface Spalling**

Distance (ft): **7.1**  
 Structural Grade: **2**  
 O&M Grade: **0**  
 Clock Start/From: **2**  
 Clock To:  
 1st Value:  
 2nd Value:  
 Value Percent:  
 Continuous Index:  
 Within 8" of Joint: **NO**  
 Remarks:

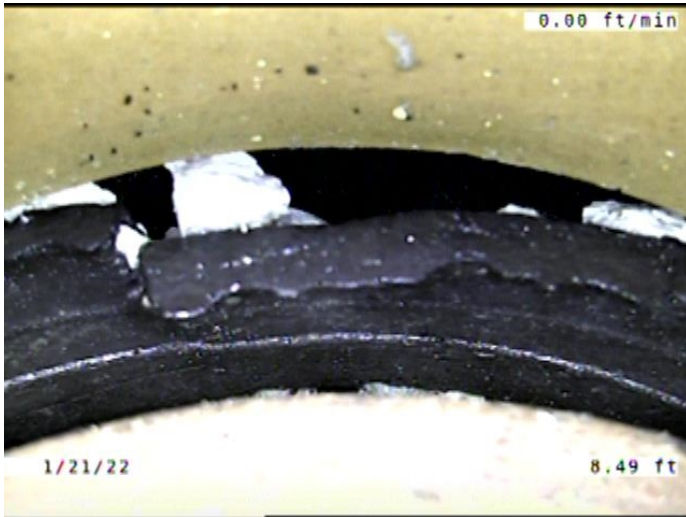
Code: **JOLD**  
 Description: **Joint Offset Large Defective**

Distance (ft): **8.5**  
 Structural Grade: **4**  
 O&M Grade: **0**  
 Clock Start/From:  
 Clock To:  
 1st Value:  
 2nd Value:  
 Value Percent:  
 Continuous Index:  
 Within 8" of Joint: **NO**  
 Remarks: **ROCKS/ SOIL VISIBLE**

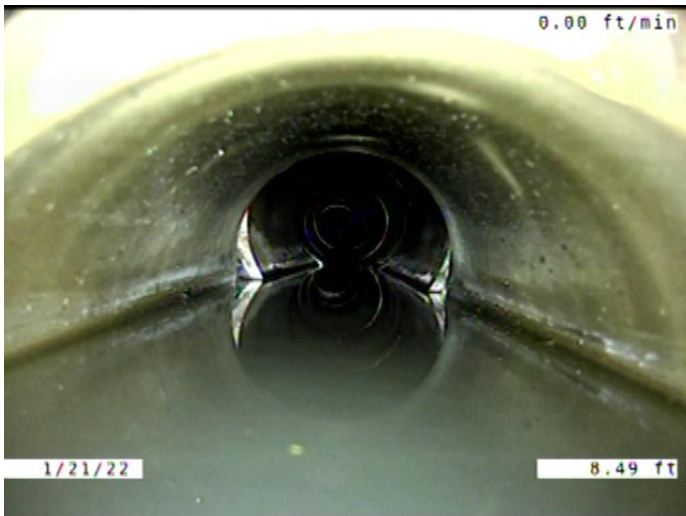
Code: **MWL**  
 Description: **Miscellaneous Water Level**

Distance (ft): **8.5**  
 Structural Grade: **0**  
 O&M Grade: **0**  
 Clock Start/From:  
 Clock To:  
 1st Value:  
 2nd Value:  
 Value Percent: **50.000**  
 Continuous Index:  
 Within 8" of Joint: **NO**  
 Remarks:

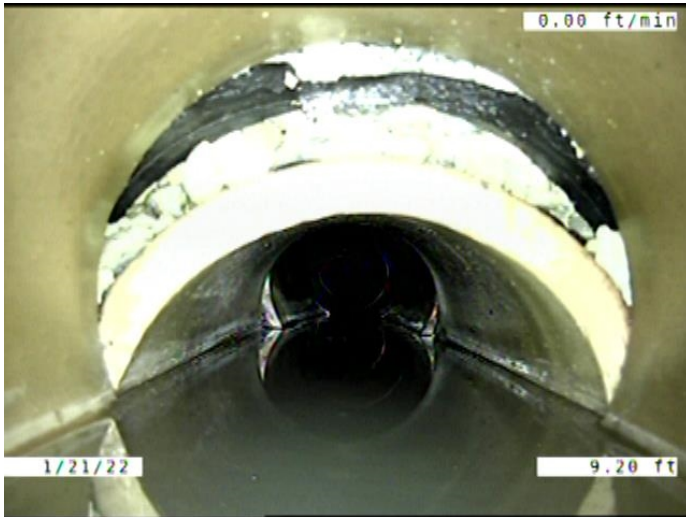
**MSA**

**Miscellaneous Survey Abandoned**

**9.2**

**CAMERA CANT MAKE IT PAST  
OFFSET JOINT. MADE IT TO POINT O**
