Profile/Photo Observation Report

| Pipe Length (ft): | 205.0 | Owner: | City of Hobart | Pre Clean: | Heavy Cleaning |

| Street: | West 7th Place | Flow Control: | Not Controlled |
| US MH: | M-506-011 | DS MH: | M-506-012 |

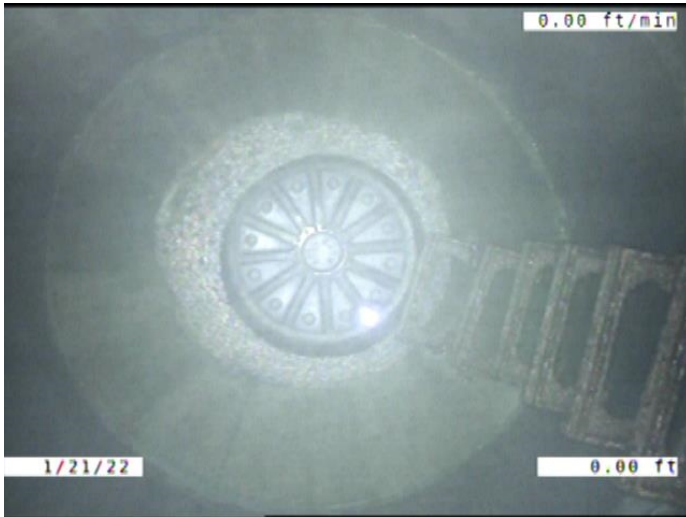
Code: **AMH**
 Description: **Manhole**

Distance (ft): **.0**
 Structural Grade: **0**
 O&M Grade: **0**
 Clock Start/From:
 Clock To:
 1st Value:
 2nd Value:
 Value Percent:
 Continuous Index:
 Within 8" of Joint: **NO**
 Remarks: **M-506-011**

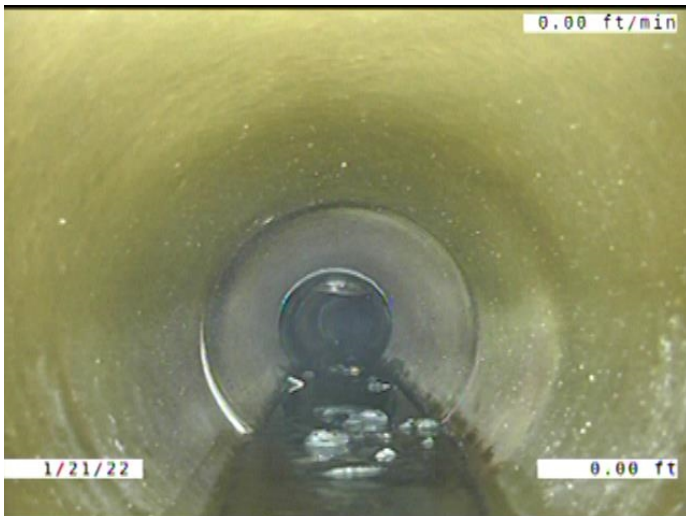
Code: **MWL**
 Description: **Miscellaneous Water Level**

Distance (ft): **.0**
 Structural Grade: **0**
 O&M Grade: **0**
 Clock Start/From:
 Clock To:
 1st Value:
 2nd Value:
 Value Percent: **5.000**
 Continuous Index:
 Within 8" of Joint: **NO**
 Remarks:

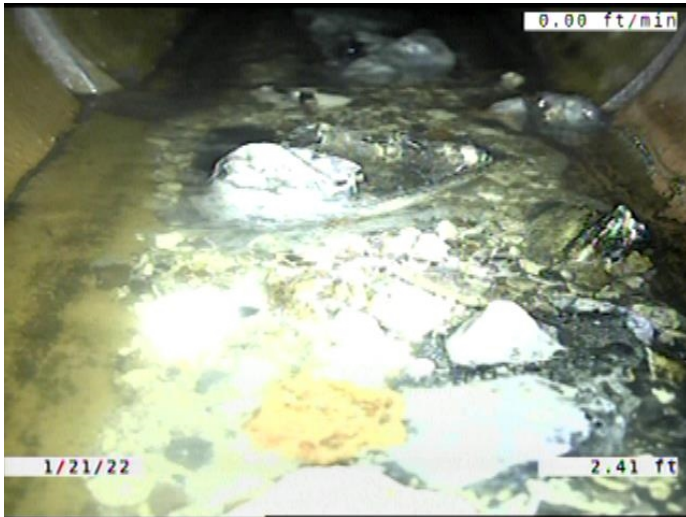
| Description: | Deposits Settled Other |
| Distance (ft): | 2.4 |
| O&M Grade: | 2 |
| Remarks: | PIECES OF ENCRUSTATION THAT WAS REMOVED FROM THE PIPE WA |

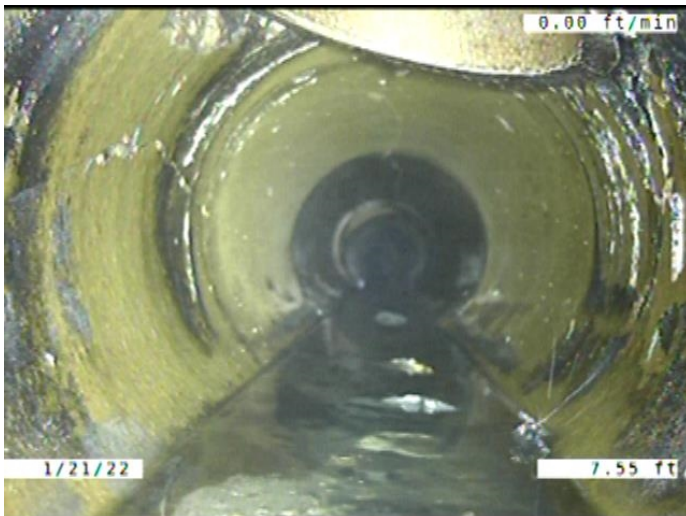
| Description: | Fracture Multiple |
| Distance (ft): | 7.6 |
| Structural Grade: | 4 |

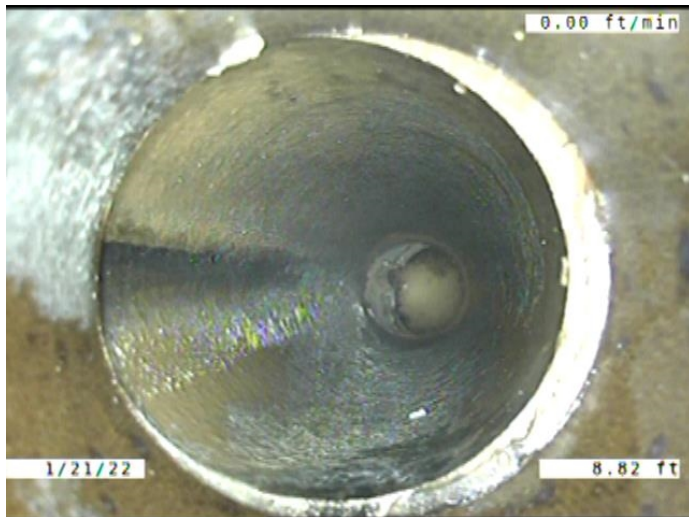
Code: **TBI**
Description: **Tap Break-in Intruding**

Distance (ft): **8.8**
Structural Grade: **0**
O&M Grade: **2**
Clock Start/From: **12**
Clock To:
1st Value: **6.000**
2nd Value: **2.000**
Value Percent:
Continuous Index:
Within 8" of Joint: **YES**
Remarks: **CONSTANTLY DRIPPING WATER**

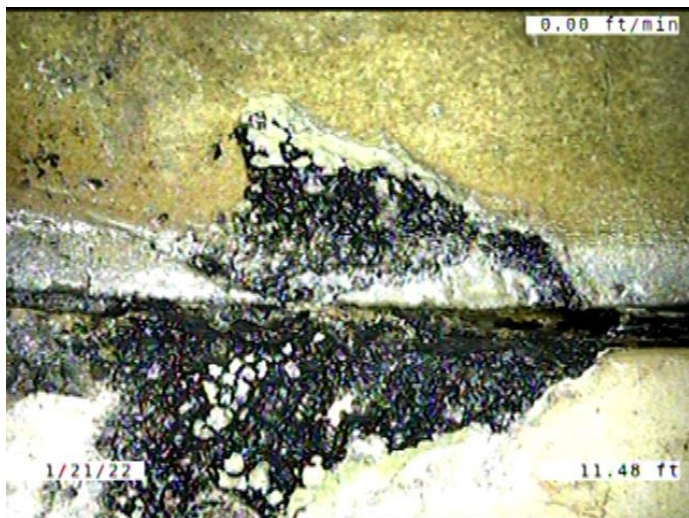
Code: **DAE**
Description: **Deposits Attached Encrustation**

Distance (ft): **11.5**
Structural Grade: **0**
O&M Grade: **2**
Clock Start/From: **7**
Clock To: **5**
1st Value:
2nd Value:
Value Percent: **5.000**
Continuous Index: **S03**
Within 8" of Joint: **YES**
Remarks:

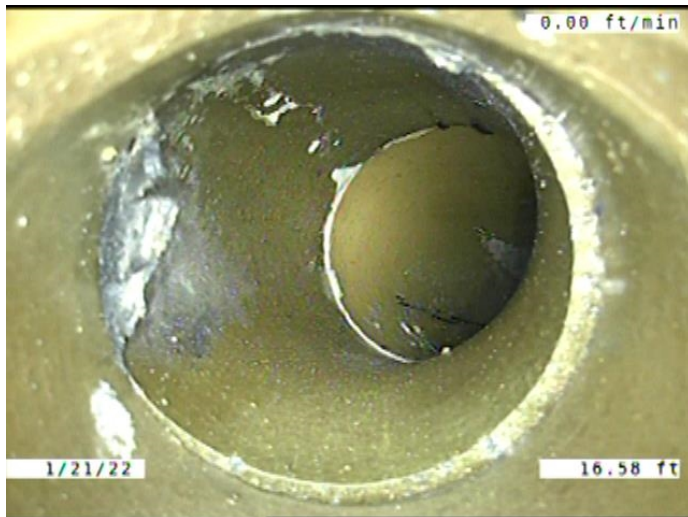
Code: **TF**
 Description: **Tap Factory**

Distance (ft): **16.6**
 Structural Grade: **0**
 O&M Grade: **0**
 Clock Start/From: **11**
 Clock To:
 1st Value: **6.000**
 2nd Value:
 Value Percent:
 Continuous Index:
 Within 8" of Joint: **YES**
 Remarks:

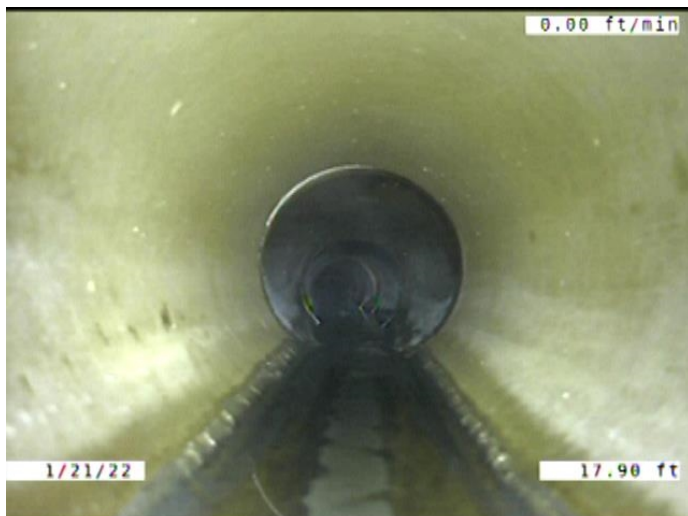
Code: **DSZ**
 Description: **Deposits Settled Other**

Distance (ft): **17.9**
 Structural Grade: **0**
 O&M Grade: **2**
 Clock Start/From: **5**
 Clock To: **7**
 1st Value:
 2nd Value:
 Value Percent: **5.000**
 Continuous Index: **F01**
 Within 8" of Joint: **YES**
 Remarks: **PIECES OF ENCRUSTATION THAT WAS REMOVED FROM THE PIPE WA**

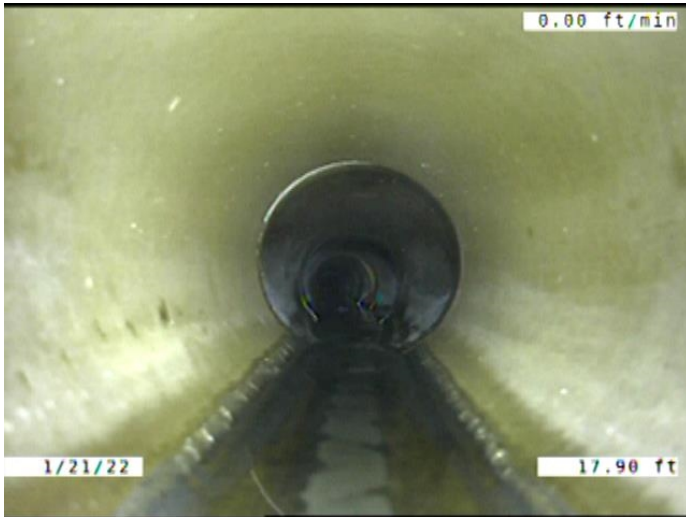
Code: **FM**
Description: **Fracture Multiple**

Distance (ft): **17.9**
Structural Grade: **4**
O&M Grade: **0**
Clock Start/From: **12**
Clock To: **12**
1st Value:
2nd Value:
Value Percent:
Continuous Index: **F02**
Within 8" of Joint: **YES**
Remarks:

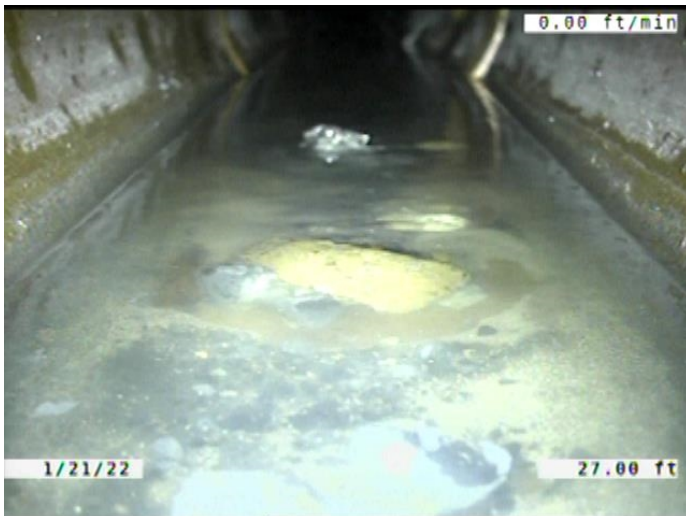
Code: **DSF**
Description: **Deposits Settled Fine**

Distance (ft): **27.0**
Structural Grade: **0**
O&M Grade: **2**
Clock Start/From: **5**
Clock To: **7**
1st Value:
2nd Value:
Value Percent: **5.000**
Continuous Index: **S04**
Within 8" of Joint: **YES**
Remarks:

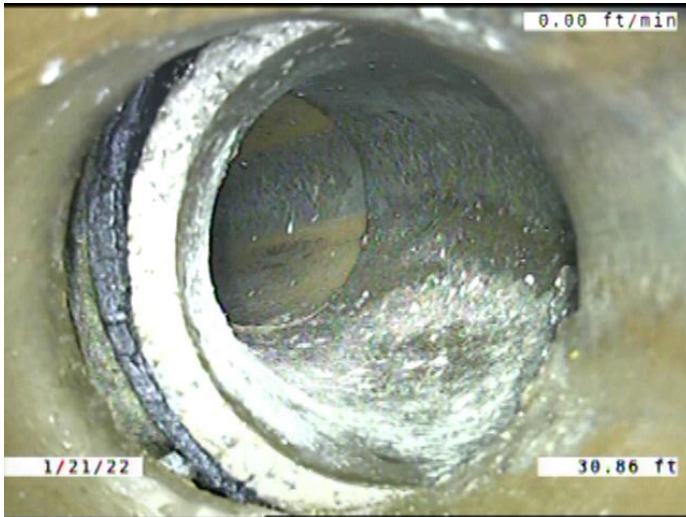
Code: **TFD**
Description: **Tap Factory Defective**

Distance (ft): **30.9**
Structural Grade: **0**
O&M Grade: **3**
Clock Start/From: **2**
Clock To:
1st Value: **6.000**
2nd Value:
Value Percent:
Continuous Index:
Within 8" of Joint: **YES**
Remarks: **BROKEN. OFFSET. SOIL VISIBLE**

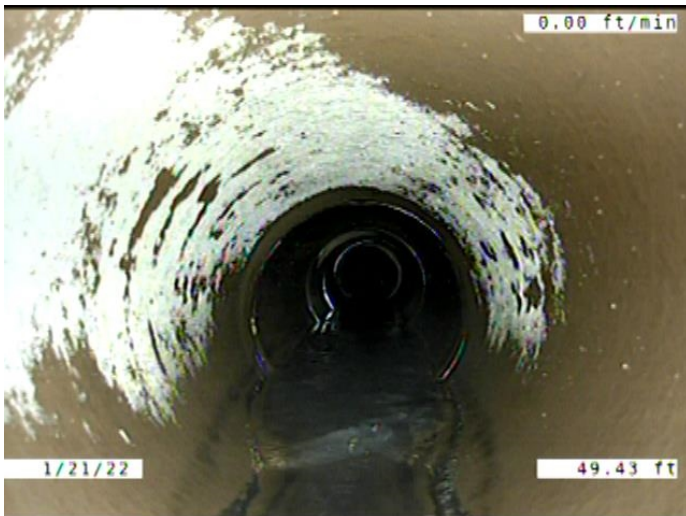
Code: **LD**
Description: **Line Down**

Distance (ft): **49.4**
Structural Grade: **0**
O&M Grade: **1**
Clock Start/From:
Clock To:
1st Value:
2nd Value:
Value Percent: **5.000**
Continuous Index:
Within 8" of Joint: **NO**
Remarks:

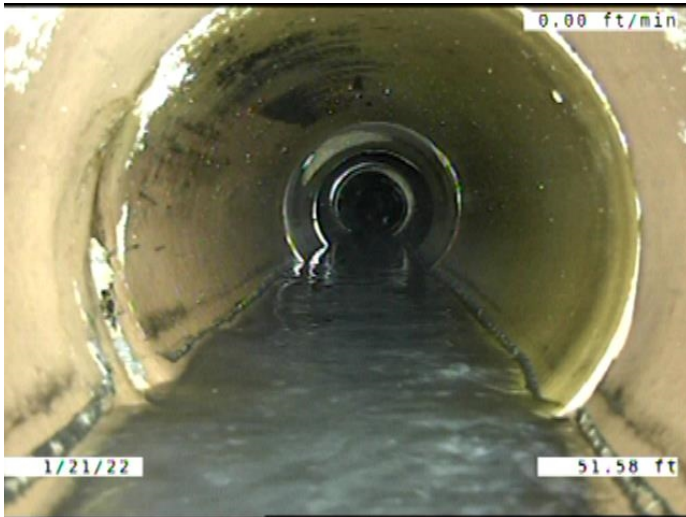
Code: **MWLS**
 Description: **Miscellaneous Water Level Sag**

Distance (ft): **51.6**
 Structural Grade: **2**
 O&M Grade: **0**
 Clock Start/From:
 Clock To:
 1st Value:
 2nd Value:
 Value Percent: **10.000**
 Continuous Index: **S05**
 Within 8" of Joint: **NO**
 Remarks:

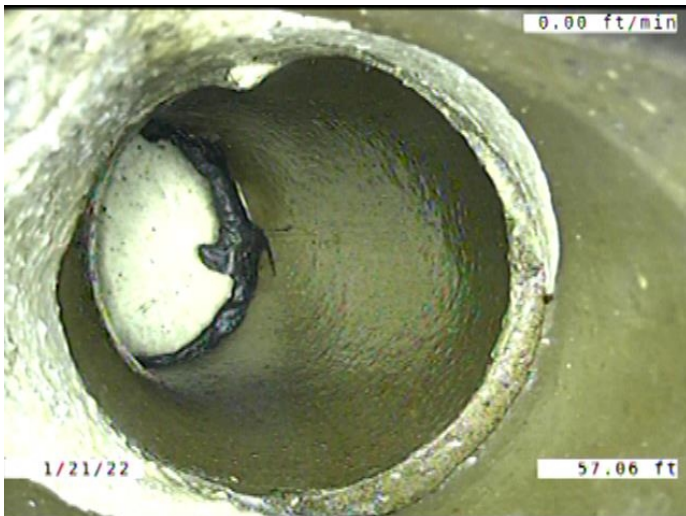
Code: **TFC**
 Description: **Tap Factory Capped**

Distance (ft): **57.1**
 Structural Grade: **0**
 O&M Grade: **0**
 Clock Start/From: **11**
 Clock To:
 1st Value: **6.000**
 2nd Value:
 Value Percent:
 Continuous Index:
 Within 8" of Joint: **YES**
 Remarks: **ENCUSTATION COMING FROM THE TAP TO MAIN CONNECTION.**

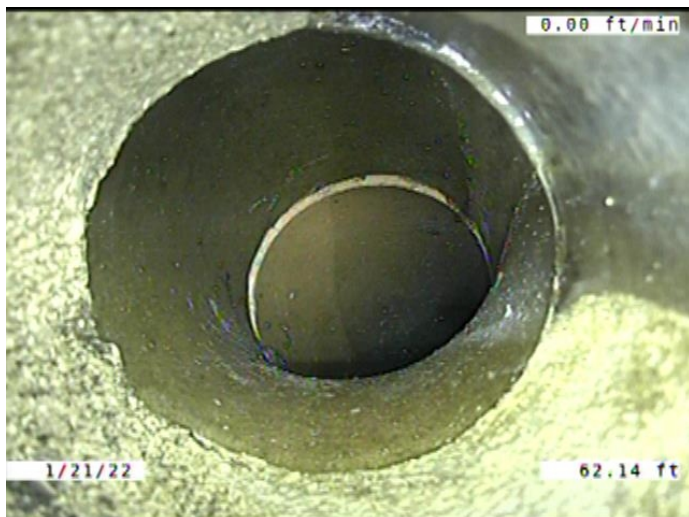
Code: **TF**
 Description: **Tap Factory**

Distance (ft): **62.1**
 Structural Grade: **0**
 O&M Grade: **0**
 Clock Start/From: **1**
 Clock To:
 1st Value: **6.000**
 2nd Value:
 Value Percent:
 Continuous Index:
 Within 8" of Joint: **YES**
 Remarks: **ENCUSTATION COMING FROM THE TAP TO MAIN CONNECTION.**

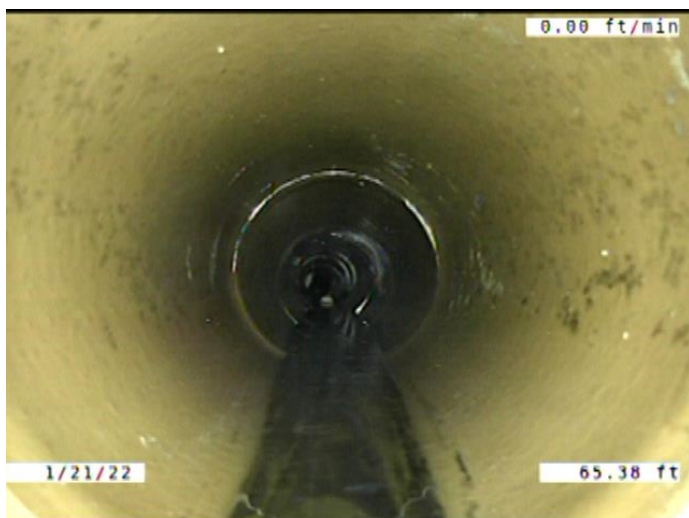
Code: **MWLS**
 Description: **Miscellaneous Water Level Sag**

Distance (ft): **65.4**
 Structural Grade: **2**
 O&M Grade: **0**
 Clock Start/From:
 Clock To:
 1st Value:
 2nd Value:
 Value Percent: **10.000**
 Continuous Index: **F05**
 Within 8" of Joint: **NO**
 Remarks:

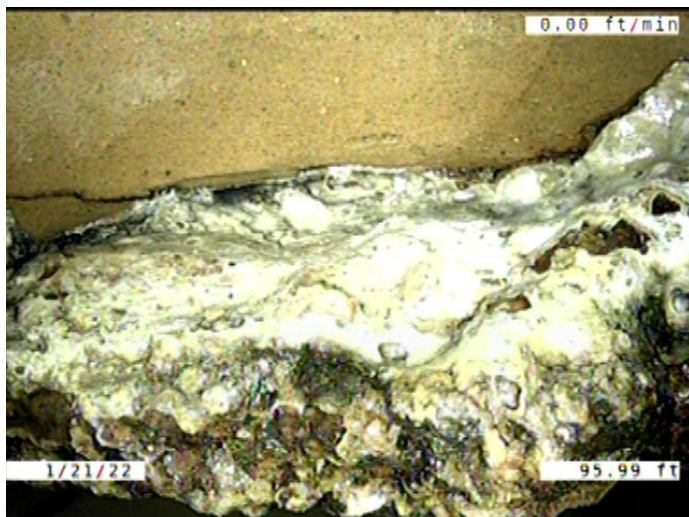
Code: **DAE**
 Description: **Deposits Attached Encrustation**

Distance (ft): **96.0**
 Structural Grade: **0**
 O&M Grade: **3**
 Clock Start/From: **7**
 Clock To: **5**
 1st Value:
 2nd Value:
 Value Percent: **15.000**
 Continuous Index:
 Within 8" of Joint: **YES**
 Remarks:

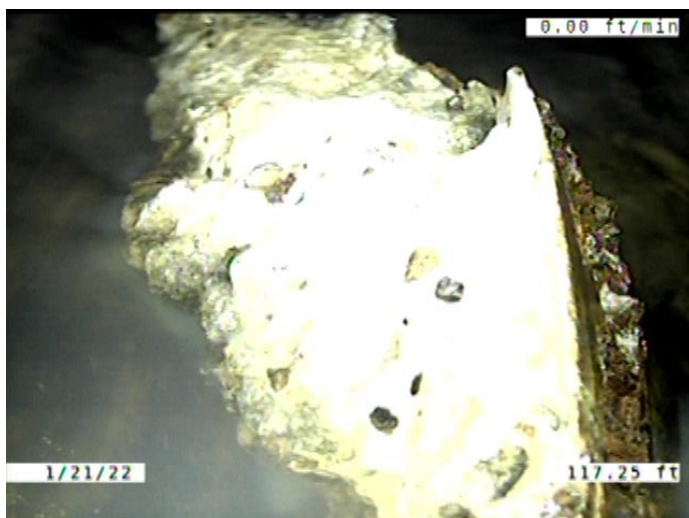
Code: **DSZ**
 Description: **Deposits Settled Other**

Distance (ft): **117.3**
 Structural Grade: **0**
 O&M Grade: **2**
 Clock Start/From: **6**
 Clock To:
 1st Value:
 2nd Value:
 Value Percent: **5.000**
 Continuous Index:
 Within 8" of Joint: **NO**
 Remarks: **A PIECE OF ENCRUSTATION THAT WAS CUT OFF THE PIPE WALLS**

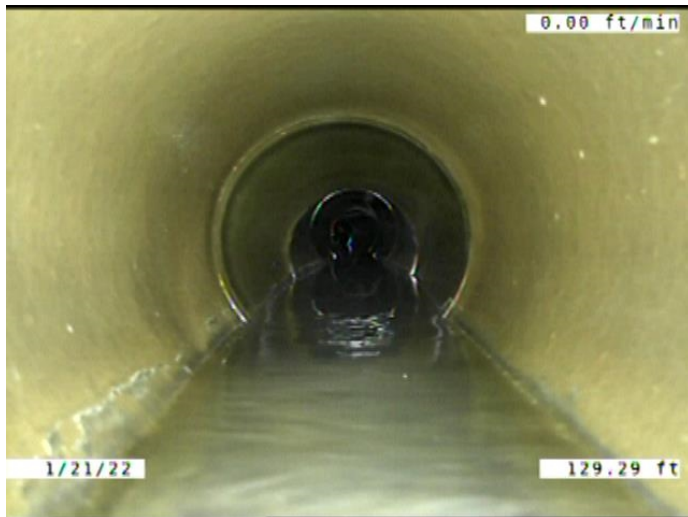
Code: **MWLS**
Description: **Miscellaneous Water Level Sag**

Distance (ft): **129.3**
Structural Grade: **2**
O&M Grade: **0**
Clock Start/From:
Clock To:
1st Value:
2nd Value:
Value Percent: **15.000**
Continuous Index: **S06**
Within 8" of Joint: **NO**
Remarks:

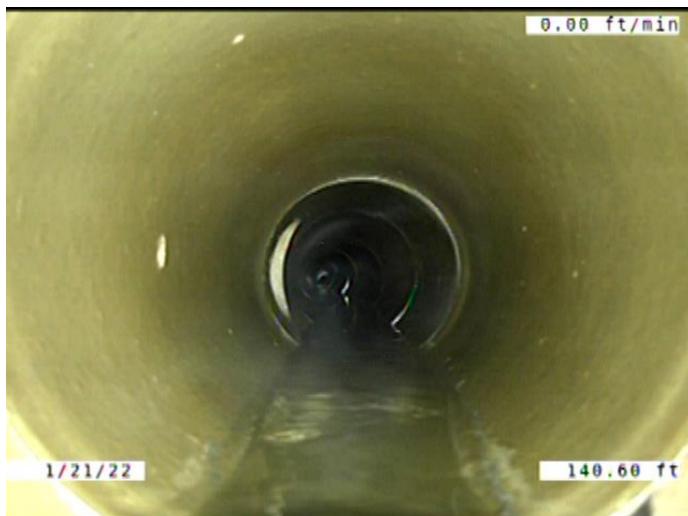
Code: **MWLS**
Description: **Miscellaneous Water Level Sag**

Distance (ft): **140.6**
Structural Grade: **2**
O&M Grade: **0**
Clock Start/From:
Clock To:
1st Value:
2nd Value:
Value Percent: **15.000**
Continuous Index: **F06**
Within 8" of Joint: **NO**
Remarks:

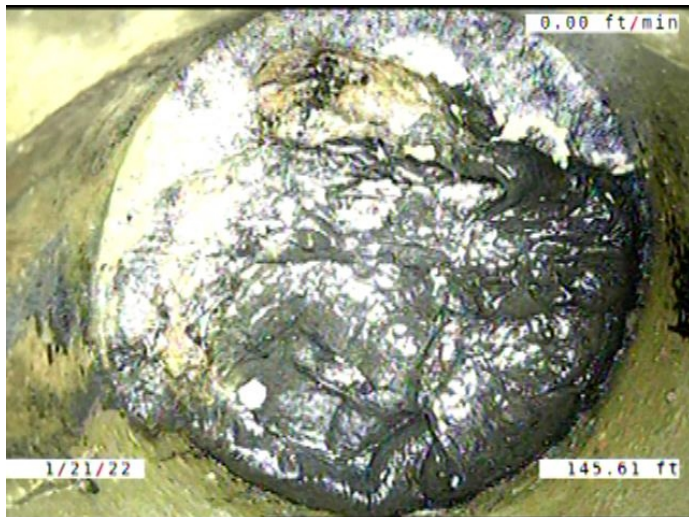
Code: **TFC**
 Description: **Tap Factory Capped**

Distance (ft): **145.6**
 Structural Grade: **0**
 O&M Grade: **0**
 Clock Start/From: **9**
 Clock To:
 1st Value: **6.000**
 2nd Value:
 Value Percent:
 Continuous Index:
 Within 8" of Joint: **YES**
 Remarks:

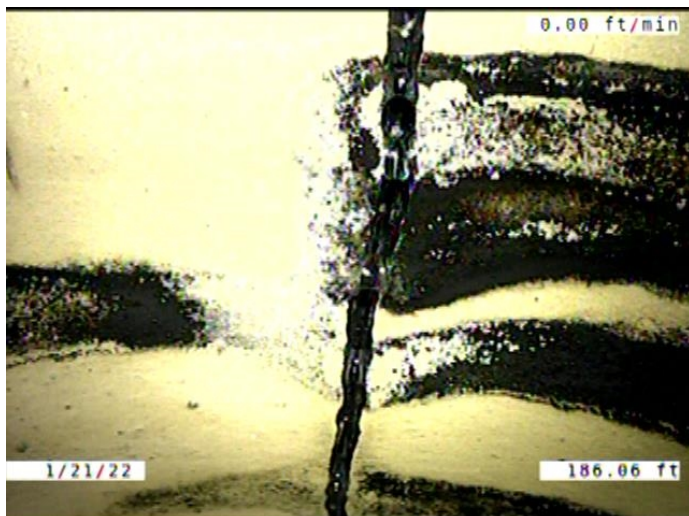
Code: **IRB**
 Description: **Infiltration Runner Barrel**

Distance (ft): **186.1**
 Structural Grade: **0**
 O&M Grade: **4**
 Clock Start/From: **12**
 Clock To:
 1st Value:
 2nd Value:
 Value Percent:
 Continuous Index:
 Within 8" of Joint: **YES**
 Remarks:

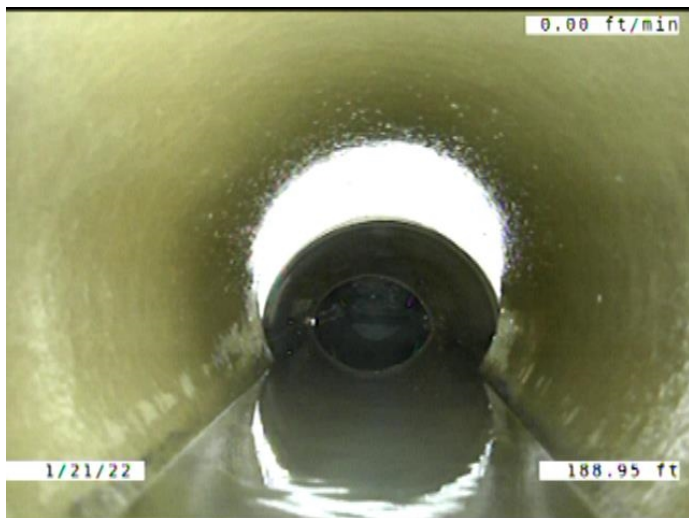
Code: **MWLS**
 Description: **Miscellaneous Water Level Sag**

Distance (ft): **188.9**
 Structural Grade: **3**
 O&M Grade: **0**
 Clock Start/From:
 Clock To:
 1st Value:
 2nd Value:
 Value Percent: **50.000**
 Continuous Index: **S07**
 Within 8" of Joint: **NO**
 Remarks:

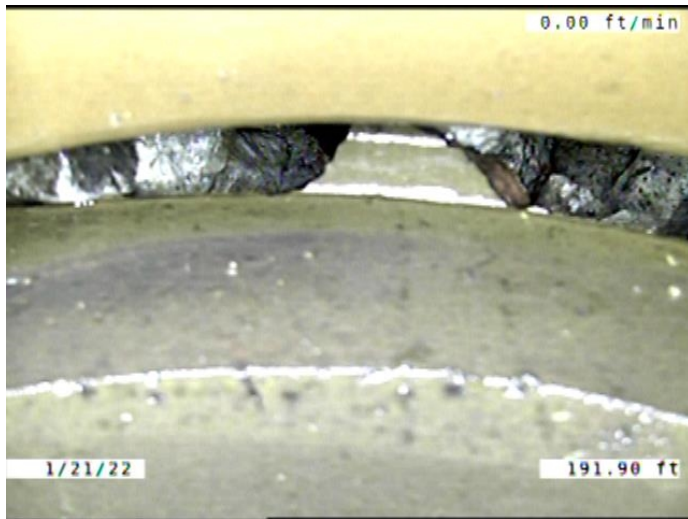
Code: **JOLD**
 Description: **Joint Offset Large Defective**

Distance (ft): **191.9**
 Structural Grade: **4**
 O&M Grade: **0**
 Clock Start/From:
 Clock To:
 1st Value:
 2nd Value:
 Value Percent:
 Continuous Index:
 Within 8" of Joint: **NO**
 Remarks: **SOIL VISIBLE**

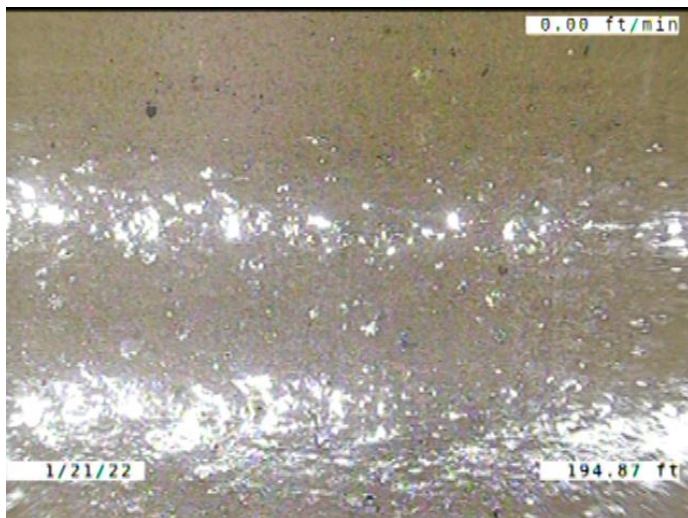
Code: **MCU**
 Description: **Miscellaneous Camera Underwater**

Distance (ft): **194.9**
 Structural Grade: **0**
 O&M Grade: **4**
 Clock Start/From:
 Clock To:
 1st Value:
 2nd Value:
 Value Percent:
 Continuous Index:
 Within 8" of Joint: **NO**
 Remarks: **Out at 195.5**

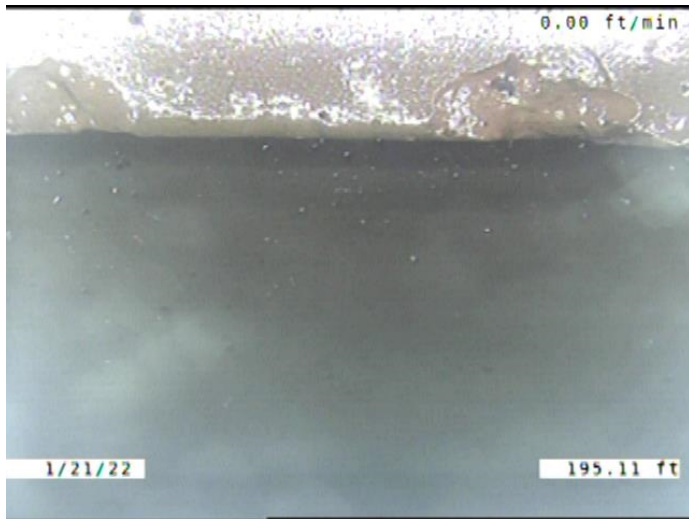
Code: **JOLD**
Description: **Joint Offset Large Defective**

Distance (ft): **195.1**
Structural Grade: **4**
O&M Grade: **0**
Clock Start/From:
Clock To:
1st Value:
2nd Value:
Value Percent:
Continuous Index:
Within 8" of Joint: **NO**
Remarks: **SOIL VISIBLE**

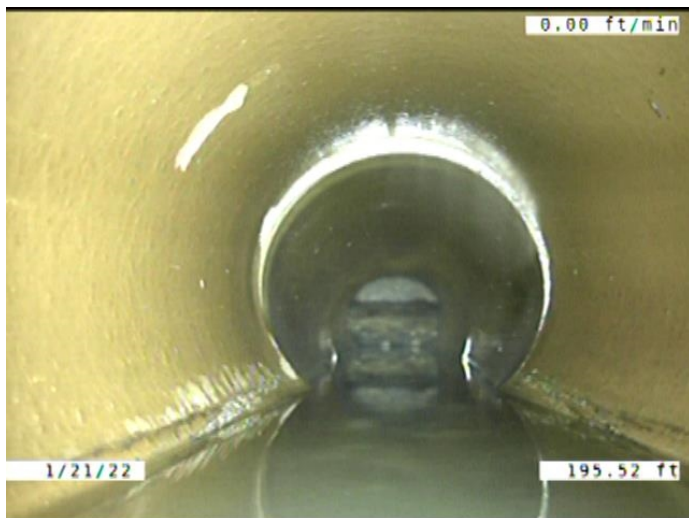
Code: **MWLS**
Description: **Miscellaneous Water Level Sag**

Distance (ft): **195.5**
Structural Grade: **3**
O&M Grade: **0**
Clock Start/From:
Clock To:
1st Value:
2nd Value:
Value Percent: **50.000**
Continuous Index: **F07**
Within 8" of Joint: **NO**
Remarks:

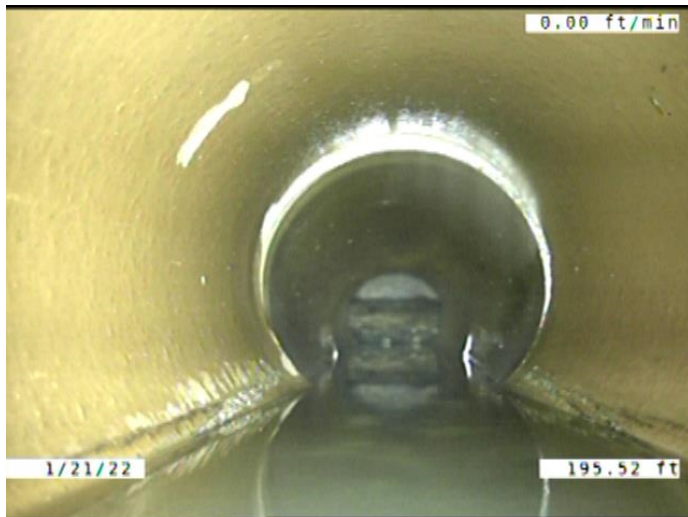
Code: **DAE**
Description: **Deposits Attached Encrustation**

Distance (ft): **195.5**
Structural Grade: **0**
O&M Grade: **2**
Clock Start/From: **7**
Clock To: **5**
1st Value:
2nd Value:
Value Percent: **5.000**
Continuous Index: **F03**
Within 8" of Joint: **YES**
Remarks:

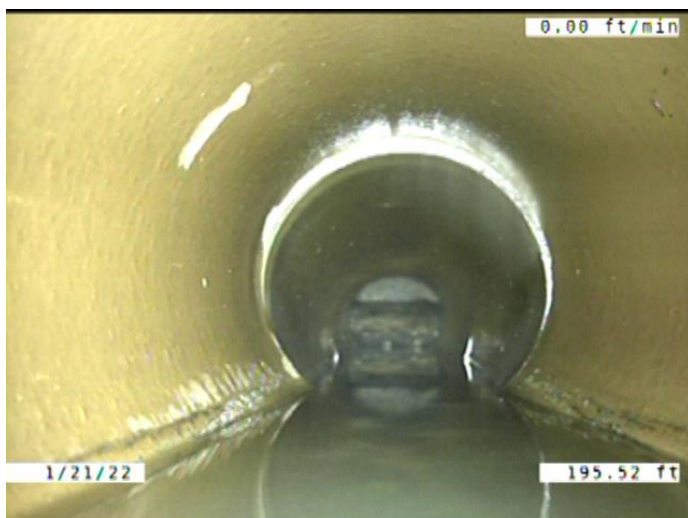
Code: **DSF**
Description: **Deposits Settled Fine**

Distance (ft): **195.5**
Structural Grade: **0**
O&M Grade: **2**
Clock Start/From: **5**
Clock To: **7**
1st Value:
2nd Value:
Value Percent: **5.000**
Continuous Index: **F04**
Within 8" of Joint: **YES**
Remarks:

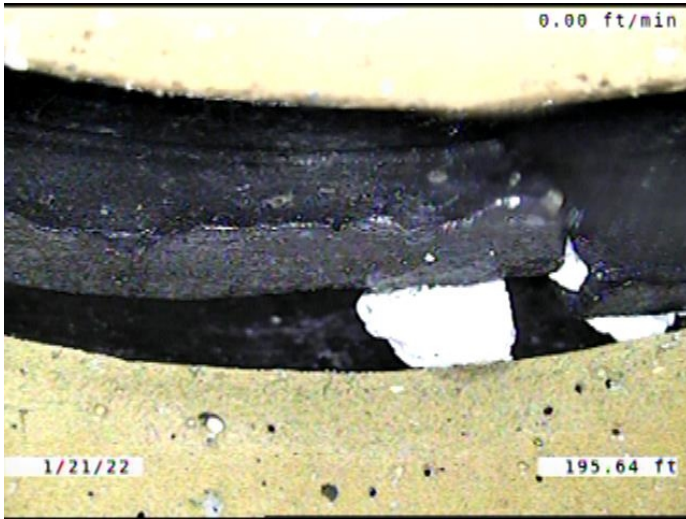
| Description: | Miscellaneous Survey Abandoned |
| Distance (ft): | 195.6 |
| Remarks: | CAMERA CANT MAKE IT PAST OFFSET JOINT. |
