Profile/Photo Observation Report

| Street: | W 7TH PL | Flow Control: | Not Controlled |
| City: | Hobart, IN | Year Renewed: | |
| US MH: | M-506-012 | DS MH: | M-506-013 |

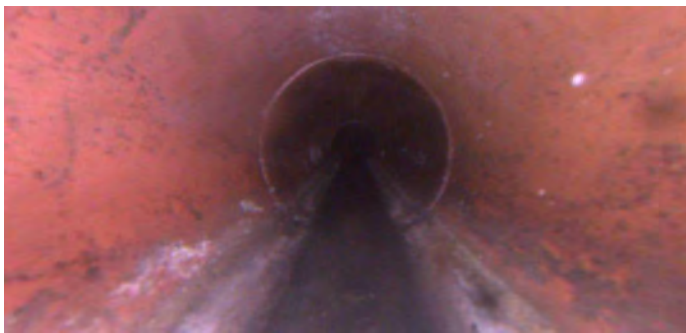
Code: **AMH**
Description: **Manhole**

Distance (ft): **.0**
Structural Grade: **0**
O&M Grade: **0**
Clock Start/From:
Clock To:
1st Value:
2nd Value:
Value Percent:
Continuous Index:
Within 8" of Joint: **NO**
Remarks: **M-506-013**

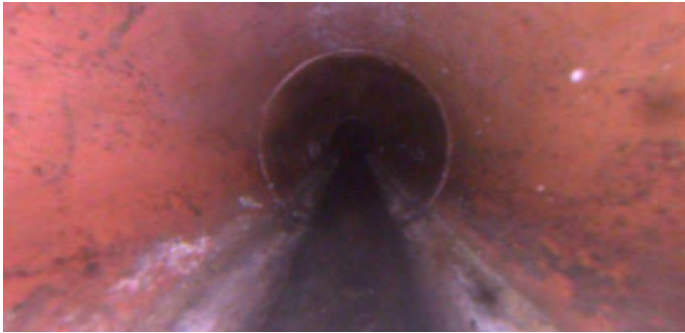
| Code: | MWL |
| Description: | Water Level |

| Value Percent: | 5.000 |

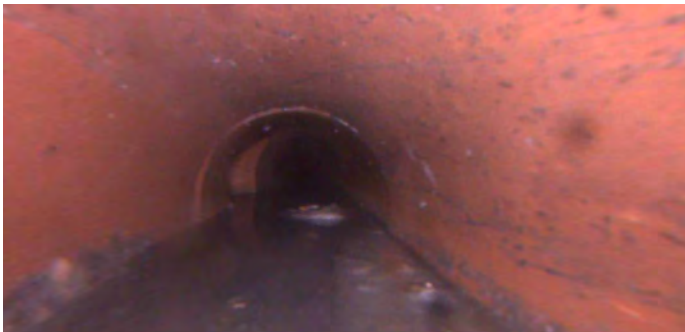
| Code: | DSZ |
| Description: | Deposits Settled Other |

| Distance (ft): | 8.7 |
| O&M Grade: | 2 |
| Remarks: | tissue |

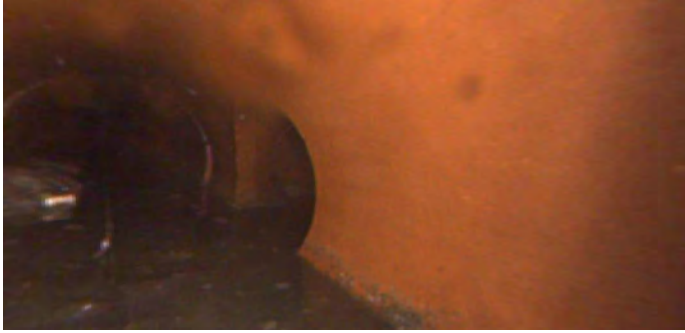
Code: **TF**
Description: **Tap Factory**

Distance (ft): **11.7**
Structural Grade: **0**
O&M Grade: **0**
Clock Start/From: **9**
Clock To:
1st Value: **4.000**
2nd Value:
Value Percent:
Continuous Index:
Within 8" of Joint: **YES**
Remarks:
