Profile/Photo Observation Report

Date:	04/07/2018	Weather:		Coding:	PACP 6.0
Pipe Length (ft):	203.4	Owner:	NA	Pre Clean:	No Pre-Cleaning
P.O.#:		Surveyor:	Byrd Fitzgerald	PSR:	P-506-013-012
Customer:		Clean Date:	01/01/1900	Shape:	C

Street:	FOXCROFT STREET	Flow Control:	Not Controlled
City:	Hobart, IN	Year Renewed:	
Location:	Yard	Tape/Media #:	
Purpose:	Routine Assessment	Dia/Height:	10"
Use:	Sanitary	Material:	VCP
Drain Area:	NA	Lining:	
Category:	NA		
Comment:	Roll_Max 27lf debris, flow direction is marked wrong.		
Location Details:		Direction of Survey:	Upstream
US MH:	M-506-012	DS MH:	M-506-013
		Total Length Surveyed (ft):	28.7

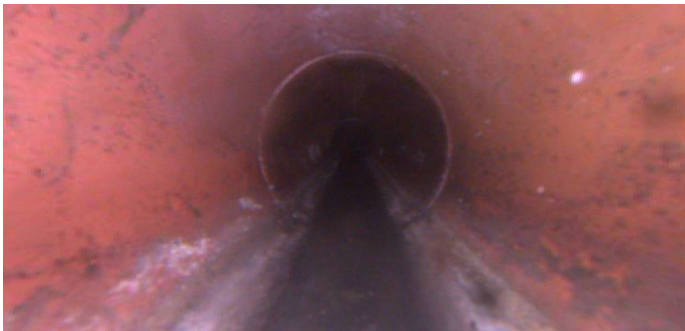
Code: **AMH**
Description: **Manhole**

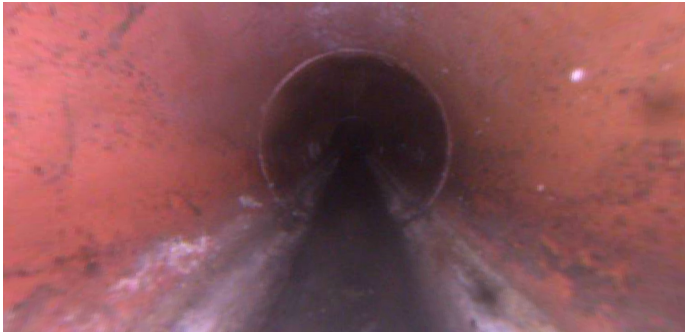
Code:	MWL
Description:	Water Level

Distance (ft):	.0
Structural Grade:	0
O&M Grade:	0
Clock Start/From:	
Clock To:	
1st Value:	
2nd Value:	
Value Percent:	5.000
Continuous Index:	
Within 8" of Joint:	NO
Remarks:

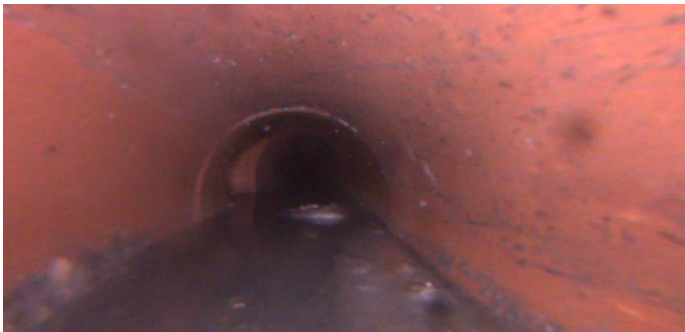
Code:	DSZ
Description:	Deposits Settled Other

Distance (ft):	8.7
Structural Grade:	0
O&M Grade:	2
Clock Start/From:	6
Clock To:	
1st Value:	
2nd Value:	
Value Percent:	5.000
Continuous Index:	S01
Within 8" of Joint:	NO
Remarks:	tissue

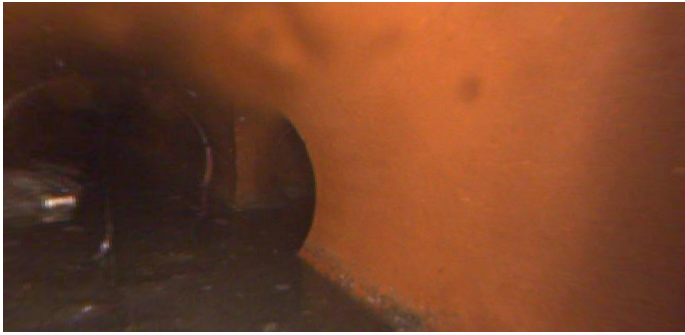
Code: **TF**
Description: **Tap Factory**

Distance (ft): **11.7**
Structural Grade: **0**
O&M Grade: **0**
Clock Start/From: **9**
Clock To:
1st Value: **4.000**
2nd Value:
Value Percent:
Continuous Index:
Within 8" of Joint: **YES**
Remarks:

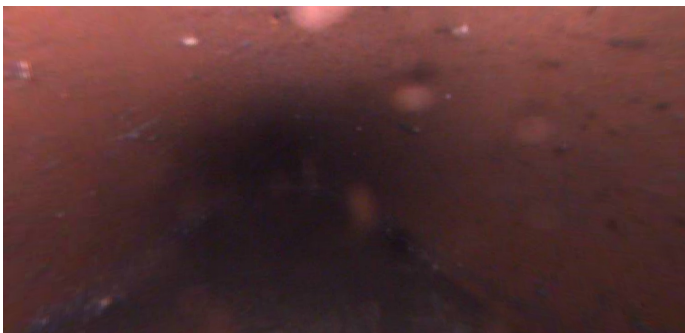
Code: **MSA**
Description: **Abandoned Survey**

Distance (ft): **28.7**
Structural Grade: **0**
O&M Grade: **0**
Clock Start/From:
Clock To:
1st Value:
2nd Value:
Value Percent:
Continuous Index:
Within 8" of Joint: **NO**
Remarks: **no blockage**

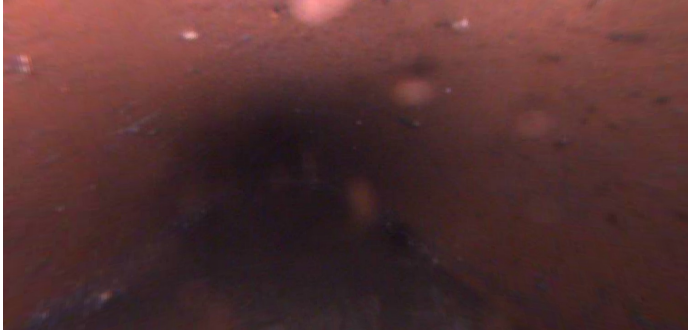
Code:	DSZ
Description:	Deposits Settled Other
Distance (ft):	28.7
Structural Grade:	0
O&M Grade:	2
Clock Start/From:	6
Clock To:	
1st Value:	
2nd Value:	
Value Percent:	5.000
Continuous Index:	F01
Within 8" of Joint:	NO
Remarks:	tissue
