Profile/Photo Observation Report

Date:	04/07/2018	Weather:		Coding:	PACP 6.0
Pipe Length (ft):	203.4	Owner:	NA	Pre Clean:	No Pre-Cleaning
P.O.#:		Surveyor:	Byrd Fitzgerald	PSR:	P-506-013-012
Customer:		Clean Date:	01/01/1900	Shape:	C

Street:	W 7TH PL	Flow Control:	Not Controlled
City:	Hobart, IN	Year Renewed:	
Location:	Yard	Tape/Media #:	
Purpose:	Routine Assessment	Dia/Height:	10"
Use:	Sanitary	Material:	VCP
Drain Area:	NA	Lining:	
Category:	NA		
Comment:	Roll_Max 30lf debris, flow direction is marked wrong.		
Location Details:		Direction of Survey:	Downstream
US MH:	M-506-012	DS MH:	M-506-013
		Total Length Surveyed (ft):	31.9

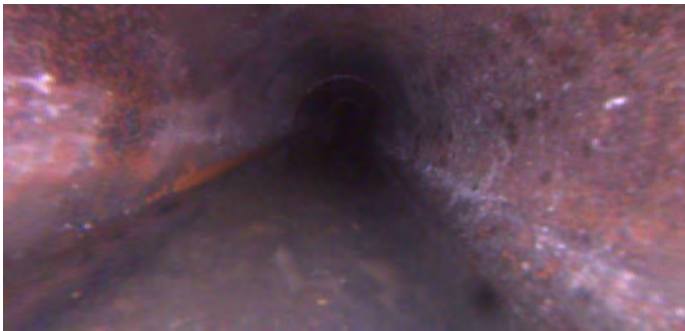
Code: **AMH**
Description: **Manhole**

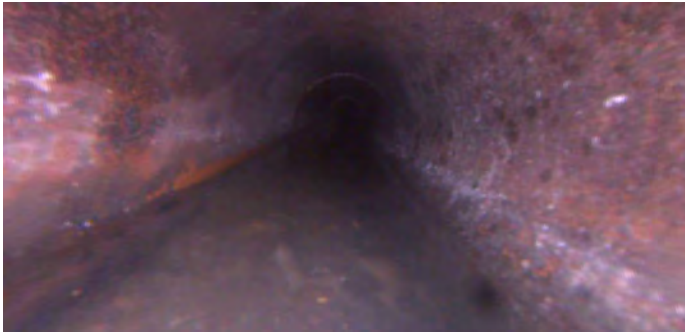
Code:	MWL
Description:	Water Level

Distance (ft):	.0
Structural Grade:	0
O&M Grade:	0
Clock Start/From:	
Clock To:	
1st Value:	
2nd Value:	
Value Percent:	5.000
Continuous Index:	
Within 8" of Joint:	NO
Remarks:

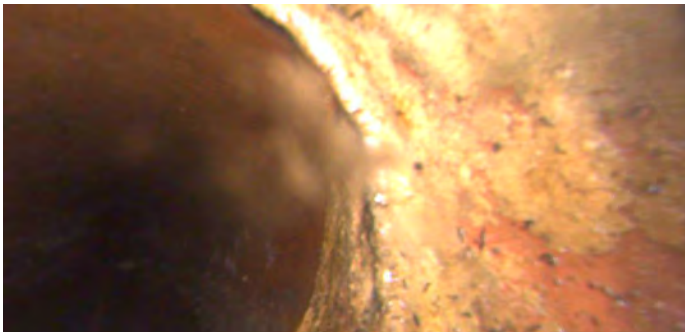
Code:	DAZ
Description:	Deposits Attached Other

Distance (ft):	7.8
Structural Grade:	0
O&M Grade:	2
Clock Start/From:	7
Clock To:	5
1st Value:	
2nd Value:	
Value Percent:	5.000
Continuous Index:	S01
Within 8" of Joint:	YES
Remarks:	into barrel

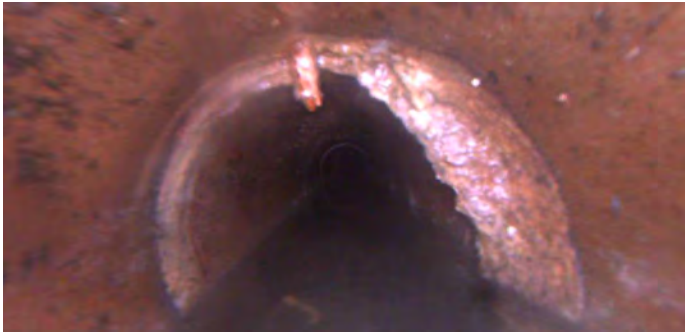
Code: **DAE**
Description: **Deposits Attached Encrustation**

Distance (ft): **18.9**
Structural Grade: **0**
O&M Grade: **2**
Clock Start/From: **12**
Clock To: **5**
1st Value:
2nd Value:
Value Percent: **10.000**
Continuous Index:
Within 8" of Joint: **YES**
Remarks:

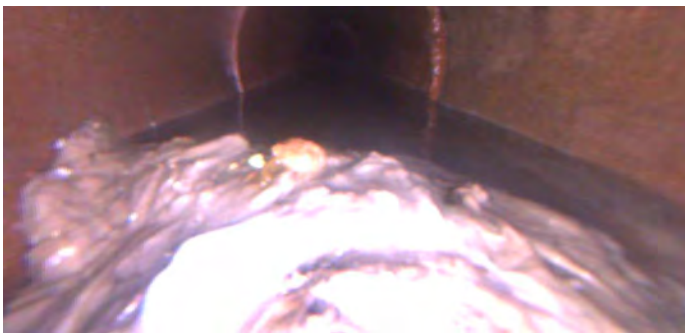
Code: **DSZ**
Description: **Deposits Settled Other**

Distance (ft): **30.4**
Structural Grade: **0**
O&M Grade: **3**
Clock Start/From: **6**
Clock To:
1st Value:
2nd Value:
Value Percent: **20.000**
Continuous Index:
Within 8" of Joint: **NO**
Remarks: **tissue/debris**

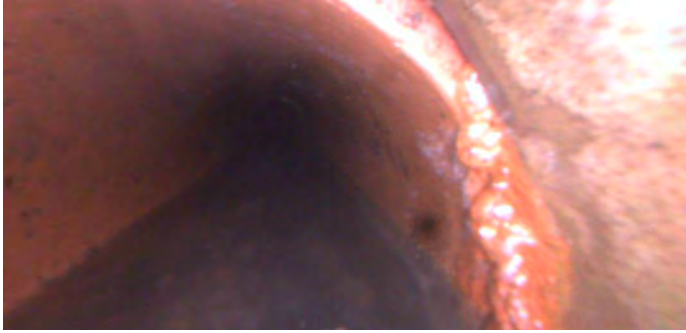
Code: **DAE**
Description: **Deposits Attached Encrustation**

Distance (ft): **31.3**
Structural Grade: **0**
O&M Grade: **2**
Clock Start/From: **3**
Clock To: **5**
1st Value:
2nd Value:
Value Percent: **5.000**
Continuous Index:
Within 8" of Joint: **YES**
Remarks:

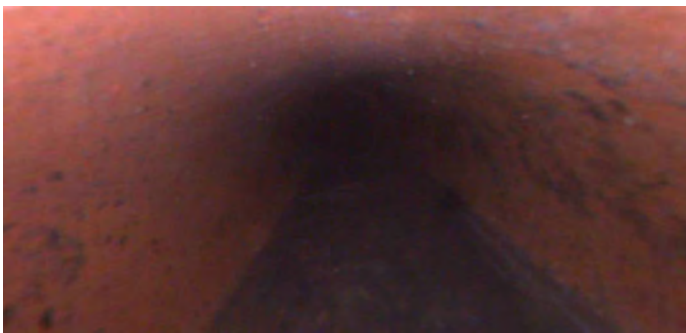
Code: **MSA**
Description: **Abandoned Survey**

Distance (ft): **31.9**
Structural Grade: **0**
O&M Grade: **0**
Clock Start/From:
Clock To:
1st Value:
2nd Value:
Value Percent:
Continuous Index:
Within 8" of Joint: **NO**
Remarks: **dsz**

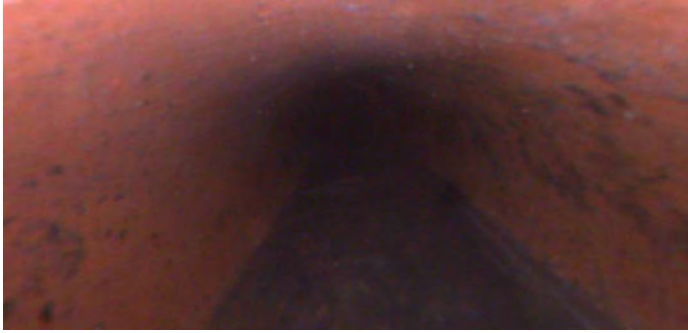
Code:	DAZ
Description:	Deposits Attached Other
Distance (ft):	31.9
Structural Grade:	0
O&M Grade:	2
Clock Start/From:	7
Clock To:	5
1st Value:	
2nd Value:	
Value Percent:	5.000
Continuous Index:	F01
Within 8" of Joint:	YES
Remarks:	into barrel
