Profile/Photo Observation Report

Date:	04/07/2018	Weather:		Coding:	PACP 6.0
Pipe Length (ft):	203.4	Owner:	NA	Pre Clean:	No Pre-Cleaning
P.O.#:		Surveyor:	Byrd Fitzgerald	PSR:	P-506-013-012
Customer:		Clean Date:	01/01/1900	Shape:	C

Street:	FOXCROFT STREET	Flow Control:	Not Controlled
City:	Hobart, IN	Year Renewed:	
Location:	Yard	Tape/Media #:	
Purpose:	Routine Assessment	Dia/Height:	10"
Use:	Sanitary	Material:	VCP
Drain Area:	NA	Lining:	
Category:	NA		
Comment:	Roll_Max 30lf debris, flow direction is marked wrong.		
Location Details:		Direction of Survey:	Downstream
US MH:	M-506-012	DS MH:	M-506-013
		Total Length Surveyed (ft):	31.9

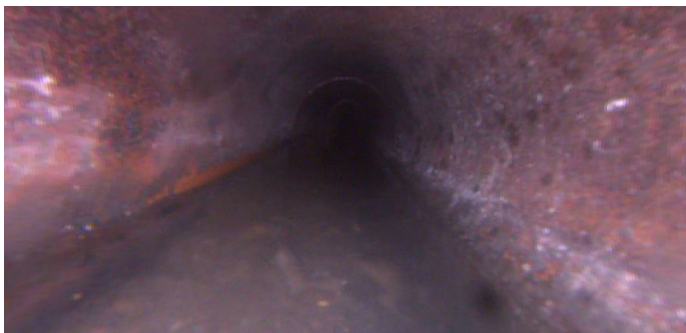
Code: **AMH**
Description: **Manhole**

Distance (ft): **.0**
Structural Grade: **0**
O&M Grade: **0**
Clock Start/From:
Clock To:
1st Value:
2nd Value:
Value Percent:
Continuous Index:
Within 8" of Joint: **NO**
Remarks: **M-506-012**

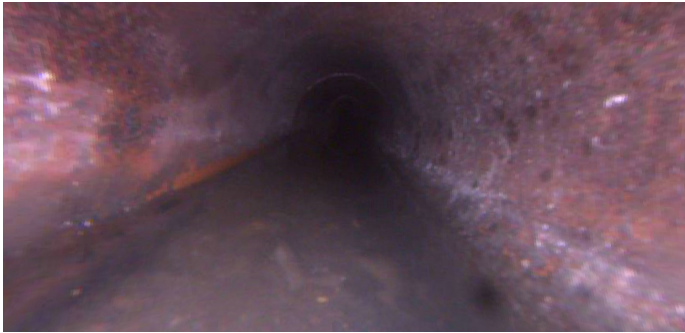
Code:	MWL
Description:	Water Level

Distance (ft):	.0
Structural Grade:	0
O&M Grade:	0
Clock Start/From:	
Clock To:	
1st Value:	
2nd Value:	
Value Percent:	5.000
Continuous Index:	
Within 8" of Joint:	NO
Remarks:

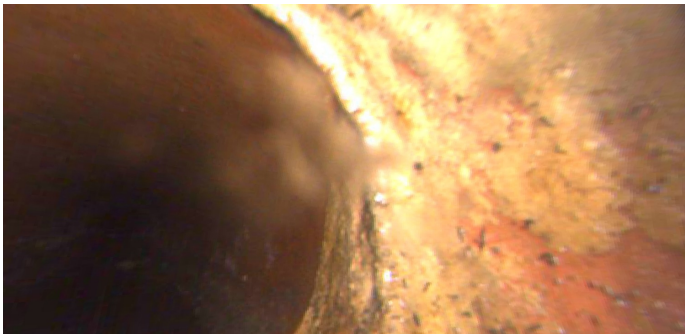
Code:	DAZ
Description:	Deposits Attached Other

Distance (ft):	7.8
Structural Grade:	0
O&M Grade:	2
Clock Start/From:	7
Clock To:	5
1st Value:	
2nd Value:	
Value Percent:	5.000
Continuous Index:	S01
Within 8" of Joint:	YES
Remarks:	into barrel

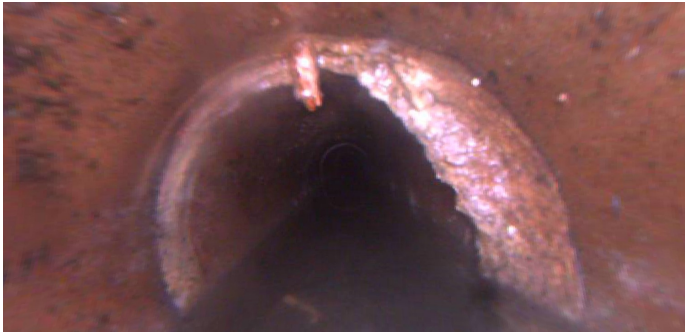
Code: **DAE**
Description: **Deposits Attached Encrustation**

Distance (ft): **18.9**
Structural Grade: **0**
O&M Grade: **2**
Clock Start/From: **12**
Clock To: **5**
1st Value:
2nd Value:
Value Percent: **10.000**
Continuous Index:
Within 8" of Joint: **YES**
Remarks:

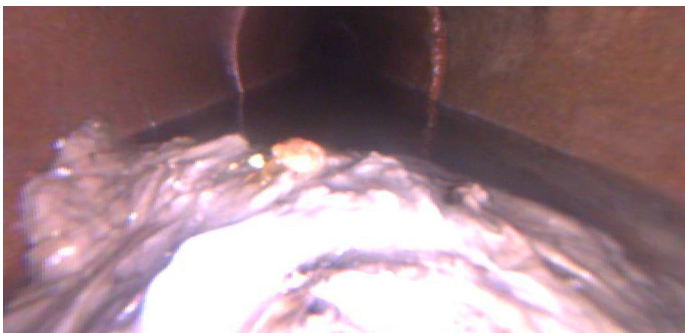
Code: **DSZ**
Description: **Deposits Settled Other**

Distance (ft): **30.4**
Structural Grade: **0**
O&M Grade: **3**
Clock Start/From: **6**
Clock To:
1st Value:
2nd Value:
Value Percent: **20.000**
Continuous Index:
Within 8" of Joint: **NO**
Remarks: **tissue/debris**

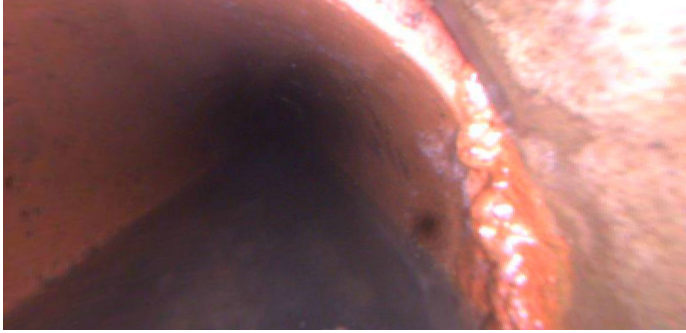
Code: **DAE**
Description: **Deposits Attached Encrustation**

Distance (ft): **31.3**
Structural Grade: **0**
O&M Grade: **2**
Clock Start/From: **3**
Clock To: **5**
1st Value:
2nd Value:
Value Percent: **5.000**
Continuous Index:
Within 8" of Joint: **YES**
Remarks:

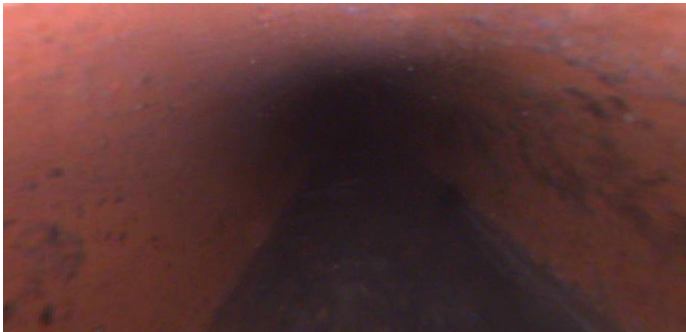
Code: **MSA**
Description: **Abandoned Survey**

Distance (ft): **31.9**
Structural Grade: **0**
O&M Grade: **0**
Clock Start/From:
Clock To:
1st Value:
2nd Value:
Value Percent:
Continuous Index:
Within 8" of Joint: **NO**
Remarks: **dsz**

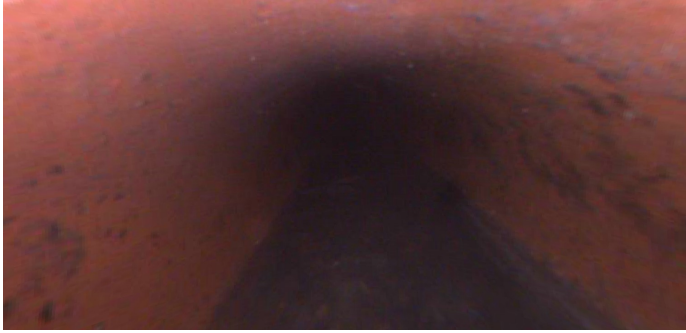
Code:	DAZ
Description:	Deposits Attached Other
Distance (ft):	31.9
Structural Grade:	0
O&M Grade:	2
Clock Start/From:	7
Clock To:	5
1st Value:	
2nd Value:	
Value Percent:	5.000
Continuous Index:	F01
Within 8" of Joint:	YES
Remarks:	into barrel
