Profile/Photo Observation Report

Date:	01/21/2022	Weather:		Coding:	PACP 7.0
Pipe Length (ft):	200.3	Owner:	City of Hobart	Pre Clean:	Heavy Cleaning
P.O.#:	YES502259	Surveyor:	S. Bucklin	PSR:	P-506-013-012
Customer:	City of Hobart	Clean Date:	01/17/2022	Shape:	C

Street:	West 7th Place	Flow Control:	Not Controlled
City:	Hobart, IN	Year Renewed:	
Location:	Local rural streets with light traffic, t	Tape/Media #:	
Purpose:	Routine Assessment	Dia/Height:	10"
Use:	Sanitary Sewage Pipe	Material:	VCP
Drain Area:		Lining:	None
Category:	NA		
Comment:			
Location Details:		Direction of Survey:	Downstream
US MH:	M-506-012	DS MH:	M-506-013
		Total Length Surveyed (ft):	200.3

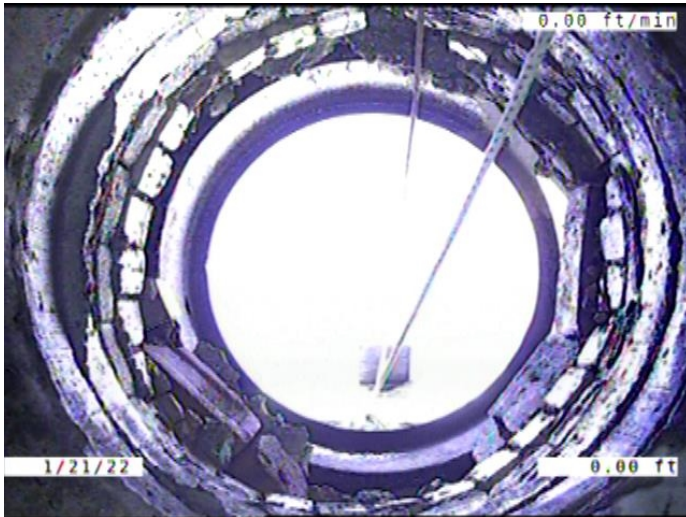
Code: **AMH**
Description: **Manhole**

Distance (ft): **.0**
Structural Grade: **0**
O&M Grade: **0**
Clock Start/From:
Clock To:
1st Value:
2nd Value:
Value Percent:
Continuous Index:
Within 8" of Joint: **NO**
Remarks: **M-506-012**

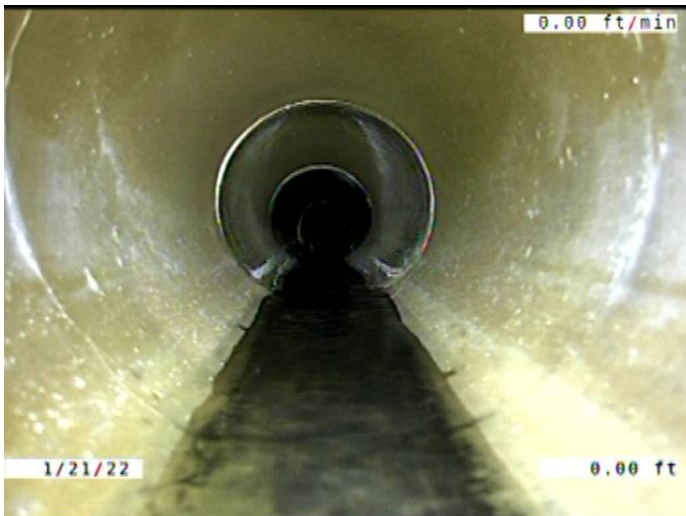
Code: **MWL**
Description: **Miscellaneous Water Level**

Distance (ft): **.0**
Structural Grade: **0**
O&M Grade: **0**
Clock Start/From:
Clock To:
1st Value:
2nd Value:
Value Percent: **5.000**
Continuous Index:
Within 8" of Joint: **NO**
Remarks:

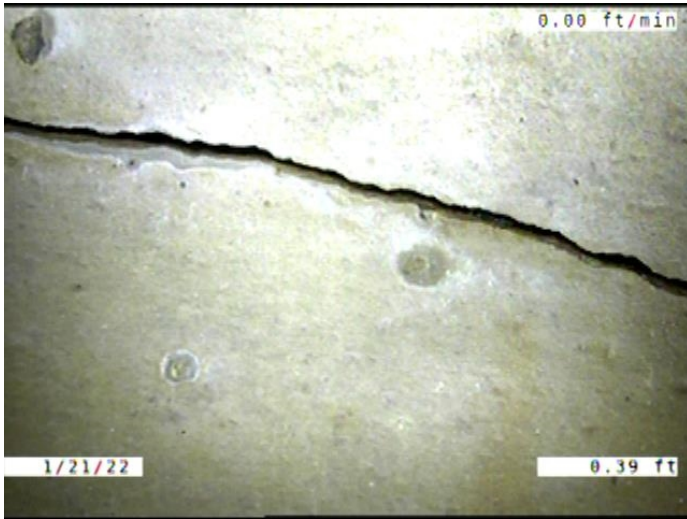
Code: **B**
Description: **Broken**

Distance (ft): **.4**
Structural Grade: **4**
O&M Grade: **0**
Clock Start/From: **12**
Clock To: **12**
1st Value:
2nd Value:
Value Percent:
Continuous Index:
Within 8" of Joint: **YES**
Remarks:

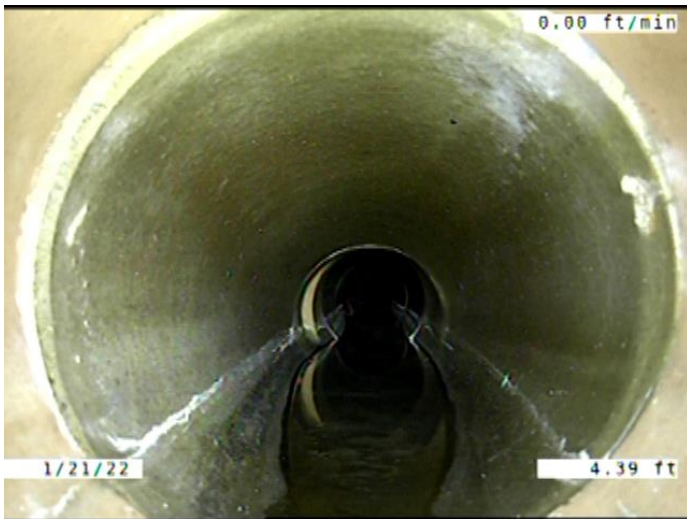
Code: **LD**
Description: **Line Down**

Distance (ft): **4.4**
Structural Grade: **0**
O&M Grade: **1**
Clock Start/From:
Clock To:
1st Value:
2nd Value:
Value Percent: **5.000**
Continuous Index:
Within 8" of Joint: **NO**
Remarks:

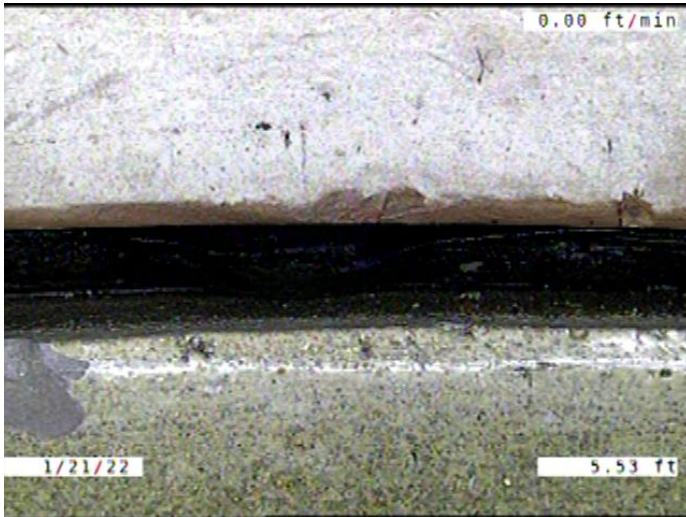
Code: **JAM**
Description: **Joint Angular Medium**

Distance (ft): **5.5**
Structural Grade: **3**
O&M Grade: **0**
Clock Start/From:
Clock To:
1st Value:
2nd Value:
Value Percent:
Continuous Index:
Within 8" of Joint: **NO**
Remarks:

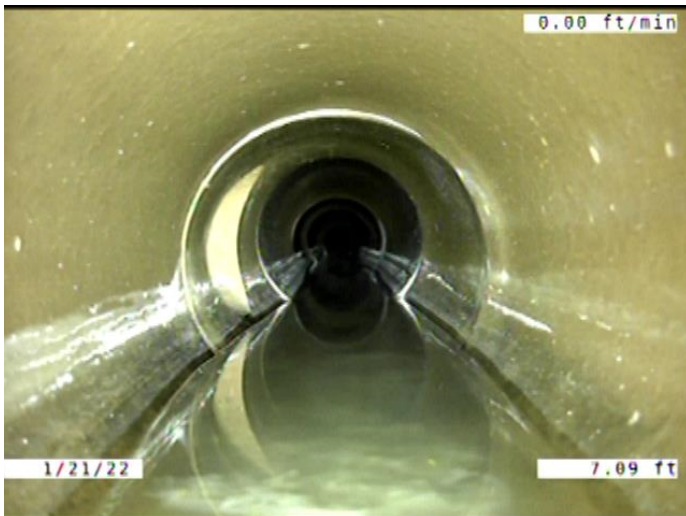
Code: **MWLS**
Description: **Miscellaneous Water Level Sag**

Distance (ft): **7.1**
Structural Grade: **2**
O&M Grade: **0**
Clock Start/From:
Clock To:
1st Value:
2nd Value:
Value Percent: **10.000**
Continuous Index: **S01**
Within 8" of Joint: **NO**
Remarks:

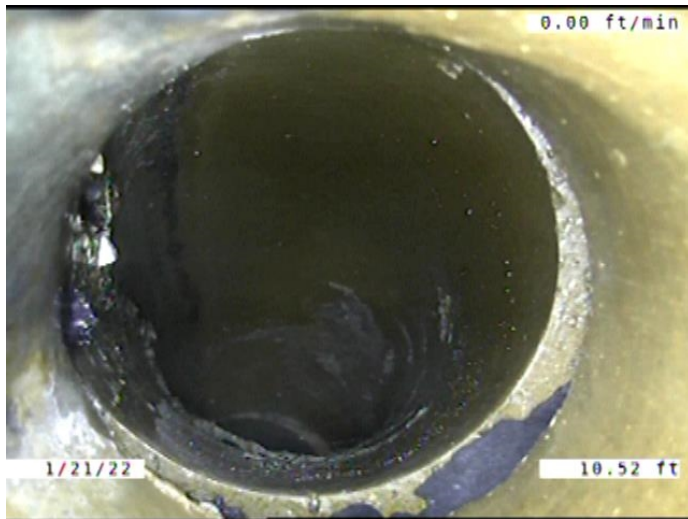
Code: **TF**
 Description: **Tap Factory**

Distance (ft): **10.5**
 Structural Grade: **0**
 O&M Grade: **0**
 Clock Start/From: **9**
 Clock To:
 1st Value: **4.000**
 2nd Value:
 Value Percent:
 Continuous Index:
 Within 8" of Joint: **YES**
 Remarks:

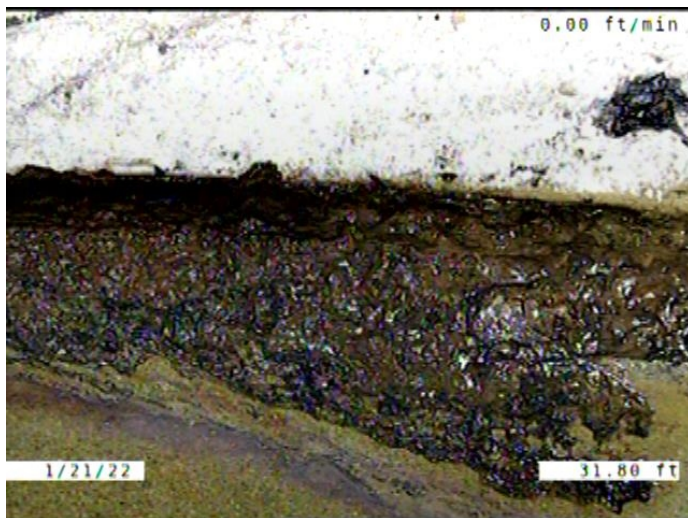
Code: **DAE**
 Description: **Deposits Attached Encrustation**

Distance (ft): **31.8**
 Structural Grade: **0**
 O&M Grade: **2**
 Clock Start/From: **8**
 Clock To: **4**
 1st Value:
 2nd Value:
 Value Percent: **5.000**
 Continuous Index: **S02**
 Within 8" of Joint: **YES**
 Remarks:

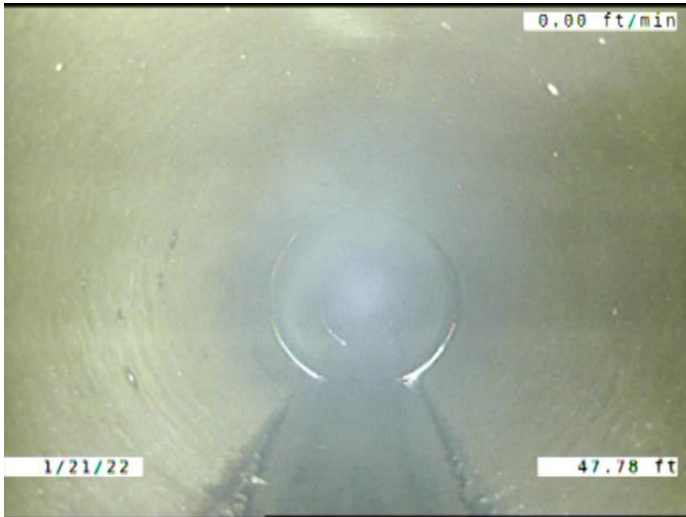
Code: **MWLS**
 Description: **Miscellaneous Water Level Sag**

Distance (ft): **47.8**
 Structural Grade: **2**
 O&M Grade: **0**
 Clock Start/From:
 Clock To:
 1st Value:
 2nd Value:
 Value Percent: **10.000**
 Continuous Index: **F01**
 Within 8" of Joint: **NO**
 Remarks:

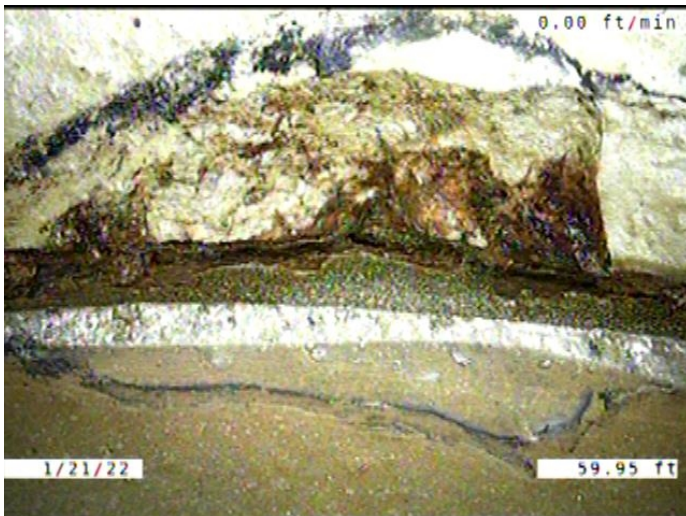
Code: **SZ**
 Description: **Surface Damage Other**

Distance (ft): **59.9**
 Structural Grade: **0**
 O&M Grade: **0**
 Clock Start/From: **2**
 Clock To: **3**
 1st Value:
 2nd Value:
 Value Percent:
 Continuous Index:
 Within 8" of Joint: **YES**
 Remarks: **A PIECE CHIPPED AWAY FROM THE JOINT**

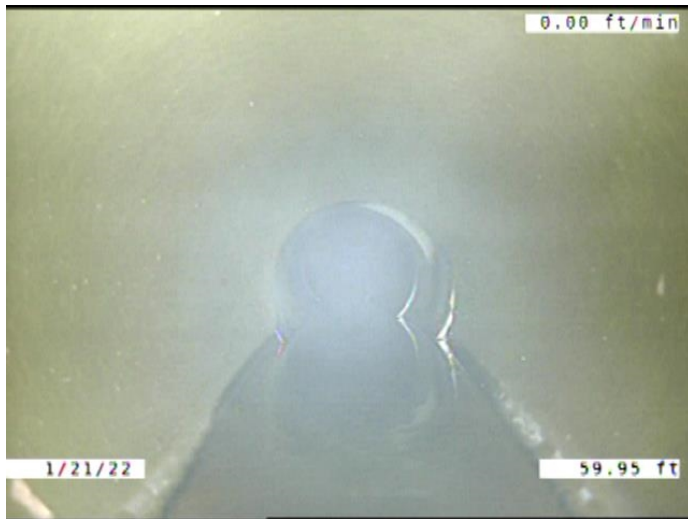
Code: **MWLS**
Description: **Miscellaneous Water Level Sag**

Distance (ft): **59.9**
Structural Grade: **2**
O&M Grade: **0**
Clock Start/From:
Clock To:
1st Value:
2nd Value:
Value Percent: **10.000**
Continuous Index: **S03**
Within 8" of Joint: **NO**
Remarks:

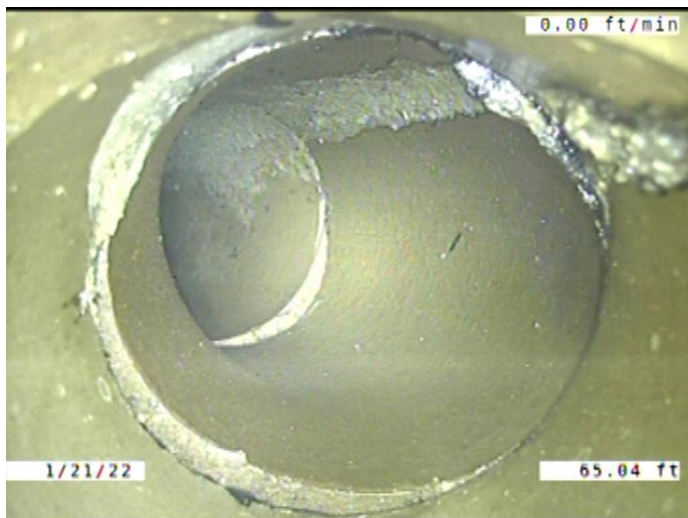
Code: **TF**
Description: **Tap Factory**

Distance (ft): **65.0**
Structural Grade: **0**
O&M Grade: **0**
Clock Start/From: **1**
Clock To:
1st Value: **4.000**
2nd Value:
Value Percent:
Continuous Index:
Within 8" of Joint: **YES**
Remarks: **ENCUSTATION COMING FROM THE TAP TO MAIN CONNECTION. ALSO H**

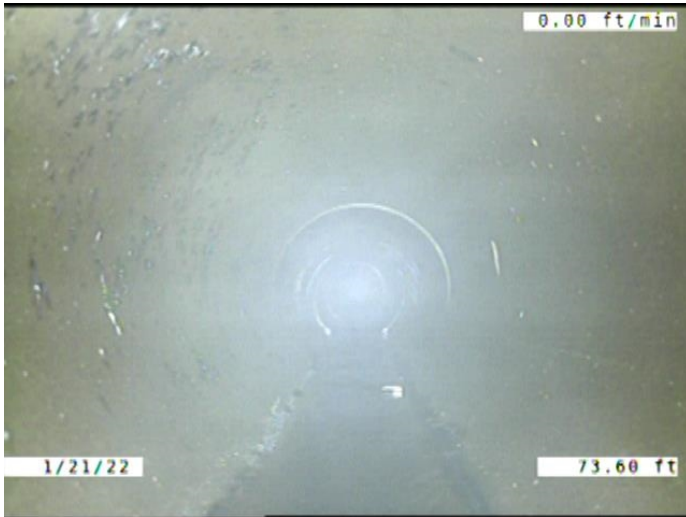
Code: **MWLS**
Description: **Miscellaneous Water Level Sag**

Distance (ft): **73.6**
Structural Grade: **2**
O&M Grade: **0**
Clock Start/From:
Clock To:
1st Value:
2nd Value:
Value Percent: **10.000**
Continuous Index: **F03**
Within 8" of Joint: **NO**
Remarks:

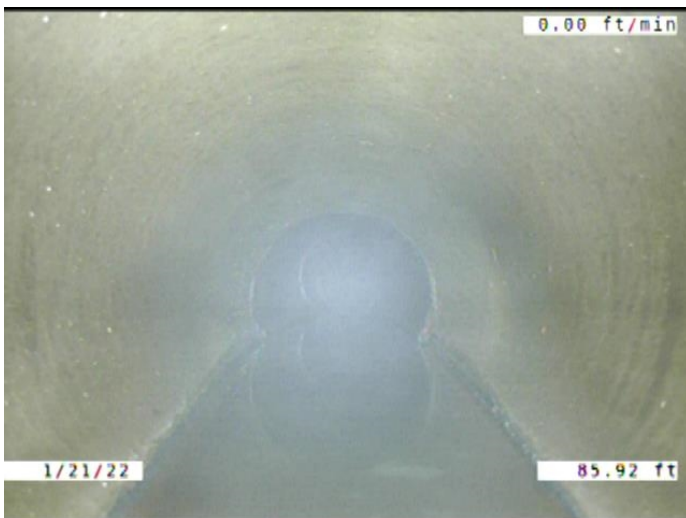
Code: **MWLS**
Description: **Miscellaneous Water Level Sag**

Distance (ft): **85.9**
Structural Grade: **2**
O&M Grade: **0**
Clock Start/From:
Clock To:
1st Value:
2nd Value:
Value Percent: **10.000**
Continuous Index: **S04**
Within 8" of Joint: **NO**
Remarks:

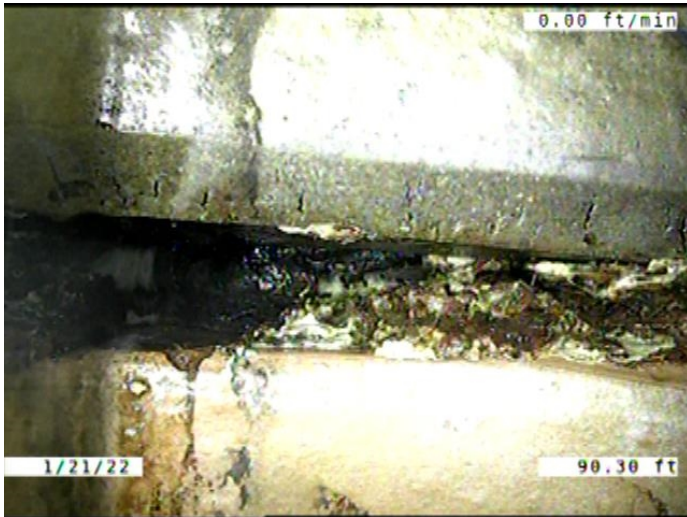
Code: **JAM**
Description: **Joint Angular Medium**

Distance (ft): **90.3**
Structural Grade: **3**
O&M Grade: **0**
Clock Start/From:
Clock To:
1st Value:
2nd Value:
Value Percent:
Continuous Index:
Within 8" of Joint: **NO**
Remarks:

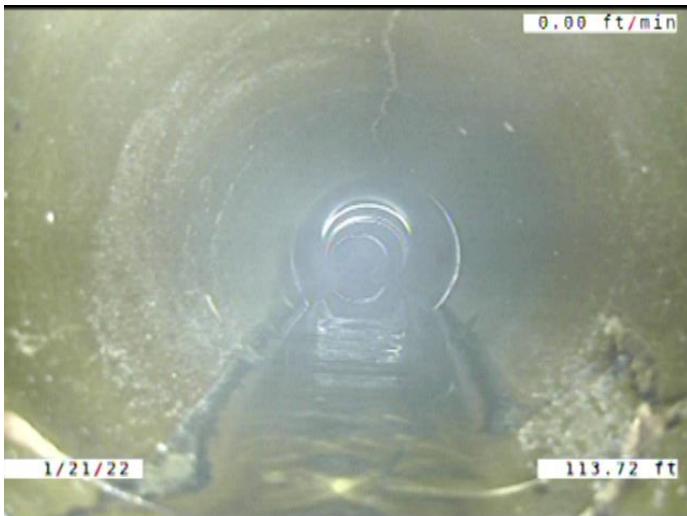
Code: **MWLS**
Description: **Miscellaneous Water Level Sag**

Distance (ft): **113.7**
Structural Grade: **2**
O&M Grade: **0**
Clock Start/From:
Clock To:
1st Value:
2nd Value:
Value Percent: **10.000**
Continuous Index: **F04**
Within 8" of Joint: **NO**
Remarks:

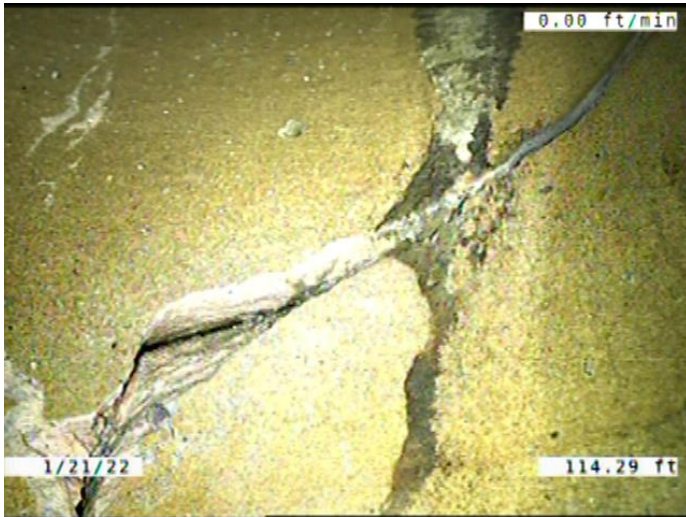
Code: **B**
Description: **Broken**

Distance (ft): **114.3**
Structural Grade: **4**
O&M Grade: **0**
Clock Start/From: **12**
Clock To: **12**
1st Value:
2nd Value:
Value Percent:
Continuous Index: **S05**
Within 8" of Joint: **YES**
Remarks:

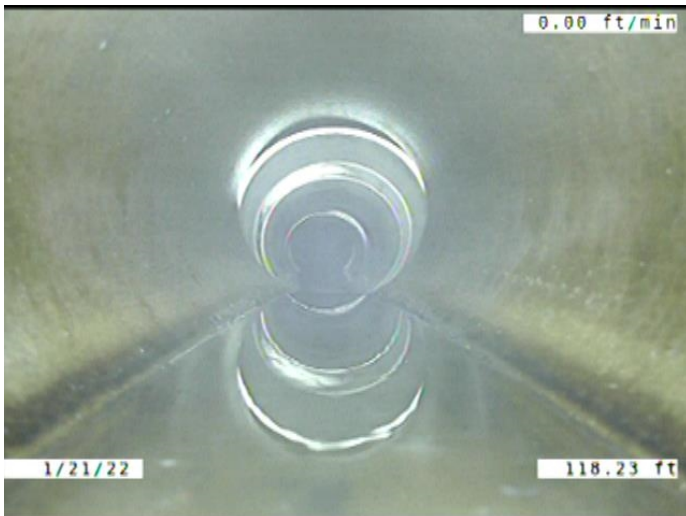
Code: **B**
Description: **Broken**

Distance (ft): **118.2**
Structural Grade: **4**
O&M Grade: **0**
Clock Start/From: **12**
Clock To: **12**
1st Value:
2nd Value:
Value Percent:
Continuous Index: **F05**
Within 8" of Joint: **YES**
Remarks:

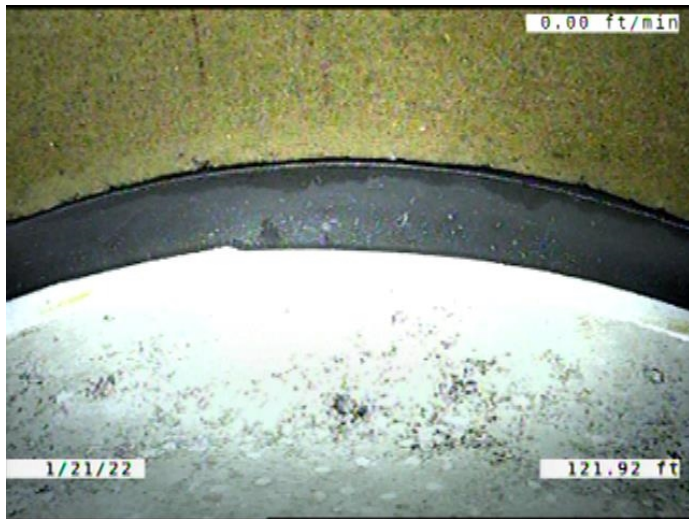
Code: **JOM**
 Description: **Joint Offset Medium**

Distance (ft): **121.9**
 Structural Grade: **3**
 O&M Grade: **0**
 Clock Start/From:
 Clock To:
 1st Value: **1.000**
 2nd Value:
 Value Percent:
 Continuous Index:
 Within 8" of Joint: **NO**
 Remarks:

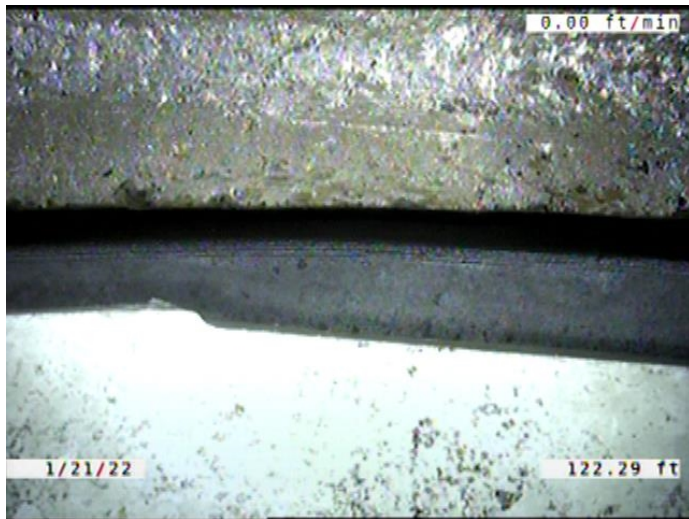
Code: **MMC**
 Description: **Miscellaneous Material Change**

Distance (ft): **122.3**
 Structural Grade: **0**
 O&M Grade: **0**
 Clock Start/From:
 Clock To:
 1st Value:
 2nd Value:
 Value Percent:
 Continuous Index:
 Within 8" of Joint: **NO**
 Remarks: **VCP TO PVC**

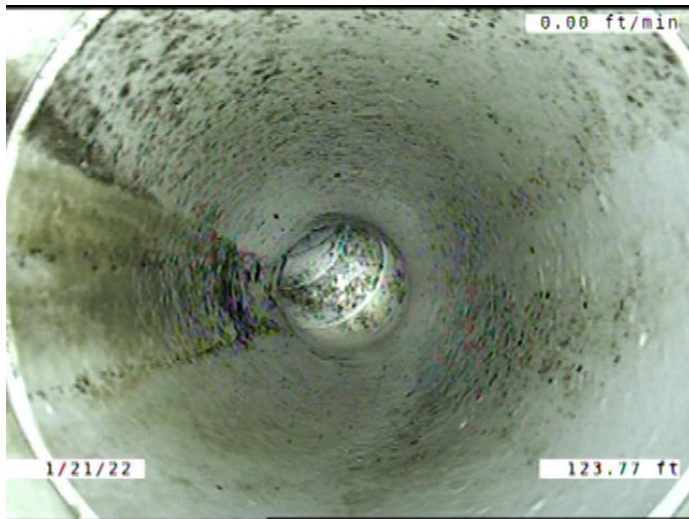
Code: **TF**
Description: **Tap Factory**

Distance (ft): **123.8**
Structural Grade: **0**
O&M Grade: **0**
Clock Start/From: **11**
Clock To:
1st Value: **6.000**
2nd Value:
Value Percent:
Continuous Index:
Within 8" of Joint: **YES**
Remarks:

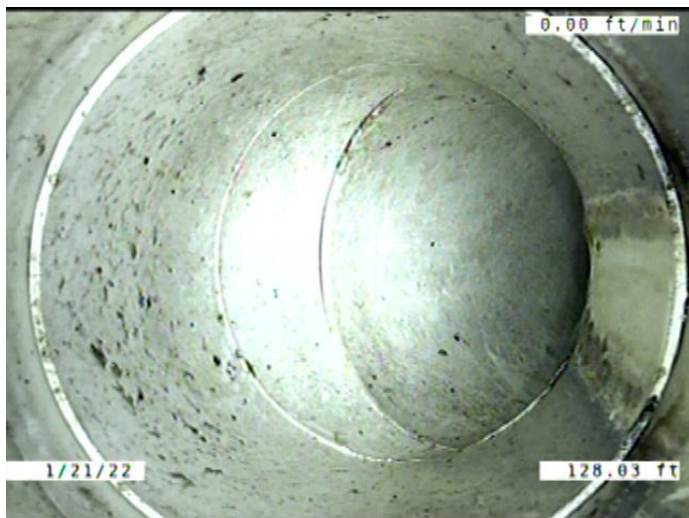
Code: **TF**
Description: **Tap Factory**

Distance (ft): **128.0**
Structural Grade: **0**
O&M Grade: **0**
Clock Start/From: **1**
Clock To:
1st Value: **6.000**
2nd Value:
Value Percent:
Continuous Index:
Within 8" of Joint: **YES**
Remarks: **CONSTANTLY RUNNING WATER.**

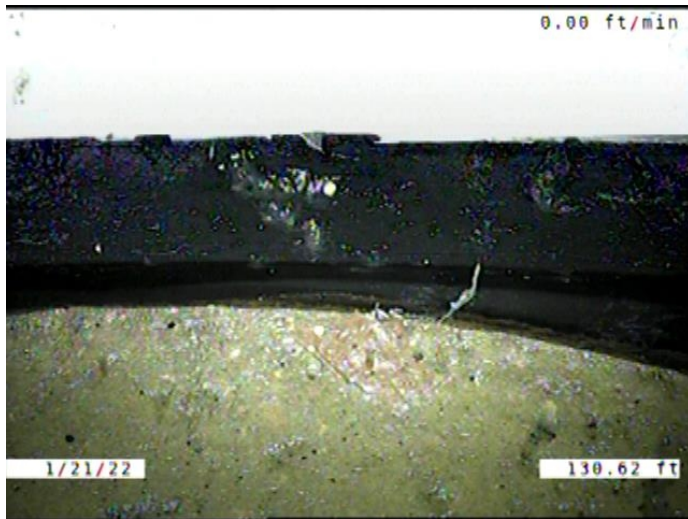
Code: **MMC**
Description: **Miscellaneous Material Change**

Distance (ft): **130.6**
Structural Grade: **0**
O&M Grade: **0**
Clock Start/From:
Clock To:
1st Value:
2nd Value:
Value Percent:
Continuous Index:
Within 8" of Joint: **NO**
Remarks: **PVC TO VCP**

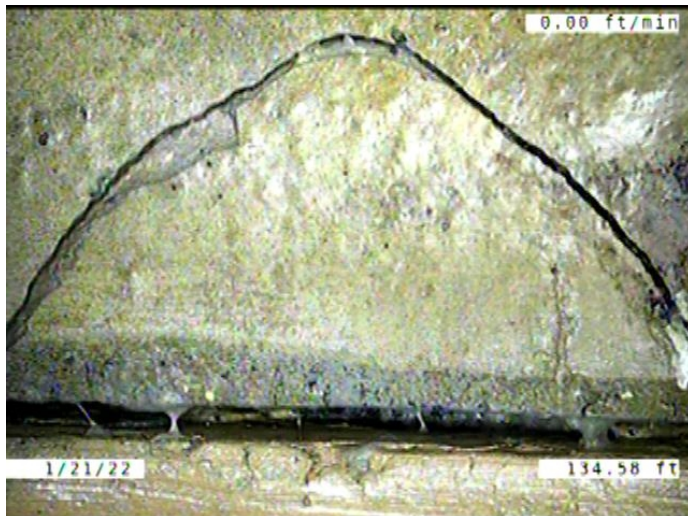
Code: **B**
Description: **Broken**

Distance (ft): **134.6**
Structural Grade: **4**
O&M Grade: **0**
Clock Start/From: **8**
Clock To: **9**
1st Value:
2nd Value:
Value Percent:
Continuous Index:
Within 8" of Joint: **YES**
Remarks:

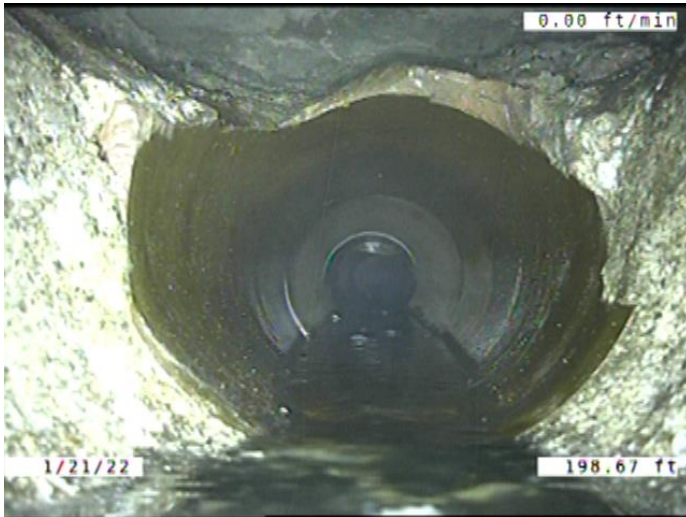
Code: **DAE**
 Description: **Deposits Attached Encrustation**

Distance (ft): **198.7**
 Structural Grade: **0**
 O&M Grade: **2**
 Clock Start/From: **8**
 Clock To: **4**
 1st Value:
 2nd Value:
 Value Percent: **5.000**
 Continuous Index: **F02**
 Within 8" of Joint: **YES**
 Remarks:

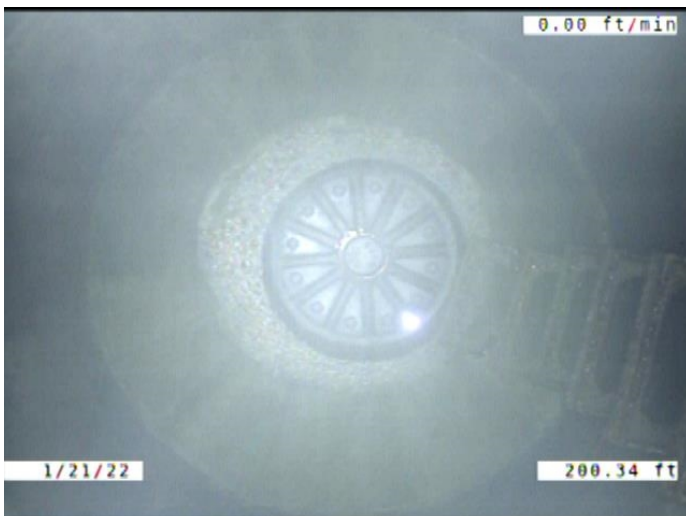
Code: **AMH**
 Description: **Manhole**

Distance (ft): **200.3**
 Structural Grade: **0**
 O&M Grade: **0**
 Clock Start/From:
 Clock To:
 1st Value:
 2nd Value:
 Value Percent:
 Continuous Index:
 Within 8" of Joint: **NO**
 Remarks: **M-506-013**
