## Profile/Photo Observation Report

Date:	<b>01/20/2022</b>	Weather:		Coding:	<b>PACP 7.0</b>
Pipe Length (ft):	<b>202.0</b>	Owner:	<b>City of Hobart</b>	Pre Clean:	<b>Heavy Cleaning</b>
P.O.#:	<b>YES502259</b>	Surveyor:	<b>S. Bucklin</b>	PSR:	<b>P-506-014-013</b>
Customer:	<b>City of Hobart</b>	Clean Date:	<b>01/16/2022</b>	Shape:	<b>C</b>

Street:	<b>West 7th Place</b>	Flow Control:	<b>Not Controlled</b>
City:	<b>Hobart, IN</b>	Year Renewed:	
Location:	<b>Local rural streets with light traffic, t</b>	Tape/Media #:	
Purpose:	<b>Routine Assessment</b>	Dia/Height:	<b>10"</b>
Use:	<b>Sanitary Sewage Pipe</b>	Material:	<b>VCP</b>
Drain Area:		Lining:	<b>None</b>
Category:	<b>NA</b>		
Comment:			
Location Details:		Direction of Survey:	<b>Downstream</b>
US MH:	<b>M-506-013</b>	DS MH:	<b>M-506-014</b>
		Total Length Surveyed (ft):	<b>199.0</b>

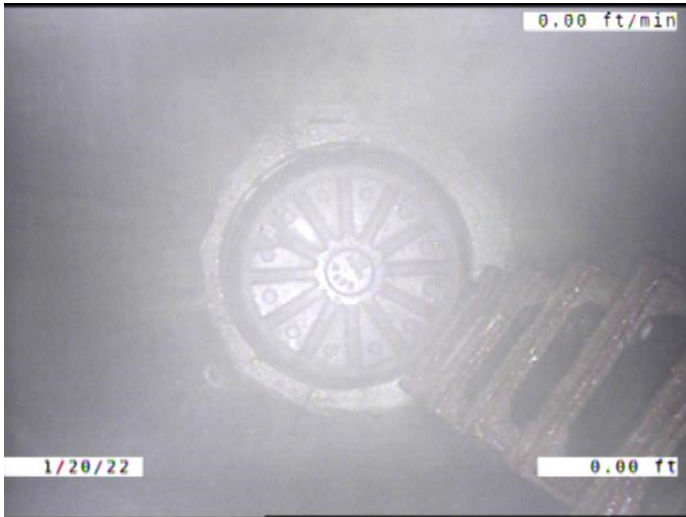
Code: **AMH**  
Description: **Manhole**

Distance (ft): **.0**  
Structural Grade: **0**  
O&M Grade: **0**  
Clock Start/From:  
Clock To:  
1st Value:  
2nd Value:  
Value Percent:  
Continuous Index:  
Within 8" of Joint: **NO**  
Remarks: **M-506-013**

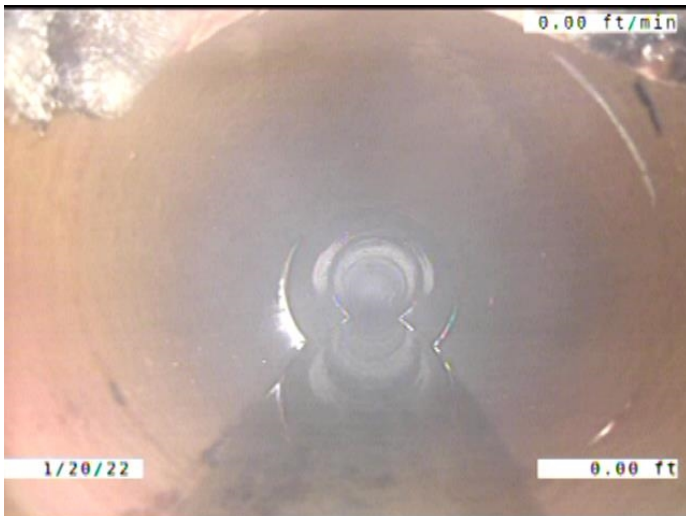
Code: **MWL**  
Description: **Miscellaneous Water Level**

Distance (ft): **.0**  
Structural Grade: **0**  
O&M Grade: **0**  
Clock Start/From:  
Clock To:  
1st Value:  
2nd Value:  
Value Percent: **5.000**  
Continuous Index:  
Within 8" of Joint: **NO**  
Remarks:

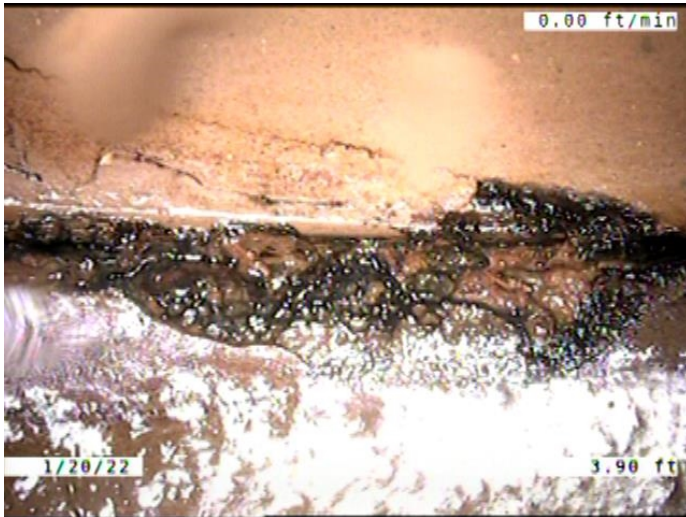
Code: **DAE**  
 Description: **Deposits Attached Encrustation**

Distance (ft): **3.9**  
 Structural Grade: **0**  
 O&M Grade: **2**  
 Clock Start/From: **7**  
 Clock To: **5**  
 1st Value:  
 2nd Value:  
 Value Percent: **5.000**  
 Continuous Index: **S01**  
 Within 8" of Joint: **YES**  
 Remarks:

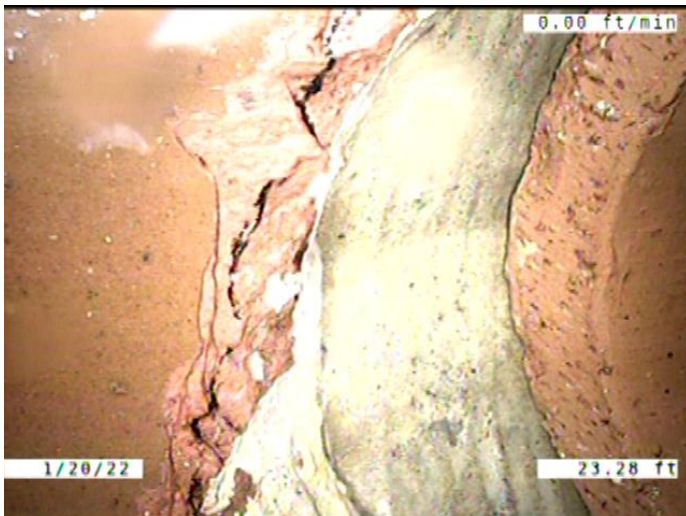
Code: **SSS**  
 Description: **Surface Damage Surface Spalling**

Distance (ft): **23.3**  
 Structural Grade: **2**  
 O&M Grade: **0**  
 Clock Start/From: **1**  
 Clock To: **4**  
 1st Value:  
 2nd Value:  
 Value Percent:  
 Continuous Index:  
 Within 8" of Joint: **YES**  
 Remarks:

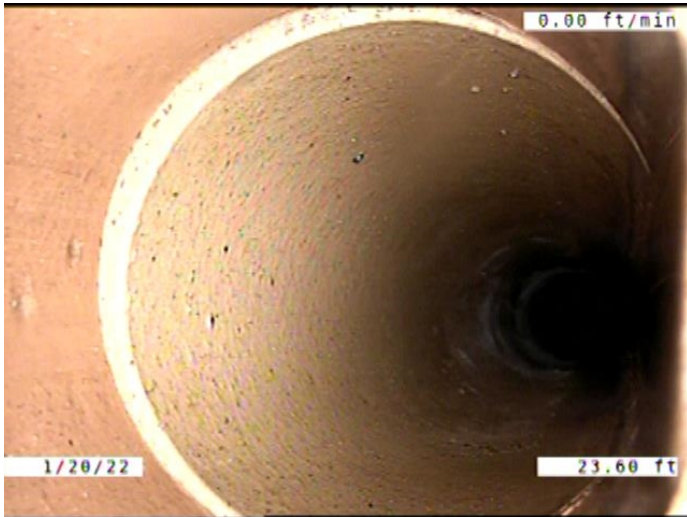
Code: **TBI**  
Description: **Tap Break-in Intruding**

Distance (ft): **23.6**  
Structural Grade: **0**  
O&M Grade: **2**  
Clock Start/From: **3**  
Clock To:  
1st Value: **4.000**  
2nd Value: **1.000**  
Value Percent:  
Continuous Index:  
Within 8" of Joint: **YES**  
Remarks:

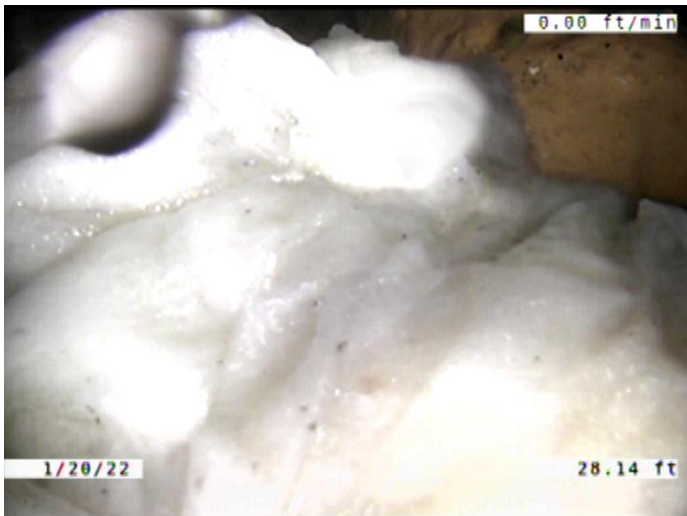
Code: **DSF**  
Description: **Deposits Settled Fine**

Distance (ft): **28.1**  
Structural Grade: **0**  
O&M Grade: **2**  
Clock Start/From: **6**  
Clock To:  
1st Value:  
2nd Value:  
Value Percent: **5.000**  
Continuous Index:  
Within 8" of Joint: **YES**  
Remarks: **ALSO TP**

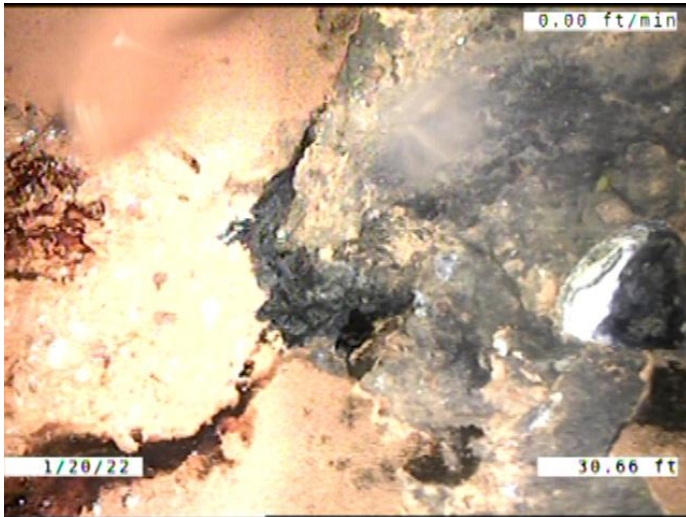
Code: **SSS**  
 Description: **Surface Damage Surface Spalling**

Distance (ft): **30.7**  
 Structural Grade: **2**  
 O&M Grade: **0**  
 Clock Start/From: **6**  
 Clock To: **8**  
 1st Value:  
 2nd Value:  
 Value Percent:  
 Continuous Index:  
 Within 8" of Joint: **NO**  
 Remarks:

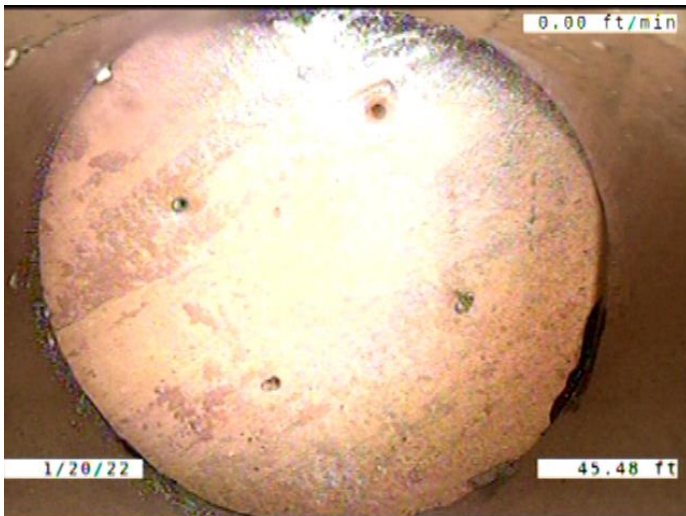
Code: **TFC**  
 Description: **Tap Factory Capped**

Distance (ft): **45.5**  
 Structural Grade: **0**  
 O&M Grade: **0**  
 Clock Start/From: **3**  
 Clock To:  
 1st Value: **4.000**  
 2nd Value:  
 Value Percent:  
 Continuous Index:  
 Within 8" of Joint: **YES**  
 Remarks:

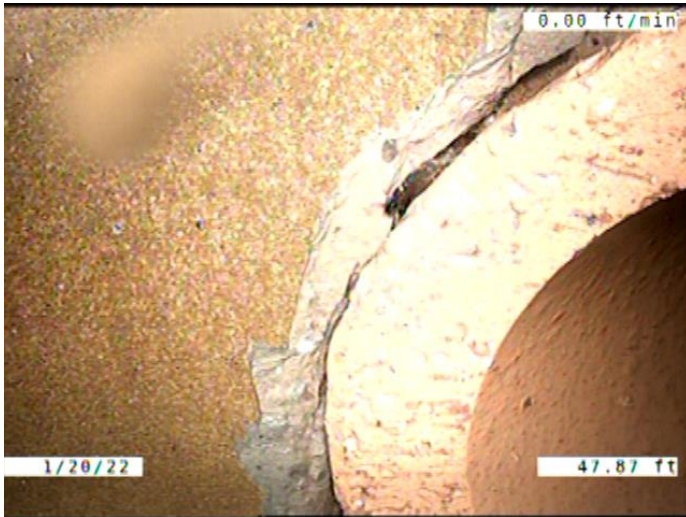
Code: **SSS**  
 Description: **Surface Damage Surface Spalling**

Distance (ft): **47.9**  
 Structural Grade: **2**  
 O&M Grade: **0**  
 Clock Start/From: **12**  
 Clock To: **3**  
 1st Value:  
 2nd Value:  
 Value Percent:  
 Continuous Index:  
 Within 8" of Joint: **YES**  
 Remarks:

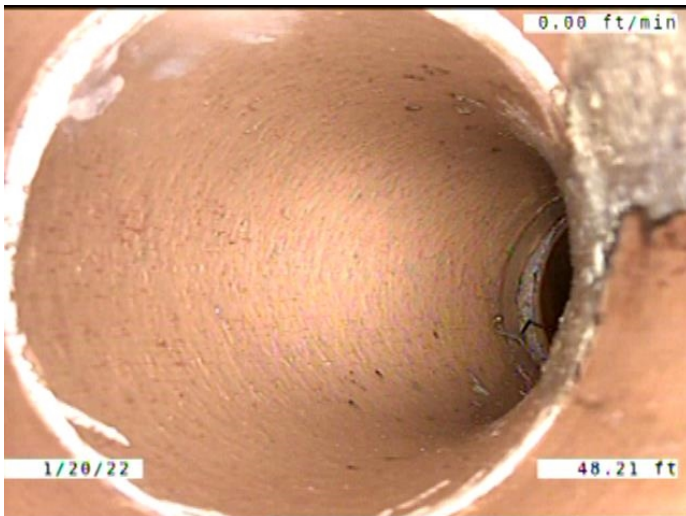
Code: **TBI**  
 Description: **Tap Break-in Intruding**

Distance (ft): **48.2**  
 Structural Grade: **0**  
 O&M Grade: **2**  
 Clock Start/From: **2**  
 Clock To:  
 1st Value: **4.000**  
 2nd Value: **1.000**  
 Value Percent:  
 Continuous Index:  
 Within 8" of Joint: **YES**  
 Remarks: **ENCRUSTATION COMING DOWN THE SERVICE**

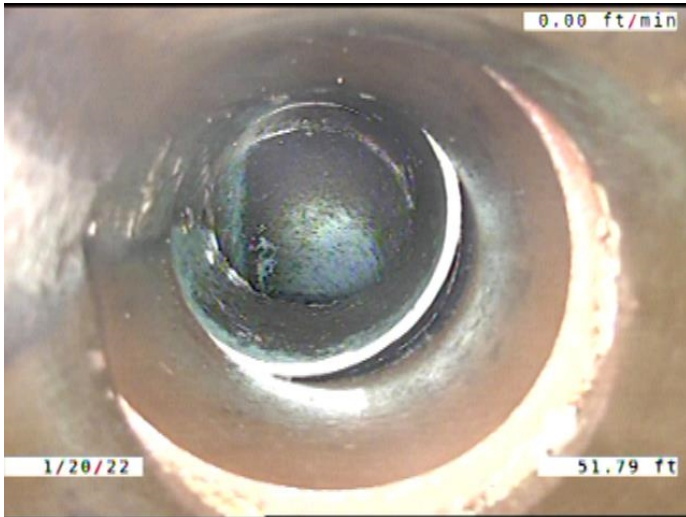
Code: **TF**  
 Description: **Tap Factory**

Distance (ft): **51.8**  
 Structural Grade: **0**  
 O&M Grade: **0**  
 Clock Start/From: **10**  
 Clock To:  
 1st Value: **4.000**  
 2nd Value:  
 Value Percent:  
 Continuous Index:  
 Within 8" of Joint: **YES**  
 Remarks: **2 OFFSET JOINTS VISIBLE**

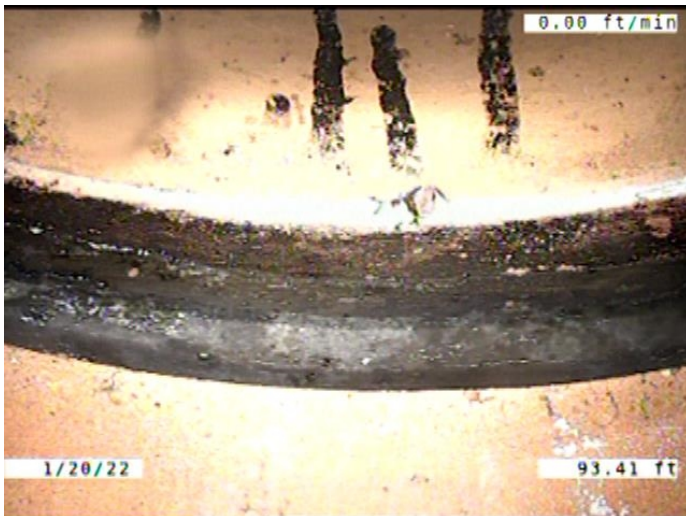
Code: **JOM**  
 Description: **Joint Offset Medium**

Distance (ft): **93.4**  
 Structural Grade: **3**  
 O&M Grade: **0**  
 Clock Start/From:  
 Clock To:  
 1st Value:  
 2nd Value:  
 Value Percent:  
 Continuous Index:  
 Within 8" of Joint: **NO**  
 Remarks:

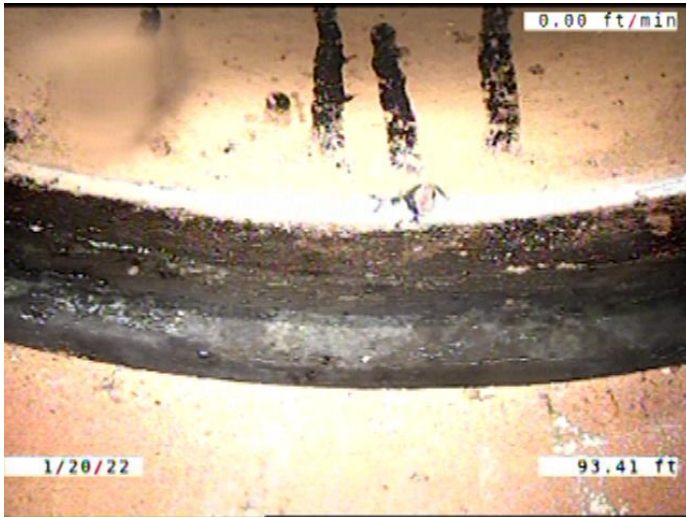
Code: **JAM**  
 Description: **Joint Angular Medium**

Distance (ft): **93.4**  
 Structural Grade: **3**  
 O&M Grade: **0**  
 Clock Start/From:  
 Clock To:  
 1st Value:  
 2nd Value:  
 Value Percent:  
 Continuous Index:  
 Within 8" of Joint: **NO**  
 Remarks:

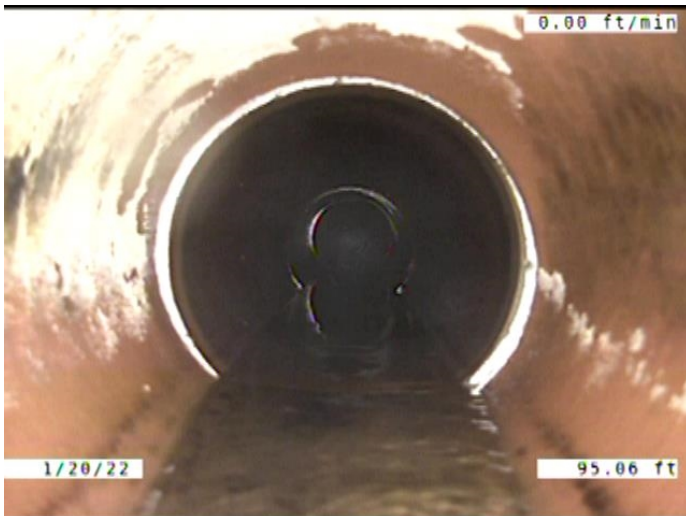
Code: **MWLS**  
 Description: **Miscellaneous Water Level Sag**

Distance (ft): **95.1**  
 Structural Grade: **2**  
 O&M Grade: **0**  
 Clock Start/From:  
 Clock To:  
 1st Value:  
 2nd Value:  
 Value Percent: **5.000**  
 Continuous Index: **S02**  
 Within 8" of Joint: **NO**  
 Remarks:

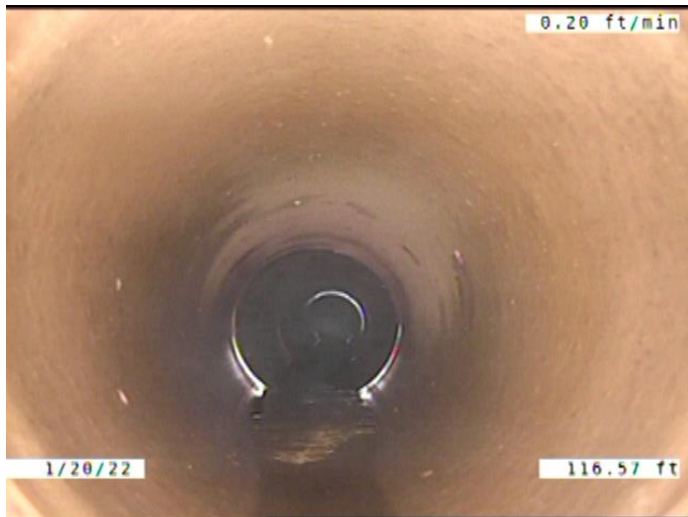
Code: **MWLS**  
Description: **Miscellaneous Water Level Sag**

Distance (ft): **116.6**  
Structural Grade: **2**  
O&M Grade: **0**  
Clock Start/From:  
Clock To:  
1st Value:  
2nd Value:  
Value Percent: **5.000**  
Continuous Index: **F02**  
Within 8" of Joint: **NO**  
Remarks:

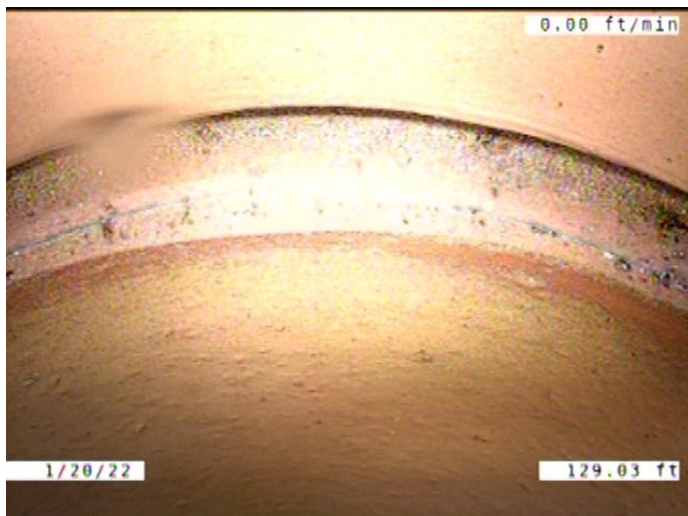
Code: **JOM**  
Description: **Joint Offset Medium**

Distance (ft): **129.0**  
Structural Grade: **3**  
O&M Grade: **0**  
Clock Start/From:  
Clock To:  
1st Value:  
2nd Value:  
Value Percent:  
Continuous Index:  
Within 8" of Joint: **NO**  
Remarks:

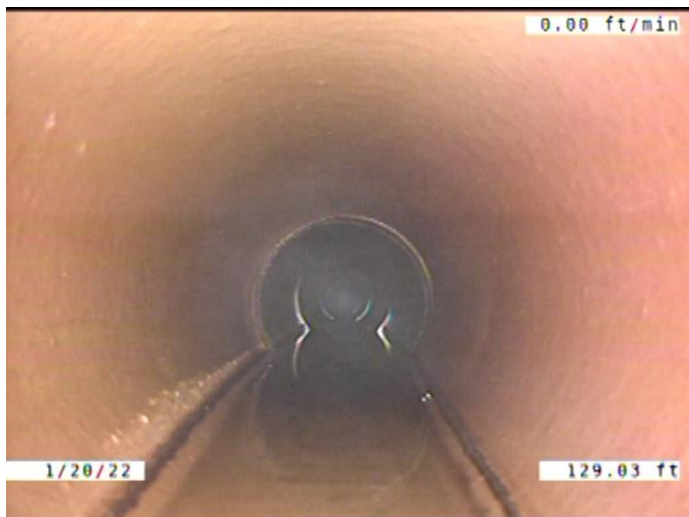
Code: **MWLS**  
Description: **Miscellaneous Water Level Sag**

Distance (ft): **129.0**  
Structural Grade: **2**  
O&M Grade: **0**  
Clock Start/From:  
Clock To:  
1st Value:  
2nd Value:  
Value Percent: **5.000**  
Continuous Index: **S03**  
Within 8" of Joint: **NO**  
Remarks:

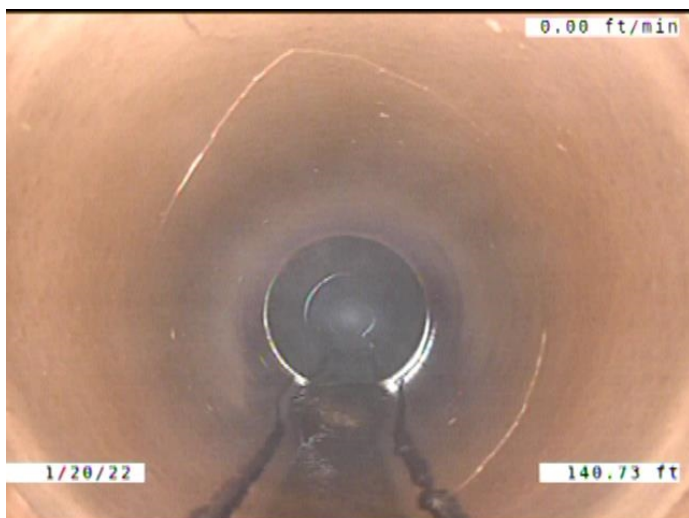
Code: **MWLS**  
Description: **Miscellaneous Water Level Sag**

Distance (ft): **140.7**  
Structural Grade: **2**  
O&M Grade: **0**  
Clock Start/From:  
Clock To:  
1st Value:  
2nd Value:  
Value Percent: **5.000**  
Continuous Index: **F03**  
Within 8" of Joint: **NO**  
Remarks:

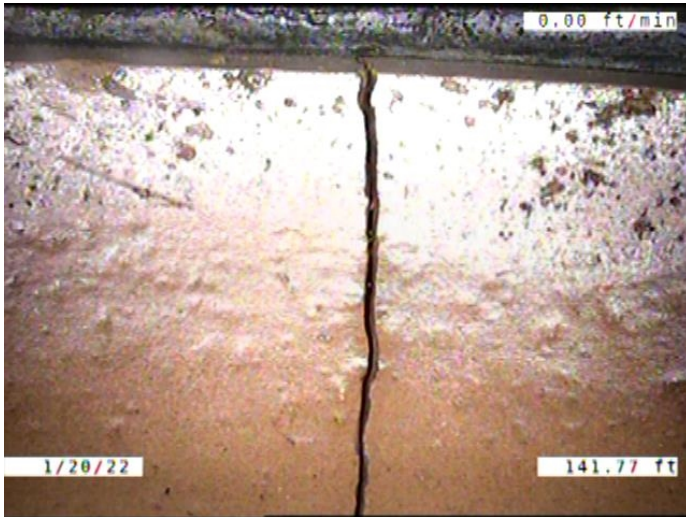
Code: **FM**  
 Description: **Fracture Multiple**

Distance (ft): **141.8**  
 Structural Grade: **4**  
 O&M Grade: **0**  
 Clock Start/From: **12**  
 Clock To: **12**  
 1st Value:  
 2nd Value:  
 Value Percent:  
 Continuous Index:  
 Within 8" of Joint: **YES**  
 Remarks:

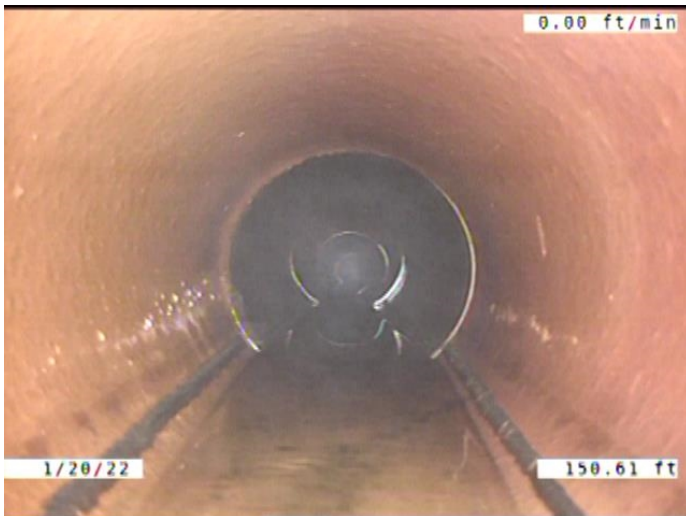
Code: **MWLS**  
 Description: **Miscellaneous Water Level Sag**

Distance (ft): **150.6**  
 Structural Grade: **2**  
 O&M Grade: **0**  
 Clock Start/From:  
 Clock To:  
 1st Value:  
 2nd Value:  
 Value Percent: **5.000**  
 Continuous Index: **S04**  
 Within 8" of Joint: **NO**  
 Remarks:

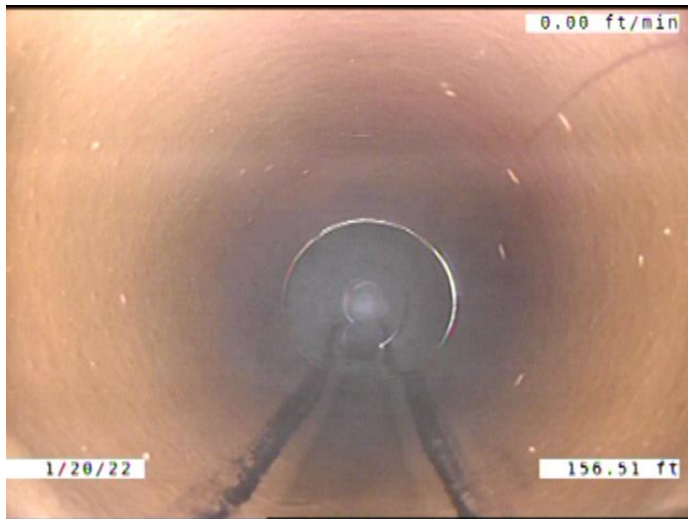
Code: **MWLS**  
Description: **Miscellaneous Water Level Sag**

Distance (ft): **156.5**  
Structural Grade: **2**  
O&M Grade: **0**  
Clock Start/From:  
Clock To:  
1st Value:  
2nd Value:  
Value Percent: **5.000**  
Continuous Index: **F04**  
Within 8" of Joint: **NO**  
Remarks:

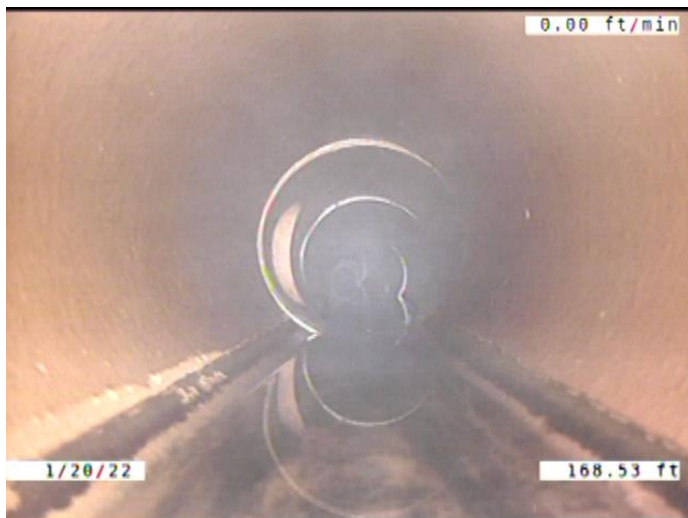
Code: **MWLS**  
Description: **Miscellaneous Water Level Sag**

Distance (ft): **168.5**  
Structural Grade: **2**  
O&M Grade: **0**  
Clock Start/From:  
Clock To:  
1st Value:  
2nd Value:  
Value Percent: **5.000**  
Continuous Index:  
Within 8" of Joint: **NO**  
Remarks:

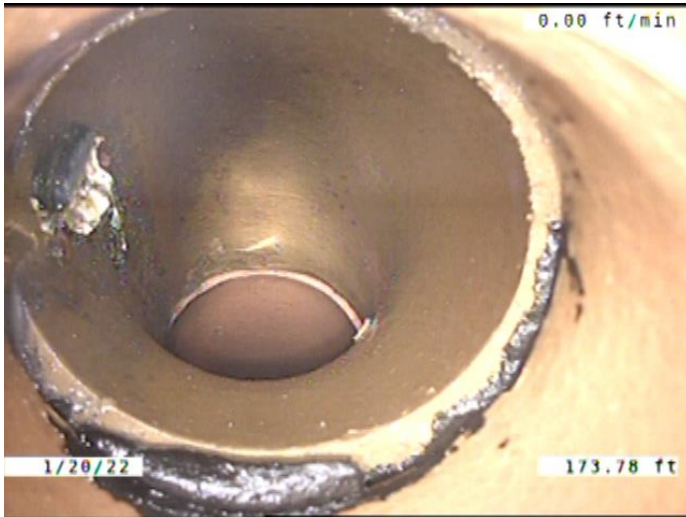
Code: **TF**  
 Description: **Tap Factory**

Distance (ft): **173.8**  
 Structural Grade: **0**  
 O&M Grade: **0**  
 Clock Start/From: **9**  
 Clock To:  
 1st Value: **4.000**  
 2nd Value:  
 Value Percent:  
 Continuous Index:  
 Within 8" of Joint: **YES**  
 Remarks:

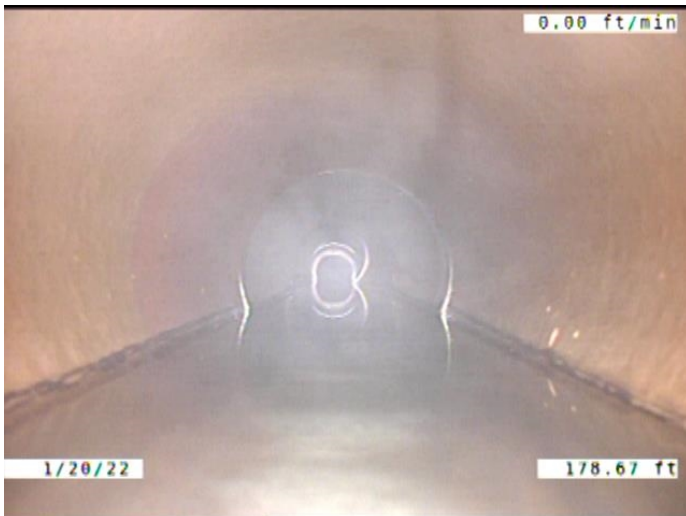
Code: **MWL**  
 Description: **Miscellaneous Water Level**

Distance (ft): **178.7**  
 Structural Grade: **0**  
 O&M Grade: **0**  
 Clock Start/From:  
 Clock To:  
 1st Value:  
 2nd Value:  
 Value Percent: **15.000**  
 Continuous Index:  
 Within 8" of Joint: **NO**  
 Remarks:

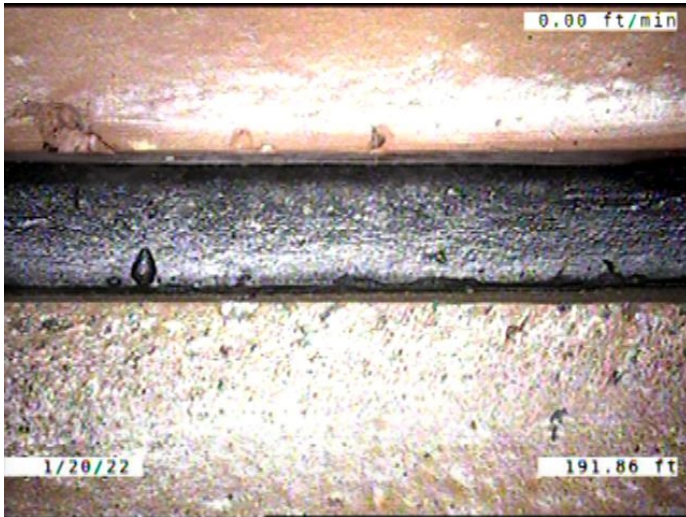
Code: **JAM**  
Description: **Joint Angular Medium**

Distance (ft): **191.9**  
Structural Grade: **3**  
O&M Grade: **0**  
Clock Start/From:  
Clock To:  
1st Value:  
2nd Value:  
Value Percent:  
Continuous Index:  
Within 8" of Joint: **NO**  
Remarks:

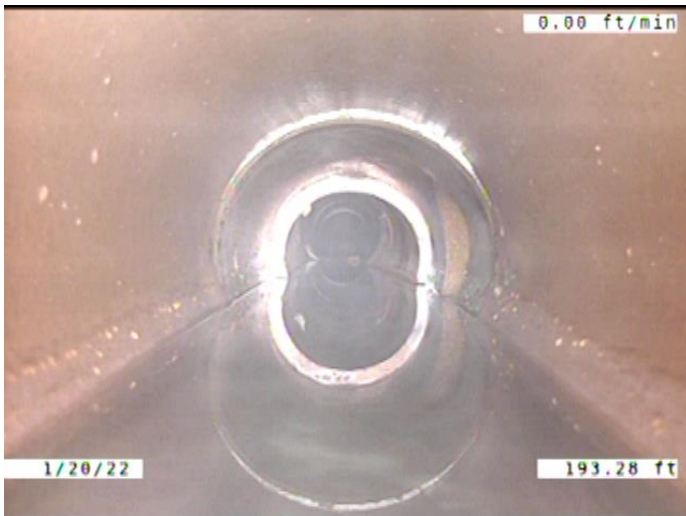
Code: **MWLS**  
Description: **Miscellaneous Water Level Sag**

Distance (ft): **193.3**  
Structural Grade: **2**  
O&M Grade: **0**  
Clock Start/From:  
Clock To:  
1st Value:  
2nd Value:  
Value Percent: **15.000**  
Continuous Index: **S05**  
Within 8" of Joint: **NO**  
Remarks:

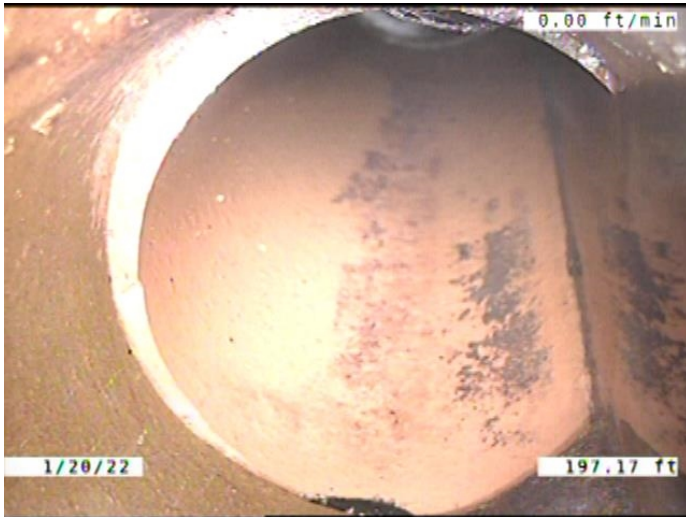
Code: **TF**  
 Description: **Tap Factory**

Distance (ft): **197.2**  
 Structural Grade: **0**  
 O&M Grade: **0**  
 Clock Start/From: **3**  
 Clock To:  
 1st Value: **4.000**  
 2nd Value:  
 Value Percent:  
 Continuous Index:  
 Within 8" of Joint: **YES**  
 Remarks:

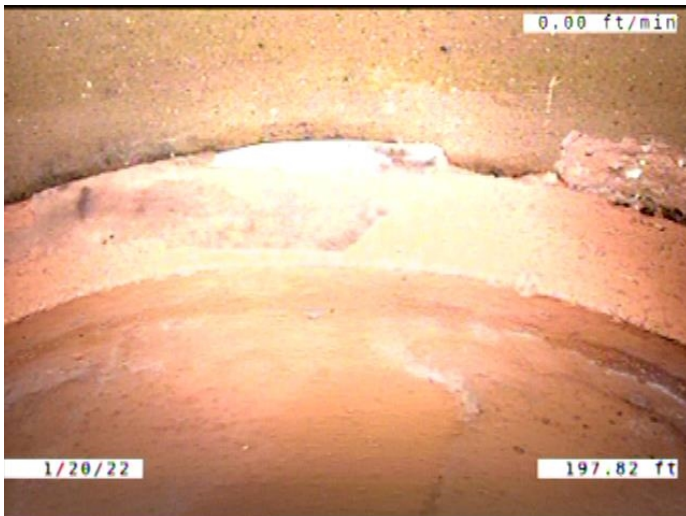
Code: **JOM**  
 Description: **Joint Offset Medium**

Distance (ft): **197.8**  
 Structural Grade: **3**  
 O&M Grade: **0**  
 Clock Start/From:  
 Clock To:  
 1st Value:  
 2nd Value:  
 Value Percent:  
 Continuous Index:  
 Within 8" of Joint: **NO**  
 Remarks:

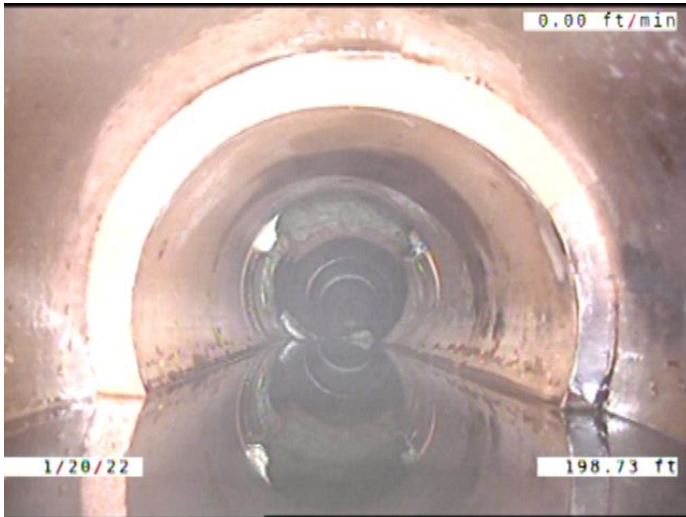
Code: **MSC**  
Description: **Miscellaneous Shape/Size Change**

Distance (ft): **198.7**  
Structural Grade: **0**  
O&M Grade: **0**  
Clock Start/From:  
Clock To:  
1st Value: **8.000**  
2nd Value:  
Value Percent:  
Continuous Index:  
Within 8" of Joint: **NO**  
Remarks:

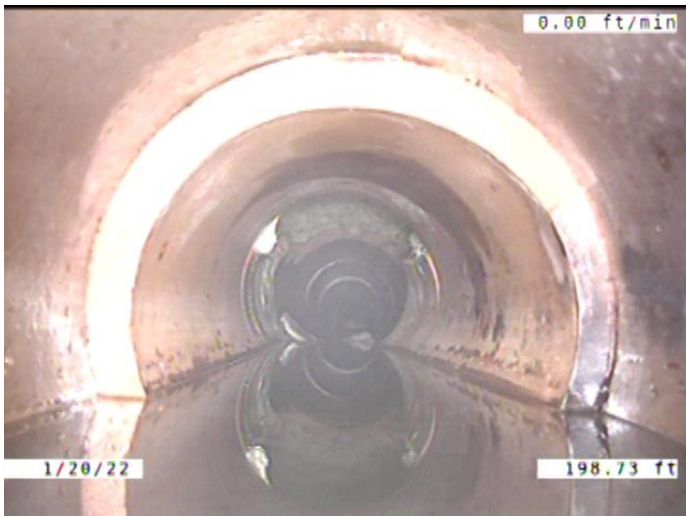
Code: **MGO**  
Description: **Miscellaneous General Observation**

Distance (ft): **198.7**  
Structural Grade: **0**  
O&M Grade: **0**  
Clock Start/From:  
Clock To:  
1st Value:  
2nd Value:  
Value Percent:  
Continuous Index:  
Within 8" of Joint: **NO**  
Remarks: **PIPE CHANGES FROM 10" TO 8" AT THE MANHOLE BUT THEN LOOKS TO**

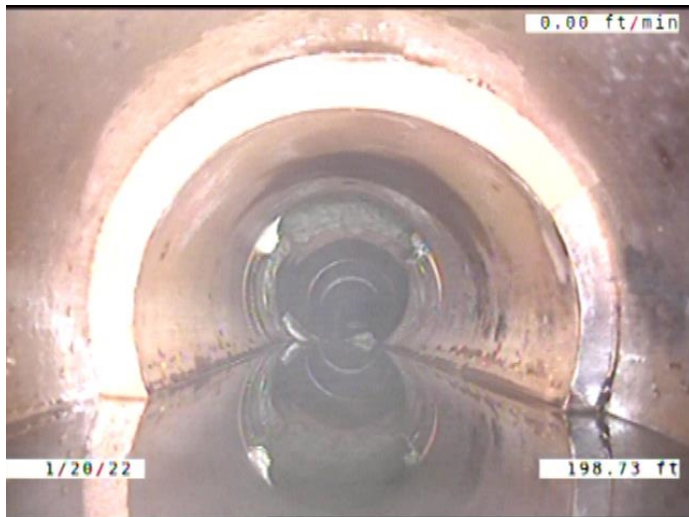
Code: **DAE**  
 Description: **Deposits Attached Encrustation**

Distance (ft): **198.7**  
 Structural Grade: **0**  
 O&M Grade: **2**  
 Clock Start/From: **7**  
 Clock To: **5**  
 1st Value:  
 2nd Value:  
 Value Percent: **5.000**  
 Continuous Index: **F01**  
 Within 8" of Joint: **YES**  
 Remarks:

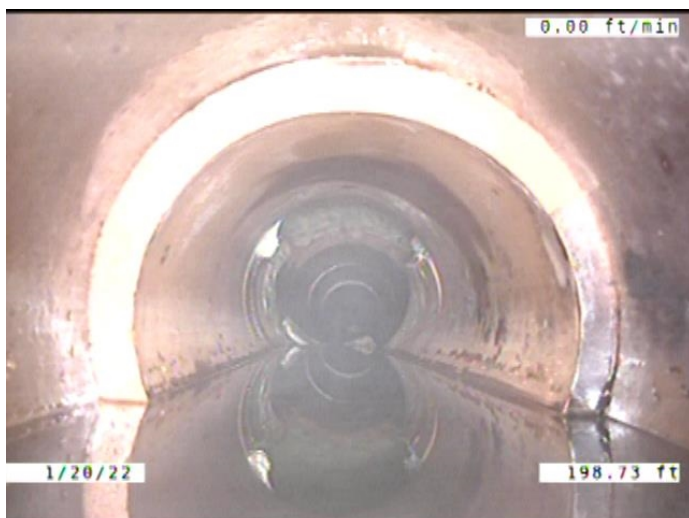
Code: **MWLS**  
 Description: **Miscellaneous Water Level Sag**

Distance (ft): **198.7**  
 Structural Grade: **2**  
 O&M Grade: **0**  
 Clock Start/From:  
 Clock To:  
 1st Value:  
 2nd Value:  
 Value Percent: **15.000**  
 Continuous Index: **F05**  
 Within 8" of Joint: **NO**  
 Remarks:

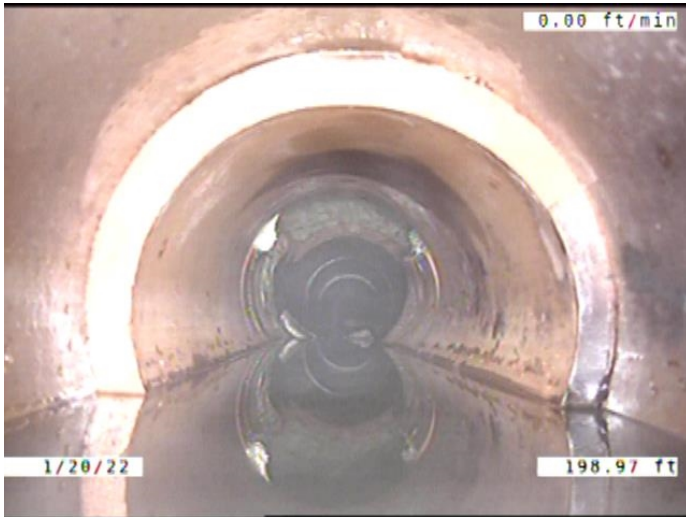
Code:	<b>MSA</b>
Description:	<b>Miscellaneous Survey Abandoned</b>
Distance (ft):	<b>199.0</b>
Structural Grade:	<b>0</b>
O&M Grade:	<b>0</b>
Clock Start/From:	
Clock To:	
1st Value:	
2nd Value:	
Value Percent:	
Continuous Index:	
Within 8" of Joint:	<b>NO</b>
Remarks:	<b>CAMERA CANT FIT INTO 8" PIPE.</b>
