Profile/Photo Observation Report

Date:	01/20/2022	Weather:		Coding:	PACP 7.0
Pipe Length	(ft): 206.5	Owner:	City of Hobart	Pre Clean:	Heavy Cleaning
P.O.#:	YES502259	Surveyor:	S. Bucklin	PSR:	P-506-015-014
Customer:	City of Hobart	Clean Date:	01/16/2022	Shape:	С

West 7th Place Not Controlled Street: Flow Control:

US MH: M-506-014 M-506-015 Total Length Surveyed (ft): DS MH: 206.5

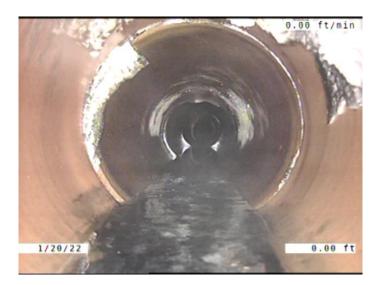
Code: MWL

Description: Miscellaneous Water Level

Distance (ft): .0
Structural Grade: 0
O&M Grade: 0

Value Percent: 5.000

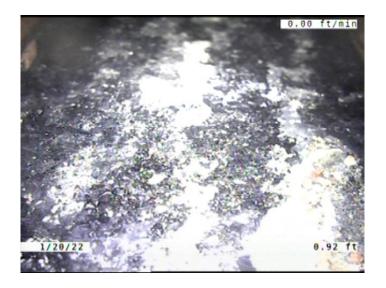
Code: DSC

Description: Deposits Settled Hard/Compacted

Distance (ft): .9
Structural Grade: 0
O&M Grade: 2
Clock Start/From: 5
Clock To: 7

Value Percent: 5.000

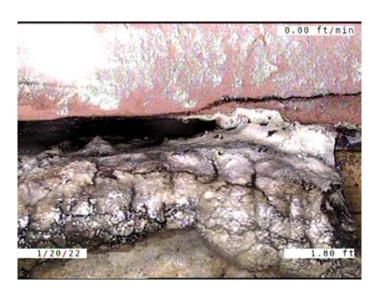
Code: DAE

Description: Deposits Attached Encrustation

Distance (ft): 1.8
Structural Grade: 0
O&M Grade: 2
Clock Start/From: 7
Clock To: 5
1st Value:
2nd Value:

Value Percent: 5.000
Continuous Index: S01
Within 8" of Joint: YES

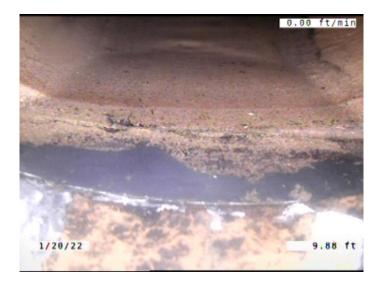
Code: **JOM**

Description: Joint Offset Medium

Distance (ft): 9.9
Structural Grade: 3
O&M Grade: 0

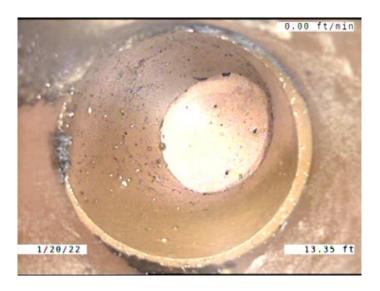
Code: TFC

Description: Tap Factory Capped

Distance (ft): 13.4
Structural Grade: 0

Remarks: ENCRUSTATION COMING FROM THE

SERVICE TO MAIN CONNECTION.

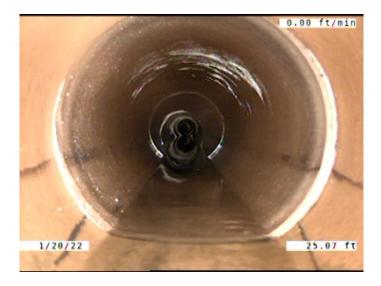
Description: **Miscellaneous Water Level Sag**

Distance (ft): 25.1 Structural Grade: 2 0 O&M Grade:

Value Percent: 10.000 Continuous Index: **S02** Within 8" of Joint: NO

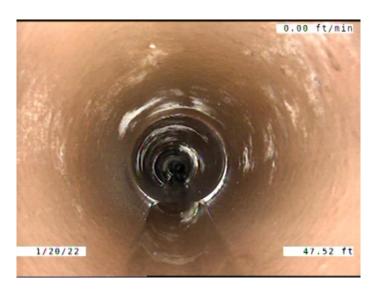
Code: **MWLS**

Description: **Miscellaneous Water Level Sag**

47.5 Distance (ft): Structural Grade: 2 O&M Grade: 0

Value Percent: 10.000 Continuous Index: F02 Within 8" of Joint: NO

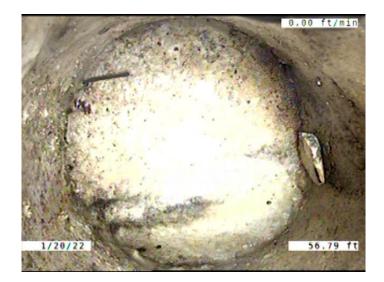
Code: TFC

Description: Tap Factory Capped

Distance (ft): 56.8
Structural Grade: 0

Remarks: CAP LEAKING. ENCRUSTATION
COMING FROM AROUND THE CAP A

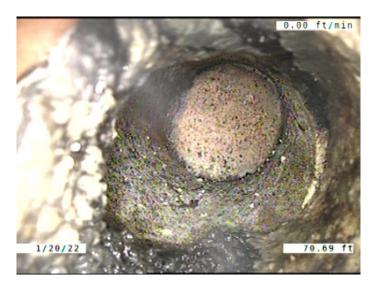
Code: TFC

Description: Tap Factory Capped

Distance (ft): 70.7
Structural Grade: 0
O&M Grade: 0
Clock Start/From: 11

Remarks: ENCRUSTATION COMING FROM THE

SERVICE TO MAIN CONNECTION.

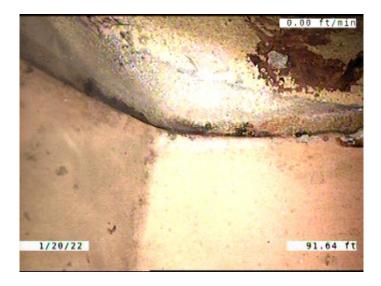
Code: JOM

Description: **Joint Offset Medium**

Distance (ft): 91.6 Structural Grade: 3 0 O&M Grade:

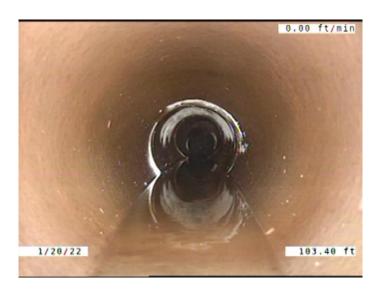
Code: **MWLS**

Description: **Miscellaneous Water Level Sag**

Distance (ft): 103.4 Structural Grade: 2 O&M Grade: 0

5.000 Value Percent: Continuous Index: **S03** Within 8" of Joint: NO

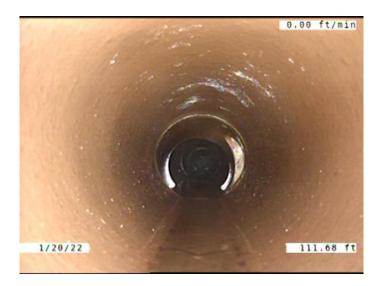
Description: **Miscellaneous Water Level Sag**

Distance (ft): 111.7 Structural Grade: 2 0 O&M Grade:

Value Percent: 5.000 Continuous Index: F03 Within 8" of Joint: NO

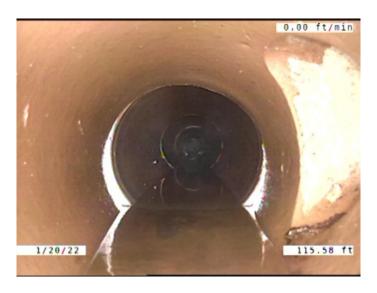
Code: **MWLS**

Description: **Miscellaneous Water Level Sag**

Distance (ft): 115.6 Structural Grade: 2 O&M Grade: 0

5.000 Value Percent: Continuous Index: **S04** Within 8" of Joint: NO

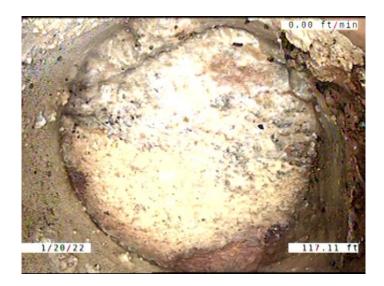
Code: TFC

Description: **Tap Factory Capped**

Distance (ft): 117.1 Structural Grade: 0 O&M Grade: 0 Clock Start/From: 3

Remarks: **CAP LEAKING. ENCRUSTATION**

AROUND THE CAP AND COMING INT

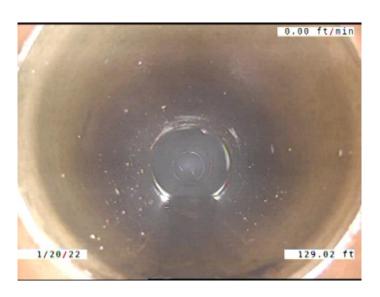
MWLS Code:

Description: **Miscellaneous Water Level Sag**

Distance (ft): 129.0 Structural Grade: 2 O&M Grade: 0

Value Percent: 5.000 Continuous Index: F04 Within 8" of Joint: NO

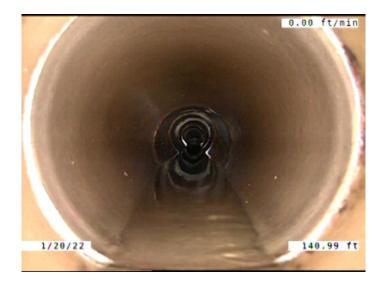
Description: Miscellaneous Water Level Sag

Distance (ft): 141.0
Structural Grade: 2
O&M Grade: 0

Value Percent: 5.000
Continuous Index: S05
Within 8" of Joint: NO

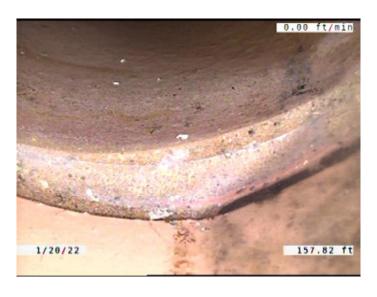
Code: JOM

Description: Joint Offset Medium

Distance (ft): 157.8
Structural Grade: 3
O&M Grade: 0

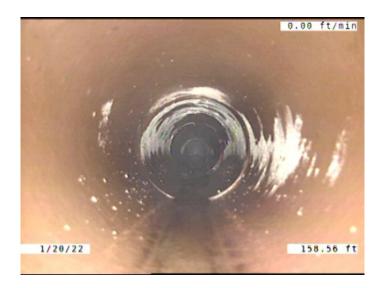
Description: Miscellaneous Water Level Sag

Distance (ft): 158.6
Structural Grade: 2
O&M Grade: 0

Value Percent: 5.000
Continuous Index: F05
Within 8" of Joint: NO

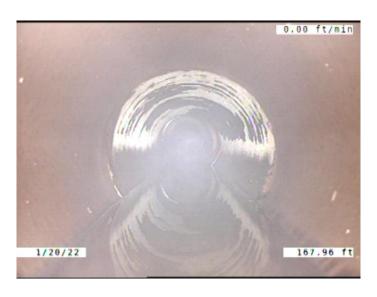
Code: MWLS

Description: Miscellaneous Water Level Sag

Distance (ft): 168.0
Structural Grade: 2
O&M Grade: 0

Value Percent: 5.000
Continuous Index: S06
Within 8" of Joint: NO

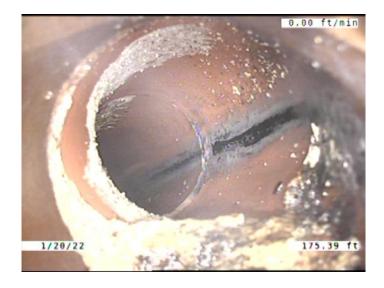
Code: **TF**

Description: Tap Factory

Distance (ft): 175.4
Structural Grade: 0
O&M Grade: 0
Clock Start/From: 3

Remarks: **ENCRUSTATION COMING FROM THE**

SERVICE TO MAIN CONNECTION.

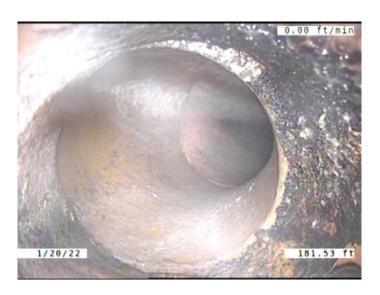
Code: TFA

Description: Tap Factory Activity

Distance (ft): 181.5
Structural Grade: 0
O&M Grade: 0
Clock Start/From: 11

Remarks: CONSTANTLY RUNNING WATER.

ENCRUSTATION COMING FROM THE

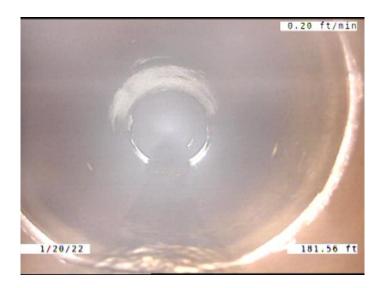
Description: **Miscellaneous Water Level Sag**

Distance (ft): 181.6 Structural Grade: 2 0 O&M Grade:

Value Percent: 5.000 F06 Continuous Index: Within 8" of Joint: NO

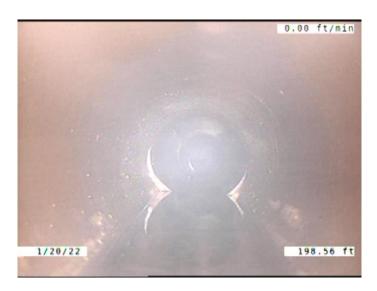
Code: **MWLS**

Description: **Miscellaneous Water Level Sag**

Distance (ft): 198.6 Structural Grade: 2 O&M Grade: 0

Value Percent: 10.000 Continuous Index: **S07** Within 8" of Joint: NO

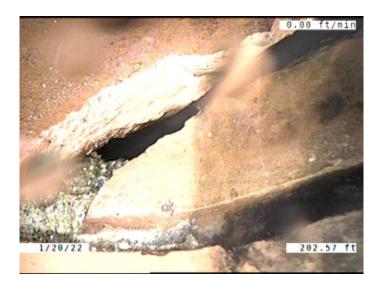
BVV Code:

Description: **Broken Void Visible**

Distance (ft): 202.6 Structural Grade: 5 O&M Grade: 0 Clock Start/From: 6 8

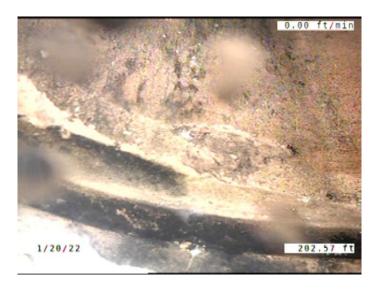
Code: **JOMD**

Description: **Joint Offset Medium Defective**

Distance (ft): 202.6 Structural Grade: 3 O&M Grade: 0

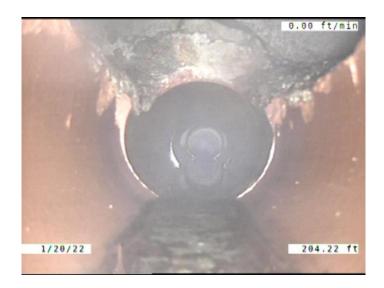
Description: **Miscellaneous Water Level Sag**

Distance (ft): 204.2 Structural Grade: 2 0 O&M Grade:

Value Percent: 10.000 Continuous Index: F07 Within 8" of Joint: NO

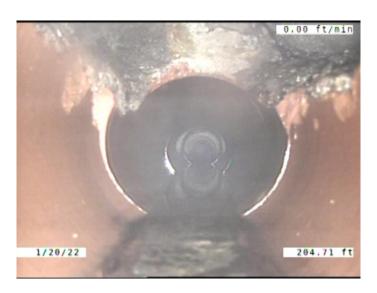
Code: DAE

Description: **Deposits Attached Encrustation**

Distance (ft): 204.7 Structural Grade: 0 O&M Grade: 2 Clock Start/From: 7 5 Clock To: 1st Value: 2nd Value:

Value Percent: 5.000 Continuous Index: F01 Within 8" of Joint: YES
