Profile/Photo Observation Report

Date:	04/07/2018	Weather:		Coding:	PACP 6.0
Pipe Length (ft):	202.8	Owner:	NA	Pre Clean:	No Pre-Cleaning
P.O.#:		Surveyor:	Jen Costello	PSR:	P-506-016-015
Customer:		Clean Date:	01/01/1900	Shape:	C

Street:	W 7TH PL	Flow Control:	Not Controlled
City:	Hobart, IN	Year Renewed:	
Location:	Yard	Tape/Media #:	
Purpose:	Routine Assessment	Dia/Height:	10"
Use:	Sanitary	Material:	VCP
Drain Area:	NA	Lining:	
Category:	NA		
Comment:	F_S_P_C calcium build up, flow direction is marked wrong.		
Location Details:		Direction of Survey:	Downstream
US MH:	M-506-015	DS MH:	M-506-016
		Total Length Surveyed (ft):	3.9

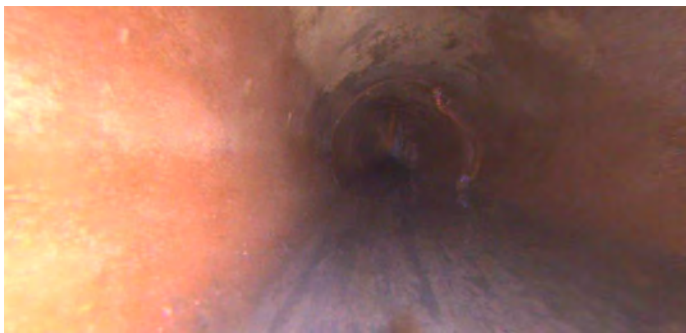
Code: **AMH**
Description: **Manhole**

Distance (ft): **.0**
Structural Grade: **0**
O&M Grade: **0**
Clock Start/From:
Clock To:
1st Value:
2nd Value:
Value Percent:
Continuous Index:
Within 8" of Joint: **NO**
Remarks: **M-506-015**

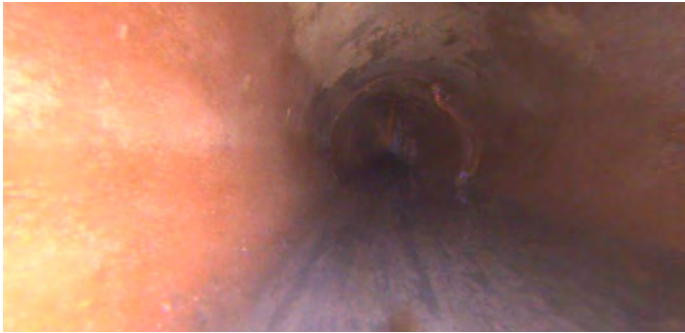
Code:	MWL
Description:	Water Level

Distance (ft):	.0
Structural Grade:	0
O&M Grade:	0
Clock Start/From:	
Clock To:	
1st Value:	
2nd Value:	
Value Percent:	10.000
Continuous Index:	
Within 8" of Joint:	NO
Remarks:

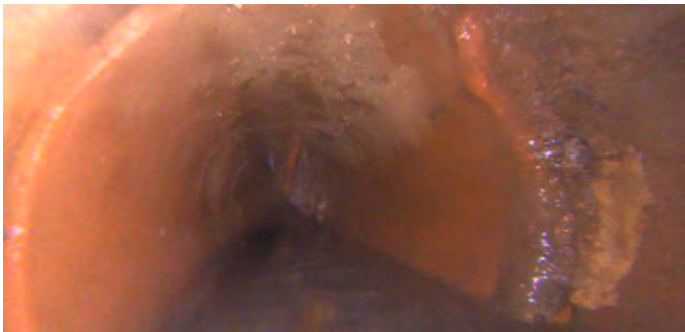
Code:	DAE
Description:	Deposits Attached Encrustation

Distance (ft):	2.7
Structural Grade:	0
O&M Grade:	2
Clock Start/From:	1
Clock To:	4
1st Value:	
2nd Value:	
Value Percent:	10.000
Continuous Index:	
Within 8" of Joint:	YES
Remarks:

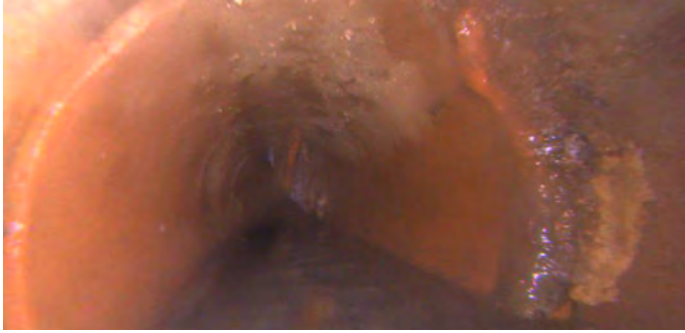
Code: **IW**
Description: **Infil Weeper**

Distance (ft): **2.7**
Structural Grade: **0**
O&M Grade: **2**
Clock Start/From: **1**
Clock To: **4**
1st Value:
2nd Value:
Value Percent:
Continuous Index:
Within 8" of Joint: **YES**
Remarks:

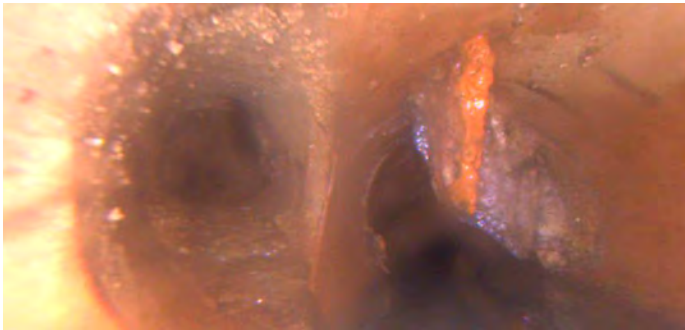
Code: **TF**
Description: **Tap Factory**

Distance (ft): **3.6**
Structural Grade: **0**
O&M Grade: **0**
Clock Start/From: **9**
Clock To:
1st Value: **4.000**
2nd Value:
Value Percent:
Continuous Index:
Within 8" of Joint:
Remarks:

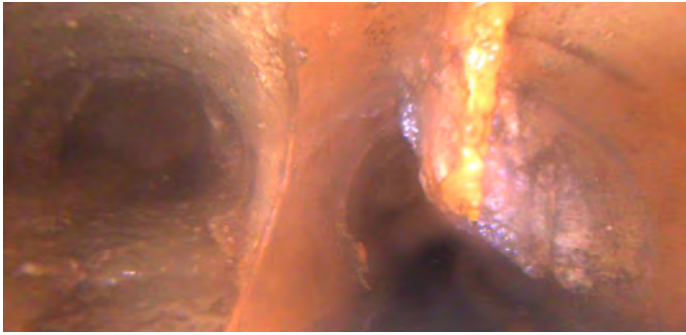
Code: **ID**
Description: **Infil Dripper**

Distance (ft): **3.9**
Structural Grade: **0**
O&M Grade: **3**
Clock Start/From: **12**
Clock To:
1st Value:
2nd Value:
Value Percent:
Continuous Index:
Within 8" of Joint:
Remarks:

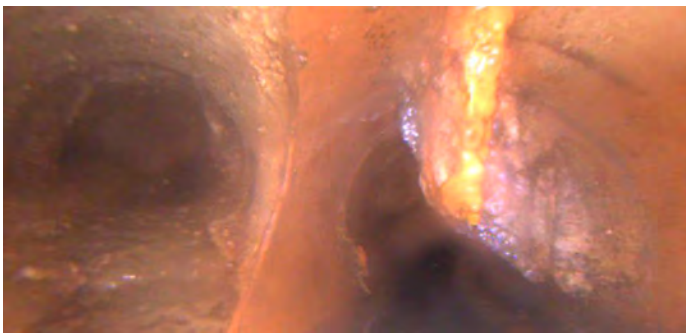
Code: **DAE**
Description: **Deposits Attached Encrustation**

Distance (ft): **3.9**
Structural Grade: **0**
O&M Grade: **5**
Clock Start/From: **12**
Clock To: **4**
1st Value:
2nd Value:
Value Percent: **40.000**
Continuous Index:
Within 8" of Joint: **NO**
Remarks:

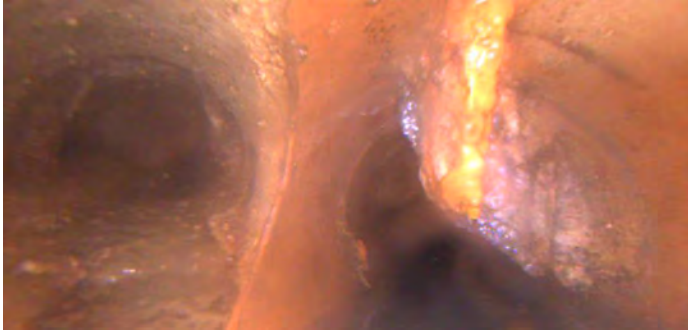
Code:	MSA
Description:	Abandoned Survey
Distance (ft):	3.9
Structural Grade:	0
O&M Grade:	0
Clock Start/From:	
Clock To:	
1st Value:	
2nd Value:	
Value Percent:	
Continuous Index:	
Within 8" of Joint:	NO
Remarks:	dae
