Profile/Photo Observation Report

Date:	04/07/2018	Weather:		Coding:	PACP 6.0
Pipe Length (ft):	202.8	Owner:	NA	Pre Clean:	No Pre-Cleaning
P.O.#:		Surveyor:	Jen Costello	PSR:	P-506-016-015
Customer:		Clean Date:	01/01/1900	Shape:	C

Street:	FOXCROFT STREET	Flow Control:	Not Controlled
City:	Hobart, IN	Year Renewed:	
Location:	Yard	Tape/Media #:	
Purpose:	Routine Assessment	Dia/Height:	10"
Use:	Sanitary	Material:	VCP
Drain Area:	NA	Lining:	
Category:	NA		
Comment:	F_S_P_C calcium build up, flow direction is marked wrong.		
Location Details:		Direction of Survey:	Downstream
US MH:	M-506-015	DS MH:	M-506-016
		Total Length Surveyed (ft):	3.9

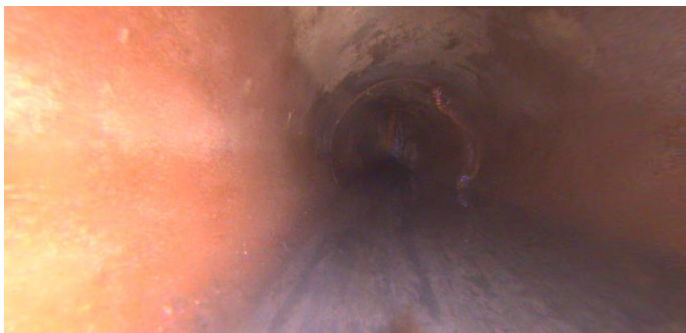
Code: **AMH**
Description: **Manhole**

Distance (ft): **.0**
Structural Grade: **0**
O&M Grade: **0**
Clock Start/From:
Clock To:
1st Value:
2nd Value:
Value Percent:
Continuous Index:
Within 8" of Joint: **NO**
Remarks: **M-506-015**

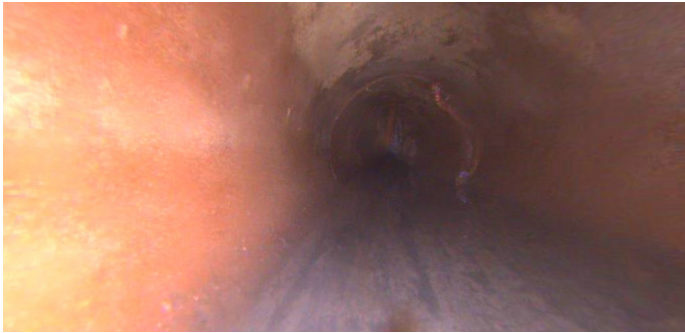
Code:	MWL
Description:	Water Level

Distance (ft):	.0
Structural Grade:	0
O&M Grade:	0
Clock Start/From:	
Clock To:	
1st Value:	
2nd Value:	
Value Percent:	10.000
Continuous Index:	
Within 8" of Joint:	NO
Remarks:

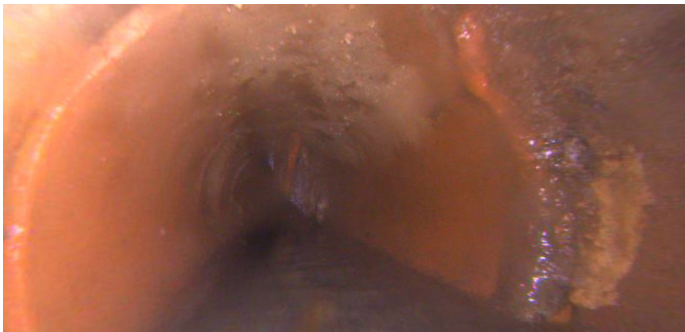
Code:	DAE
Description:	Deposits Attached Encrustation

Distance (ft):	2.7
Structural Grade:	0
O&M Grade:	2
Clock Start/From:	1
Clock To:	4
1st Value:	
2nd Value:	
Value Percent:	10.000
Continuous Index:	
Within 8" of Joint:	YES
Remarks:

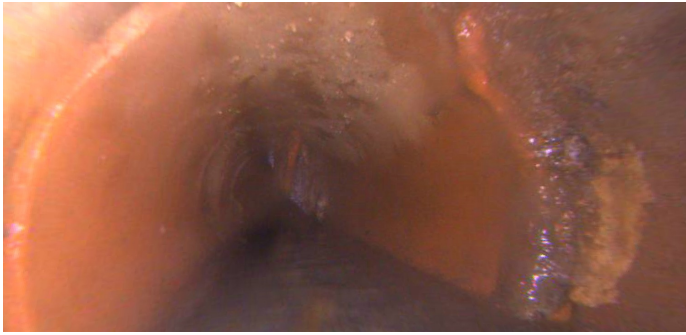
Code: **IW**
Description: **Infil Weeper**

Distance (ft): **2.7**
Structural Grade: **0**
O&M Grade: **2**
Clock Start/From: **1**
Clock To: **4**
1st Value:
2nd Value:
Value Percent:
Continuous Index:
Within 8" of Joint: **YES**
Remarks:

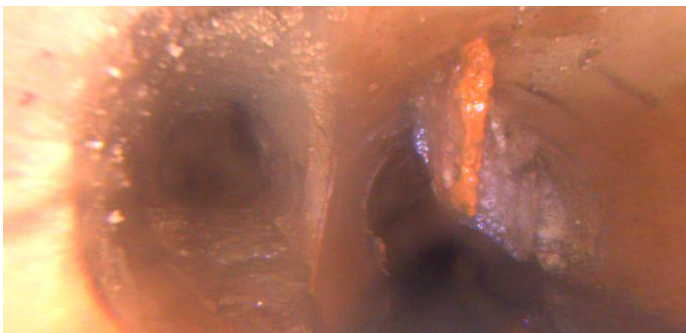
Code: **TF**
Description: **Tap Factory**

Distance (ft): **3.6**
Structural Grade: **0**
O&M Grade: **0**
Clock Start/From: **9**
Clock To:
1st Value: **4.000**
2nd Value:
Value Percent:
Continuous Index:
Within 8" of Joint:
Remarks:

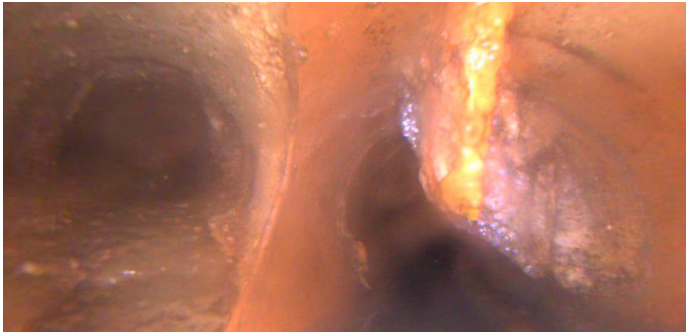
Code: **ID**
Description: **Infil Dripper**

Distance (ft): **3.9**
Structural Grade: **0**
O&M Grade: **3**
Clock Start/From: **12**
Clock To:
1st Value:
2nd Value:
Value Percent:
Continuous Index:
Within 8" of Joint:
Remarks:

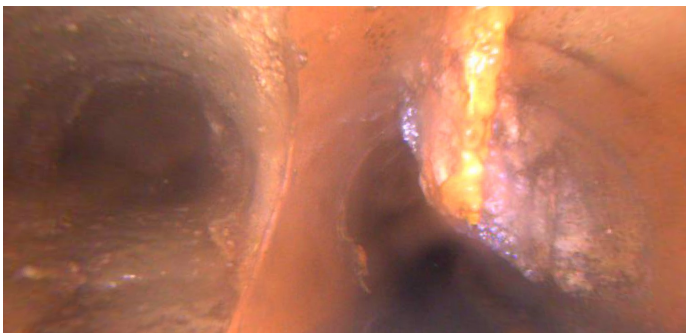
Code: **DAE**
Description: **Deposits Attached Encrustation**

Distance (ft): **3.9**
Structural Grade: **0**
O&M Grade: **5**
Clock Start/From: **12**
Clock To: **4**
1st Value:
2nd Value:
Value Percent: **40.000**
Continuous Index:
Within 8" of Joint: **NO**
Remarks:

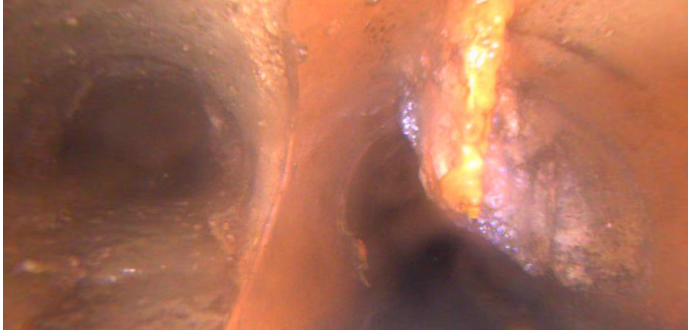
Code:	MSA
Description:	Abandoned Survey
Distance (ft):	3.9
Structural Grade:	0
O&M Grade:	0
Clock Start/From:	
Clock To:	
1st Value:	
2nd Value:	
Value Percent:	
Continuous Index:	
Within 8" of Joint:	NO
Remarks:	dae
