Profile/Photo Observation Report

Date:	04/07/2018	Weather:		Coding:	PACP 6.0
Pipe Length (ft):	202.8	Owner:	NA	Pre Clean:	No Pre-Cleaning
P.O.#:		Surveyor:	Jen Costello	PSR:	P-506-016-015
Customer:		Clean Date:	01/01/1900	Shape:	C

Street:	W 7TH PL	Flow Control:	Not Controlled
City:	Hobart, IN	Year Renewed:	
Location:	Yard	Tape/Media #:	
Purpose:	Routine Assessment	Dia/Height:	10"
Use:	Sanitary	Material:	VCP
Drain Area:	NA	Lining:	
Category:	NA		
Comment:	P_C DAE 16lf, flow direction is marked wrong.		
Location Details:		Direction of Survey:	Upstream
US MH:	M-506-015	DS MH:	M-506-016
		Total Length Surveyed (ft):	18.0

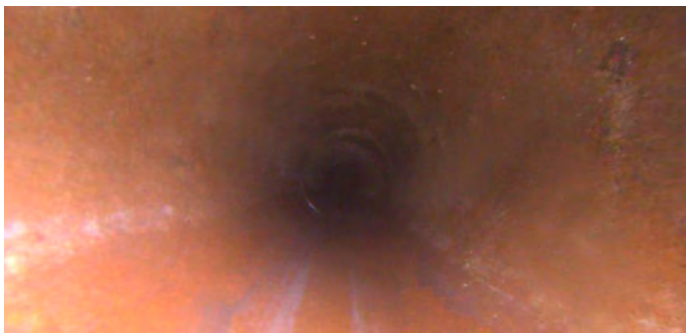
Code: **AMH**
Description: **Manhole**

Distance (ft): **.0**
Structural Grade: **0**
O&M Grade: **0**
Clock Start/From:
Clock To:
1st Value:
2nd Value:
Value Percent:
Continuous Index:
Within 8" of Joint: **NO**
Remarks: **M-506-016**

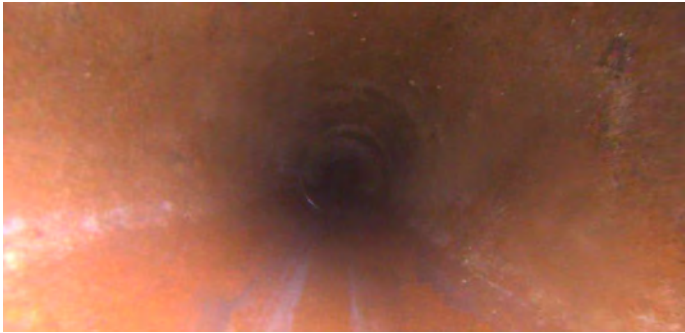
Code:	MWL
Description:	Water Level

Distance (ft):	.0
Structural Grade:	0
O&M Grade:	0
Clock Start/From:	
Clock To:	
1st Value:	
2nd Value:	
Value Percent:	5.000
Continuous Index:	
Within 8" of Joint:	NO
Remarks:

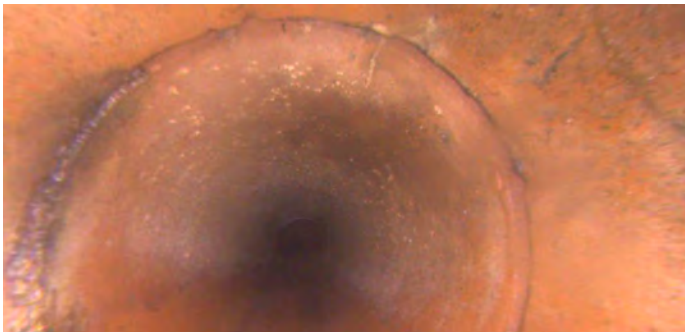
Code:	CL
Description:	Crack Longitudinal

Distance (ft):	3.3
Structural Grade:	2
O&M Grade:	0
Clock Start/From:	1
Clock To:	
1st Value:	
2nd Value:	
Value Percent:	
Continuous Index:	
Within 8" of Joint:	YES
Remarks:

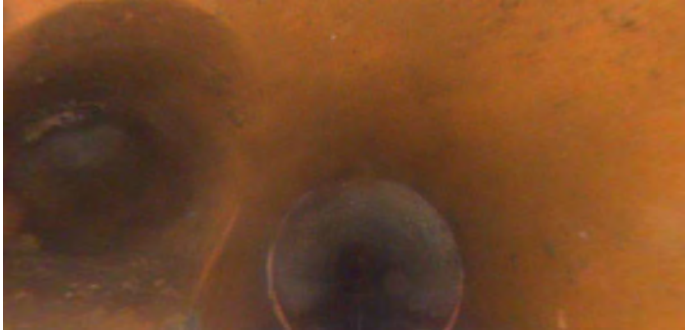
Code: **TF**
Description: **Tap Factory**

Distance (ft): **9.1**
Structural Grade: **0**
O&M Grade: **0**
Clock Start/From: **3**
Clock To:
1st Value: **4.000**
2nd Value:
Value Percent:
Continuous Index:
Within 8" of Joint:
Remarks:

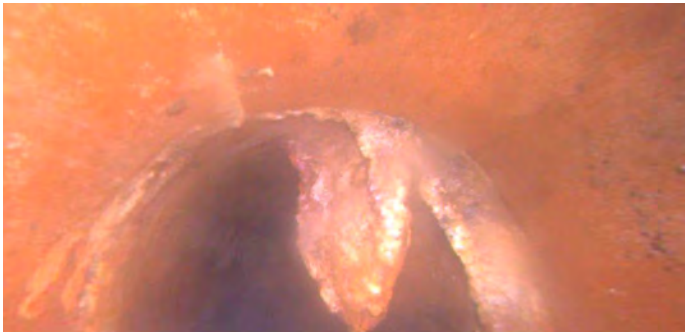
Code: **CL**
Description: **Crack Longitudinal**

Distance (ft): **17.1**
Structural Grade: **2**
O&M Grade: **0**
Clock Start/From: **12**
Clock To:
1st Value:
2nd Value:
Value Percent:
Continuous Index:
Within 8" of Joint: **YES**
Remarks:

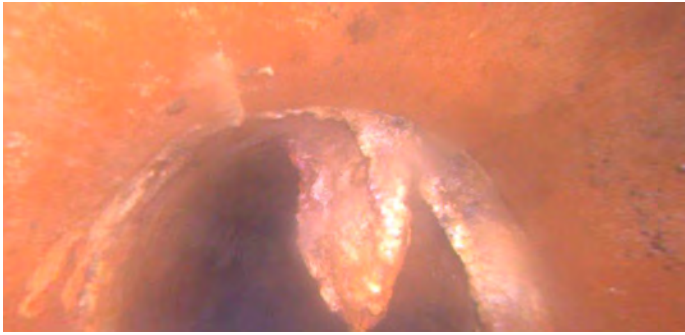
Code: **DAE**
Description: **Deposits Attached Encrustation**

Distance (ft): **17.1**
Structural Grade: **0**
O&M Grade: **2**
Clock Start/From: **8**
Clock To: **4**
1st Value:
2nd Value:
Value Percent: **10.000**
Continuous Index:
Within 8" of Joint: **YES**
Remarks:
