## Profile/Photo Observation Report

Date:	<b>04/07/2018</b>	Weather:		Coding:	<b>PACP 6.0</b>
Pipe Length (ft):	<b>202.8</b>	Owner:	<b>NA</b>	Pre Clean:	<b>No Pre-Cleaning</b>
P.O.#:		Surveyor:	<b>Jen Costello</b>	PSR:	<b>P-506-016-015</b>
Customer:		Clean Date:	<b>01/01/1900</b>	Shape:	<b>C</b>

Street:	<b>FOXCROFT STREET</b>	Flow Control:	<b>Not Controlled</b>
City:	<b>Hobart, IN</b>	Year Renewed:	
Location:	<b>Yard</b>	Tape/Media #:	
Purpose:	<b>Routine Assessment</b>	Dia/Height:	<b>10"</b>
Use:	<b>Sanitary</b>	Material:	<b>VCP</b>
Drain Area:	<b>NA</b>	Lining:	
Category:	<b>NA</b>		
Comment:	<b>P_C DAE 16lf, flow direction is marked wrong.</b>		
Location Details:		Direction of Survey:	<b>Upstream</b>
US MH:	<b>M-506-015</b>	DS MH:	<b>M-506-016</b>
		Total Length Surveyed (ft):	<b>18.0</b>

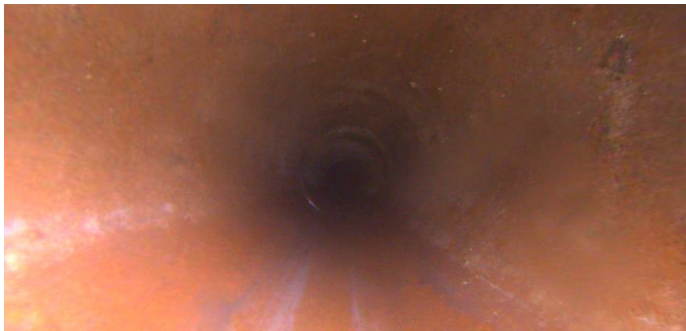
Code: **AMH**  
Description: **Manhole**

Distance (ft): **.0**  
Structural Grade: **0**  
O&M Grade: **0**  
Clock Start/From:  
Clock To:  
1st Value:  
2nd Value:  
Value Percent:  
Continuous Index:  
Within 8" of Joint: **NO**  
Remarks: **M-506-016**

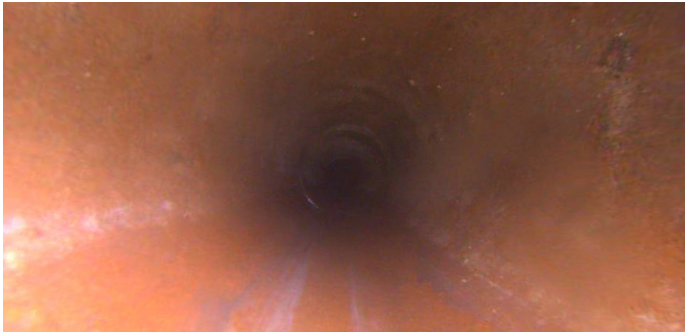
Code:	<b>MWL</b>
Description:	<b>Water Level</b>

Distance (ft):	<b>.0</b>
Structural Grade:	<b>0</b>
O&M Grade:	<b>0</b>
Clock Start/From:	
Clock To:	
1st Value:	
2nd Value:	
Value Percent:	<b>5.000</b>
Continuous Index:	
Within 8" of Joint:	<b>NO</b>
Remarks:

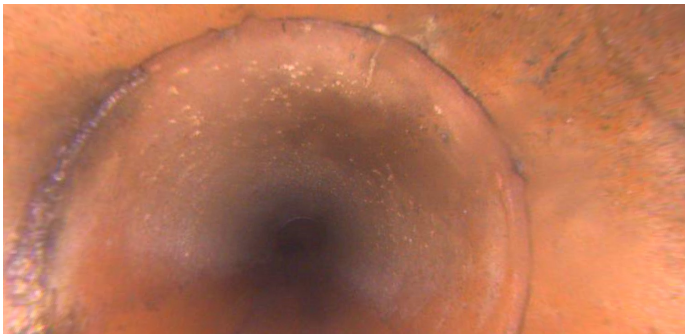
Code:	<b>CL</b>
Description:	<b>Crack Longitudinal</b>

Distance (ft):	<b>3.3</b>
Structural Grade:	<b>2</b>
O&M Grade:	<b>0</b>
Clock Start/From:	<b>1</b>
Clock To:	
1st Value:	
2nd Value:	
Value Percent:	
Continuous Index:	
Within 8" of Joint:	<b>YES</b>
Remarks:

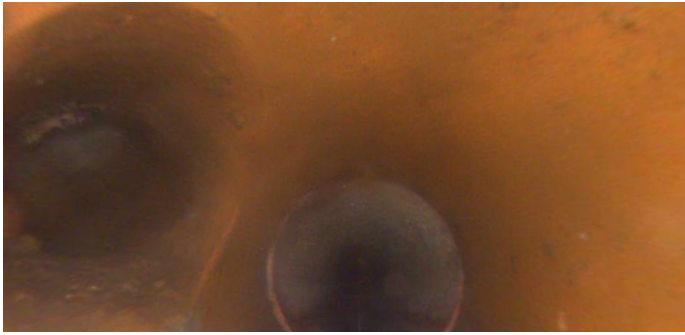
Code: **TF**  
Description: **Tap Factory**

Distance (ft): **9.1**  
Structural Grade: **0**  
O&M Grade: **0**  
Clock Start/From: **3**  
Clock To:  
1st Value: **4.000**  
2nd Value:  
Value Percent:  
Continuous Index:  
Within 8" of Joint:  
Remarks:

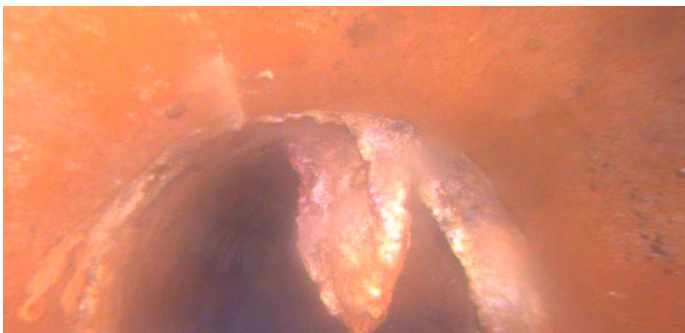
Code: **CL**  
Description: **Crack Longitudinal**

Distance (ft): **17.1**  
Structural Grade: **2**  
O&M Grade: **0**  
Clock Start/From: **12**  
Clock To:  
1st Value:  
2nd Value:  
Value Percent:  
Continuous Index:  
Within 8" of Joint: **YES**  
Remarks:

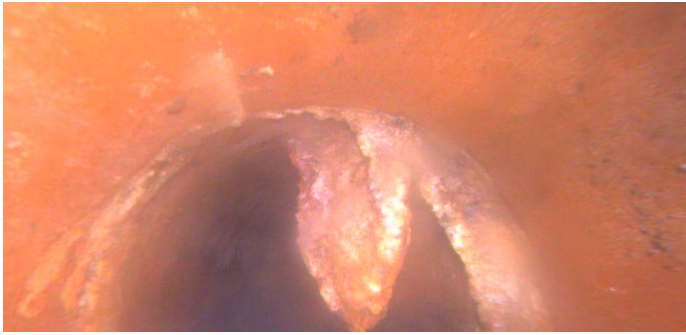
Code: **DAE**  
Description: **Deposits Attached Encrustation**

Distance (ft): **17.1**  
Structural Grade: **0**  
O&M Grade: **2**  
Clock Start/From: **8**  
Clock To: **4**  
1st Value:  
2nd Value:  
Value Percent: **10.000**  
Continuous Index:  
Within 8" of Joint: **YES**  
Remarks:

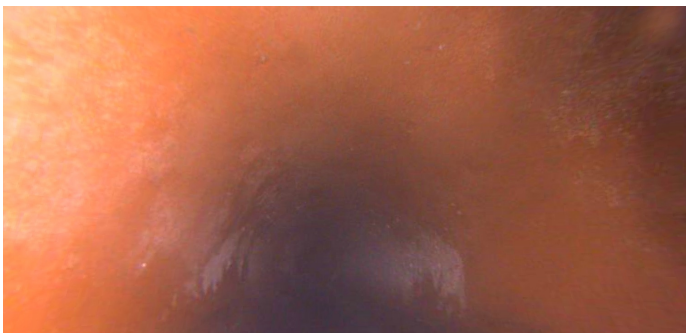
Code: **MSA**  
Description: **Abandoned Survey**

Distance (ft): **18.0**  
Structural Grade: **0**  
O&M Grade: **0**  
Clock Start/From:  
Clock To:  
1st Value:  
2nd Value:  
Value Percent:  
Continuous Index:  
Within 8" of Joint: **NO**  
Remarks: **dae**
