Profile/Photo Observation Report

Date:	01/20/2022	Weather:		Coding:	PACP 7.0
Pipe Length (ft):	203.3	Owner:	City of Hobart	Pre Clean:	Heavy Cleaning
P.O.#:	YES502259	Surveyor:	S. Bucklin	PSR:	P-506-016-015
Customer:	City of Hobart	Clean Date:	01/16/2022	Shape:	C

Street:	West 7th Place	Flow Control:	Not Controlled
City:	Hobart, IN	Year Renewed:	
Location:	Local rural streets with light traffic, t	Tape/Media #:	
Purpose:	Routine Assessment	Dia/Height:	10"
Use:	Sanitary Sewage Pipe	Material:	VCP
Drain Area:		Lining:	None
Category:	NA

Location Details:		Direction of Survey:	Downstream
US MH:	M-506-015	DS MH:	M-506-016
		Total Length Surveyed (ft):	203.3

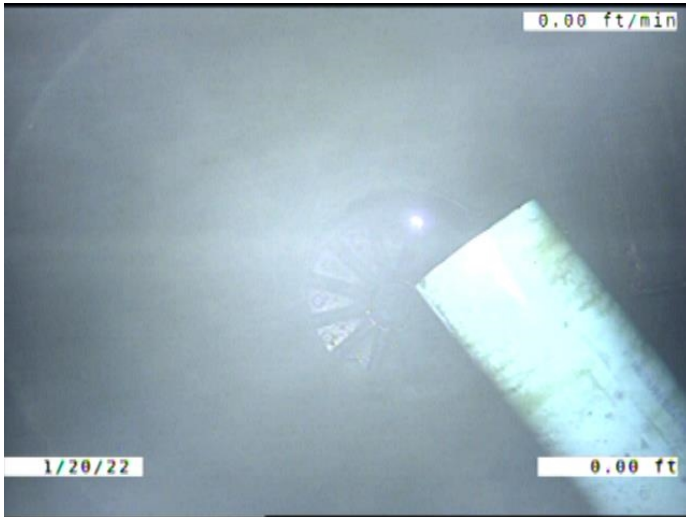
Code: **AMH**
 Description: **Manhole**

Distance (ft): **.0**
 Structural Grade: **0**
 O&M Grade: **0**
 Clock Start/From:
 Clock To:
 1st Value:
 2nd Value:
 Value Percent:
 Continuous Index:
 Within 8" of Joint: **NO**
 Remarks: **M-506-015**

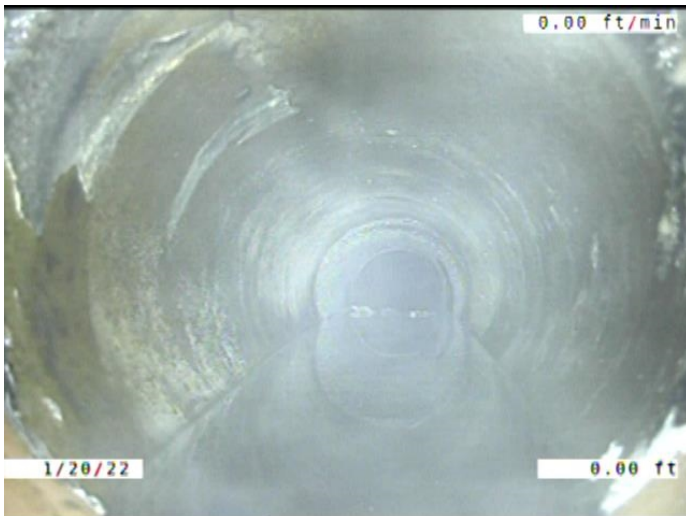
Code: **MWL**
 Description: **Miscellaneous Water Level**

Distance (ft): **.0**
 Structural Grade: **0**
 O&M Grade: **0**
 Clock Start/From:
 Clock To:
 1st Value:
 2nd Value:
 Value Percent: **10.000**
 Continuous Index:
 Within 8" of Joint: **NO**
 Remarks:

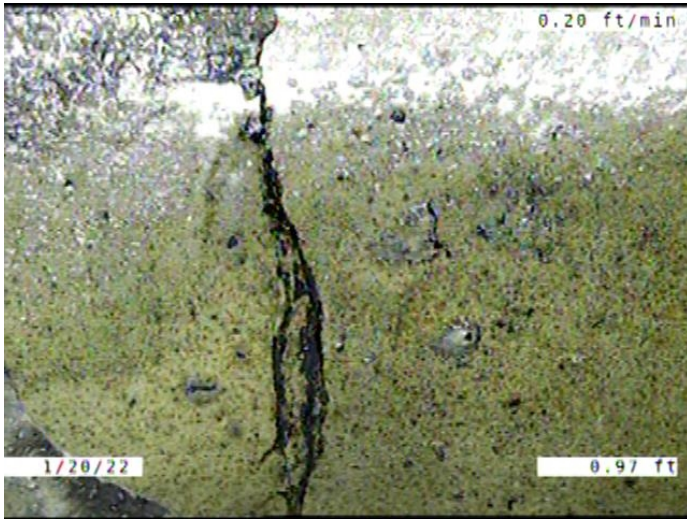
Code: **CL**
Description: **Crack Longitudinal**

Distance (ft): **1.0**
Structural Grade: **2**
O&M Grade: **0**
Clock Start/From: **11**
Clock To:
1st Value:
2nd Value:
Value Percent:
Continuous Index:
Within 8" of Joint: **YES**
Remarks:

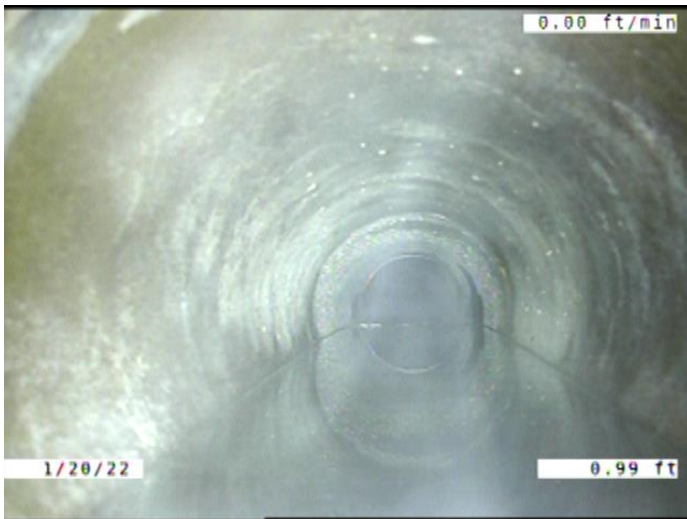
Code: **DAE**
Description: **Deposits Attached Encrustation**

Distance (ft): **1.0**
Structural Grade: **0**
O&M Grade: **2**
Clock Start/From: **8**
Clock To: **4**
1st Value:
2nd Value:
Value Percent: **5.000**
Continuous Index: **S01**
Within 8" of Joint: **YES**
Remarks:

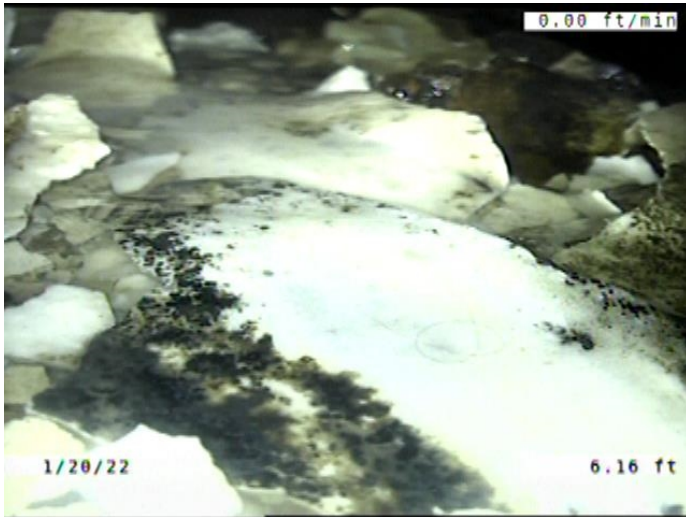
Code:	DSZ
Description:	Deposits Settled Other
Distance (ft):	6.2
Structural Grade:	0
O&M Grade:	2
Clock Start/From:	5
Clock To:	7
1st Value:	
2nd Value:	
Value Percent:	10.000
Continuous Index:	
Within 8" of Joint:	YES
Remarks:	PIECES OF ENCRUSTATION THAT HAVE BEEN BROKEN OFF THE PIPE

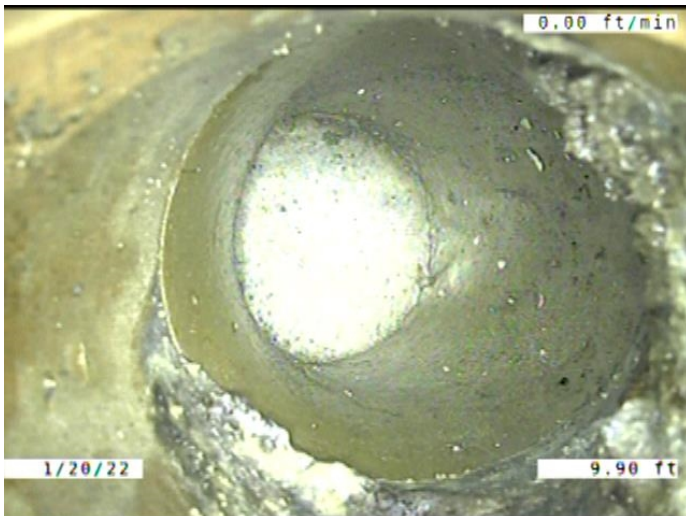
Code:	TFC
Description:	Tap Factory Capped
Distance (ft):	9.9
Structural Grade:	0
O&M Grade:	0
Clock Start/From:	2
Clock To:	
1st Value:	4.000
2nd Value:	
Value Percent:	
Continuous Index:	
Within 8" of Joint:	YES
Remarks:	ENCRUSTATION COMING FROM THE SERVICE TO MAIN CONNECTION.

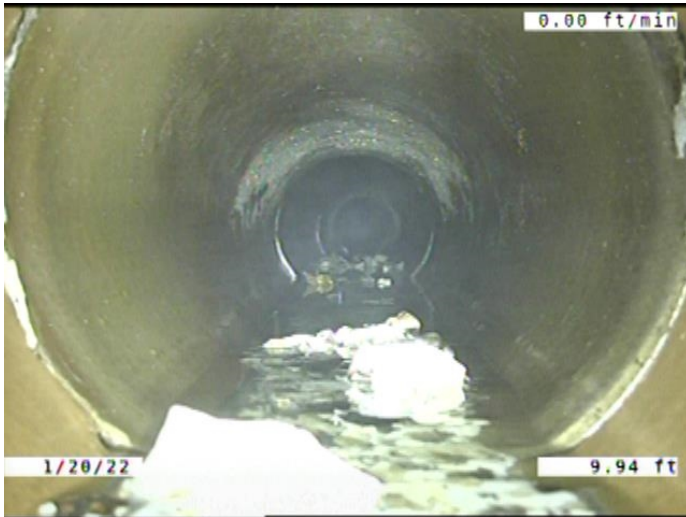
Code:	DSZ
Description:	Deposits Settled Other
Distance (ft):	9.9
Structural Grade:	0
O&M Grade:	2
Clock Start/From:	5
Clock To:	7
1st Value:	
2nd Value:	
Value Percent:	5.000
Continuous Index:	S02
Within 8" of Joint:	YES
Remarks:	PIECES OF ENCRUSTATION THAT HAVE BEEN BROKEN OFF THE PIPE

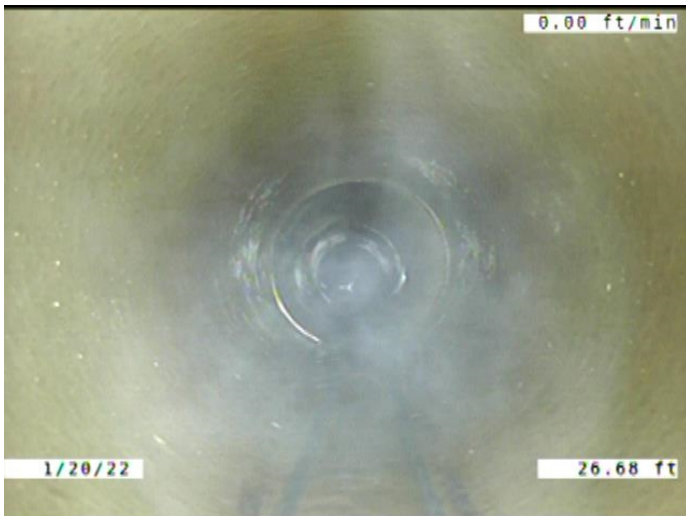
Code:	DSZ
Description:	Deposits Settled Other
Distance (ft):	26.7
Structural Grade:	0
O&M Grade:	2
Clock Start/From:	5
Clock To:	7
1st Value:	
2nd Value:	
Value Percent:	5.000
Continuous Index:	F02
Within 8" of Joint:	YES
Remarks:	PIECES OF ENCRUSTATION THAT HAVE BEEN BROKEN OFF THE PIPE

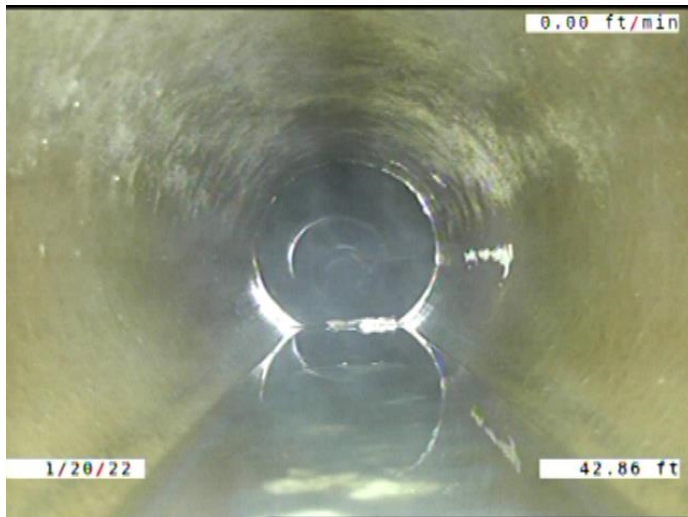
Code: **DSF**
 Description: **Deposits Settled Fine**

Distance (ft): **42.9**
 Structural Grade: **0**
 O&M Grade: **2**
 Clock Start/From: **5**
 Clock To: **7**
 1st Value:
 2nd Value:
 Value Percent: **5.000**
 Continuous Index: **S03**
 Within 8" of Joint: **YES**
 Remarks:

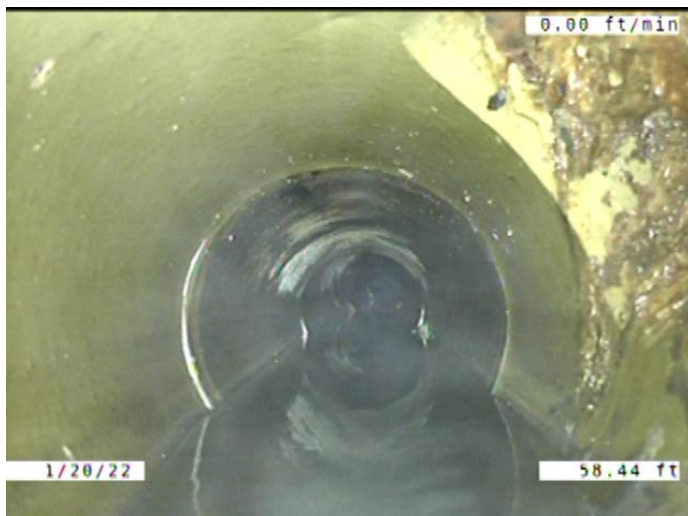
Code: **MWLS**
 Description: **Miscellaneous Water Level Sag**

Distance (ft): **58.4**
 Structural Grade: **2**
 O&M Grade: **0**
 Clock Start/From:
 Clock To:
 1st Value:
 2nd Value:
 Value Percent: **10.000**
 Continuous Index: **S04**
 Within 8" of Joint: **NO**
 Remarks:

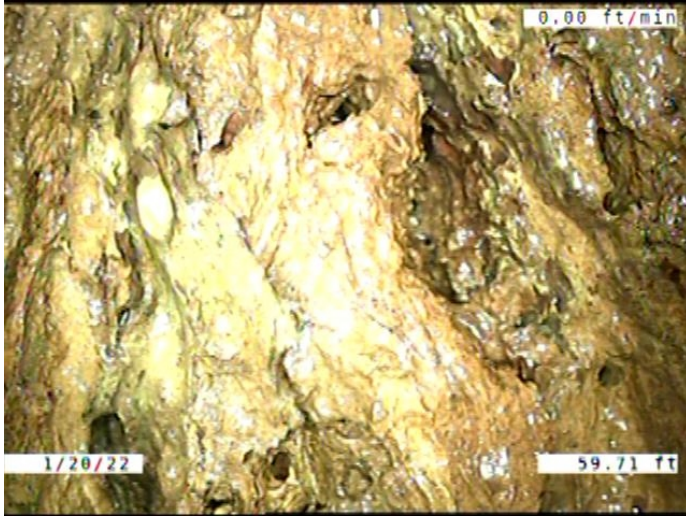
Code: **IDC**
Description: **Infiltration Dripper Connection**

Distance (ft): **59.7**
Structural Grade: **0**
O&M Grade: **3**
Clock Start/From: **1**
Clock To: **3**
1st Value:
2nd Value:
Value Percent:
Continuous Index:
Within 8" of Joint: **YES**
Remarks:

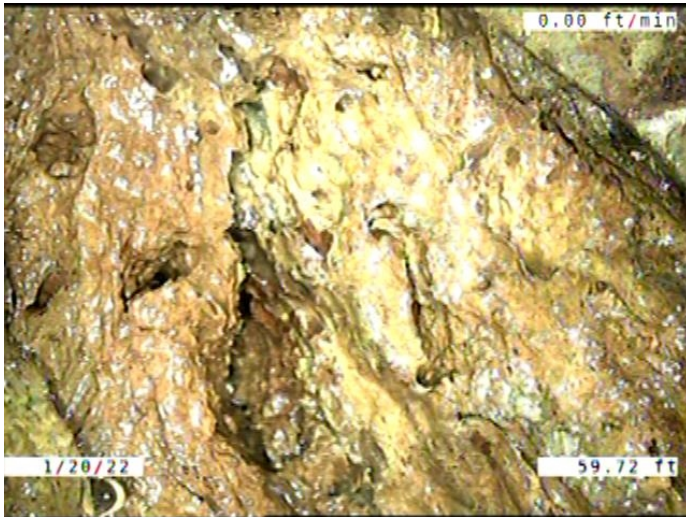
Code: **TFD**
Description: **Tap Factory Defective**

Distance (ft): **59.7**
Structural Grade: **0**
O&M Grade: **3**
Clock Start/From: **2**
Clock To:
1st Value: **6.000**
2nd Value:
Value Percent:
Continuous Index:
Within 8" of Joint: **YES**
Remarks: **100% PLUGGED WITH ENCRUSTATION.**

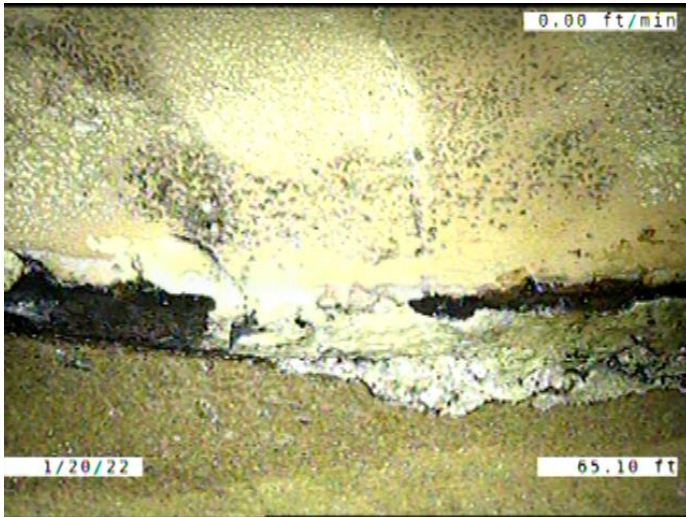
Code: **JOM**
 Description: **Joint Offset Medium**

Distance (ft): **65.1**
 Structural Grade: **3**
 O&M Grade: **0**
 Clock Start/From:
 Clock To:
 1st Value:
 2nd Value:
 Value Percent:
 Continuous Index:
 Within 8" of Joint: **NO**
 Remarks:

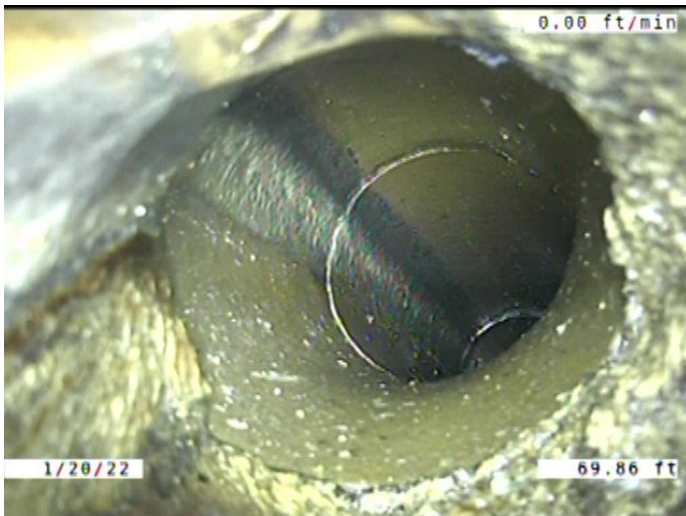
Code: **TF**
 Description: **Tap Factory**

Distance (ft): **69.9**
 Structural Grade: **0**
 O&M Grade: **0**
 Clock Start/From: **11**
 Clock To:
 1st Value: **4.000**
 2nd Value:
 Value Percent:
 Continuous Index:
 Within 8" of Joint: **YES**
 Remarks: **ENCrustATION COMING FROM THE SERVICE TO MAIN CONNECTION.**

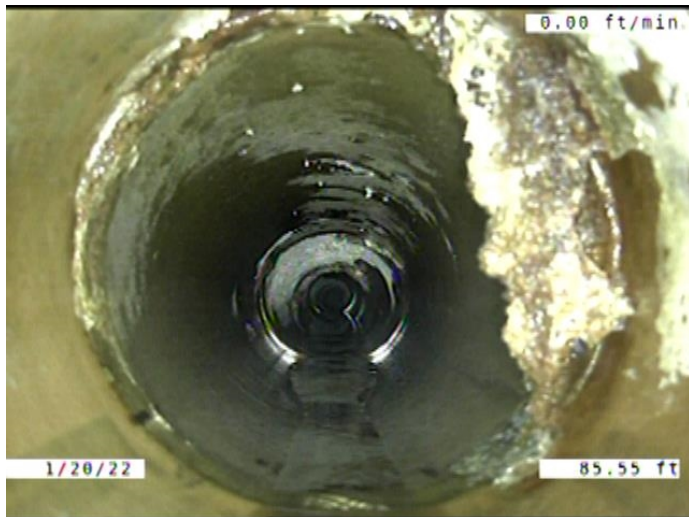
Code: **MWLS**
 Description: **Miscellaneous Water Level Sag**

Distance (ft): **85.5**
 Structural Grade: **2**
 O&M Grade: **0**
 Clock Start/From:
 Clock To:
 1st Value:
 2nd Value:
 Value Percent: **10.000**
 Continuous Index: **F04**
 Within 8" of Joint: **NO**
 Remarks:

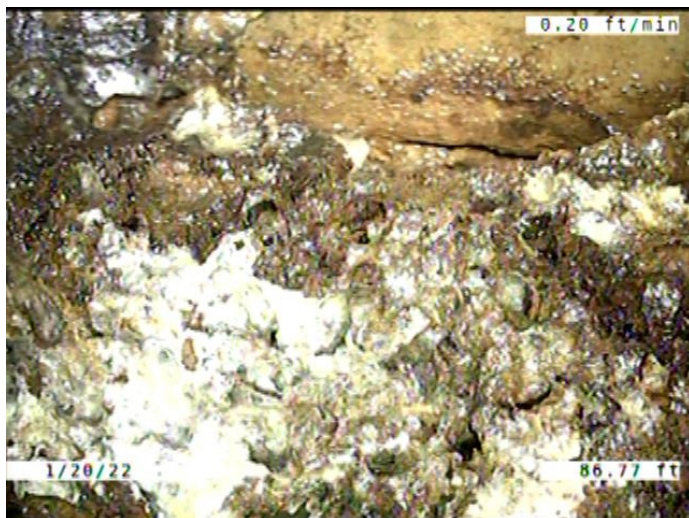
Code: **DAE**
 Description: **Deposits Attached Encrustation**

Distance (ft): **86.8**
 Structural Grade: **0**
 O&M Grade: **3**
 Clock Start/From: **7**
 Clock To: **5**
 1st Value:
 2nd Value:
 Value Percent: **15.000**
 Continuous Index:
 Within 8" of Joint: **YES**
 Remarks:

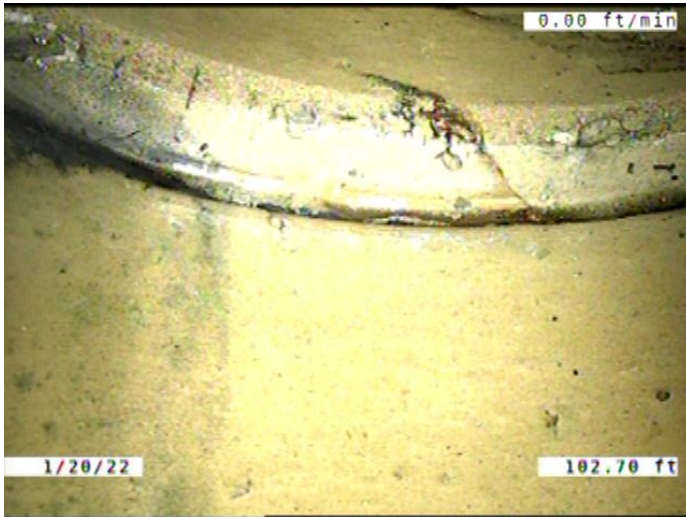
Code: **JOM**
Description: **Joint Offset Medium**

Distance (ft): **102.7**
Structural Grade: **3**
O&M Grade: **0**
Clock Start/From:
Clock To:
1st Value:
2nd Value:
Value Percent:
Continuous Index:
Within 8" of Joint: **NO**
Remarks:

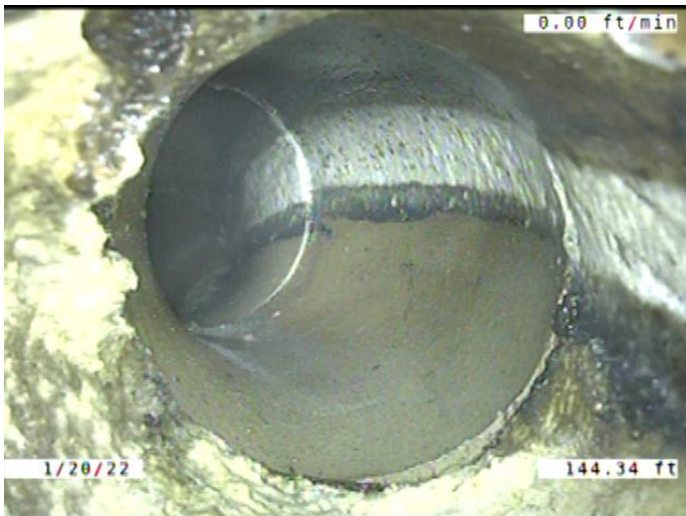
Code: **TF**
Description: **Tap Factory**

Distance (ft): **144.3**
Structural Grade: **0**
O&M Grade: **0**
Clock Start/From: **2**
Clock To:
1st Value: **4.000**
2nd Value:
Value Percent:
Continuous Index:
Within 8" of Joint: **YES**
Remarks: **ENCrustATION COMING FROM THE SERVICE TO MAIN CONNECTION.**

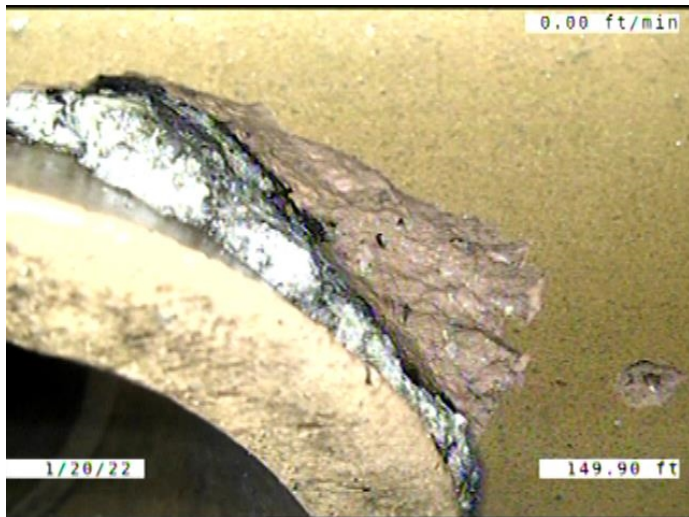
Code: **B**
 Description: **Broken**

Distance (ft): **149.9**
 Structural Grade: **4**
 O&M Grade: **0**
 Clock Start/From: **9**
 Clock To: **12**
 1st Value:
 2nd Value:
 Value Percent:
 Continuous Index:
 Within 8" of Joint: **YES**
 Remarks:

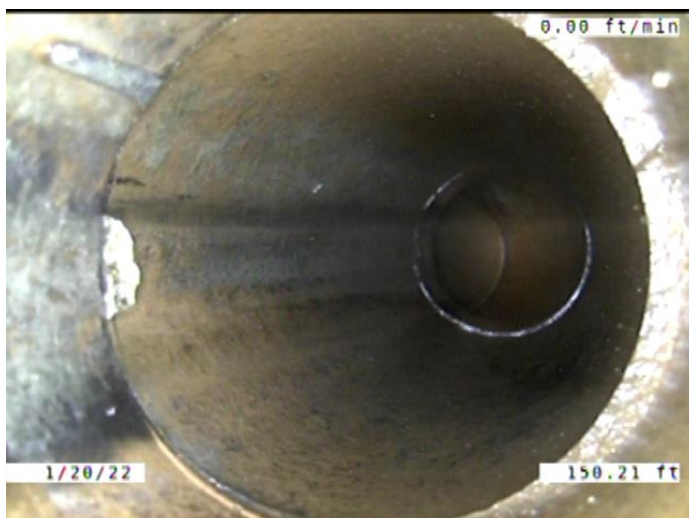
Code: **TFI**
 Description: **Tap Factory Intruding**

Distance (ft): **150.2**
 Structural Grade: **0**
 O&M Grade: **2**
 Clock Start/From: **10**
 Clock To:
 1st Value: **4.000**
 2nd Value: **2.000**
 Value Percent:
 Continuous Index:
 Within 8" of Joint: **YES**
 Remarks:

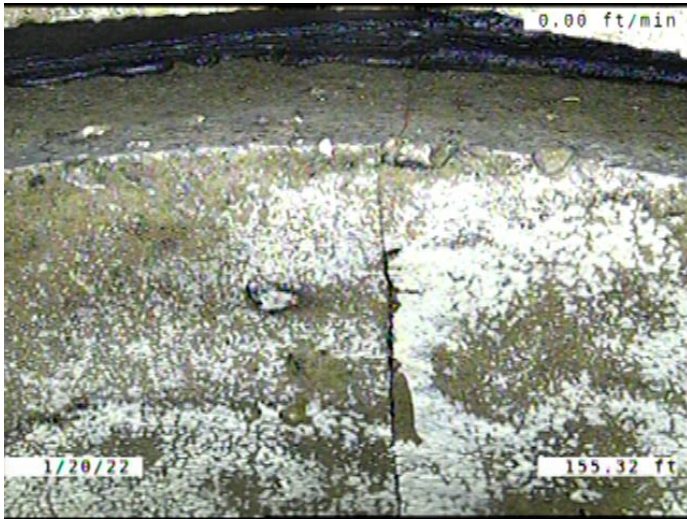
Code: **CS**
 Description: **Crack Spiral**

Distance (ft): **155.3**
 Structural Grade: **2**
 O&M Grade: **0**
 Clock Start/From: **2**
 Clock To: **3**
 1st Value:
 2nd Value:
 Value Percent:
 Continuous Index:
 Within 8" of Joint: **YES**
 Remarks:

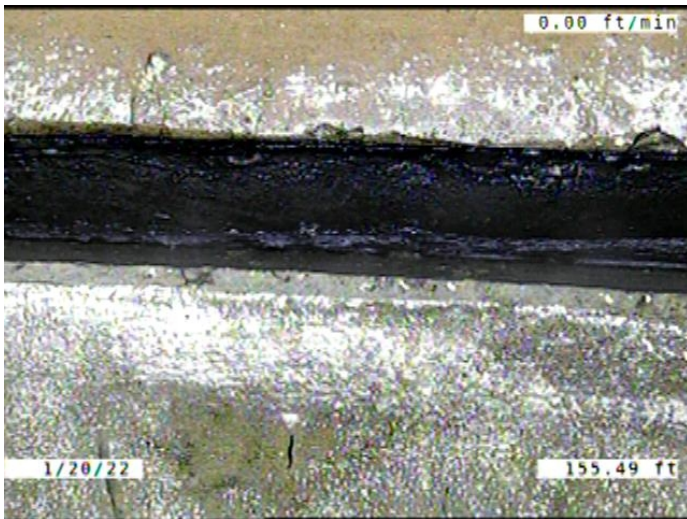
Code: **JAM**
 Description: **Joint Angular Medium**

Distance (ft): **155.5**
 Structural Grade: **3**
 O&M Grade: **0**
 Clock Start/From:
 Clock To:
 1st Value:
 2nd Value:
 Value Percent:
 Continuous Index:
 Within 8" of Joint: **NO**
 Remarks:

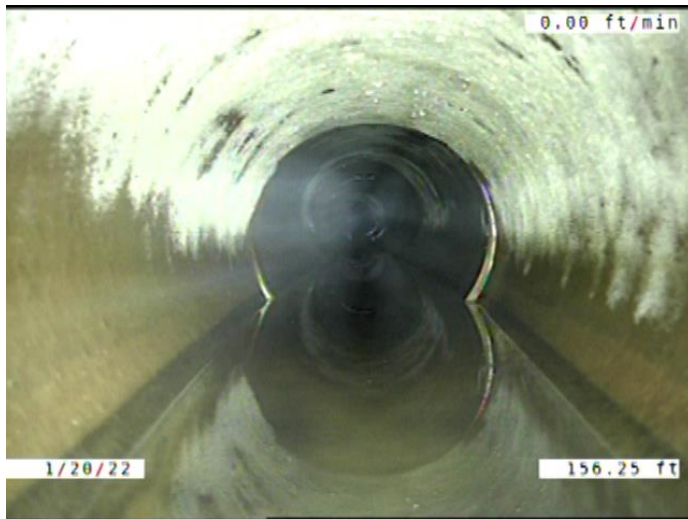
Code: **MWLS**
Description: **Miscellaneous Water Level Sag**

Distance (ft): **156.2**
Structural Grade: **2**
O&M Grade: **0**
Clock Start/From:
Clock To:
1st Value:
2nd Value:
Value Percent: **10.000**
Continuous Index: **S05**
Within 8" of Joint: **NO**
Remarks:

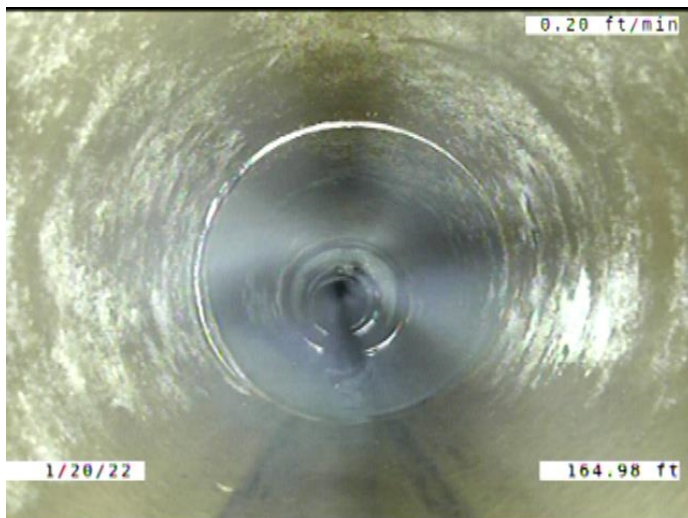
Code: **MWLS**
Description: **Miscellaneous Water Level Sag**

Distance (ft): **165.0**
Structural Grade: **2**
O&M Grade: **0**
Clock Start/From:
Clock To:
1st Value:
2nd Value:
Value Percent: **10.000**
Continuous Index: **F05**
Within 8" of Joint: **NO**
Remarks:

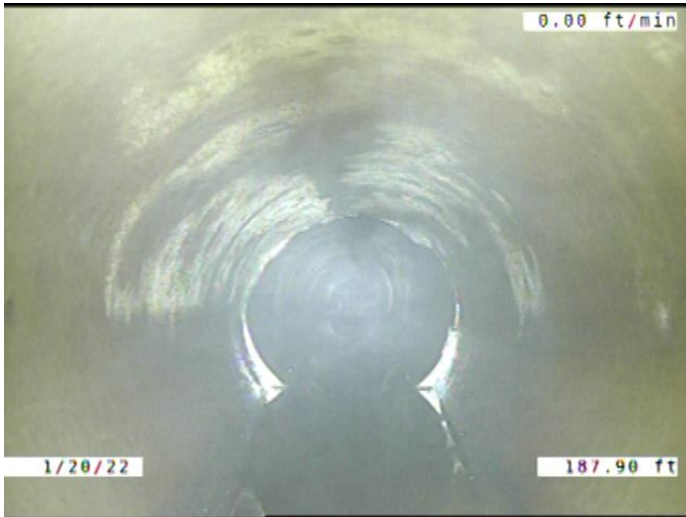
Code: **MWLS**
Description: **Miscellaneous Water Level Sag**

Distance (ft): **187.9**
Structural Grade: **2**
O&M Grade: **0**
Clock Start/From:
Clock To:
1st Value:
2nd Value:
Value Percent: **10.000**
Continuous Index: **S06**
Within 8" of Joint: **NO**
Remarks:

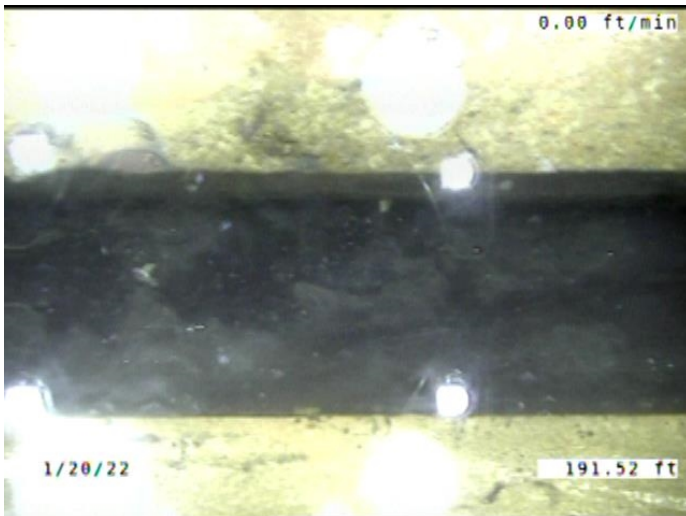
Code: **JAL**
Description: **Joint Angular Large**

Distance (ft): **191.5**
Structural Grade: **4**
O&M Grade: **0**
Clock Start/From:
Clock To:
1st Value:
2nd Value:
Value Percent:
Continuous Index:
Within 8" of Joint: **NO**
Remarks:

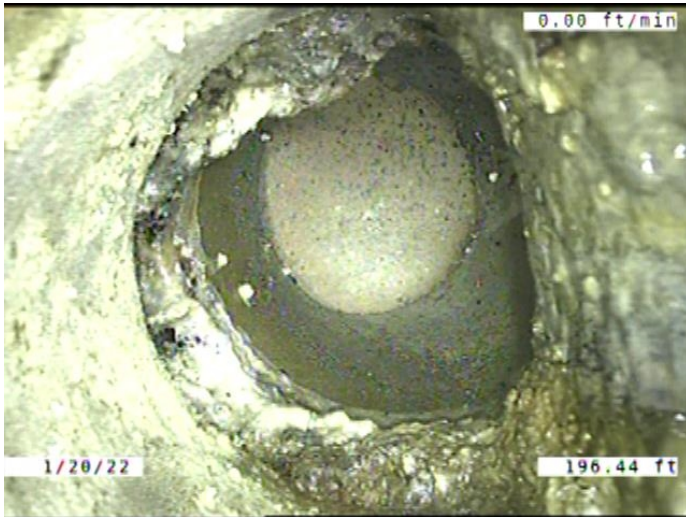
Code:	TFD
Description:	Tap Factory Defective
Distance (ft):	196.4
Structural Grade:	0
O&M Grade:	3
Clock Start/From:	2
Clock To:	
1st Value:	4.000
2nd Value:	
Value Percent:	
Continuous Index:	
Within 8" of Joint:	YES
Remarks:	CAPPED. ENCRUSTATION COMING FROM THE SERVICE TO MAIN CONN

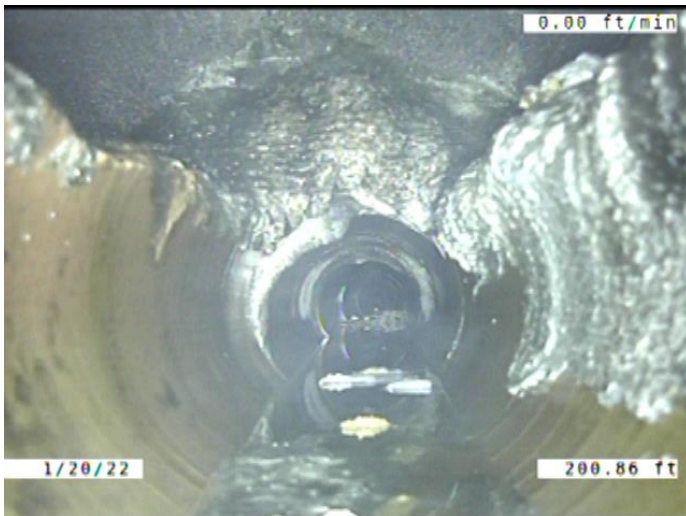
Code:	DAE
Description:	Deposits Attached Encrustation
Distance (ft):	200.9
Structural Grade:	0
O&M Grade:	2
Clock Start/From:	8
Clock To:	4
1st Value:	
2nd Value:	
Value Percent:	5.000
Continuous Index:	F01
Within 8" of Joint:	YES
Remarks:

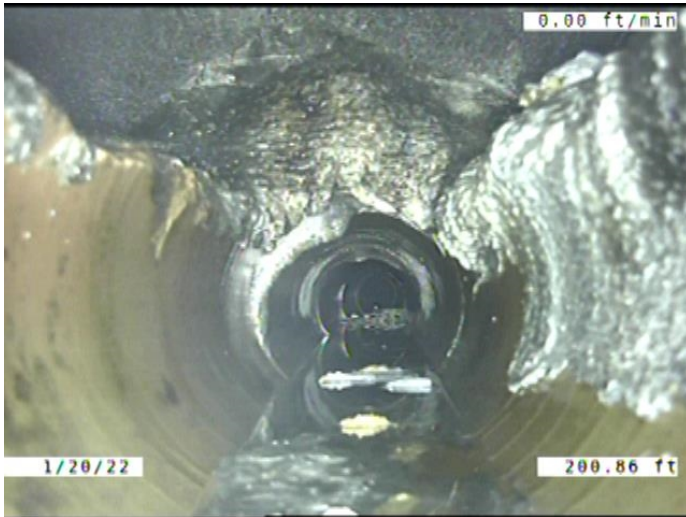
Code: **DSF**
Description: **Deposits Settled Fine**

Distance (ft): **200.9**
Structural Grade: **0**
O&M Grade: **2**
Clock Start/From: **5**
Clock To: **7**
1st Value:
2nd Value:
Value Percent: **5.000**
Continuous Index: **F03**
Within 8" of Joint: **YES**
Remarks:

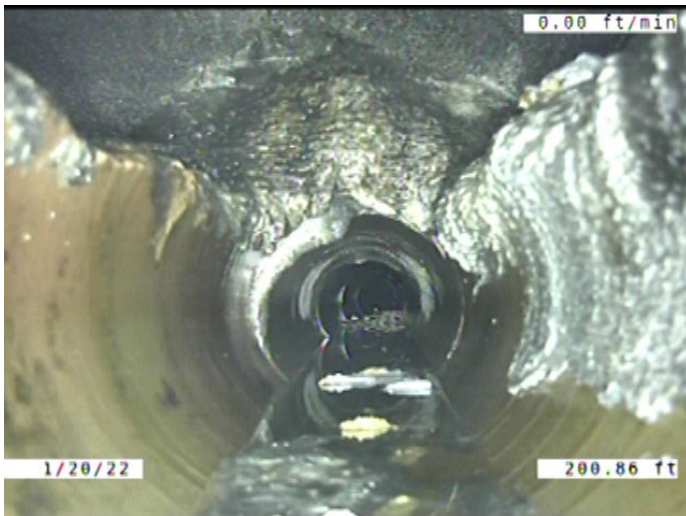
Code: **MWLS**
Description: **Miscellaneous Water Level Sag**

Distance (ft): **200.9**
Structural Grade: **2**
O&M Grade: **0**
Clock Start/From:
Clock To:
1st Value:
2nd Value:
Value Percent: **10.000**
Continuous Index: **F06**
Within 8" of Joint: **NO**
Remarks:

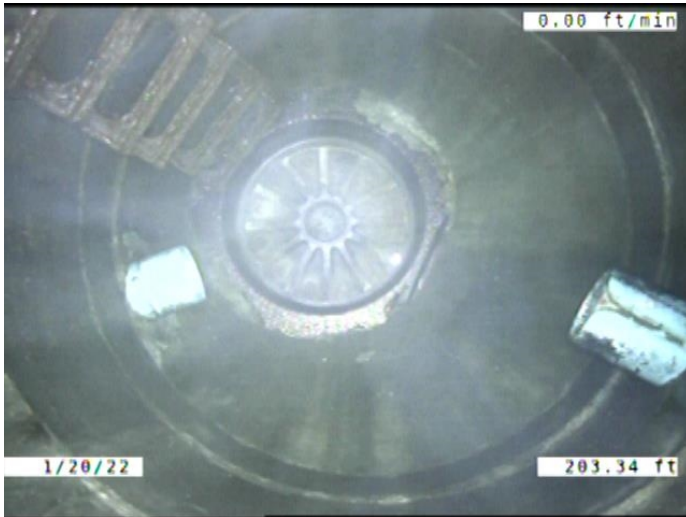
Code:	AMH
Description:	Manhole
Distance (ft):	203.3
Structural Grade:	0
O&M Grade:	0
Clock Start/From:	
Clock To:	
1st Value:	
2nd Value:	
Value Percent:	
Continuous Index:	
Within 8" of Joint:	NO
Remarks:	M-506-016
