Profile/Photo Observation Report

Date:	01/20/2022	Weather:		Coding:	PACP 7.0
Pipe Length (ft):	205.3	Owner:	City of Hobart	Pre Clean:	Heavy Cleaning
P.O.#:	YES502259	Surveyor:	S. Bucklin	PSR:	P-506-017-016
Customer:	City of Hobart	Clean Date:	01/16/2022	Shape:	C

Street:	West 7th Place	Flow Control:	Not Controlled
City:	Hobart, IN	Year Renewed:	
Location:	Local rural streets with light traffic, t	Tape/Media #:	
Purpose:	Routine Assessment	Dia/Height:	10"
Use:	Sanitary Sewage Pipe	Material:	VCP
Drain Area:		Lining:	None
Category:	NA		
Comment:			
Location Details:		Direction of Survey:	Downstream
US MH:	M-506-016	DS MH:	M-506-017
		Total Length Surveyed (ft):	205.3

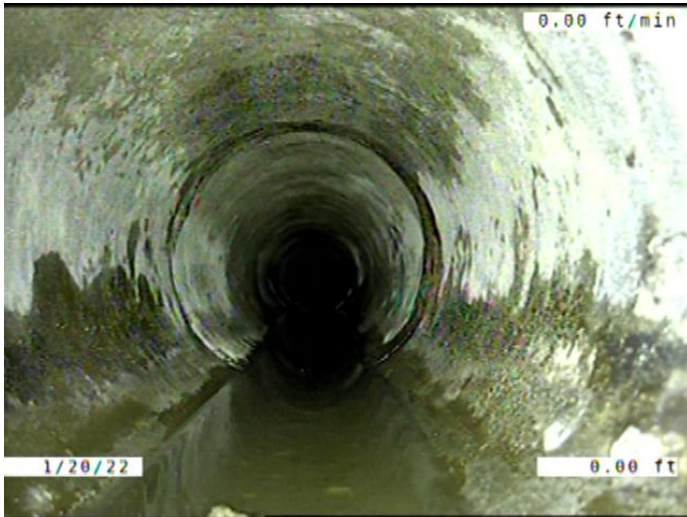
Code: **DSF**
Description: **Deposits Settled Fine**

Distance (ft): **.0**
Structural Grade: **0**
O&M Grade: **2**
Clock Start/From: **5**
Clock To: **7**
1st Value:
2nd Value:
Value Percent: **5.000**
Continuous Index: **S01**
Within 8" of Joint: **YES**
Remarks:

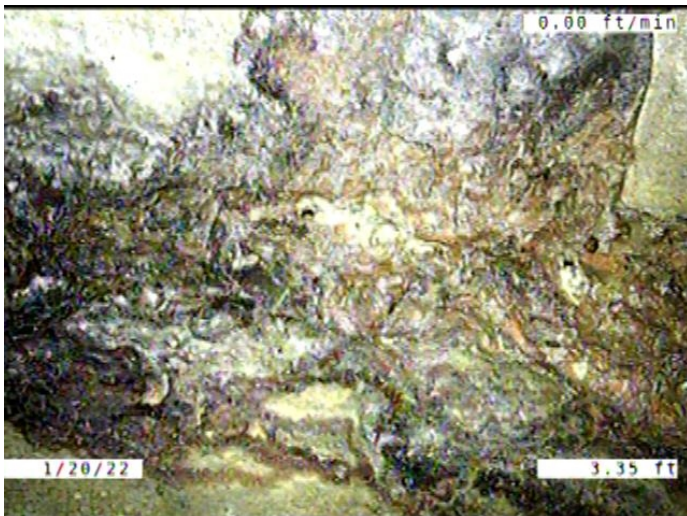
Code: **DAE**
Description: **Deposits Attached Encrustation**

Distance (ft): **3.3**
Structural Grade: **0**
O&M Grade: **2**
Clock Start/From: **7**
Clock To: **5**
1st Value:
2nd Value:
Value Percent: **5.000**
Continuous Index: **S02**
Within 8" of Joint: **YES**
Remarks:

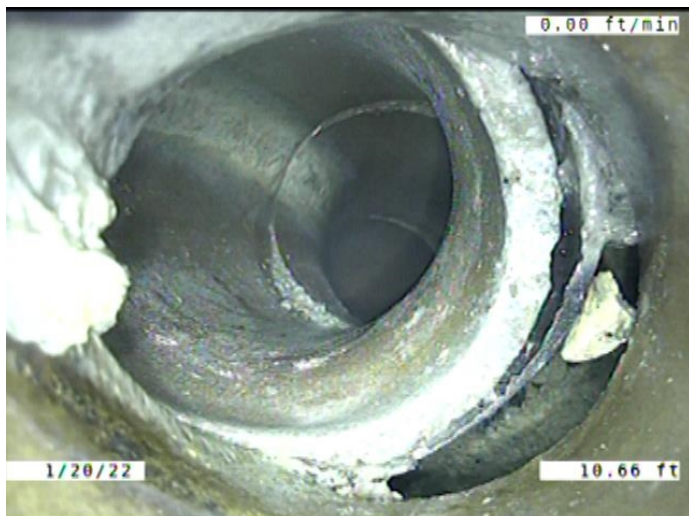
Code: **TFD**
Description: **Tap Factory Defective**

Distance (ft): **10.7**
Structural Grade: **0**
O&M Grade: **3**
Clock Start/From: **11**
Clock To:
1st Value: **4.000**
2nd Value:
Value Percent:
Continuous Index:
Within 8" of Joint: **YES**
Remarks: **TAP CRACKED. SERVICE LINE LARGE OFFSET. SOIL VISIBLE.**

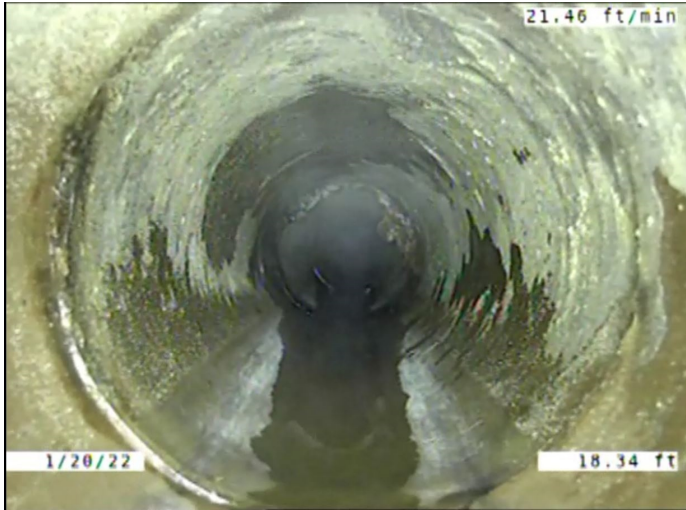
Code: **IS**
Description: **Infiltration Stain**

Distance (ft): **18.3**
Structural Grade: **0**
O&M Grade: **1**
Clock Start/From: **8**
Clock To: **10**
1st Value:
2nd Value:
Value Percent:
Continuous Index:
Within 8" of Joint: **YES**
Remarks:

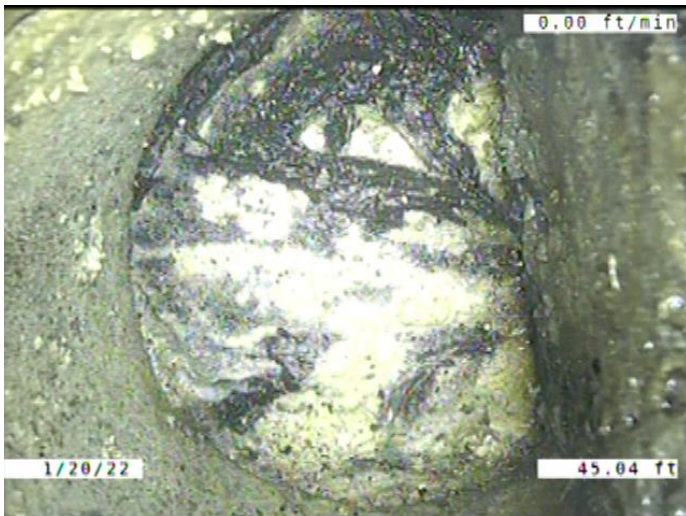
Code: **TFD**
Description: **Tap Factory Defective**

Distance (ft): **45.0**
Structural Grade: **0**
O&M Grade: **3**
Clock Start/From: **2**
Clock To:
1st Value: **4.000**
2nd Value:
Value Percent:
Continuous Index:
Within 8" of Joint: **YES**
Remarks: **CAPPED. CAP LEAKING AND
ENCUSTATION COMING FROM THE T**

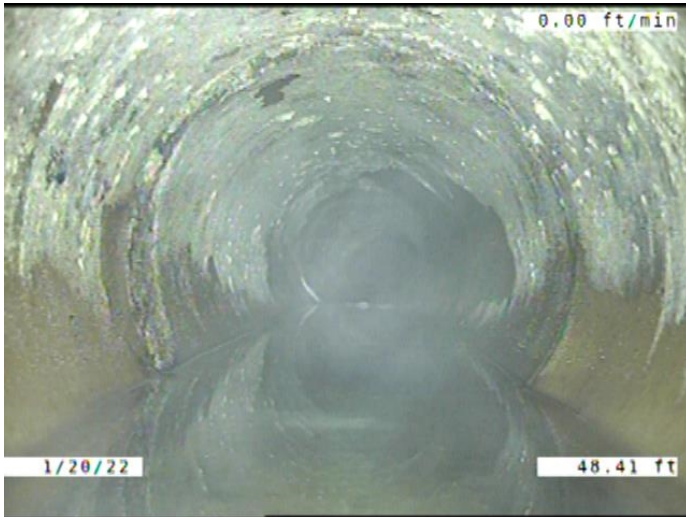
Code: **MWLS**
Description: **Miscellaneous Water Level Sag**

Distance (ft): **48.4**
Structural Grade: **2**
O&M Grade: **0**
Clock Start/From:
Clock To:
1st Value:
2nd Value:
Value Percent: **10.000**
Continuous Index: **S03**
Within 8" of Joint: **NO**
Remarks:

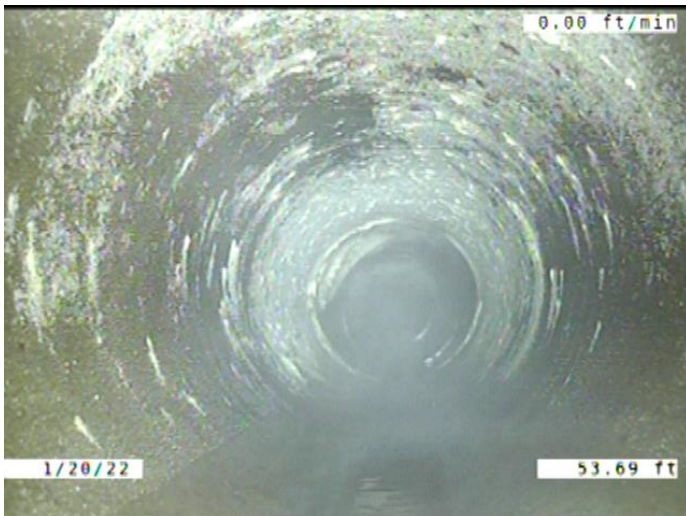
Code: **MWLS**
Description: **Miscellaneous Water Level Sag**

Distance (ft): **53.7**
Structural Grade: **2**
O&M Grade: **0**
Clock Start/From:
Clock To:
1st Value:
2nd Value:
Value Percent: **10.000**
Continuous Index: **F03**
Within 8" of Joint: **NO**
Remarks:

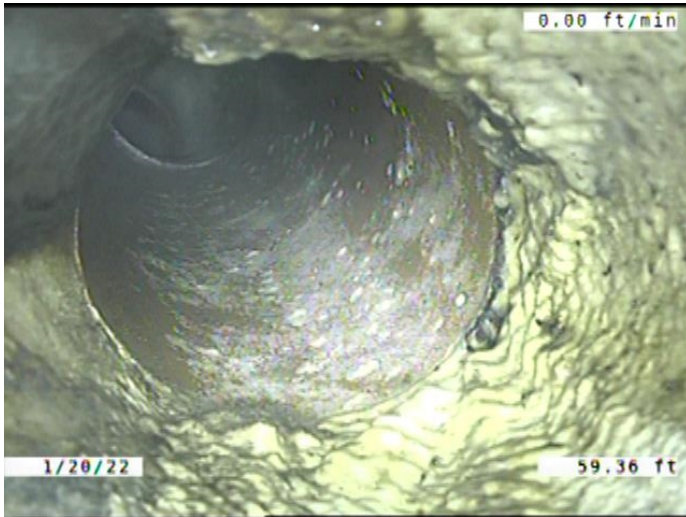
Code: **TFD**
 Description: **Tap Factory Defective**

Distance (ft): **59.4**
 Structural Grade: **0**
 O&M Grade: **3**
 Clock Start/From: **11**
 Clock To:
 1st Value: **4.000**
 2nd Value:
 Value Percent:
 Continuous Index:
 Within 8" of Joint: **YES**
 Remarks: **ENCrustation COMING FROM THE SERVICE TO MAIN CONNECTION.**

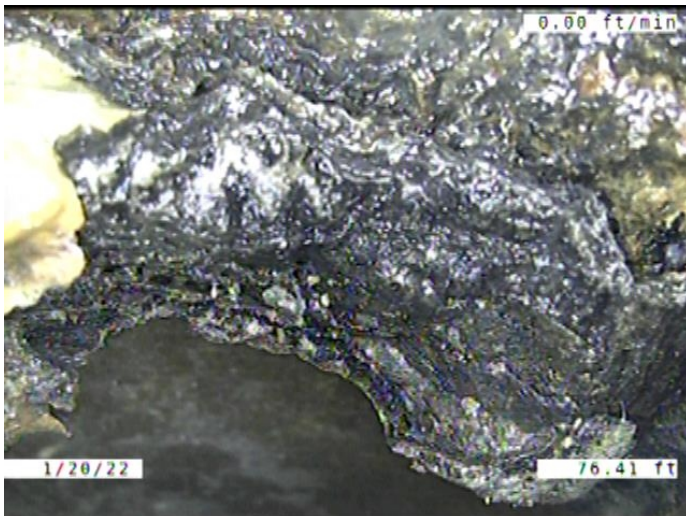
Code: **DAE**
 Description: **Deposits Attached Encrustation**

Distance (ft): **76.4**
 Structural Grade: **0**
 O&M Grade: **3**
 Clock Start/From: **7**
 Clock To: **5**
 1st Value:
 2nd Value:
 Value Percent: **15.000**
 Continuous Index:
 Within 8" of Joint: **YES**
 Remarks:

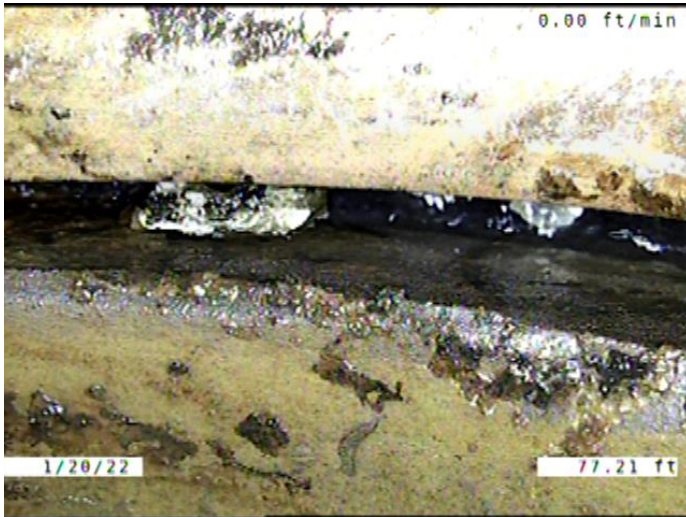
Code: **IRJ**
 Description: **Infiltration Runner Joint**

Distance (ft): **77.2**
 Structural Grade: **0**
 O&M Grade: **4**
 Clock Start/From: **2**
 Clock To:
 1st Value:
 2nd Value:
 Value Percent:
 Continuous Index:
 Within 8" of Joint: **YES**
 Remarks:

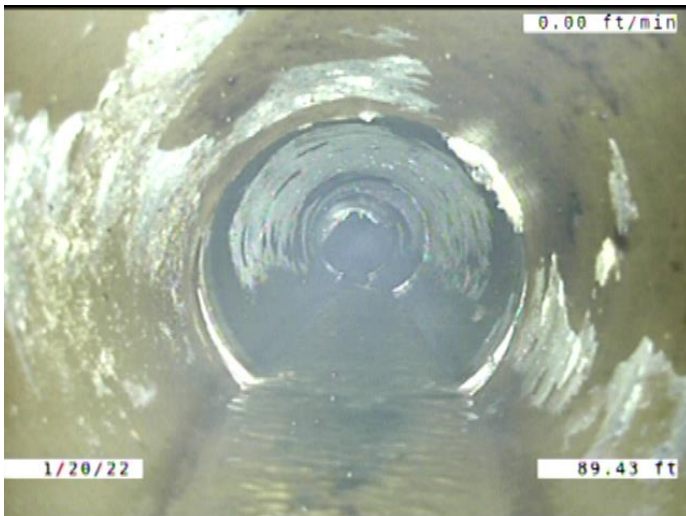
Code: **MWLS**
 Description: **Miscellaneous Water Level Sag**

Distance (ft): **89.4**
 Structural Grade: **2**
 O&M Grade: **0**
 Clock Start/From:
 Clock To:
 1st Value:
 2nd Value:
 Value Percent: **5.000**
 Continuous Index: **S04**
 Within 8" of Joint: **NO**
 Remarks:

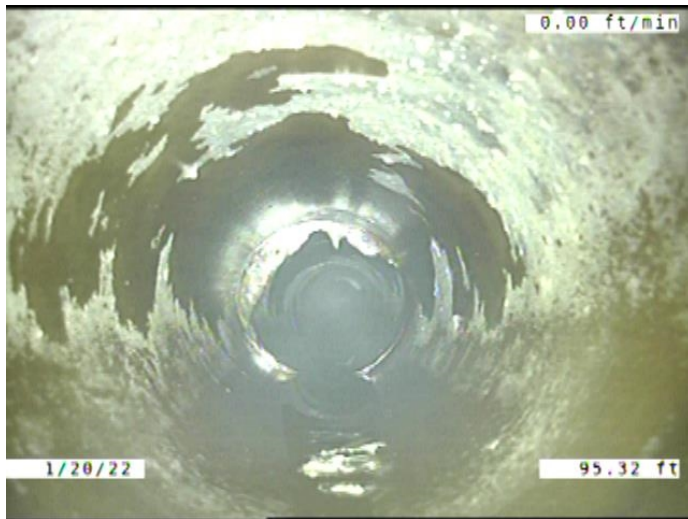
Code: **MWLS**
Description: **Miscellaneous Water Level Sag**

Distance (ft): **95.3**
Structural Grade: **2**
O&M Grade: **0**
Clock Start/From:
Clock To:
1st Value:
2nd Value:
Value Percent: **5.000**
Continuous Index: **F04**
Within 8" of Joint: **NO**
Remarks:

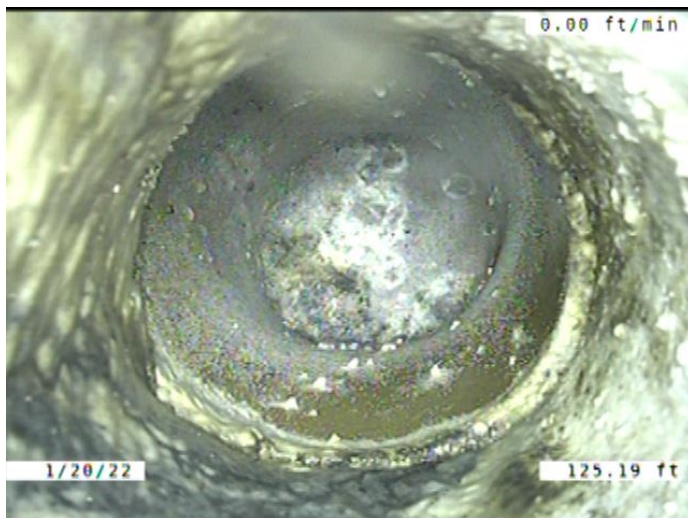
Code: **TFC**
Description: **Tap Factory Capped**

Distance (ft): **125.2**
Structural Grade: **0**
O&M Grade: **0**
Clock Start/From: **10**
Clock To:
1st Value: **4.000**
2nd Value:
Value Percent:
Continuous Index:
Within 8" of Joint: **YES**
Remarks: **ENCrustation COMING FROM THE SERVICE TO MAIN CONNECTION. IT**

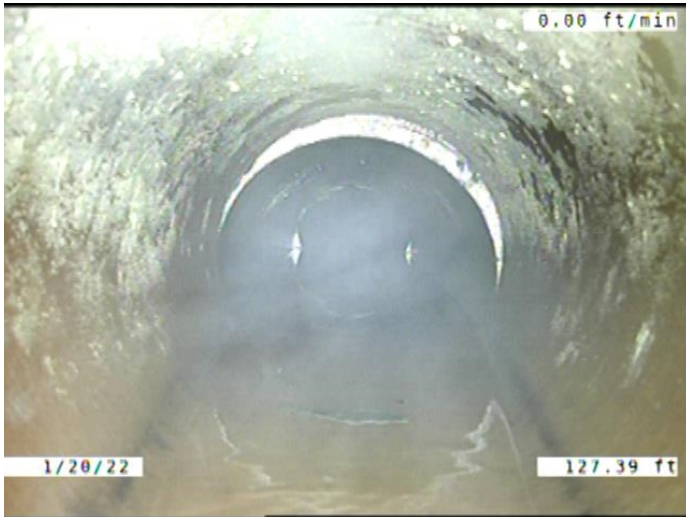
Code: **MWLS**
Description: **Miscellaneous Water Level Sag**

Distance (ft): **127.4**
Structural Grade: **2**
O&M Grade: **0**
Clock Start/From:
Clock To:
1st Value:
2nd Value:
Value Percent: **15.000**
Continuous Index: **S05**
Within 8" of Joint: **NO**
Remarks:

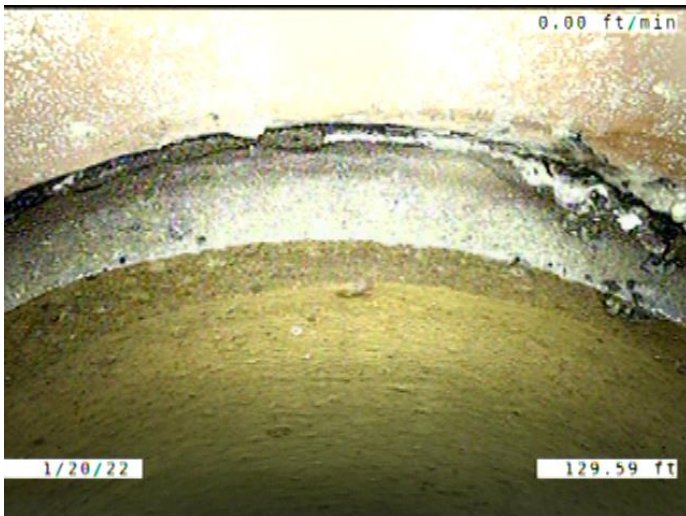
Code: **JOM**
Description: **Joint Offset Medium**

Distance (ft): **129.6**
Structural Grade: **3**
O&M Grade: **0**
Clock Start/From:
Clock To:
1st Value:
2nd Value:
Value Percent:
Continuous Index:
Within 8" of Joint: **NO**
Remarks:

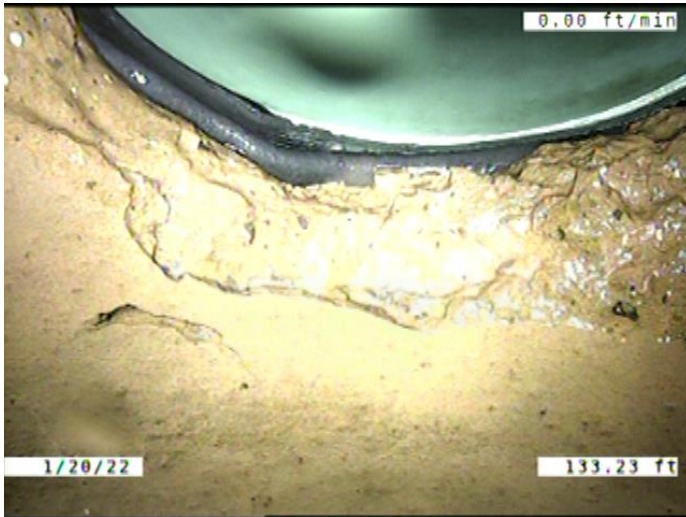
Code: **SSS**
 Description: **Surface Damage Surface Spalling**

Distance (ft): **133.2**
 Structural Grade: **2**
 O&M Grade: **0**
 Clock Start/From: **11**
 Clock To: **1**
 1st Value:
 2nd Value:
 Value Percent:
 Continuous Index:
 Within 8" of Joint: **YES**
 Remarks:

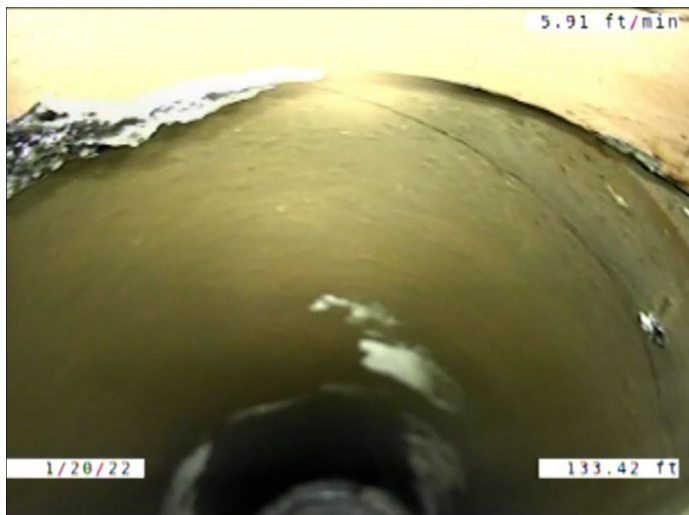
Code: **CC**
 Description: **Crack Circumferential**

Distance (ft): **133.4**
 Structural Grade: **1**
 O&M Grade: **0**
 Clock Start/From: **1**
 Clock To: **4**
 1st Value:
 2nd Value:
 Value Percent:
 Continuous Index:
 Within 8" of Joint: **YES**
 Remarks:

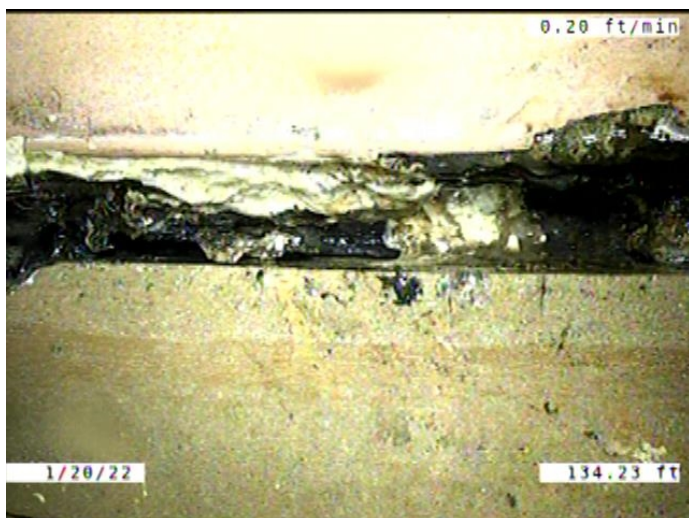
Code: **IRJ**
 Description: **Infiltration Runner Joint**

Distance (ft): **134.2**
 Structural Grade: **0**
 O&M Grade: **4**
 Clock Start/From: **1**
 Clock To:
 1st Value:
 2nd Value:
 Value Percent:
 Continuous Index:
 Within 8" of Joint: **YES**
 Remarks:

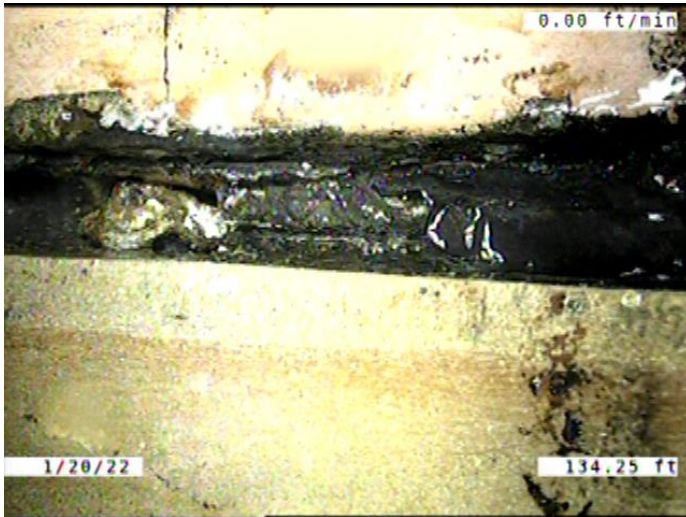
Code: **JOMD**
 Description: **Joint Offset Medium Defective**

Distance (ft): **134.2**
 Structural Grade: **3**
 O&M Grade: **0**
 Clock Start/From:
 Clock To:
 1st Value:
 2nd Value:
 Value Percent:
 Continuous Index:
 Within 8" of Joint: **NO**
 Remarks:

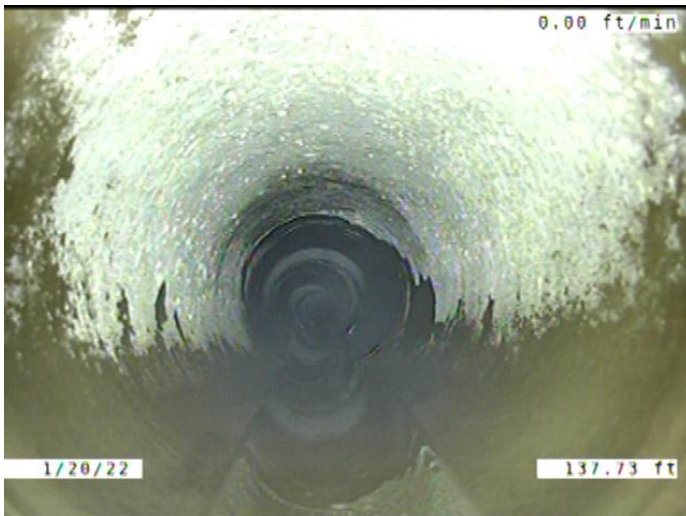
Code: **MWLS**
 Description: **Miscellaneous Water Level Sag**

Distance (ft): **137.7**
 Structural Grade: **2**
 O&M Grade: **0**
 Clock Start/From:
 Clock To:
 1st Value:
 2nd Value:
 Value Percent: **15.000**
 Continuous Index: **F05**
 Within 8" of Joint: **NO**
 Remarks:

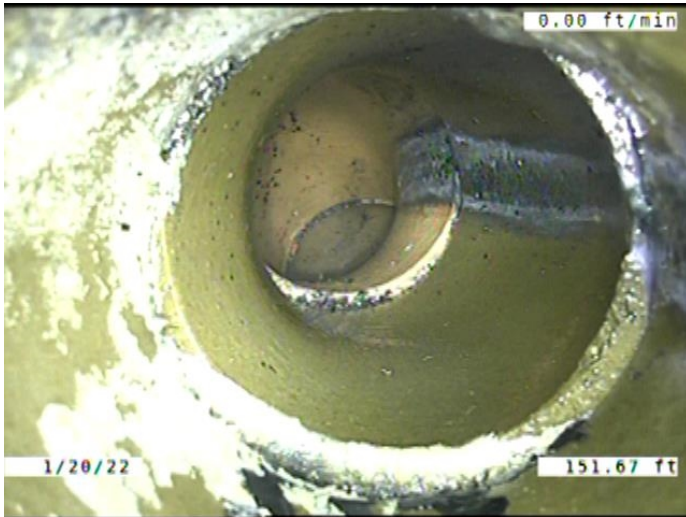
Code: **TF**
Description: **Tap Factory**

Distance (ft): **151.7**
Structural Grade: **0**
O&M Grade: **0**
Clock Start/From: **2**
Clock To:
1st Value: **4.000**

2nd Value:
Value Percent:
Continuous Index:
Within 8" of Joint: **YES**
Remarks: **ENCRUSTATION COMING FROM THE SERVICE TO MAIN CONNECTION.**

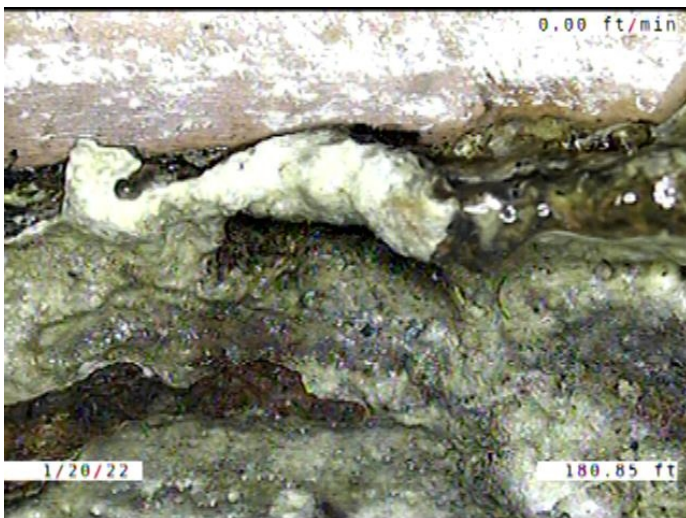
Code: **IRJ**
Description: **Infiltration Runner Joint**

Distance (ft): **180.8**
Structural Grade: **0**
O&M Grade: **4**
Clock Start/From: **12**
Clock To: **1**

1st Value:
2nd Value:
Value Percent:
Continuous Index:
Within 8" of Joint: **YES**
Remarks:

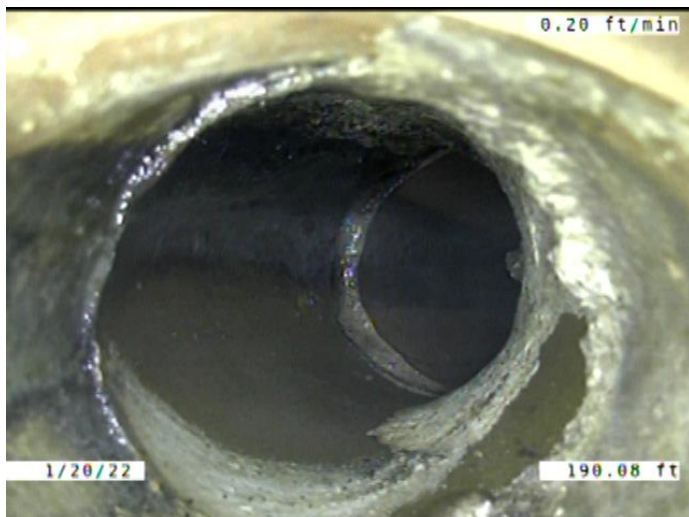
Code: **TF**
 Description: **Tap Factory**

Distance (ft): **190.1**
 Structural Grade: **0**
 O&M Grade: **0**
 Clock Start/From: **10**
 Clock To:
 1st Value: **4.000**

2nd Value:
 Value Percent:
 Continuous Index:
 Within 8" of Joint: **YES**
 Remarks: **CONSTANTLY RUNNING WATER. ENCRUSTATION COMING FROM THE**

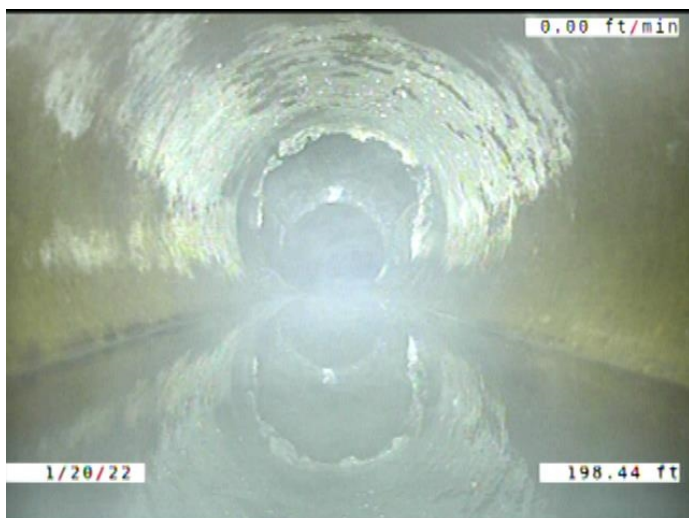
Code: **MWLS**
 Description: **Miscellaneous Water Level Sag**

Distance (ft): **198.4**
 Structural Grade: **2**
 O&M Grade: **0**
 Clock Start/From:
 Clock To:
 1st Value:
 2nd Value:
 Value Percent: **15.000**

Continuous Index:
 Within 8" of Joint: **NO**
 Remarks:

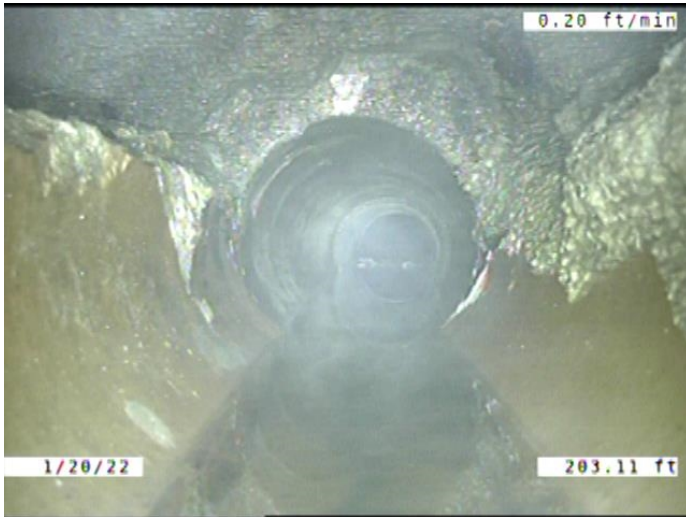
Code: **DSF**
 Description: **Deposits Settled Fine**

Distance (ft): **203.1**
 Structural Grade: **0**
 O&M Grade: **2**
 Clock Start/From: **5**
 Clock To: **7**
 1st Value:
 2nd Value:
 Value Percent: **5.000**
 Continuous Index: **F01**
 Within 8" of Joint: **YES**
 Remarks:

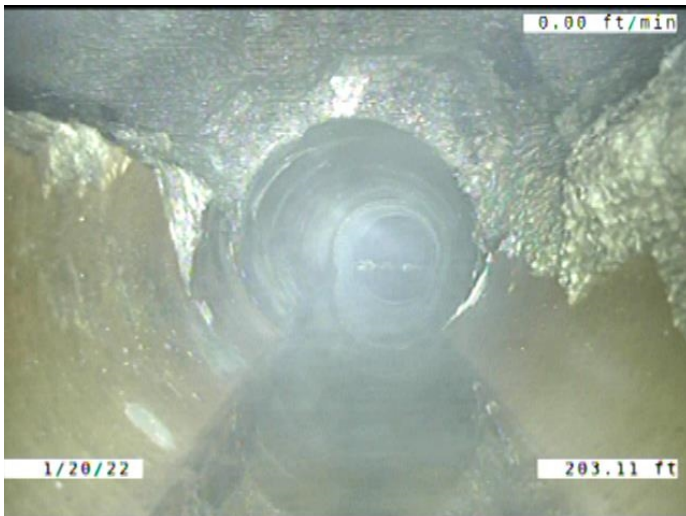
Code: **DAE**
 Description: **Deposits Attached Encrustation**

Distance (ft): **203.1**
 Structural Grade: **0**
 O&M Grade: **2**
 Clock Start/From: **7**
 Clock To: **5**
 1st Value:
 2nd Value:
 Value Percent: **5.000**
 Continuous Index: **F02**
 Within 8" of Joint: **YES**
 Remarks:
