Profile/Photo Observation Report

Date:	01/30/2022	Weather:		Coding:	PACP 7.0
Pipe Length (ft):	228.3	Owner:	City of Hobart	Pre Clean:	Heavy Cleaning
P.O.#:	YES502259	Surveyor:	S. Bucklin	PSR:	P-506-018-019
Customer:	City of Hobart	Clean Date:	01/28/2022	Shape:	C

Street:	South Wisconsin Street	Flow Control:	Not Controlled
City:	Hobart, IN	Year Renewed:	
Location:	Yard	Tape/Media #:	
Purpose:	Routine Assessment	Dia/Height:	10"
Use:	Sanitary Sewage Pipe	Material:	VCP
Drain Area:		Lining:	None
Category:	NA		
Comment:			
Location Details:	WEST OF THE NW CORNER OF THE H	Direction of Survey:	Downstream
US MH:	M-506-018	DS MH:	M-506-019
		Total Length Surveyed (ft):	228.3

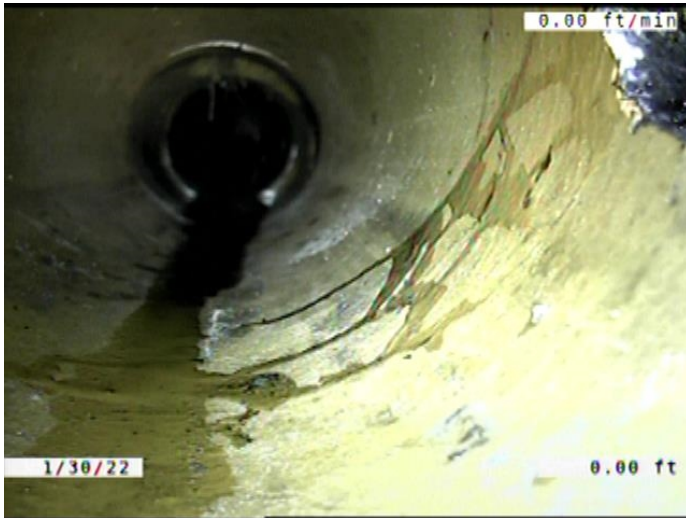
Code:	MWL
Description:	Miscellaneous Water Level
Distance (ft):	.0
Structural Grade:	0
O&M Grade:	0
Clock Start/From:	
Clock To:	
1st Value:	
2nd Value:	
Value Percent:	5.000
Continuous Index:	
Within 8" of Joint:	NO
Remarks:

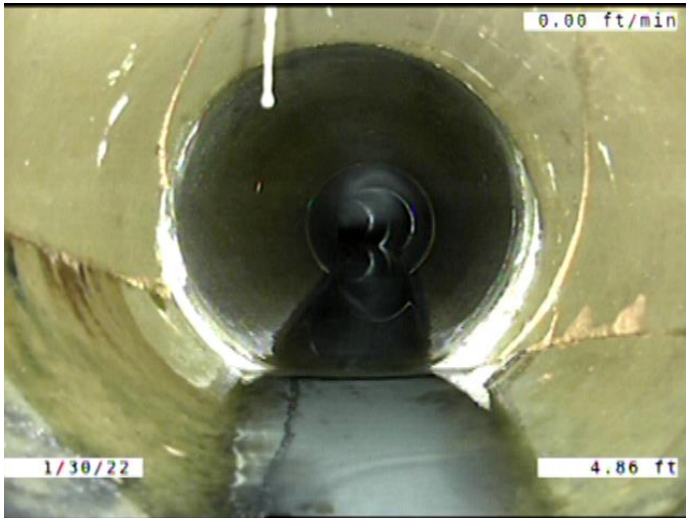
Code:	B
Description:	Broken
Distance (ft):	4.9
Structural Grade:	4
O&M Grade:	0
Clock Start/From:	12
Clock To:	12
1st Value:	
2nd Value:	
Value Percent:	
Continuous Index:	
Within 8" of Joint:	YES
Remarks:

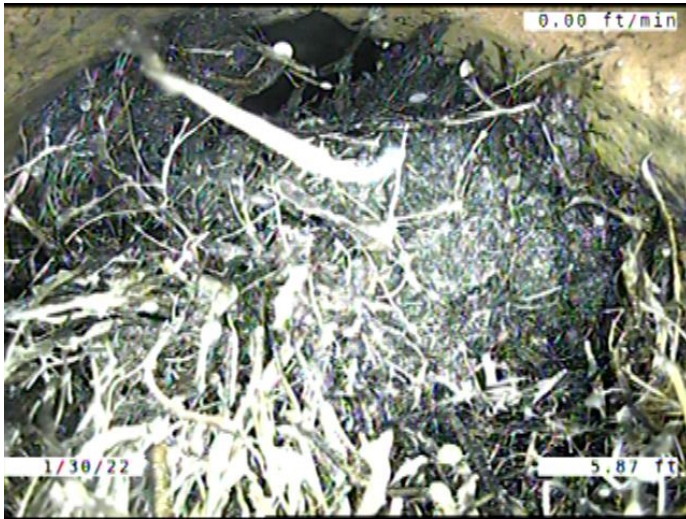
Code: **TFD**
 Description: **Tap Factory Defective**

Distance (ft): **5.9**
 Structural Grade: **0**
 O&M Grade: **3**
 Clock Start/From: **1**
 Clock To:
 1st Value: **4.000**
 2nd Value:
 Value Percent:
 Continuous Index:
 Within 8" of Joint: **YES**
 Remarks: **BROKEN. 95% PLUGGED WITH ROOTS**

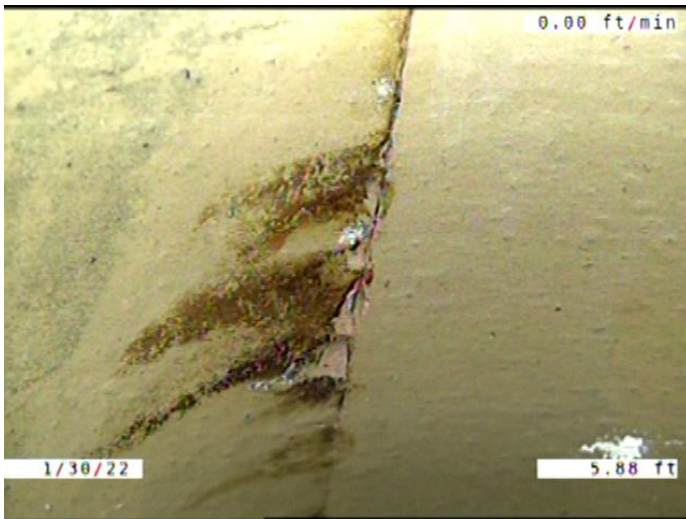
Code: **ISB**
 Description: **Infiltration Stain Barrel**

Distance (ft): **5.9**
 Structural Grade: **0**
 O&M Grade: **1**
 Clock Start/From: **7**
 Clock To: **9**
 1st Value:
 2nd Value:
 Value Percent:
 Continuous Index:
 Within 8" of Joint: **YES**
 Remarks:

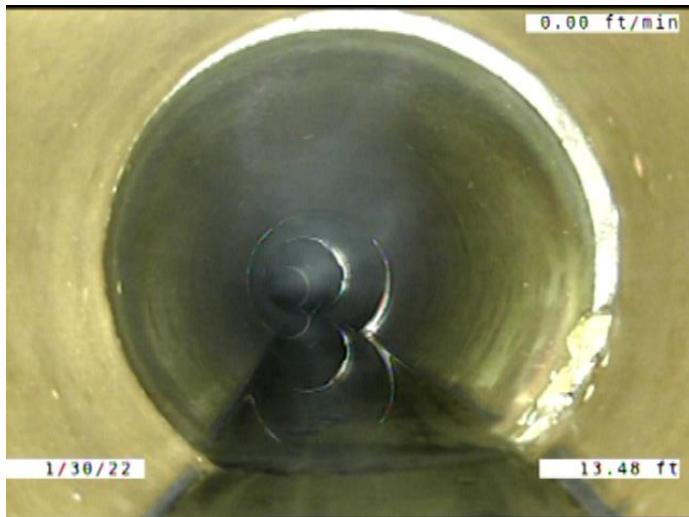
Code: **LL**
 Description: **Line Left**

Distance (ft): **13.5**
 Structural Grade: **0**
 O&M Grade: **1**
 Clock Start/From:
 Clock To:
 1st Value:
 2nd Value:
 Value Percent: **5.000**
 Continuous Index:
 Within 8" of Joint: **NO**
 Remarks:

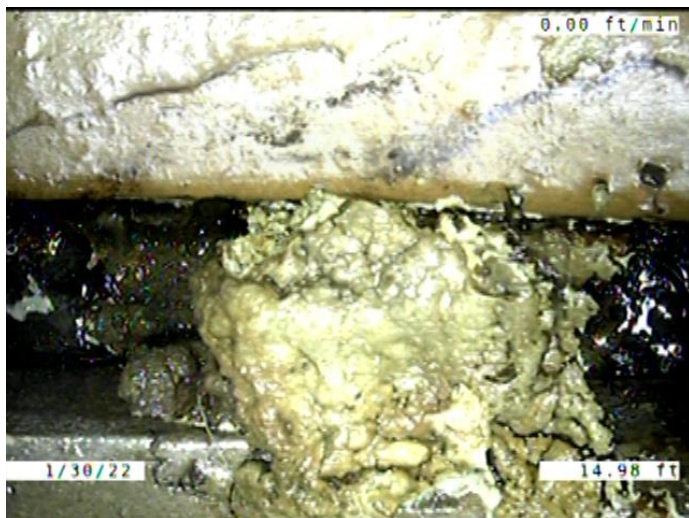
Code: **DAE**
 Description: **Deposits Attached Encrustation**

Distance (ft): **15.0**
 Structural Grade: **0**
 O&M Grade: **2**
 Clock Start/From: **8**
 Clock To: **4**
 1st Value:
 2nd Value:
 Value Percent: **5.000**
 Continuous Index: **S01**
 Within 8" of Joint: **YES**
 Remarks:

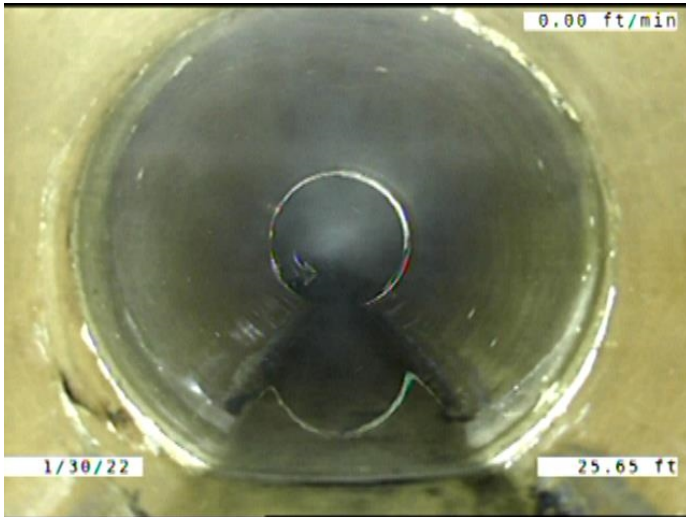
Code: **MWLS**
Description: **Miscellaneous Water Level Sag**

Distance (ft): **25.6**
Structural Grade: **2**
O&M Grade: **0**
Clock Start/From:
Clock To:
1st Value:
2nd Value:
Value Percent: **5.000**
Continuous Index:
Within 8" of Joint: **NO**
Remarks:

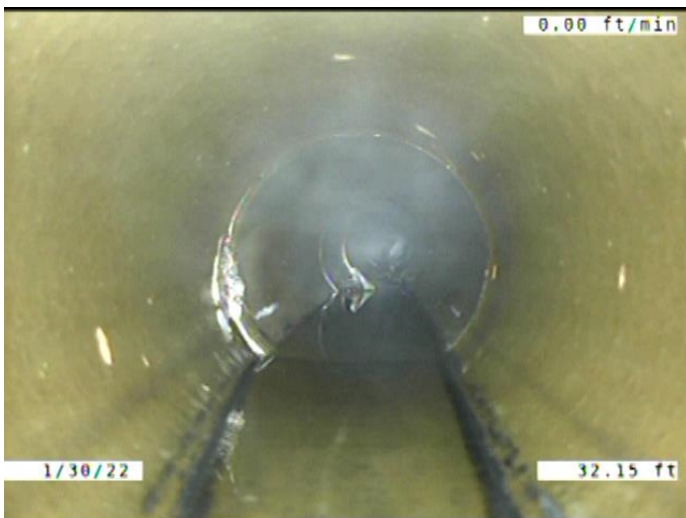
Code: **MWLS**
Description: **Miscellaneous Water Level Sag**

Distance (ft): **32.1**
Structural Grade: **2**
O&M Grade: **0**
Clock Start/From:
Clock To:
1st Value:
2nd Value:
Value Percent: **5.000**
Continuous Index: **S02**
Within 8" of Joint: **NO**
Remarks:

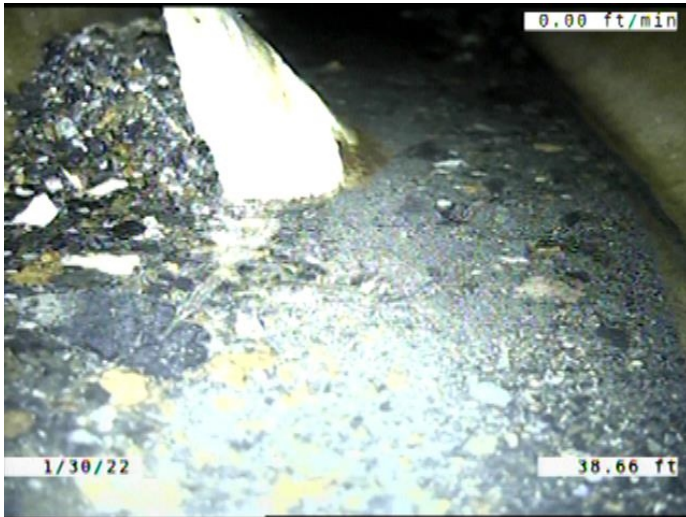
Code: **DSF**
Description: **Deposits Settled Fine**

Distance (ft): **38.7**
Structural Grade: **0**
O&M Grade: **2**
Clock Start/From: **5**
Clock To: **7**
1st Value:
2nd Value:
Value Percent: **5.000**
Continuous Index: **S03**
Within 8" of Joint: **YES**
Remarks:

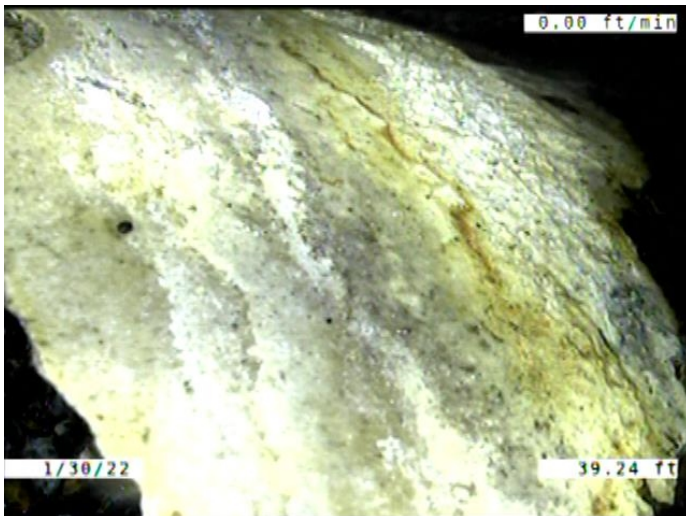
Code: **OBZ**
Description: **Obstruction Other**

Distance (ft): **39.2**
Structural Grade: **0**
O&M Grade: **2**
Clock Start/From: **6**
Clock To: **7**
1st Value:
2nd Value:
Value Percent: **5.000**
Continuous Index:
Within 8" of Joint: **YES**
Remarks: **A PIECE OF ENCRUSTATION THAT WAS CUT OFF THE PIPE WALL.**

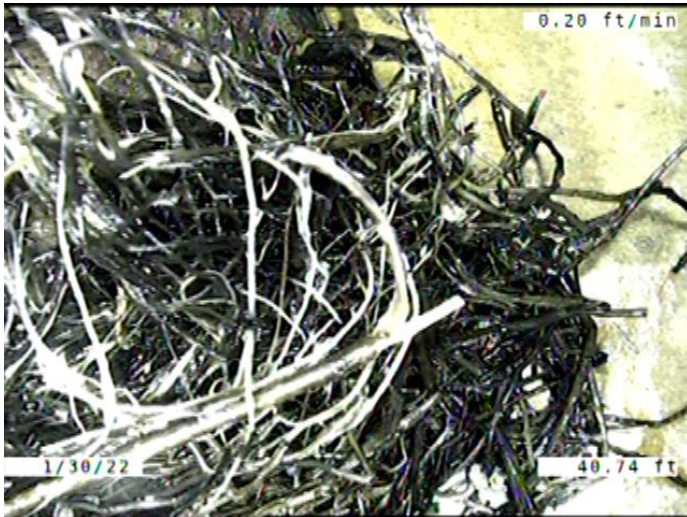
Code: **OBZ**
 Description: **Obstruction Other**

Distance (ft): **40.7**
 Structural Grade: **0**
 O&M Grade: **2**
 Clock Start/From: **5**
 Clock To: **6**
 1st Value:
 2nd Value:
 Value Percent: **5.000**
 Continuous Index:
 Within 8" of Joint: **YES**
 Remarks: **ROOTS THAT HAVE BEEN CUT OUT**

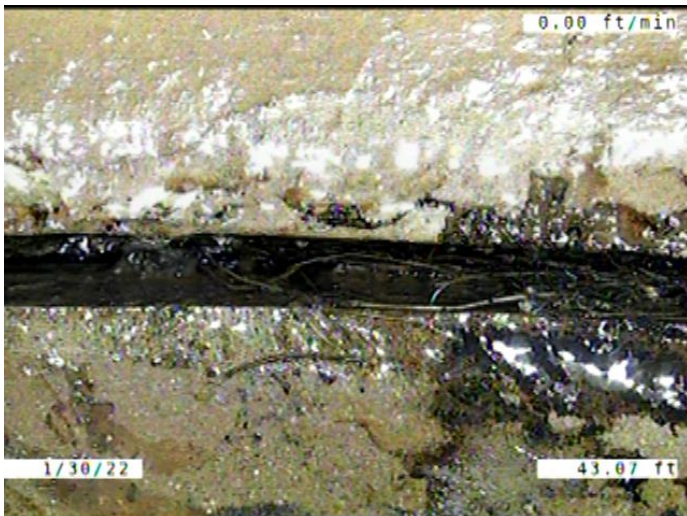
Code: **RFJ**
 Description: **Roots Fine Joint**

Distance (ft): **43.1**
 Structural Grade: **0**
 O&M Grade: **1**
 Clock Start/From: **9**
 Clock To: **3**
 1st Value:
 2nd Value:
 Value Percent:
 Continuous Index:
 Within 8" of Joint: **YES**
 Remarks:

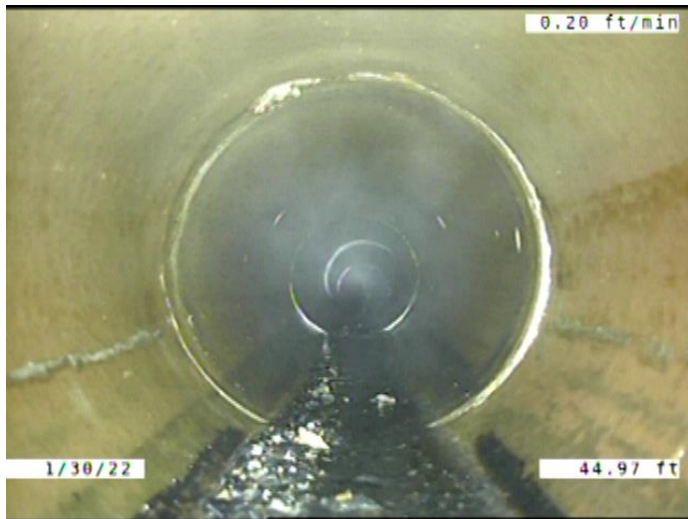
Code: **MWLS**
 Description: **Miscellaneous Water Level Sag**

Distance (ft): **45.0**
 Structural Grade: **2**
 O&M Grade: **0**
 Clock Start/From:
 Clock To:
 1st Value:
 2nd Value:
 Value Percent: **5.000**
 Continuous Index: **F02**
 Within 8" of Joint: **NO**
 Remarks:

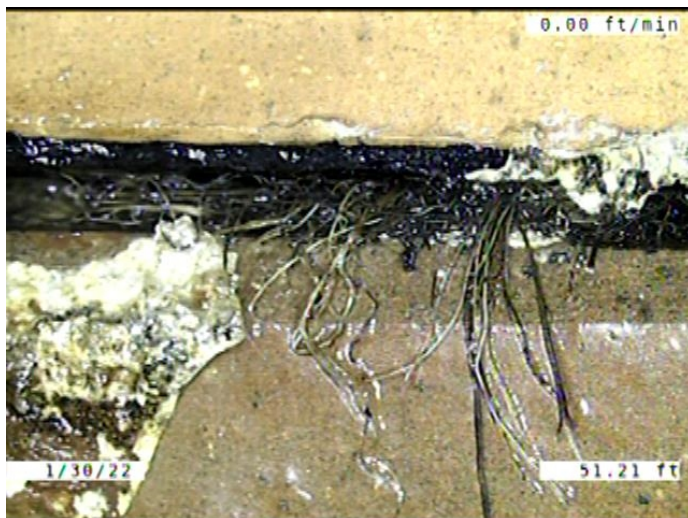
Code: **RFJ**
 Description: **Roots Fine Joint**

Distance (ft): **51.2**
 Structural Grade: **0**
 O&M Grade: **1**
 Clock Start/From: **9**
 Clock To: **3**
 1st Value:
 2nd Value:
 Value Percent:
 Continuous Index:
 Within 8" of Joint: **YES**
 Remarks:

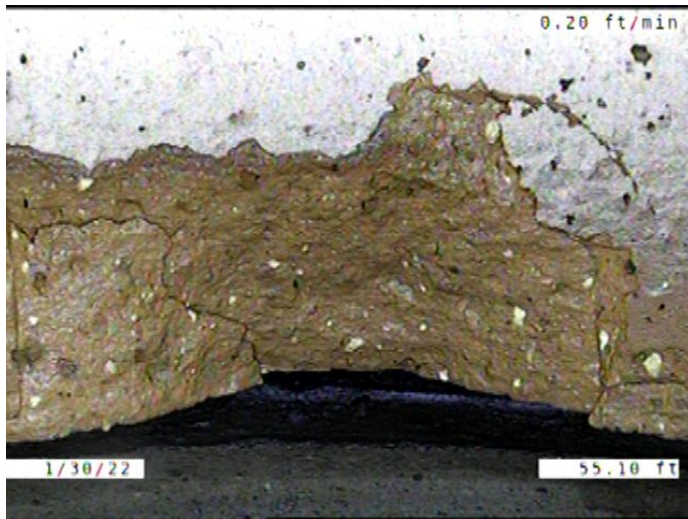
Code:	SZ
Description:	Surface Damage Other
Distance (ft):	55.1
Structural Grade:	0
O&M Grade:	0
Clock Start/From:	11
Clock To:	12
1st Value:	
2nd Value:	
Value Percent:	
Continuous Index:	
Within 8" of Joint:	YES
Remarks:	A PIECE CHIPPED AWAY FROM THE JOINT

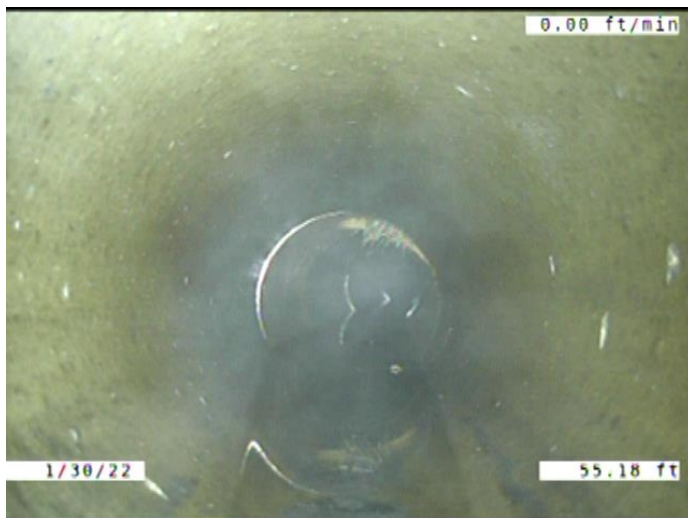
Code:	MWLS
Description:	Miscellaneous Water Level Sag
Distance (ft):	55.2
Structural Grade:	2
O&M Grade:	0
Clock Start/From:	
Clock To:	
1st Value:	
2nd Value:	
Value Percent:	10.000
Continuous Index:	S04
Within 8" of Joint:	NO
Remarks:

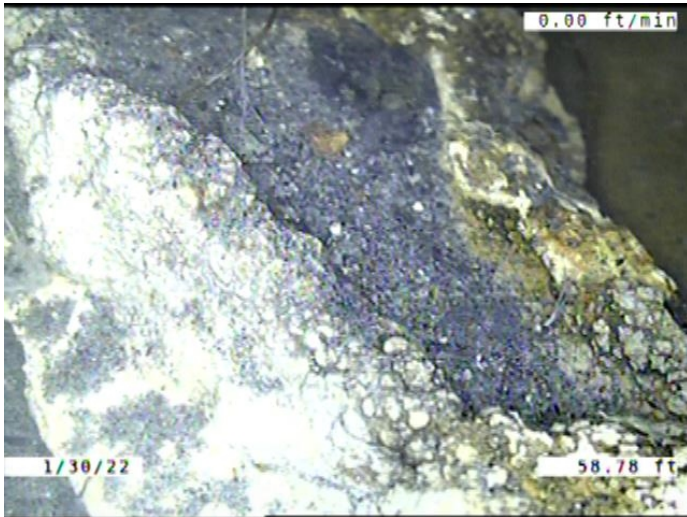
Code:	OBZ
Description:	Obstruction Other
Distance (ft):	58.8
Structural Grade:	0
O&M Grade:	2
Clock Start/From:	5
Clock To:	6
1st Value:	
2nd Value:	
Value Percent:	5.000
Continuous Index:	
Within 8" of Joint:	YES
Remarks:	A PIECE OF ENCRUSTATION THAT WAS CUT OFF THE PIPE WALL

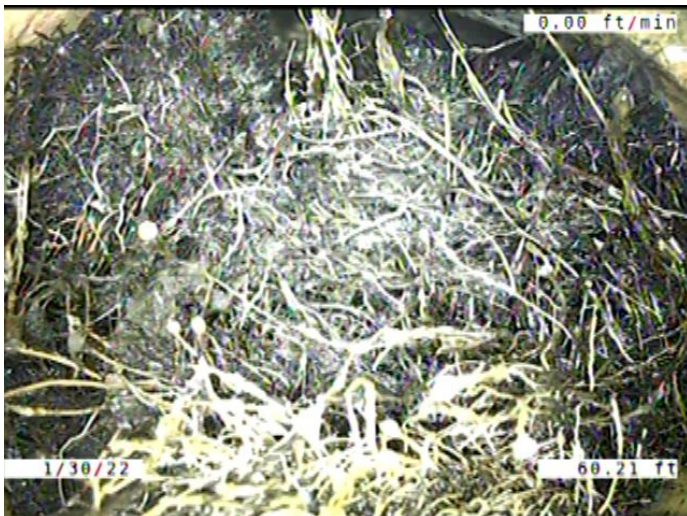
Code:	TF
Description:	Tap Factory
Distance (ft):	60.2
Structural Grade:	0
O&M Grade:	0
Clock Start/From:	1
Clock To:	
1st Value:	4.000
2nd Value:	
Value Percent:	
Continuous Index:	
Within 8" of Joint:	YES
Remarks:	95% PLUGGED WITH ROOTS.

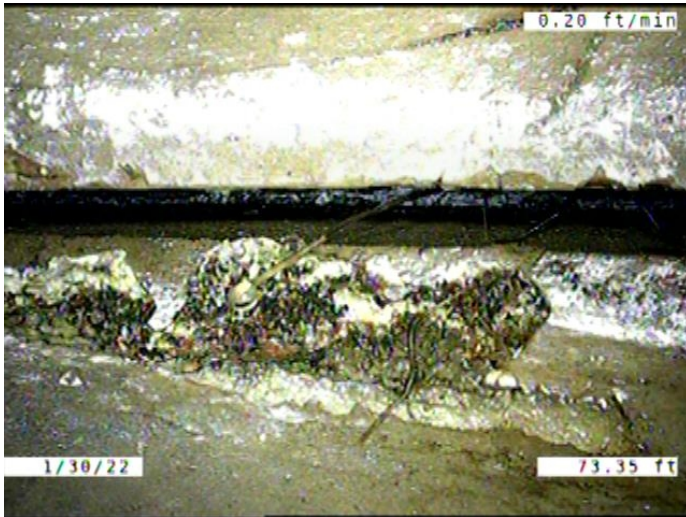
Code: **RFJ**
 Description: **Roots Fine Joint**

Distance (ft): **73.3**
 Structural Grade: **0**
 O&M Grade: **1**
 Clock Start/From: **9**
 Clock To: **3**
 1st Value:
 2nd Value:
 Value Percent:
 Continuous Index: **S06**
 Within 8" of Joint: **YES**
 Remarks:

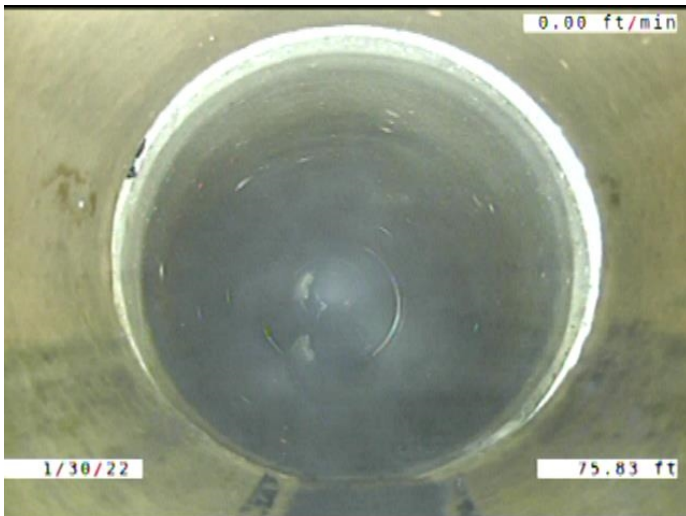
Code: **MWLS**
 Description: **Miscellaneous Water Level Sag**

Distance (ft): **75.8**
 Structural Grade: **2**
 O&M Grade: **0**
 Clock Start/From:
 Clock To:
 1st Value:
 2nd Value:
 Value Percent: **10.000**
 Continuous Index: **F04**
 Within 8" of Joint: **NO**
 Remarks:

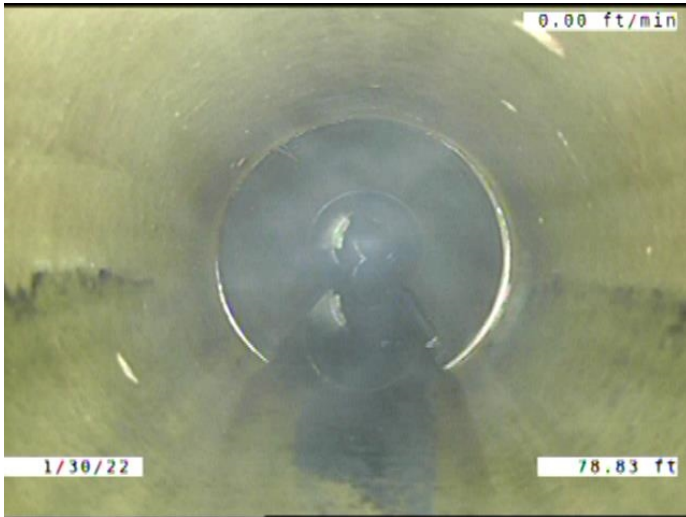
Code: **MWLS**
Description: **Miscellaneous Water Level Sag**

Distance (ft): **78.8**
Structural Grade: **2**
O&M Grade: **0**
Clock Start/From:
Clock To:
1st Value:
2nd Value:
Value Percent: **10.000**
Continuous Index: **S05**
Within 8" of Joint: **NO**
Remarks:

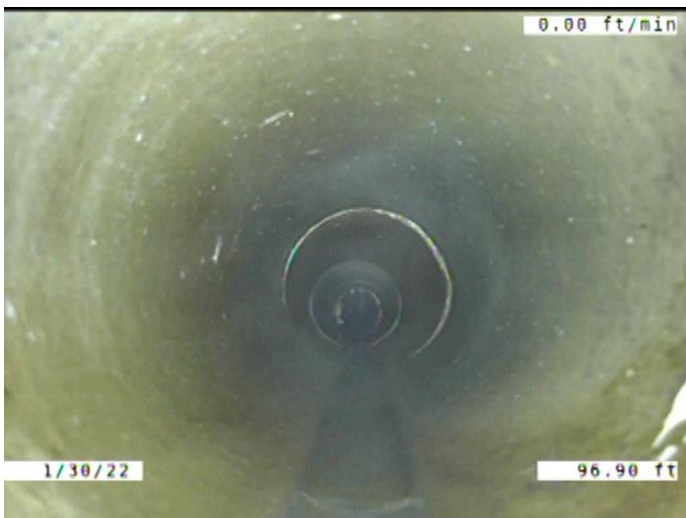
Code: **MWLS**
Description: **Miscellaneous Water Level Sag**

Distance (ft): **96.9**
Structural Grade: **2**
O&M Grade: **0**
Clock Start/From:
Clock To:
1st Value:
2nd Value:
Value Percent: **10.000**
Continuous Index: **F05**
Within 8" of Joint: **NO**
Remarks:

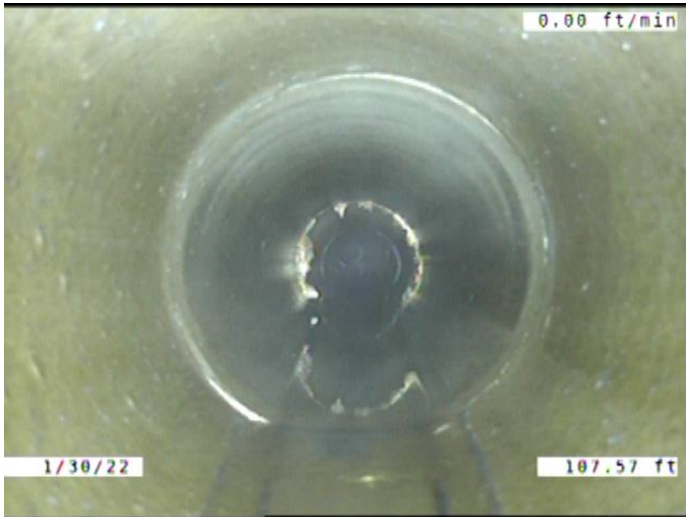
Code: **MWLS**
Description: **Miscellaneous Water Level Sag**

Distance (ft): **107.6**
Structural Grade: **2**
O&M Grade: **0**
Clock Start/From:
Clock To:
1st Value:
2nd Value:
Value Percent: **10.000**
Continuous Index: **S07**
Within 8" of Joint: **NO**
Remarks:

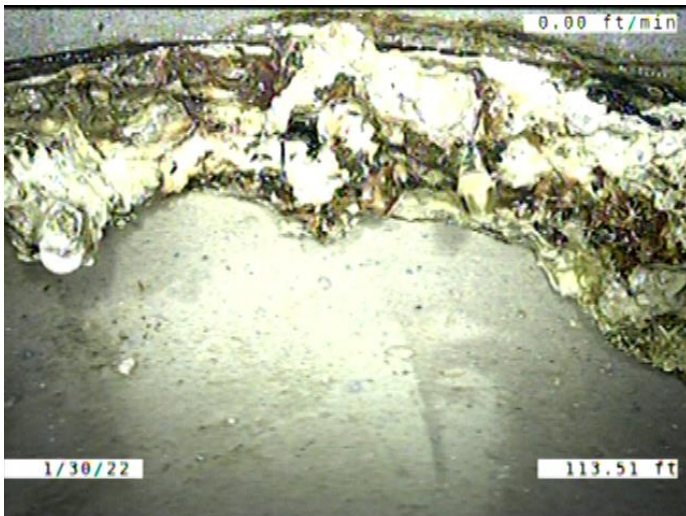
Code: **IDJ**
Description: **Infiltration Dripper Joint**

Distance (ft): **113.5**
Structural Grade: **0**
O&M Grade: **3**
Clock Start/From: **11**
Clock To: **1**
1st Value:
2nd Value:
Value Percent:
Continuous Index:
Within 8" of Joint: **YES**
Remarks:

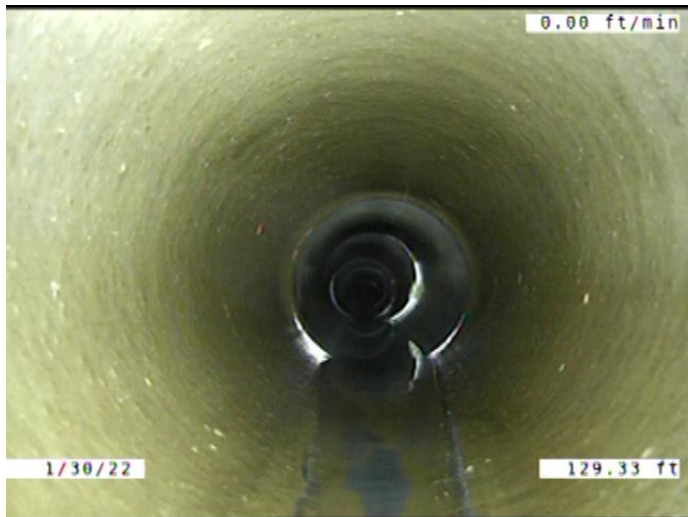
Code: **MWLS**
Description: **Miscellaneous Water Level Sag**

Distance (ft): **129.3**
Structural Grade: **2**
O&M Grade: **0**
Clock Start/From:
Clock To:
1st Value:
2nd Value:
Value Percent: **10.000**
Continuous Index: **F07**
Within 8" of Joint: **NO**
Remarks:

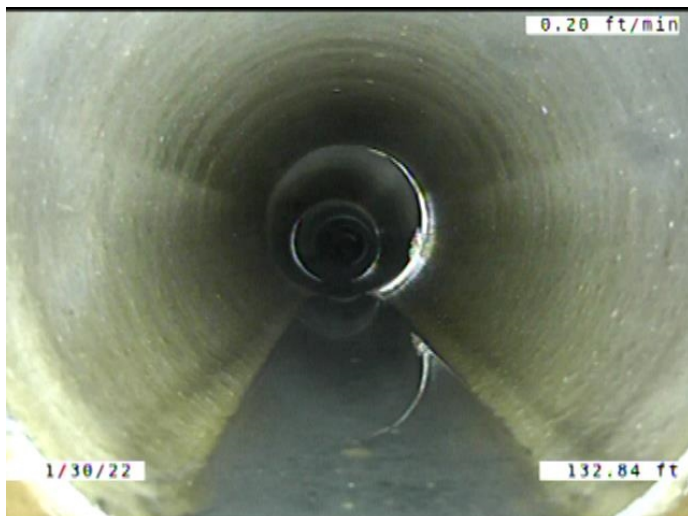
Code: **MWLS**
Description: **Miscellaneous Water Level Sag**

Distance (ft): **132.8**
Structural Grade: **2**
O&M Grade: **0**
Clock Start/From:
Clock To:
1st Value:
2nd Value:
Value Percent: **5.000**
Continuous Index:
Within 8" of Joint: **NO**
Remarks:

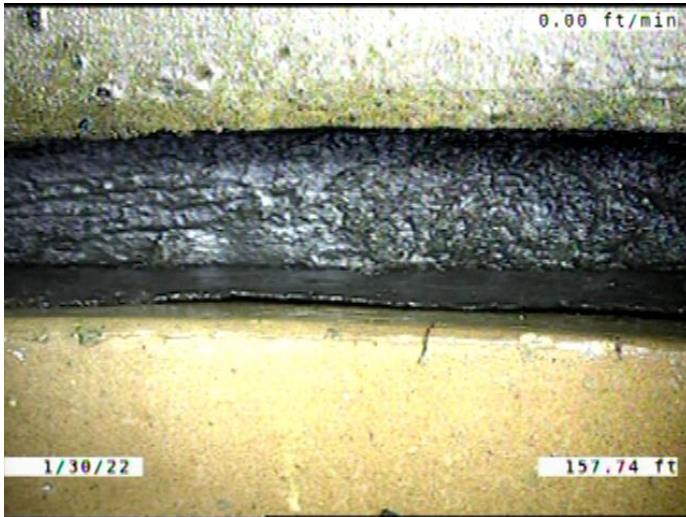
Code: **JAM**
Description: **Joint Angular Medium**

Distance (ft): **157.7**
Structural Grade: **3**
O&M Grade: **0**
Clock Start/From:
Clock To:
1st Value:
2nd Value:
Value Percent:
Continuous Index:
Within 8" of Joint: **NO**
Remarks:

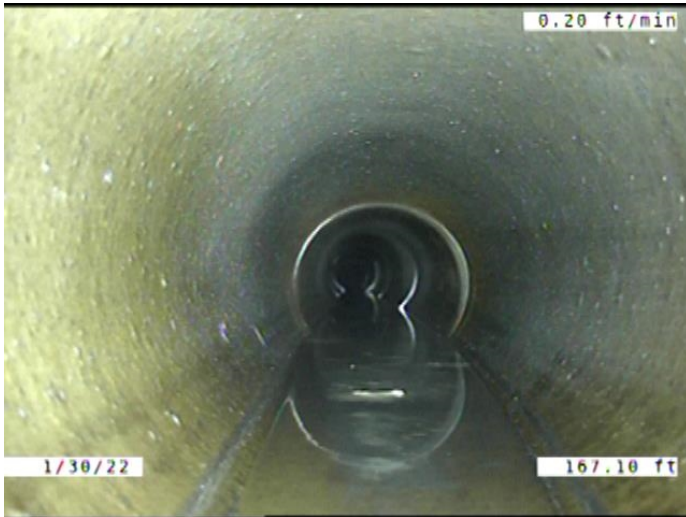
Code: **MWLS**
Description: **Miscellaneous Water Level Sag**

Distance (ft): **167.1**
Structural Grade: **2**
O&M Grade: **0**
Clock Start/From:
Clock To:
1st Value:
2nd Value:
Value Percent: **10.000**
Continuous Index: **S08**
Within 8" of Joint: **NO**
Remarks:

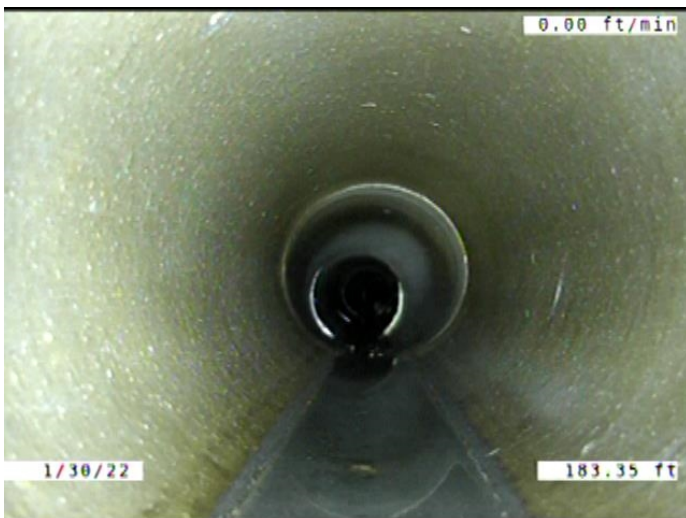
Code: **MWLS**
Description: **Miscellaneous Water Level Sag**

Distance (ft): **183.3**
Structural Grade: **2**
O&M Grade: **0**
Clock Start/From:
Clock To:
1st Value:
2nd Value:
Value Percent: **10.000**
Continuous Index: **F08**
Within 8" of Joint: **NO**
Remarks:

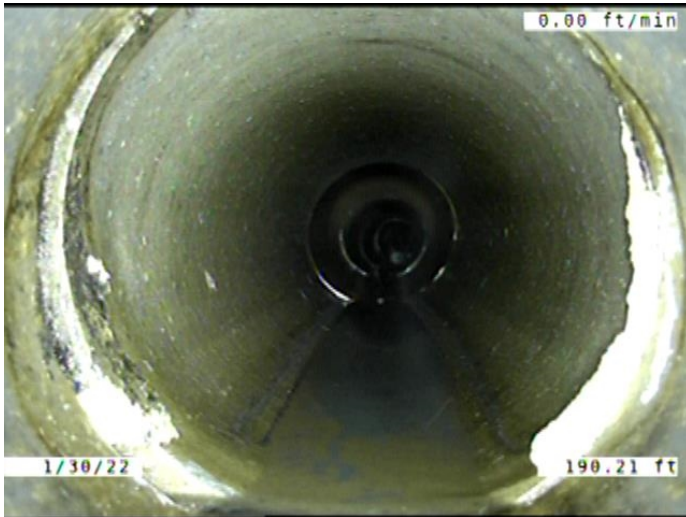
Code: **MWLS**
Description: **Miscellaneous Water Level Sag**

Distance (ft): **190.2**
Structural Grade: **2**
O&M Grade: **0**
Clock Start/From:
Clock To:
1st Value:
2nd Value:
Value Percent: **5.000**
Continuous Index: **S09**
Within 8" of Joint: **NO**
Remarks:

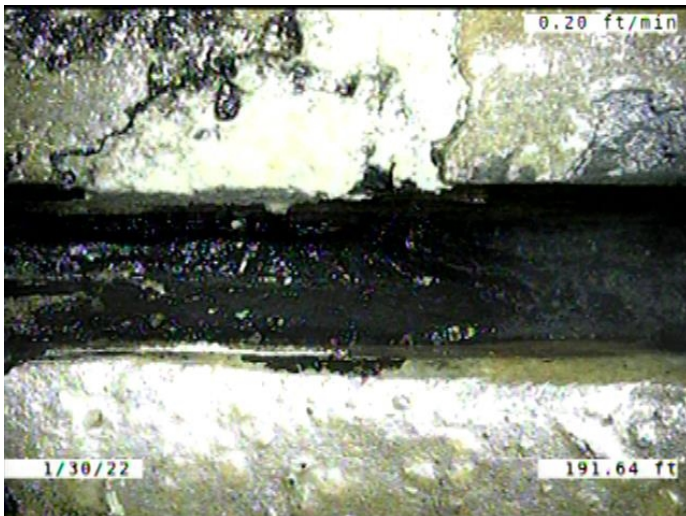
Code: **JAM**
Description: **Joint Angular Medium**

Distance (ft): **191.6**
Structural Grade: **3**
O&M Grade: **0**
Clock Start/From:
Clock To:
1st Value:
2nd Value:
Value Percent:
Continuous Index:
Within 8" of Joint: **NO**
Remarks:

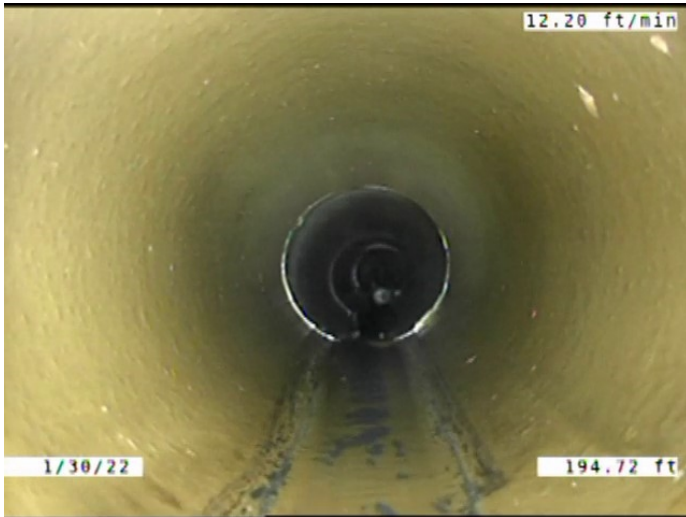
Code: **MWLS**
 Description: **Miscellaneous Water Level Sag**

Distance (ft): **194.8**
 Structural Grade: **2**
 O&M Grade: **0**
 Clock Start/From:
 Clock To:
 1st Value:
 2nd Value:
 Value Percent: **5.000**
 Continuous Index: **F09**
 Within 8" of Joint: **NO**
 Remarks:

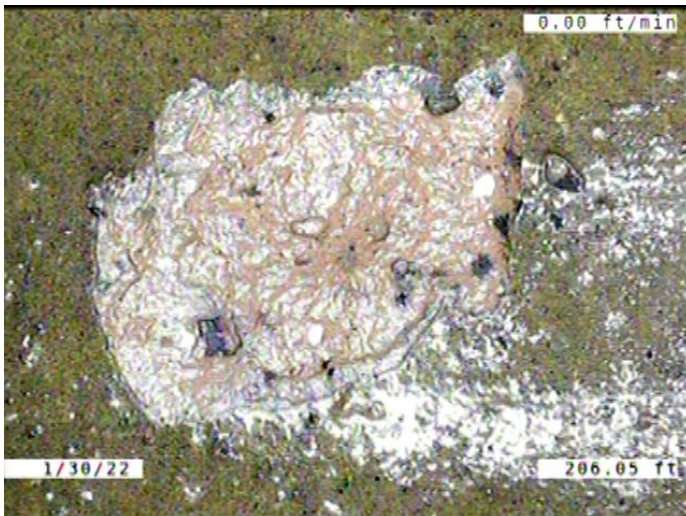
Code: **SSS**
 Description: **Surface Damage Surface Spalling**

Distance (ft): **206.0**
 Structural Grade: **2**
 O&M Grade: **0**
 Clock Start/From: **8**
 Clock To:
 1st Value:
 2nd Value:
 Value Percent:
 Continuous Index:
 Within 8" of Joint: **NO**
 Remarks:

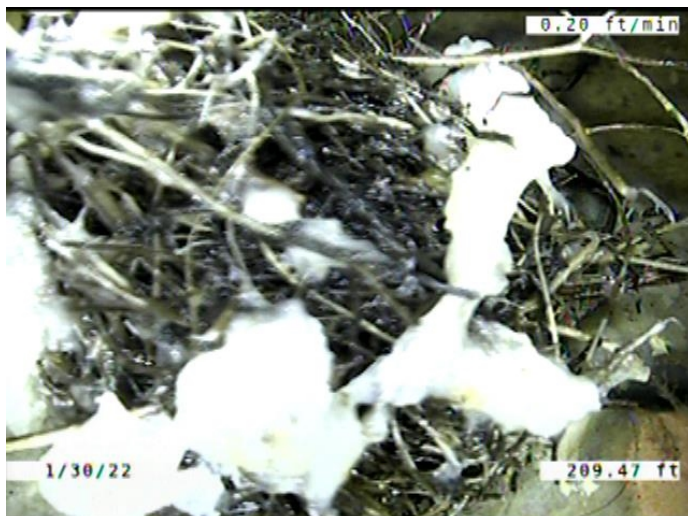
Code: **OBZ**
 Description: **Obstruction Other**

Distance (ft): **209.5**
 Structural Grade: **0**
 O&M Grade: **2**
 Clock Start/From: **5**
 Clock To: **7**
 1st Value:
 2nd Value:
 Value Percent: **5.000**
 Continuous Index:
 Within 8" of Joint: **YES**
 Remarks: **ROOTS THAT HAVE BEEN CUT**

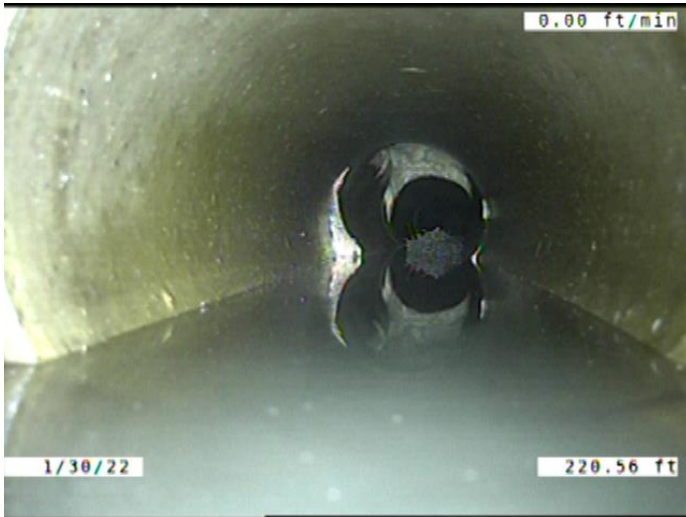
Code: **MWLS**
Description: **Miscellaneous Water Level Sag**

Distance (ft): **220.6**
Structural Grade: **2**
O&M Grade: **0**
Clock Start/From:
Clock To:
1st Value:
2nd Value:
Value Percent: **15.000**
Continuous Index: **S10**
Within 8" of Joint: **NO**
Remarks:

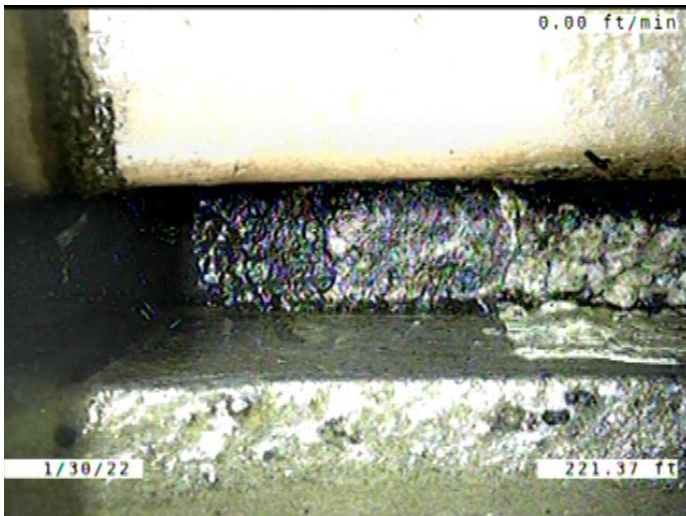
Code: **JAM**
Description: **Joint Angular Medium**

Distance (ft): **221.4**
Structural Grade: **3**
O&M Grade: **0**
Clock Start/From:
Clock To:
1st Value:
2nd Value:
Value Percent:
Continuous Index:
Within 8" of Joint: **NO**
Remarks:

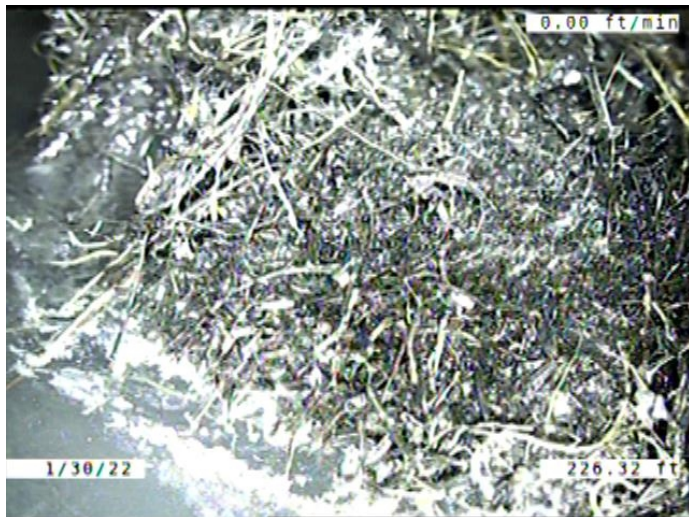
Code:	OBZ
Description:	Obstruction Other
Distance (ft):	226.3
Structural Grade:	0
O&M Grade:	2
Clock Start/From:	5
Clock To:	6
1st Value:	
2nd Value:	
Value Percent:	5.000
Continuous Index:	
Within 8" of Joint:	YES
Remarks:	ROOTS THAT HAVE BEEN CUT

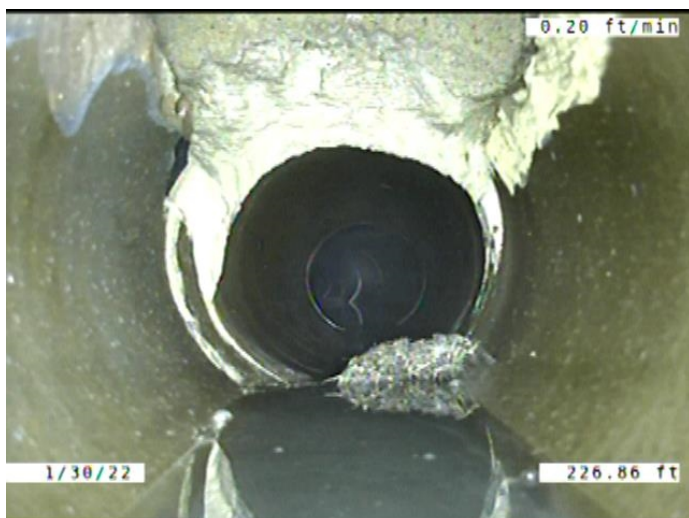
Code:	DAE
Description:	Deposits Attached Encrustation
Distance (ft):	226.9
Structural Grade:	0
O&M Grade:	2
Clock Start/From:	8
Clock To:	4
1st Value:	
2nd Value:	
Value Percent:	5.000
Continuous Index:	F01
Within 8" of Joint:	YES
Remarks:

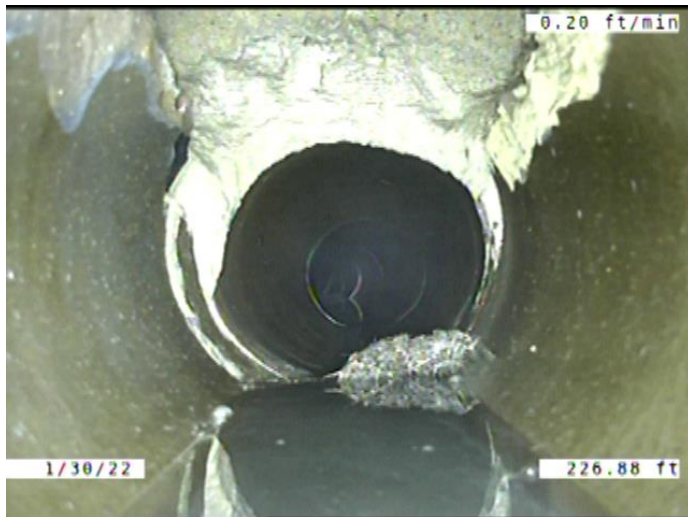
Code: **DSF**
 Description: **Deposits Settled Fine**

Distance (ft): **226.9**
 Structural Grade: **0**
 O&M Grade: **2**
 Clock Start/From: **5**
 Clock To: **7**
 1st Value:
 2nd Value:
 Value Percent: **5.000**
 Continuous Index: **F03**
 Within 8" of Joint: **YES**
 Remarks:

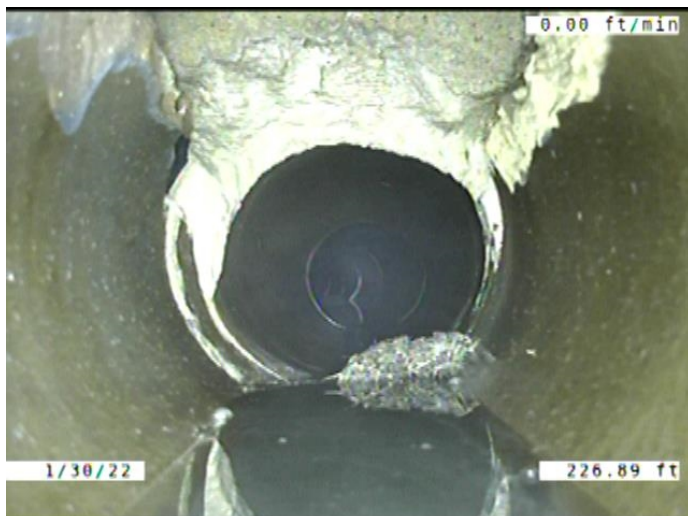
Code: **RFJ**
 Description: **Roots Fine Joint**

Distance (ft): **226.9**
 Structural Grade: **0**
 O&M Grade: **1**
 Clock Start/From: **9**
 Clock To: **3**
 1st Value:
 2nd Value:
 Value Percent:
 Continuous Index: **F06**
 Within 8" of Joint: **YES**
 Remarks:

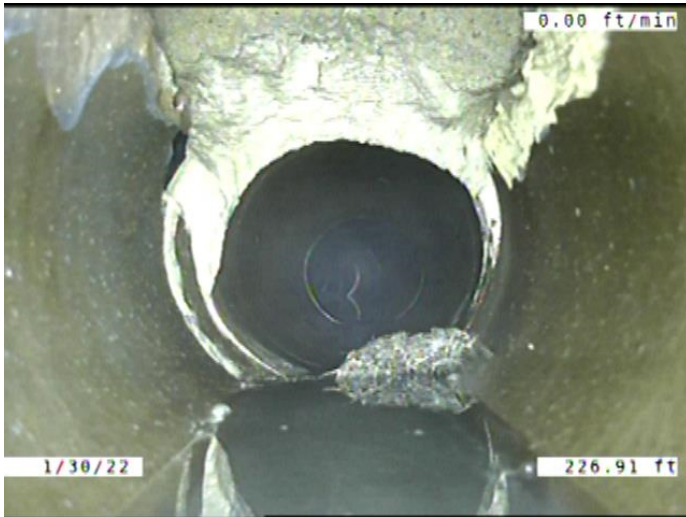
Code: **MWLS**
 Description: **Miscellaneous Water Level Sag**

Distance (ft): **226.9**
 Structural Grade: **2**
 O&M Grade: **0**
 Clock Start/From:
 Clock To:
 1st Value:
 2nd Value:
 Value Percent: **15.000**
 Continuous Index: **F10**
 Within 8" of Joint: **NO**
 Remarks:
