Profile/Photo Observation Report

Street:	S WISCONSIN ST	Flow Control:	Not Controlled
City:	Hobart, IN	Year Renewed:	
Location:	Yard	Tape/Media #:	
Purpose:	Routine Assessment	Dia/Height:	10"
Use:	Sanitary	Material:	VCP
Drain Area:	NA	Lining:	
Category:	NA		
Comment:

Location Details:		Direction of Survey:	Downstream
US MH:	M-506-020	DS MH:	M-606-094
		Total Length Surveyed (ft):	156.9

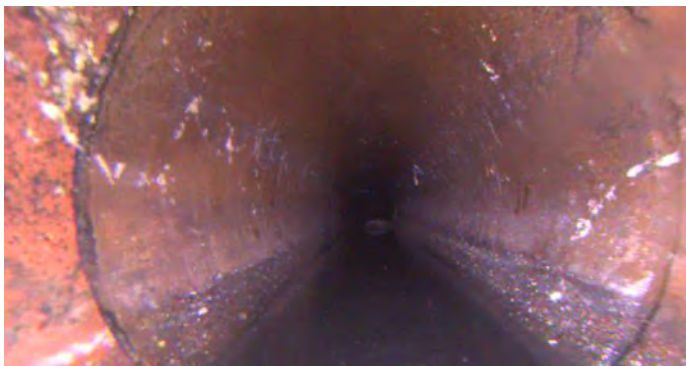
Code: **AMH**
Description: **Manhole**

Distance (ft): **.0**
Structural Grade: **0**
O&M Grade: **0**
Clock Start/From:
Clock To:
1st Value:
2nd Value:
Value Percent:
Continuous Index:
Within 8" of Joint: **NO**
Remarks: **M-506-020**

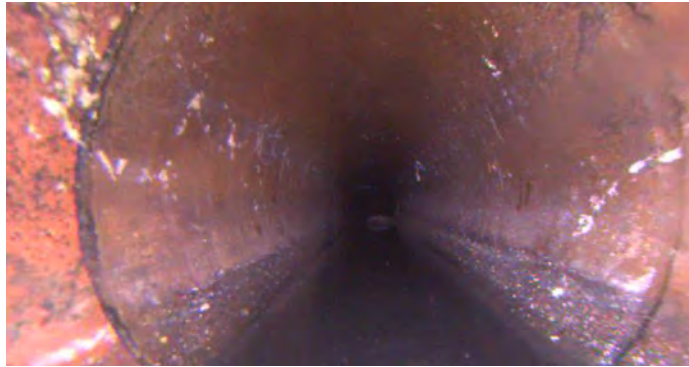
Code:	MWL
Description:	Water Level
Distance (ft):	.0
Structural Grade:	0
O&M Grade:	0
Clock Start/From:	
Clock To:	
1st Value:	
2nd Value:	
Value Percent:	10.000
Continuous Index:	
Within 8" of Joint:	NO
Remarks:

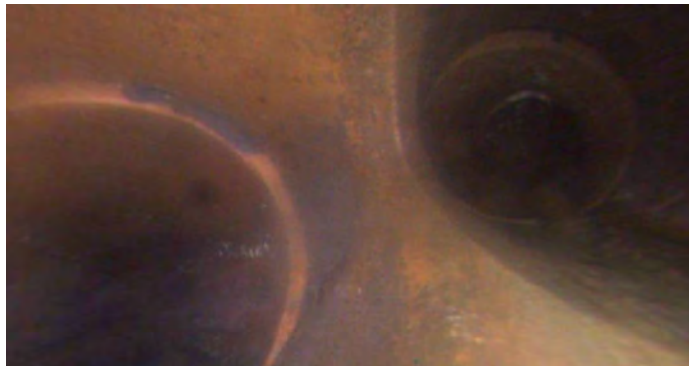
Code:	TF
Description:	Tap Factory
Distance (ft):	6.3
Structural Grade:	0
O&M Grade:	0
Clock Start/From:	9
Clock To:	
1st Value:	4.000
2nd Value:	
Value Percent:	
Continuous Index:	
Within 8" of Joint:	
Remarks:

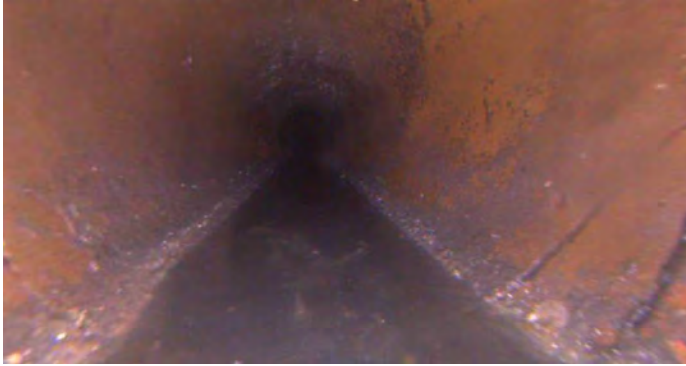
Code: **FS**
Description: **Fracture Spiral**

Distance (ft): **7.2**
Structural Grade: **3**
O&M Grade: **0**
Clock Start/From: **4**
Clock To: **10**
1st Value:
2nd Value:
Value Percent:
Continuous Index:
Within 8" of Joint: **YES**
Remarks:

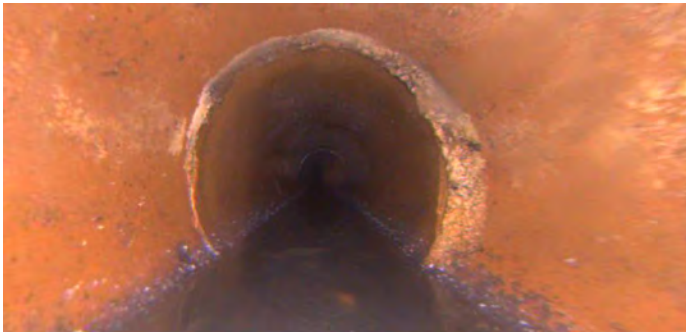
Code: **DAE**
Description: **Deposits Attached Encrustation**

Distance (ft): **38.5**
Structural Grade: **0**
O&M Grade: **2**
Clock Start/From: **8**
Clock To: **4**
1st Value:
2nd Value:
Value Percent: **5.000**
Continuous Index:
Within 8" of Joint: **YES**
Remarks:

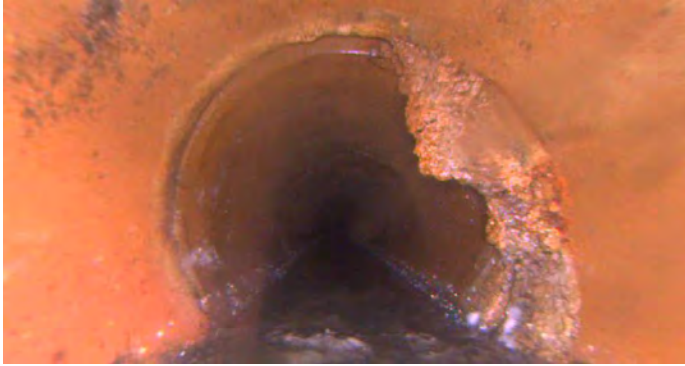
Code: **DAE**
Description: **Deposits Attached Encrustation**

Distance (ft): **50.7**
Structural Grade: **0**
O&M Grade: **2**
Clock Start/From: **12**
Clock To:
1st Value:
2nd Value:
Value Percent: **5.000**
Continuous Index:
Within 8" of Joint: **YES**
Remarks:

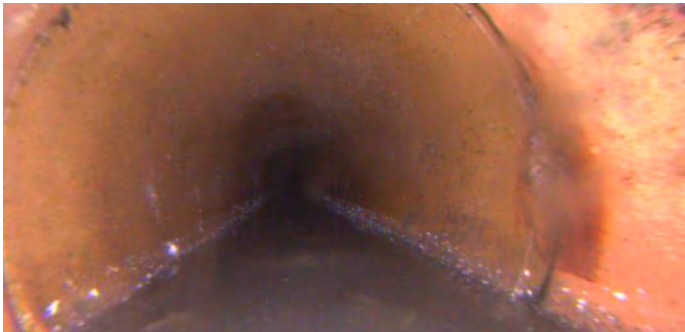
Code: **IS**
Description: **Infil Stain**

Distance (ft): **55.0**
Structural Grade: **0**
O&M Grade: **0**
Clock Start/From: **2**
Clock To: **3**
1st Value:
2nd Value:
Value Percent:
Continuous Index:
Within 8" of Joint: **YES**
Remarks:

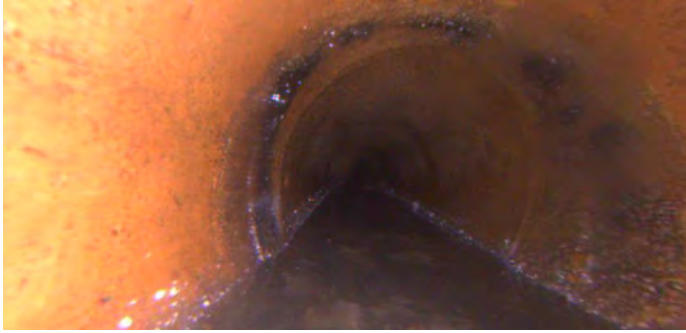
Code: **IW**
Description: **Infil Weeper**

Distance (ft): **58.8**
Structural Grade: **0**
O&M Grade: **2**
Clock Start/From: **8**
Clock To: **4**
1st Value:
2nd Value:
Value Percent:
Continuous Index:
Within 8" of Joint: **YES**
Remarks:

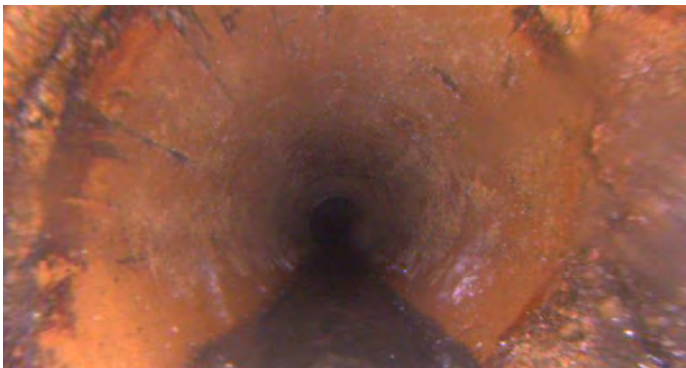
Code: **DAE**
Description: **Deposits Attached Encrustation**

Distance (ft): **75.1**
Structural Grade: **0**
O&M Grade: **2**
Clock Start/From: **7**
Clock To: **5**
1st Value:
2nd Value:
Value Percent: **5.000**
Continuous Index:
Within 8" of Joint: **YES**
Remarks:

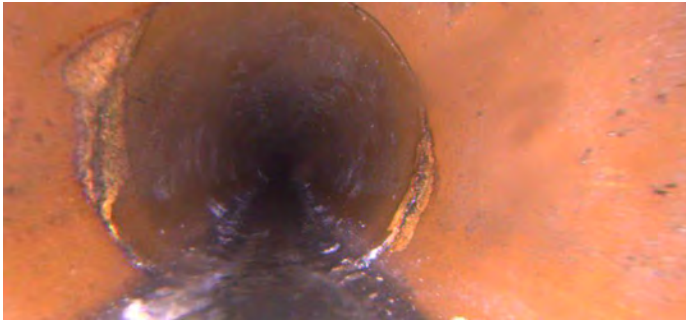
Code: **DAE**
Description: **Deposits Attached Encrustation**

Distance (ft): **82.9**
Structural Grade: **0**
O&M Grade: **2**
Clock Start/From: **8**
Clock To: **4**
1st Value:
2nd Value:
Value Percent: **5.000**
Continuous Index:
Within 8" of Joint: **YES**
Remarks:

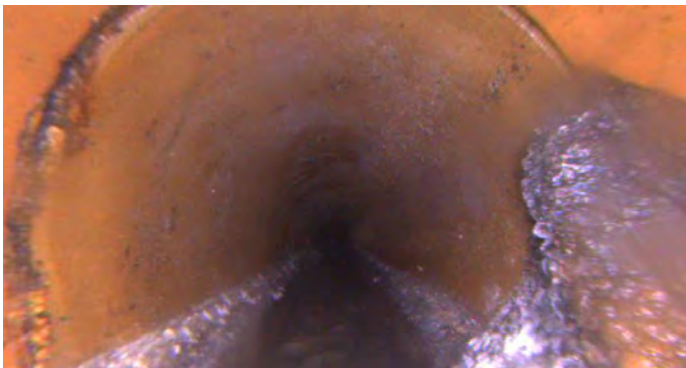
Code: **DAGS**
Description: **Deposits Attached Grease**

Distance (ft): **95.1**
Structural Grade: **0**
O&M Grade: **2**
Clock Start/From: **3**
Clock To: **4**
1st Value:
2nd Value:
Value Percent: **5.000**
Continuous Index:
Within 8" of Joint: **NO**
Remarks:

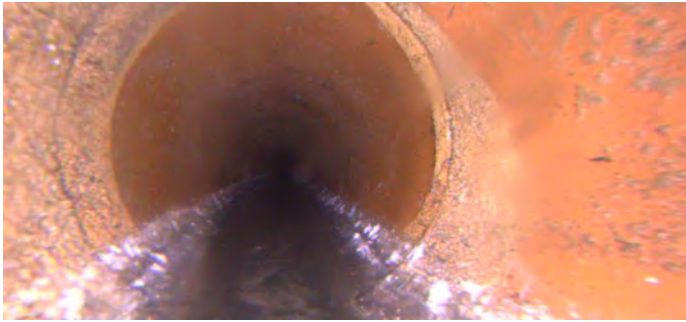
Code: **DAE**
Description: **Deposits Attached Encrustation**

Distance (ft): **111.0**
Structural Grade: **0**
O&M Grade: **2**
Clock Start/From: **8**
Clock To: **4**
1st Value:
2nd Value:
Value Percent: **5.000**
Continuous Index:
Within 8" of Joint: **YES**
Remarks:

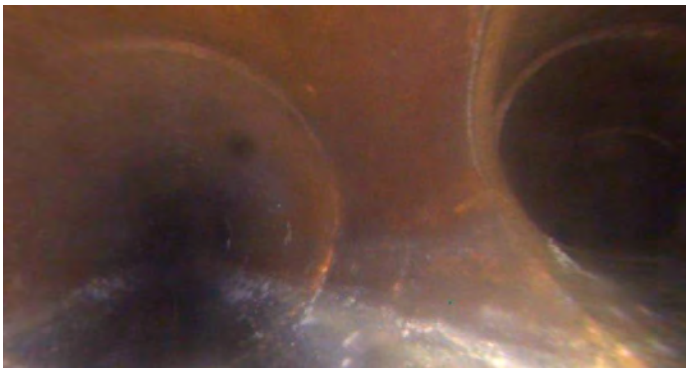
Code: **TF**
Description: **Tap Factory**

Distance (ft): **128.5**
Structural Grade: **0**
O&M Grade: **0**
Clock Start/From: **8**
Clock To:
1st Value: **4.000**
2nd Value:
Value Percent:
Continuous Index:
Within 8" of Joint:
Remarks:

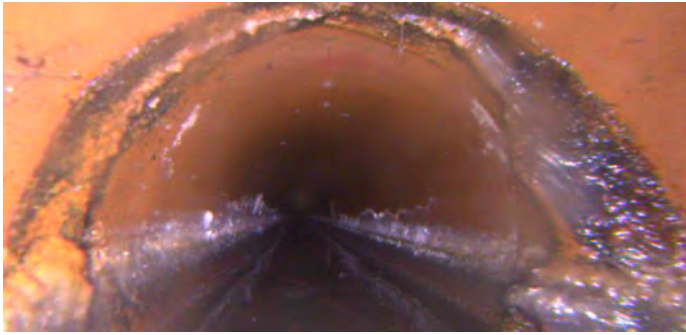
Code: **IW**
Description: **Infil Weeper**

Distance (ft): **153.5**
Structural Grade: **0**
O&M Grade: **2**
Clock Start/From: **8**
Clock To: **4**
1st Value:
2nd Value:
Value Percent:
Continuous Index:
Within 8" of Joint: **YES**
Remarks:

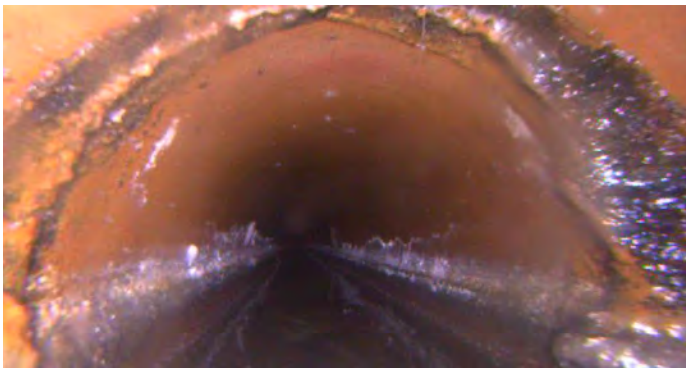
Code: **DAE**
Description: **Deposits Attached Encrustation**

Distance (ft): **153.5**
Structural Grade: **0**
O&M Grade: **2**
Clock Start/From: **12**
Clock To: **5**
1st Value:
2nd Value:
Value Percent: **5.000**
Continuous Index:
Within 8" of Joint: **YES**
Remarks:

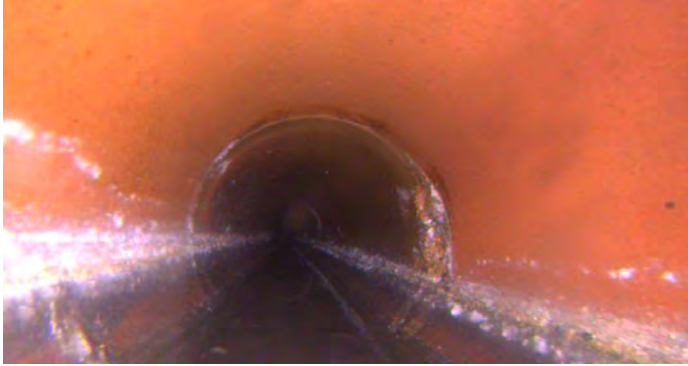
Code: **MSA**
Description: **Abandoned Survey**

Distance (ft): **156.9**
Structural Grade: **0**
O&M Grade: **0**
Clock Start/From:
Clock To:
1st Value:
2nd Value:
Value Percent:
Continuous Index:
Within 8" of Joint: **NO**
Remarks: **No blockage**
