Profile/Photo Observation Report

Street:	FOXCROFT STREET	Flow Control:	Not Controlled
City:	Hobart, IN	Year Renewed:	
Location:	Yard	Tape/Media #:	
Purpose:	Routine Assessment	Dia/Height:	10"
Use:	Sanitary	Material:	VCP
Drain Area:	NA	Lining:	
Category:	NA		
Comment:

Location Details:		Direction of Survey:	Downstream
US MH:	M-506-020	DS MH:	M-606-094
		Total Length Surveyed (ft):	156.9

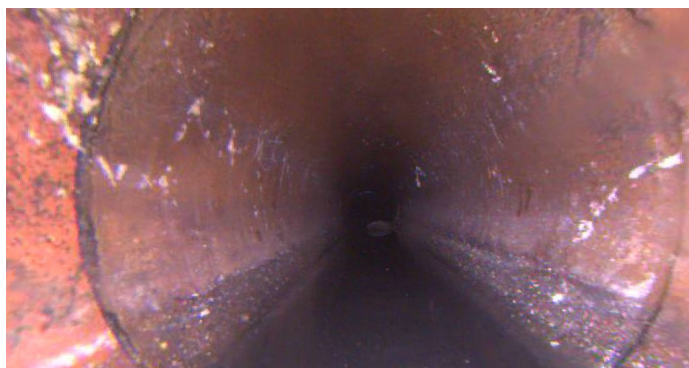
Code: **AMH**
Description: **Manhole**

Distance (ft): **.0**
Structural Grade: **0**
O&M Grade: **0**
Clock Start/From:
Clock To:
1st Value:
2nd Value:
Value Percent:
Continuous Index:
Within 8" of Joint: **NO**
Remarks: **M-506-020**

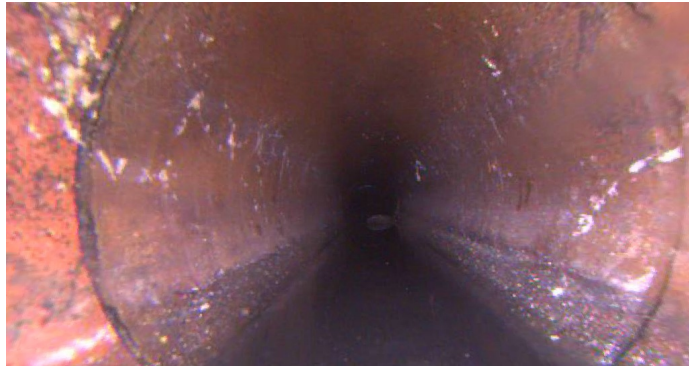
Code:	MWL
Description:	Water Level
Distance (ft):	.0
Structural Grade:	0
O&M Grade:	0
Clock Start/From:	
Clock To:	
1st Value:	
2nd Value:	
Value Percent:	10.000
Continuous Index:	
Within 8" of Joint:	NO
Remarks:

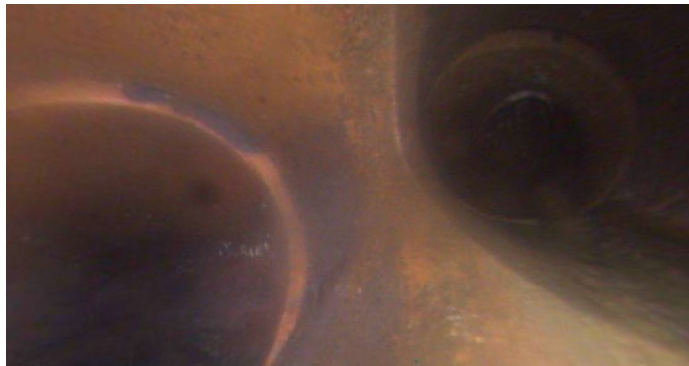
Code:	TF
Description:	Tap Factory
Distance (ft):	6.3
Structural Grade:	0
O&M Grade:	0
Clock Start/From:	9
Clock To:	
1st Value:	4.000
2nd Value:	
Value Percent:	
Continuous Index:	
Within 8" of Joint:	
Remarks:

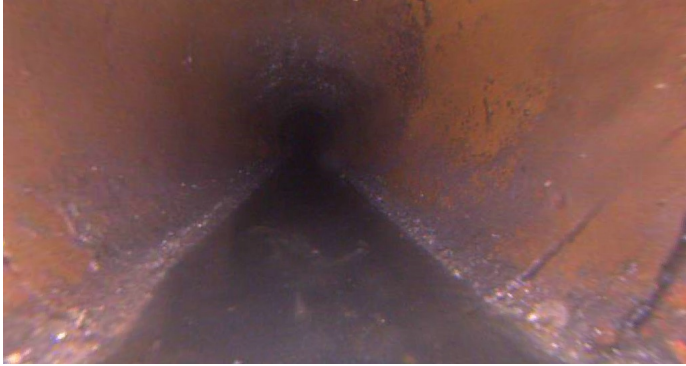
Code: **FS**
Description: **Fracture Spiral**

Distance (ft): **7.2**
Structural Grade: **3**
O&M Grade: **0**
Clock Start/From: **4**
Clock To: **10**
1st Value:
2nd Value:
Value Percent:
Continuous Index:
Within 8" of Joint: **YES**
Remarks:

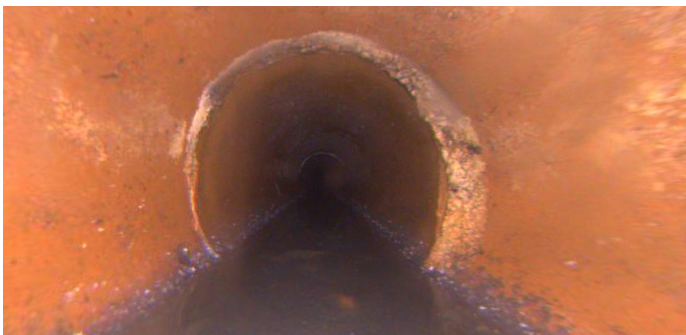
Code: **DAE**
Description: **Deposits Attached Encrustation**

Distance (ft): **38.5**
Structural Grade: **0**
O&M Grade: **2**
Clock Start/From: **8**
Clock To: **4**
1st Value:
2nd Value:
Value Percent: **5.000**
Continuous Index:
Within 8" of Joint: **YES**
Remarks:

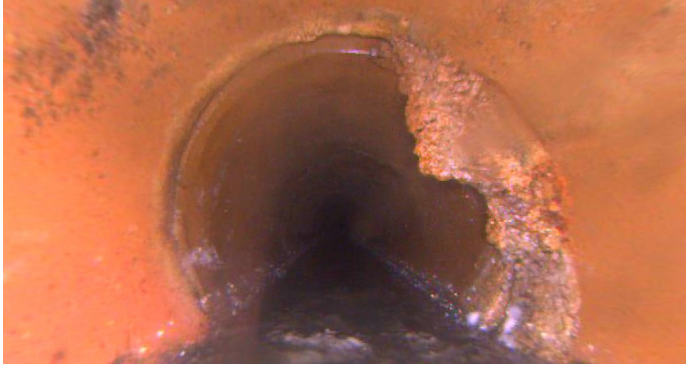
Code: **DAE**
Description: **Deposits Attached Encrustation**

Distance (ft): **50.7**
Structural Grade: **0**
O&M Grade: **2**
Clock Start/From: **12**
Clock To:
1st Value:
2nd Value:
Value Percent: **5.000**
Continuous Index:
Within 8" of Joint: **YES**
Remarks:

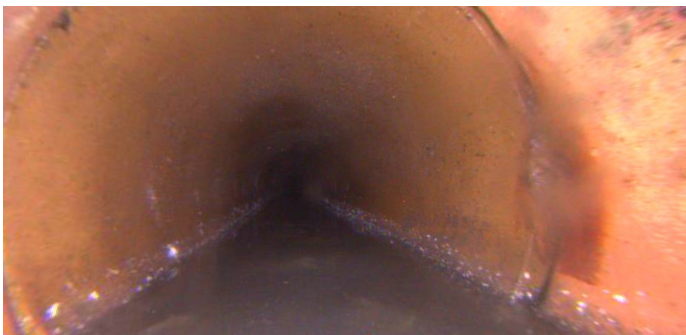
Code: **IS**
Description: **Infil Stain**

Distance (ft): **55.0**
Structural Grade: **0**
O&M Grade: **0**
Clock Start/From: **2**
Clock To: **3**
1st Value:
2nd Value:
Value Percent:
Continuous Index:
Within 8" of Joint: **YES**
Remarks:

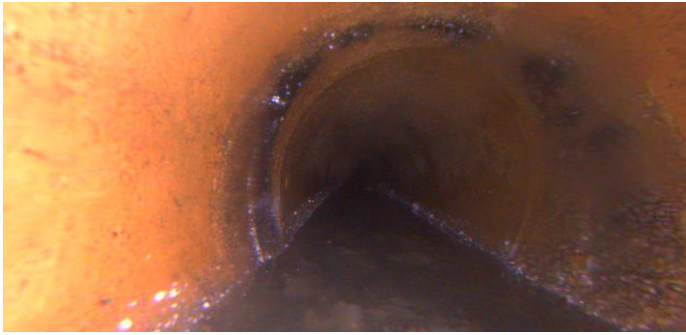
Code: **IW**
Description: **Infil Weeper**

Distance (ft): **58.8**
Structural Grade: **0**
O&M Grade: **2**
Clock Start/From: **8**
Clock To: **4**
1st Value:
2nd Value:
Value Percent:
Continuous Index:
Within 8" of Joint: **YES**
Remarks:

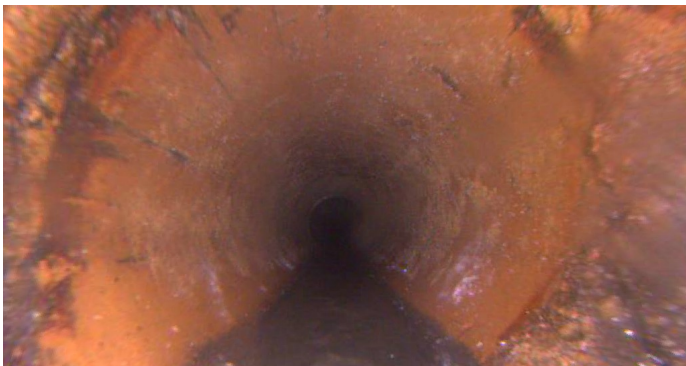
Code: **DAE**
Description: **Deposits Attached Encrustation**

Distance (ft): **75.1**
Structural Grade: **0**
O&M Grade: **2**
Clock Start/From: **7**
Clock To: **5**
1st Value:
2nd Value:
Value Percent: **5.000**
Continuous Index:
Within 8" of Joint: **YES**
Remarks:

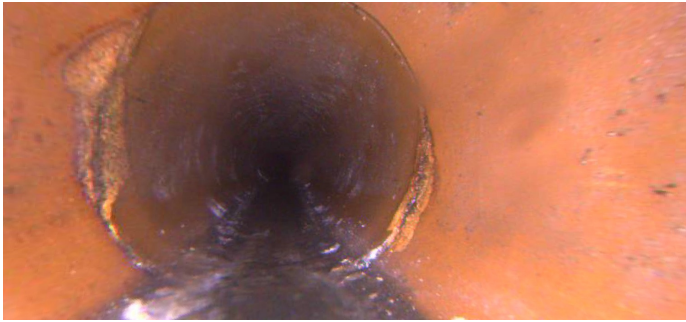
Code: **DAE**
Description: **Deposits Attached Encrustation**

Distance (ft): **82.9**
Structural Grade: **0**
O&M Grade: **2**
Clock Start/From: **8**
Clock To: **4**
1st Value:
2nd Value:
Value Percent: **5.000**
Continuous Index:
Within 8" of Joint: **YES**
Remarks:

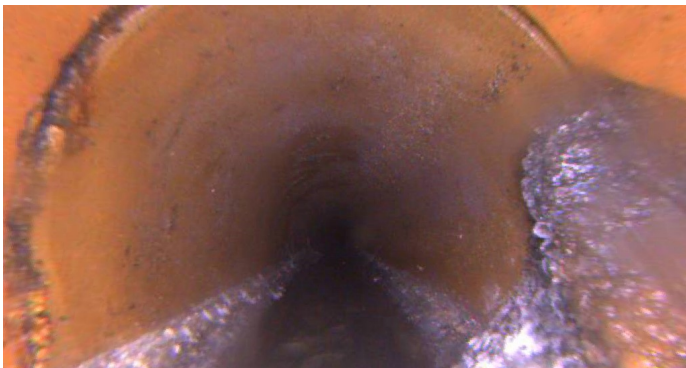
Code: **DAGS**
Description: **Deposits Attached Grease**

Distance (ft): **95.1**
Structural Grade: **0**
O&M Grade: **2**
Clock Start/From: **3**
Clock To: **4**
1st Value:
2nd Value:
Value Percent: **5.000**
Continuous Index:
Within 8" of Joint: **NO**
Remarks:

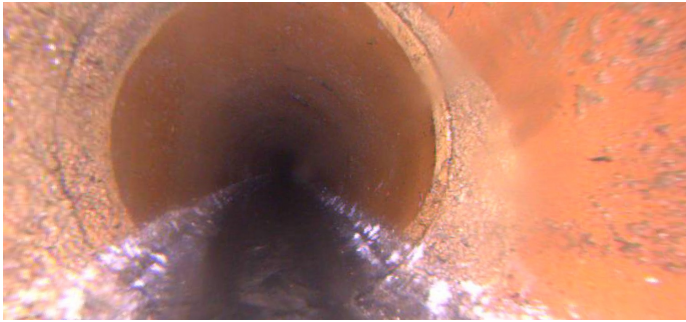
Code: **DAE**
Description: **Deposits Attached Encrustation**

Distance (ft): **111.0**
Structural Grade: **0**
O&M Grade: **2**
Clock Start/From: **8**
Clock To: **4**
1st Value:
2nd Value:
Value Percent: **5.000**
Continuous Index:
Within 8" of Joint: **YES**
Remarks:

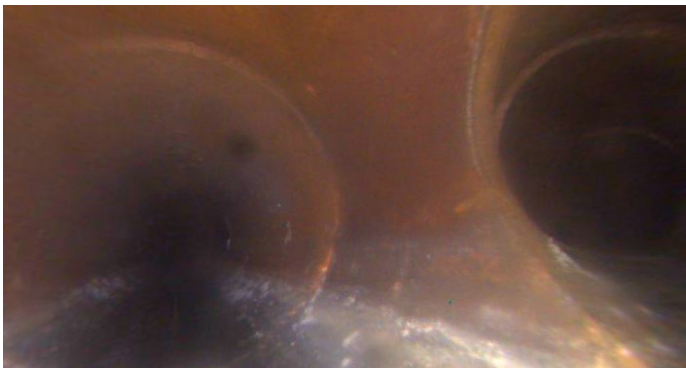
Code: **TF**
Description: **Tap Factory**

Distance (ft): **128.5**
Structural Grade: **0**
O&M Grade: **0**
Clock Start/From: **8**
Clock To:
1st Value: **4.000**
2nd Value:
Value Percent:
Continuous Index:
Within 8" of Joint:
Remarks:

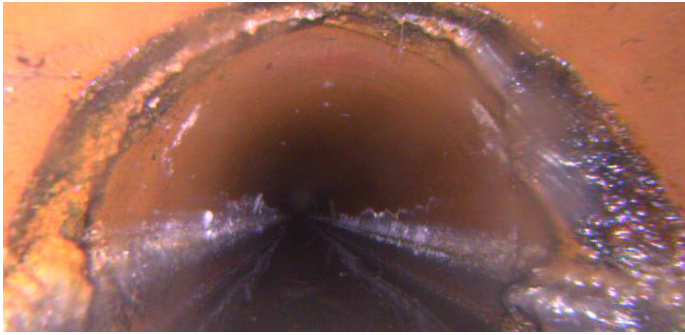
Code: **IW**
Description: **Infil Weeper**

Distance (ft): **153.5**
Structural Grade: **0**
O&M Grade: **2**
Clock Start/From: **8**
Clock To: **4**
1st Value:
2nd Value:
Value Percent:
Continuous Index:
Within 8" of Joint: **YES**
Remarks:

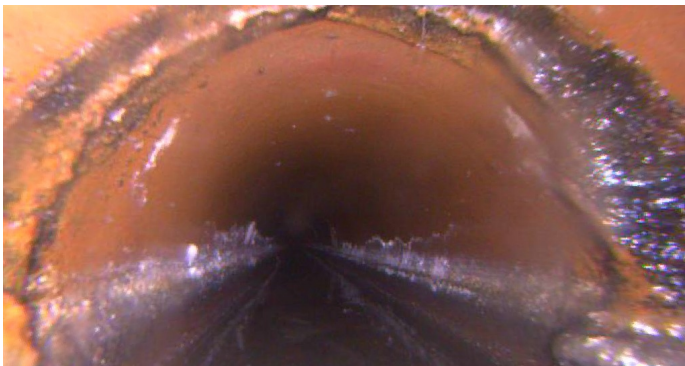
Code: **DAE**
Description: **Deposits Attached Encrustation**

Distance (ft): **153.5**
Structural Grade: **0**
O&M Grade: **2**
Clock Start/From: **12**
Clock To: **5**
1st Value:
2nd Value:
Value Percent: **5.000**
Continuous Index:
Within 8" of Joint: **YES**
Remarks:

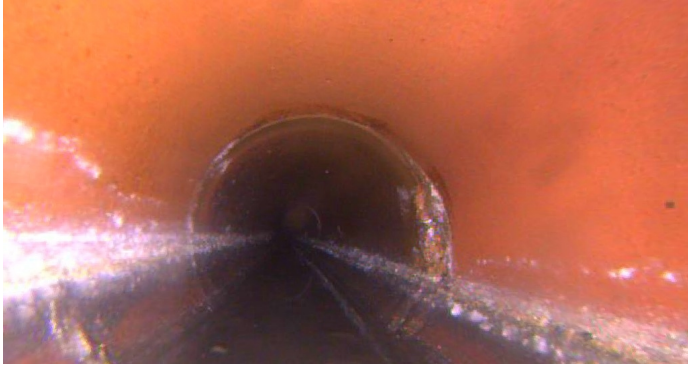
Code:	MSA
Description:	Abandoned Survey
Distance (ft):	156.9
Structural Grade:	0
O&M Grade:	0
Clock Start/From:	
Clock To:	
1st Value:	
2nd Value:	
Value Percent:	
Continuous Index:	
Within 8" of Joint:	NO
Remarks:	No blockage
