Profile/Photo Observation Report

Street:	RIVER TERR & W 8TH ST	Flow Control:	Not Controlled
City:	Hobart, IN	Year Renewed:	
Location:	Yard	Tape/Media #:	
Purpose:	Routine Assessment	Dia/Height:	10"
Use:	Sanitary	Material:	VCP
Drain Area:	NA	Lining:	
Category:	NA		
Comment:

Location Details:		Direction of Survey:	Downstream
US MH:	M-506-022	DS MH:	M-506-024
		Total Length Surveyed (ft):	16.0

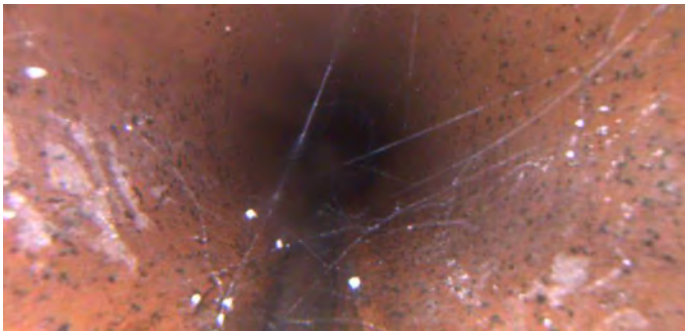
Code: **AMH**
Description: **Manhole**

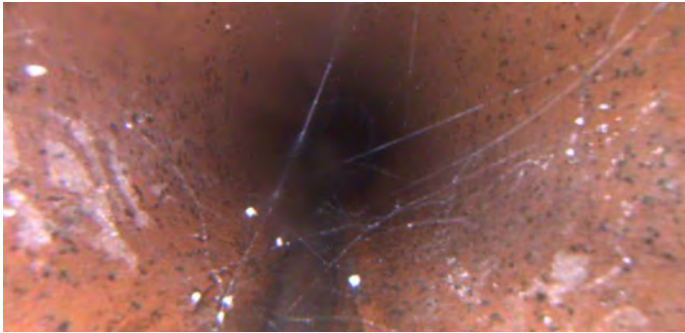
Code:	MWL
Description:	Water Level

Distance (ft):	.0
Structural Grade:	0
O&M Grade:	0
Clock Start/From:	
Clock To:	
1st Value:	
2nd Value:	
Value Percent:	5.000
Continuous Index:	
Within 8" of Joint:	NO
Remarks:

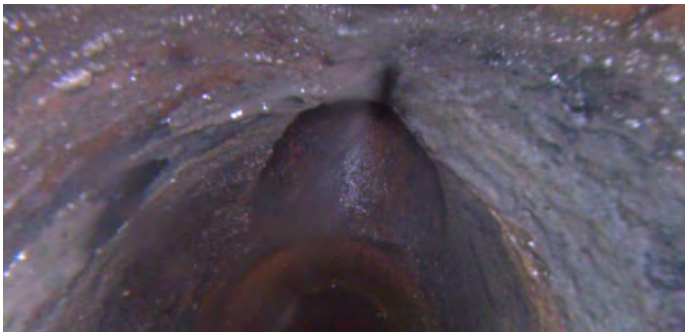
Code:	TFA
Description:	Tap Factory Active

Distance (ft):	4.3
Structural Grade:	0
O&M Grade:	0
Clock Start/From:	12
Clock To:	
1st Value:	4.000
2nd Value:	
Value Percent:	
Continuous Index:	
Within 8" of Joint:	
Remarks:

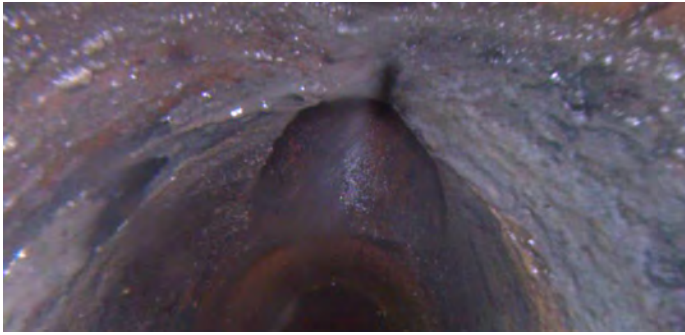
Code: **DAGS**
Description: **Deposits Attached Grease**

Distance (ft): **4.3**
Structural Grade: **0**
O&M Grade: **2**
Clock Start/From: **8**
Clock To: **4**
1st Value:
2nd Value:
Value Percent: **5.000**
Continuous Index:
Within 8" of Joint: **NO**
Remarks:

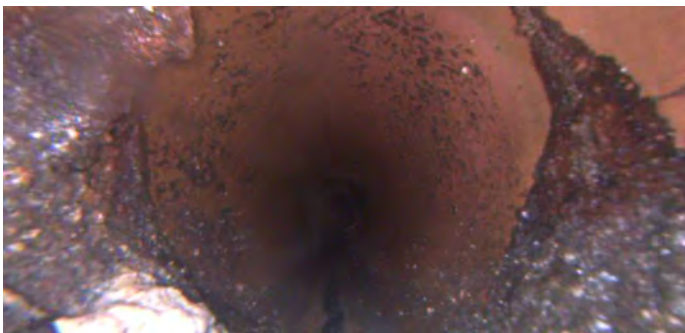
Code: **DAE**
Description: **Deposits Attached Encrustation**

Distance (ft): **5.8**
Structural Grade: **0**
O&M Grade: **2**
Clock Start/From: **7**
Clock To: **5**
1st Value:
2nd Value:
Value Percent: **10.000**
Continuous Index:
Within 8" of Joint: **YES**
Remarks:

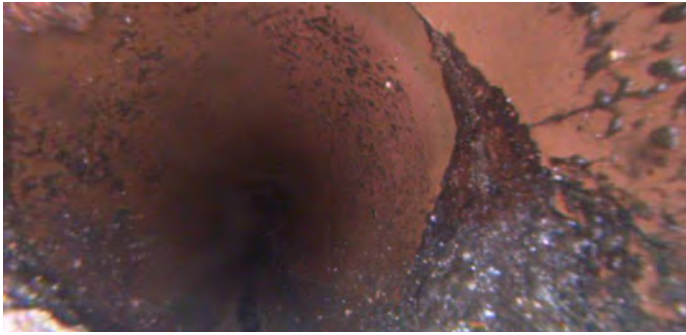
Code: **FL**
Description: **Fracture Longitudinal**

Distance (ft): **5.8**
Structural Grade: **3**
O&M Grade: **0**
Clock Start/From: **2**
Clock To:
1st Value:
2nd Value:
Value Percent:
Continuous Index:
Within 8" of Joint: **YES**
Remarks:

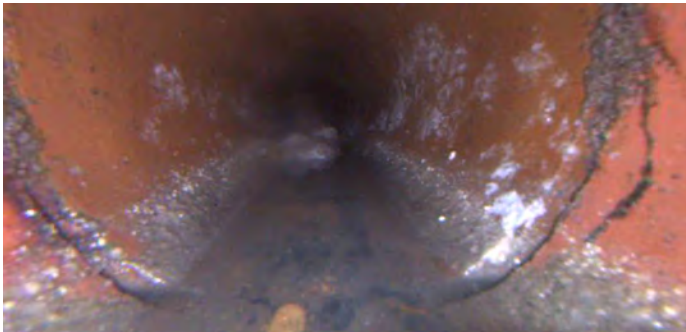
Code: **FC**
Description: **Fracture Circumferential**

Distance (ft): **13.5**
Structural Grade: **2**
O&M Grade: **0**
Clock Start/From: **3**
Clock To: **4**
1st Value:
2nd Value:
Value Percent:
Continuous Index:
Within 8" of Joint: **YES**
Remarks:

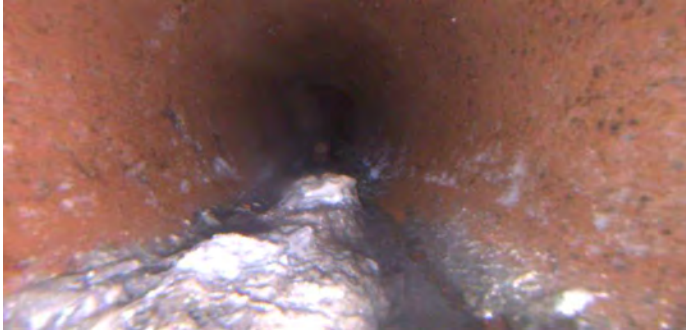
Code: **OBZ**
Description: **Obstacle Other**

Distance (ft): **14.7**
Structural Grade: **0**
O&M Grade: **2**
Clock Start/From: **5**
Clock To: **7**
1st Value:
2nd Value:
Value Percent: **10.000**
Continuous Index:
Within 8" of Joint: **NO**
Remarks: **misc**

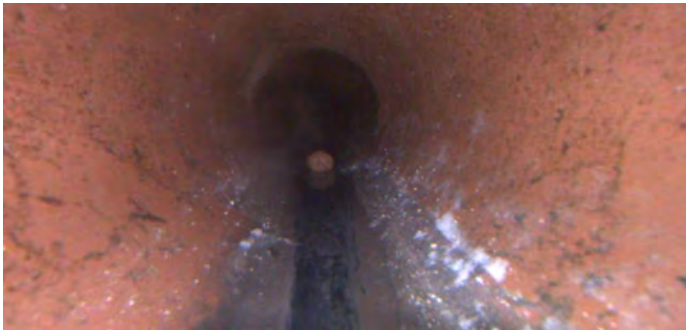
Code: **MSA**
Description: **Abandoned Survey**

Distance (ft): **16.0**
Structural Grade: **0**
O&M Grade: **0**
Clock Start/From:
Clock To:
1st Value:
2nd Value:
Value Percent:
Continuous Index:
Within 8" of Joint: **NO**
Remarks: **unknown**
