Profile/Photo Observation Report

Date:	04/06/2018	Weather:		Coding:	PACP 6.0
Pipe Length (ft):	147.2	Owner:	NA	Pre Clean:	No Pre-Cleaning
P.O.#:		Surveyor:	Jen Costello	PSR:	P-506-022-024
Customer:		Clean Date:	01/01/1900	Shape:	C

Street:	FOXCROFT STREET	Flow Control:	Not Controlled
City:	Hobart, IN	Year Renewed:	
Location:	Yard	Tape/Media #:	
Purpose:	Routine Assessment	Dia/Height:	10"
Use:	Sanitary	Material:	VCP
Drain Area:	NA	Lining:	
Category:	NA		
Comment:

Location Details:		Direction of Survey:	Downstream
US MH:	M-506-022	DS MH:	M-506-024
		Total Length Surveyed (ft):	16.0

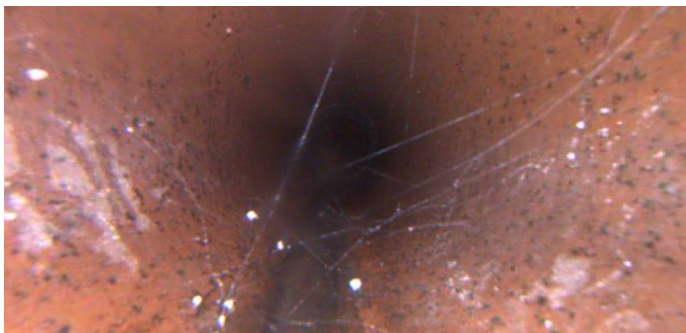
Code: **AMH**
Description: **Manhole**

Distance (ft): **.0**
Structural Grade: **0**
O&M Grade: **0**
Clock Start/From:
Clock To:
1st Value:
2nd Value:
Value Percent:
Continuous Index:
Within 8" of Joint: **NO**
Remarks: **M-506-022**

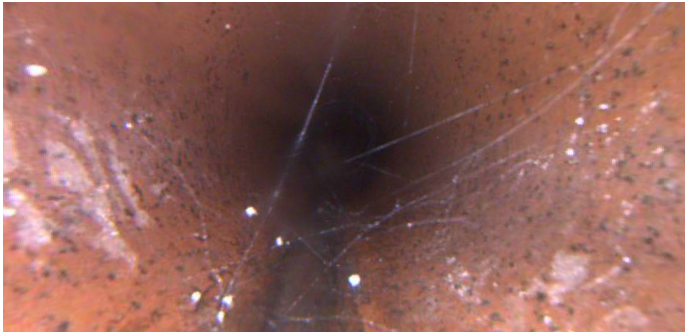
Code:	MWL
Description:	Water Level

Distance (ft):	.0
Structural Grade:	0
O&M Grade:	0
Clock Start/From:	
Clock To:	
1st Value:	
2nd Value:	
Value Percent:	5.000
Continuous Index:	
Within 8" of Joint:	NO
Remarks:

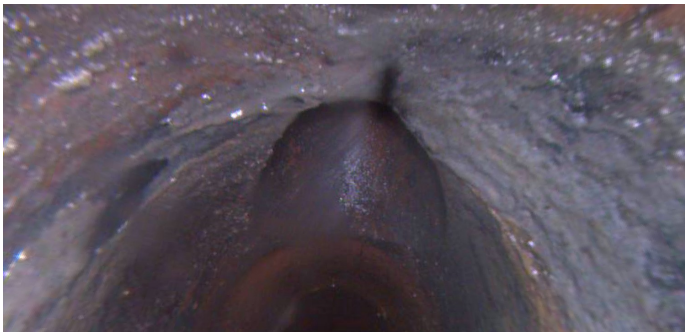
Code:	TFA
Description:	Tap Factory Active

Distance (ft):	4.3
Structural Grade:	0
O&M Grade:	0
Clock Start/From:	12
Clock To:	
1st Value:	4.000
2nd Value:	
Value Percent:	
Continuous Index:	
Within 8" of Joint:	
Remarks:

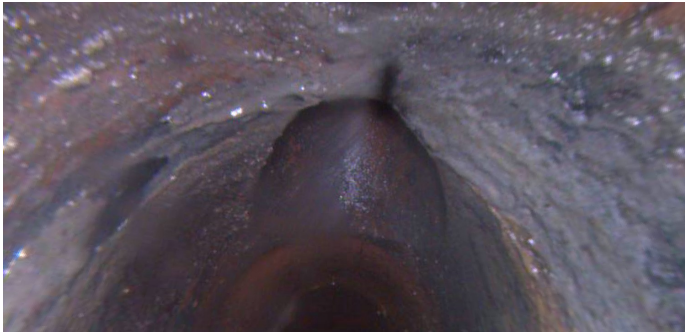
Code: **DAGS**
Description: **Deposits Attached Grease**

Distance (ft): **4.3**
Structural Grade: **0**
O&M Grade: **2**
Clock Start/From: **8**
Clock To: **4**
1st Value:
2nd Value:
Value Percent: **5.000**
Continuous Index:
Within 8" of Joint: **NO**
Remarks:

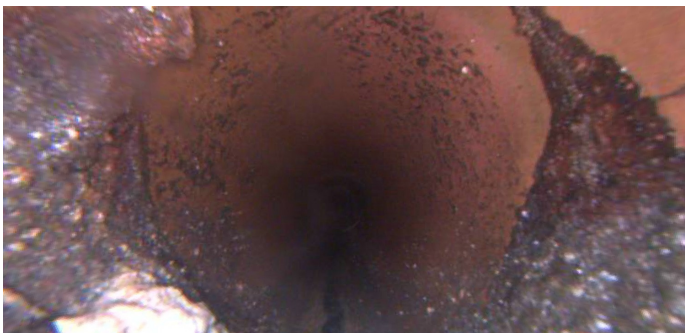
Code: **DAE**
Description: **Deposits Attached Encrustation**

Distance (ft): **5.8**
Structural Grade: **0**
O&M Grade: **2**
Clock Start/From: **7**
Clock To: **5**
1st Value:
2nd Value:
Value Percent: **10.000**
Continuous Index:
Within 8" of Joint: **YES**
Remarks:

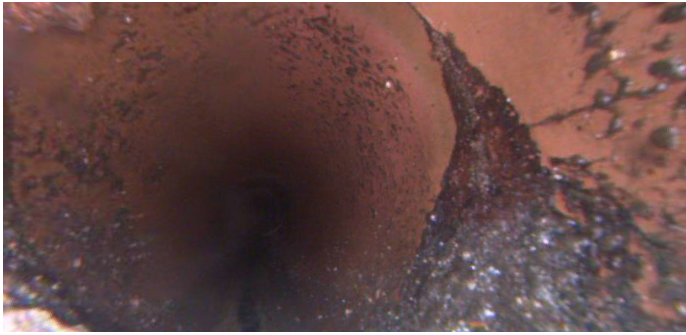
Code: **FL**
Description: **Fracture Longitudinal**

Distance (ft): **5.8**
Structural Grade: **3**
O&M Grade: **0**
Clock Start/From: **2**
Clock To:
1st Value:
2nd Value:
Value Percent:
Continuous Index:
Within 8" of Joint: **YES**
Remarks:

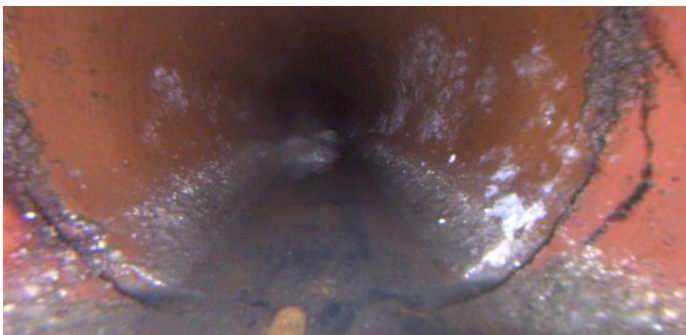
Code: **FC**
Description: **Fracture Circumferential**

Distance (ft): **13.5**
Structural Grade: **2**
O&M Grade: **0**
Clock Start/From: **3**
Clock To: **4**
1st Value:
2nd Value:
Value Percent:
Continuous Index:
Within 8" of Joint: **YES**
Remarks:

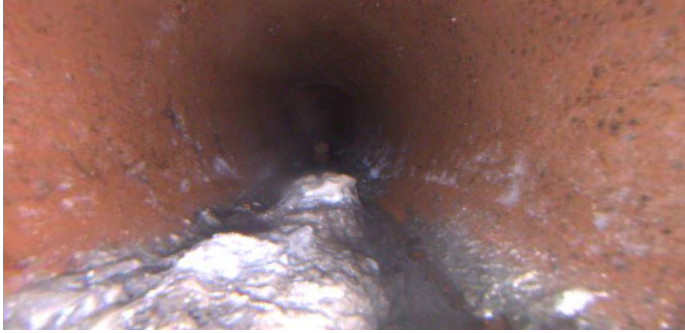
Code: **OBZ**
Description: **Obstacle Other**

Distance (ft): **14.7**
Structural Grade: **0**
O&M Grade: **2**
Clock Start/From: **5**
Clock To: **7**
1st Value:
2nd Value:
Value Percent: **10.000**
Continuous Index:
Within 8" of Joint: **NO**
Remarks: **misc**

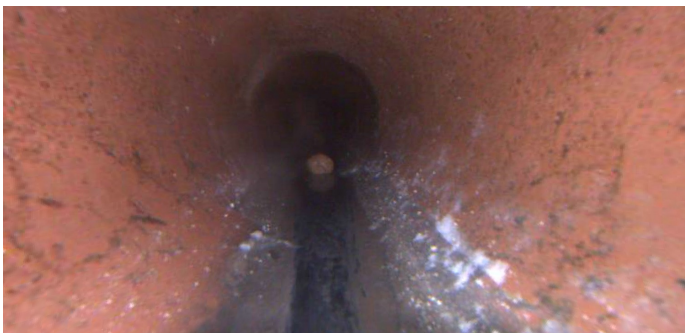
Code: **MSA**
Description: **Abandoned Survey**

Distance (ft): **16.0**
Structural Grade: **0**
O&M Grade: **0**
Clock Start/From:
Clock To:
1st Value:
2nd Value:
Value Percent:
Continuous Index:
Within 8" of Joint: **NO**
Remarks: **unknown**
