Profile/Photo Observation Report

Date:	01/18/2022	Weather:		Coding:	PACP 7.0
Pipe Length (ft):	147.0	Owner:	City of Hobart	Pre Clean:	Heavy Cleaning
P.O.#:	YES502259	Surveyor:	S. Bucklin	PSR:	P-506-022-024
Customer:	City of Hobart	Clean Date:	01/16/2021	Shape:	C

Street:	River Terrace	Flow Control:	Not Controlled
City:	Hobart, IN	Year Renewed:	
Location:	Local rural streets with light traffic, t	Tape/Media #:	
Purpose:	Routine Assessment	Dia/Height:	10"
Use:	Sanitary Sewage Pipe	Material:	VCP
Drain Area:		Lining:	None
Category:	NA		
Comment:			
Location Details:		Direction of Survey:	Downstream
US MH:	M-506-022	DS MH:	M-506-024
		Total Length Surveyed (ft):	121.8

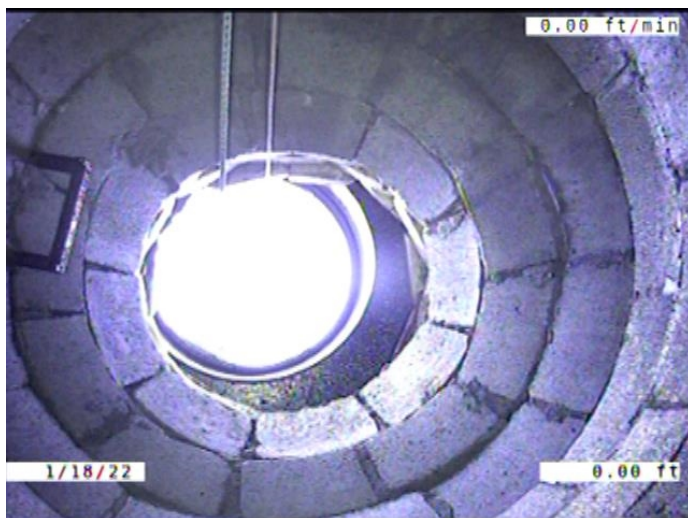
Code: **AMH**
 Description: **Manhole**

Distance (ft): **.0**
 Structural Grade: **0**
 O&M Grade: **0**
 Clock Start/From:
 Clock To:
 1st Value:
 2nd Value:
 Value Percent:
 Continuous Index:
 Within 8" of Joint: **NO**
 Remarks: **M-506-022**

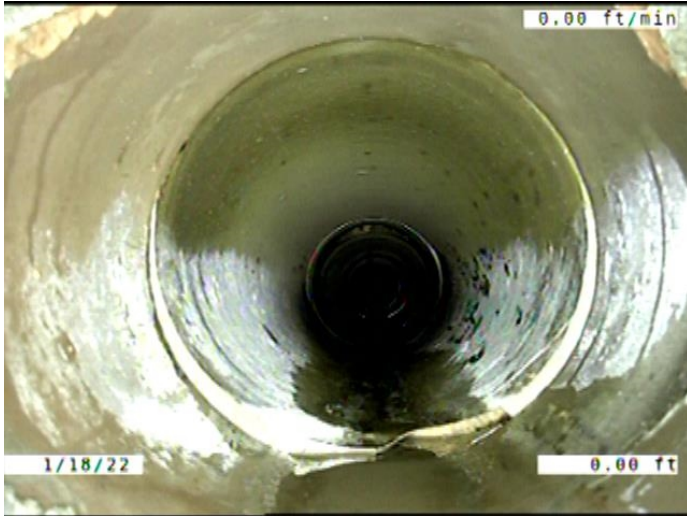
Code: **MWL**
Description: **Miscellaneous Water Level**

Distance (ft): **.0**
Structural Grade: **0**
O&M Grade: **0**
Clock Start/From:
Clock To:
1st Value:
2nd Value:
Value Percent: **5.000**
Continuous Index:
Within 8" of Joint: **NO**
Remarks:

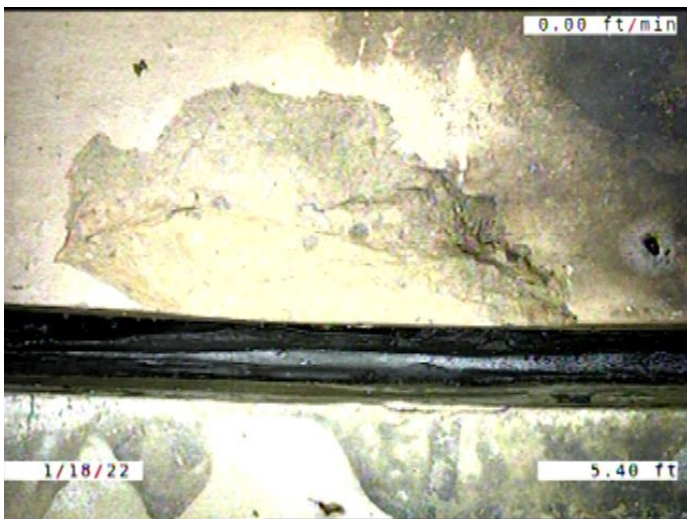
Code: **SZ**
Description: **Surface Damage Other**

Distance (ft): **5.4**
Structural Grade: **0**
O&M Grade: **0**
Clock Start/From: **2**
Clock To:
1st Value:
2nd Value:
Value Percent:
Continuous Index:
Within 8" of Joint: **YES**
Remarks: **A PIECE CHIPPED AWAY FROM THE JOINT**

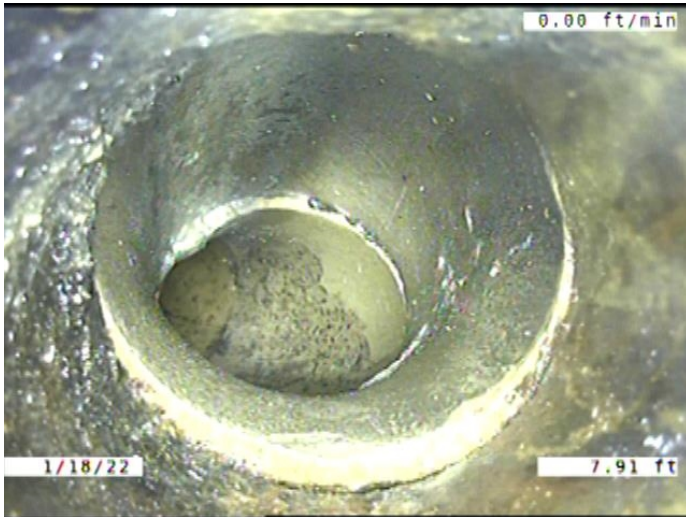
Code: **TF**
 Description: **Tap Factory**

Distance (ft): **7.9**
 Structural Grade: **0**
 O&M Grade: **0**
 Clock Start/From: **12**
 Clock To:
 1st Value: **4.000**

2nd Value:
 Value Percent:
 Continuous Index:
 Within 8" of Joint: **YES**
 Remarks: **ENCrustATION COMING FROM THE MAIN TO SERVICE CONNECTION.**

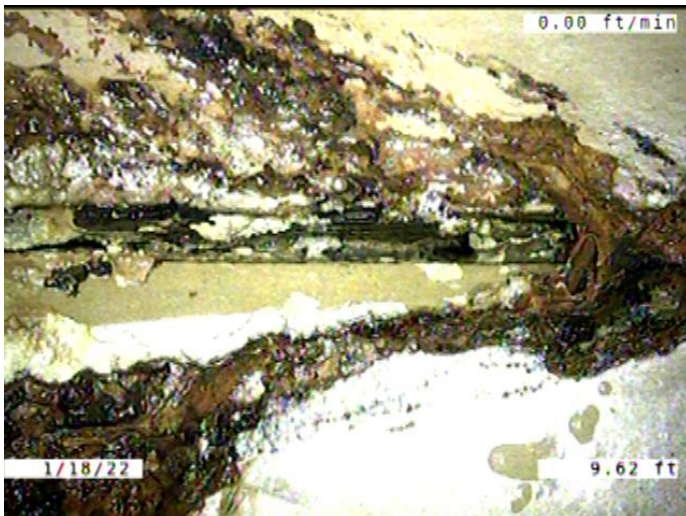
Code: **DAE**
 Description: **Deposits Attached Encrustation**

Distance (ft): **9.6**
 Structural Grade: **0**
 O&M Grade: **2**
 Clock Start/From: **7**
 Clock To: **5**

1st Value:
 2nd Value:
 Value Percent: **5.000**
 Continuous Index: **S01**
 Within 8" of Joint: **YES**
 Remarks:

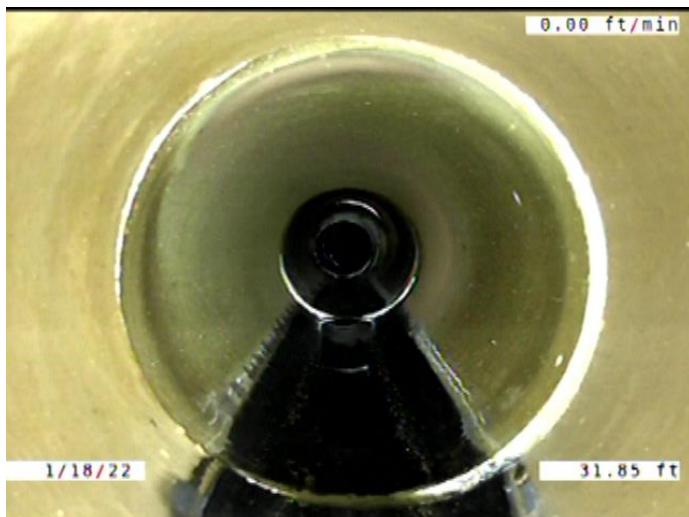
Code: **MWLS**
Description: **Miscellaneous Water Level Sag**

Distance (ft): **31.9**
Structural Grade: **2**
O&M Grade: **0**
Clock Start/From:
Clock To:
1st Value:
2nd Value:
Value Percent: **5.000**
Continuous Index: **S02**
Within 8" of Joint: **NO**
Remarks:

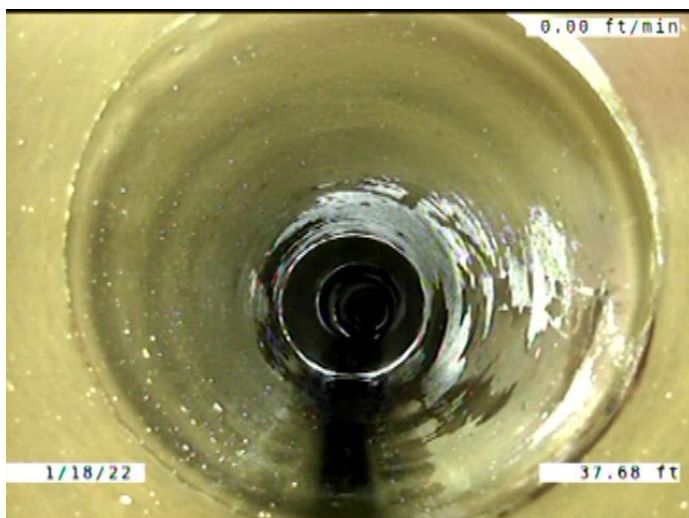
Code: **MWLS**
Description: **Miscellaneous Water Level Sag**

Distance (ft): **37.7**
Structural Grade: **2**
O&M Grade: **0**
Clock Start/From:
Clock To:
1st Value:
2nd Value:
Value Percent: **5.000**
Continuous Index: **F02**
Within 8" of Joint: **NO**
Remarks:

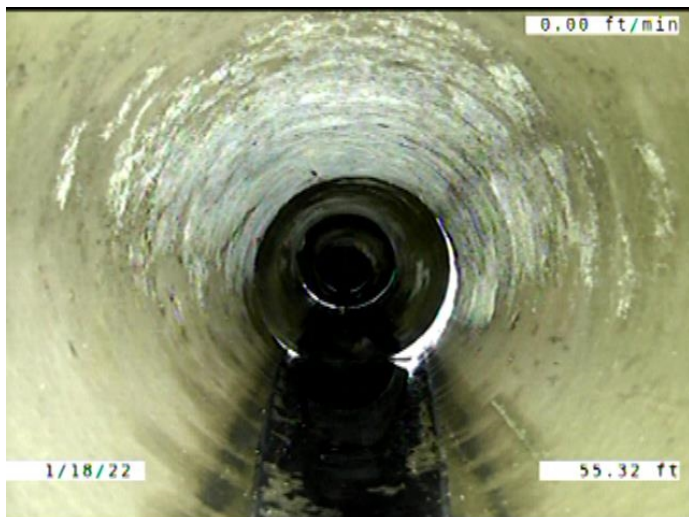
Code: **MWLS**
 Description: **Miscellaneous Water Level Sag**

Distance (ft): **55.3**
 Structural Grade: **2**
 O&M Grade: **0**
 Clock Start/From:
 Clock To:
 1st Value:
 2nd Value:
 Value Percent: **5.000**
 Continuous Index: **S03**
 Within 8" of Joint: **NO**
 Remarks:

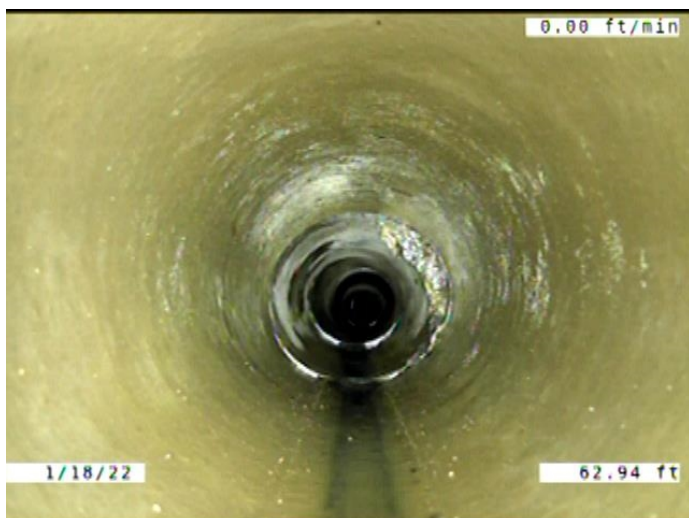
Code: **MWLS**
 Description: **Miscellaneous Water Level Sag**

Distance (ft): **62.9**
 Structural Grade: **2**
 O&M Grade: **0**
 Clock Start/From:
 Clock To:
 1st Value:
 2nd Value:
 Value Percent: **5.000**
 Continuous Index: **F03**
 Within 8" of Joint: **NO**
 Remarks:

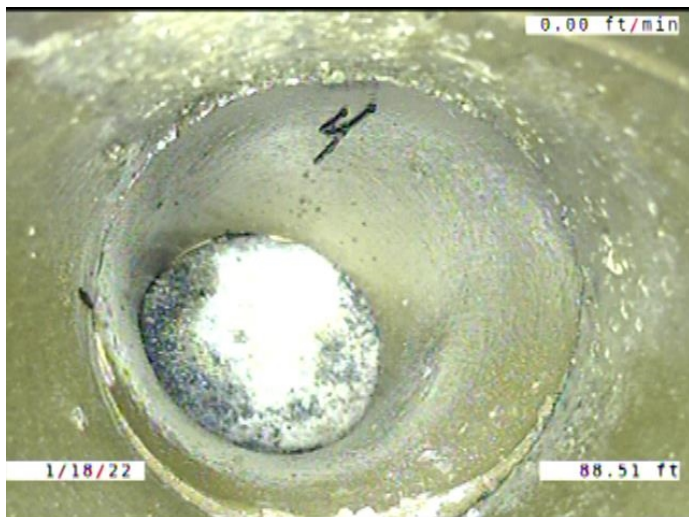
Code: **TFC**
 Description: **Tap Factory Capped**

Distance (ft): **88.5**
 Structural Grade: **0**
 O&M Grade: **0**
 Clock Start/From: **11**
 Clock To:
 1st Value: **4.000**
 2nd Value:
 Value Percent:
 Continuous Index:
 Within 8" of Joint: **YES**
 Remarks:

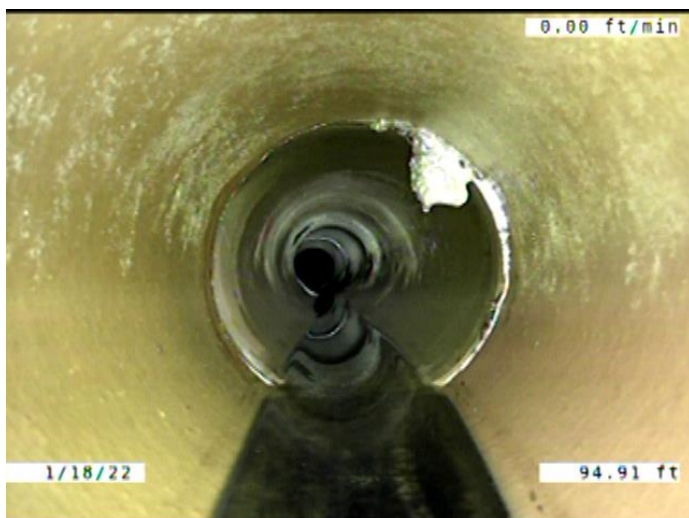
Code: **MWLS**
 Description: **Miscellaneous Water Level Sag**

Distance (ft): **94.9**
 Structural Grade: **2**
 O&M Grade: **0**
 Clock Start/From:
 Clock To:
 1st Value:
 2nd Value:
 Value Percent: **5.000**
 Continuous Index: **S04**
 Within 8" of Joint: **NO**
 Remarks:

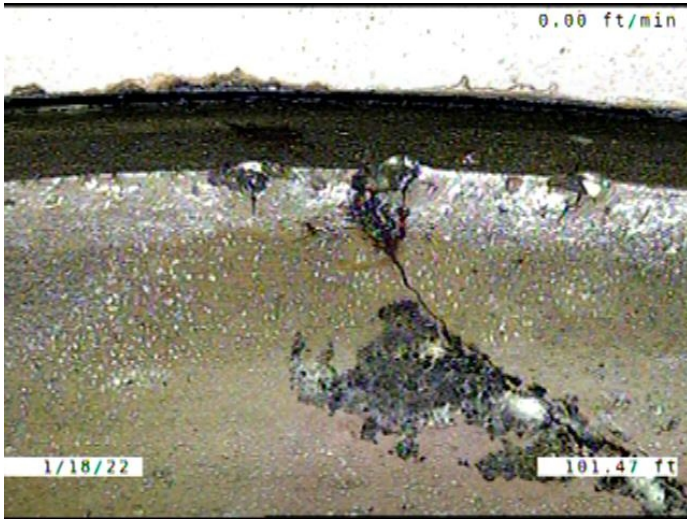
Code: **CS**
Description: **Crack Spiral**

Distance (ft): **101.5**
Structural Grade: **2**
O&M Grade: **0**
Clock Start/From: **11**
Clock To: **2**
1st Value:
2nd Value:
Value Percent:
Continuous Index:
Within 8" of Joint: **YES**
Remarks:

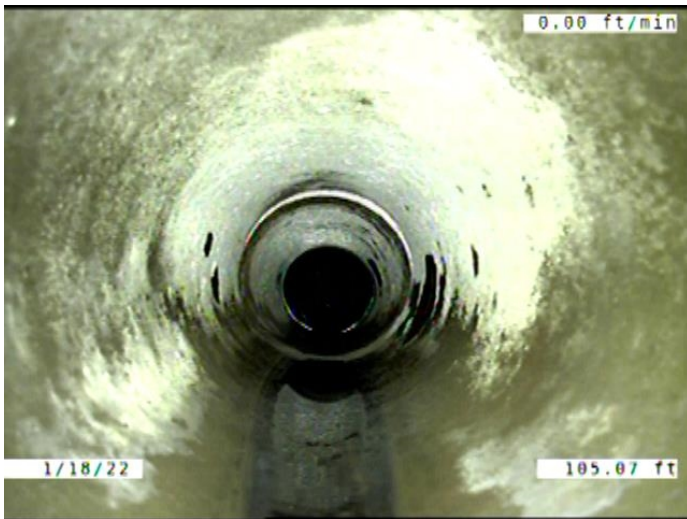
Code: **MWLS**
Description: **Miscellaneous Water Level Sag**

Distance (ft): **105.1**
Structural Grade: **2**
O&M Grade: **0**
Clock Start/From:
Clock To:
1st Value:
2nd Value:
Value Percent: **5.000**
Continuous Index: **F04**
Within 8" of Joint: **NO**
Remarks:

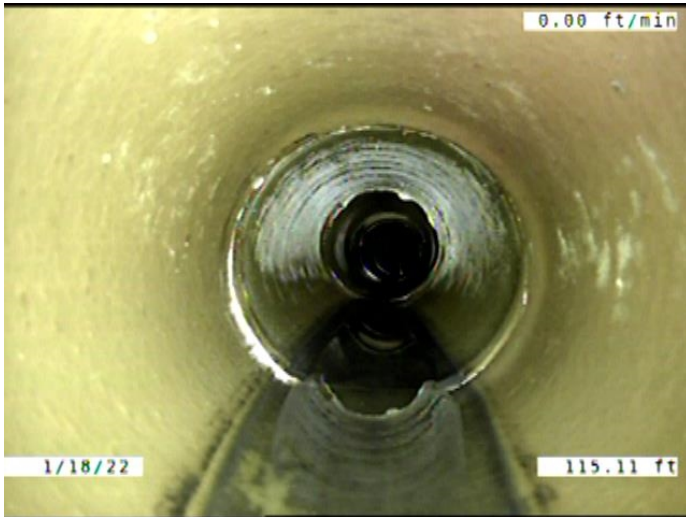
Code: **MWLS**
Description: **Miscellaneous Water Level Sag**

Distance (ft): **115.1**
Structural Grade: **2**
O&M Grade: **0**
Clock Start/From:
Clock To:
1st Value:
2nd Value:
Value Percent: **5.000**
Continuous Index: **S05**
Within 8" of Joint: **NO**
Remarks:

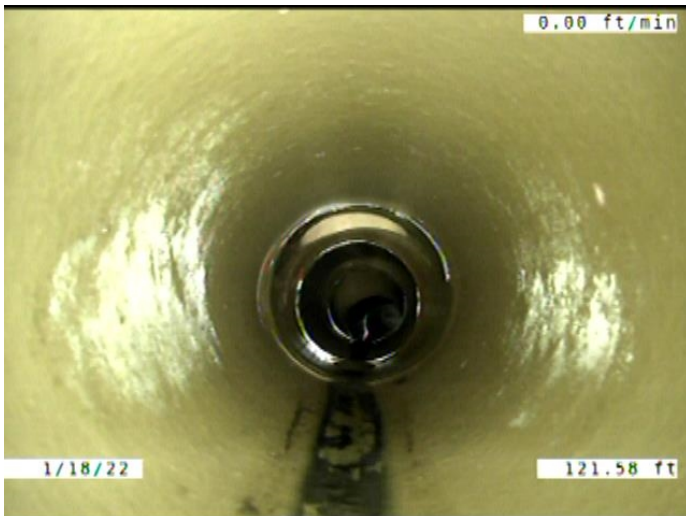
Code: **MWLS**
Description: **Miscellaneous Water Level Sag**

Distance (ft): **121.6**
Structural Grade: **2**
O&M Grade: **0**
Clock Start/From:
Clock To:
1st Value:
2nd Value:
Value Percent: **5.000**
Continuous Index: **F05**
Within 8" of Joint: **NO**
Remarks:

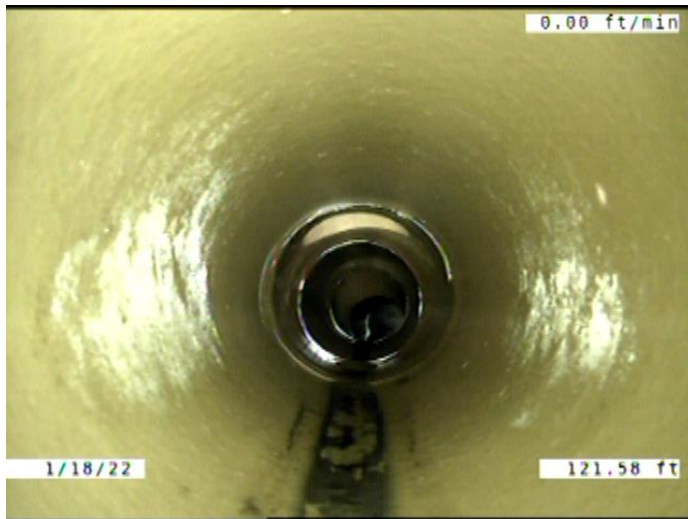
Code: **DAE**
 Description: **Deposits Attached Encrustation**

Distance (ft): **121.6**
 Structural Grade: **0**
 O&M Grade: **2**
 Clock Start/From: **7**
 Clock To: **5**
 1st Value:
 2nd Value:
 Value Percent: **5.000**
 Continuous Index: **F01**
 Within 8" of Joint: **YES**
 Remarks:

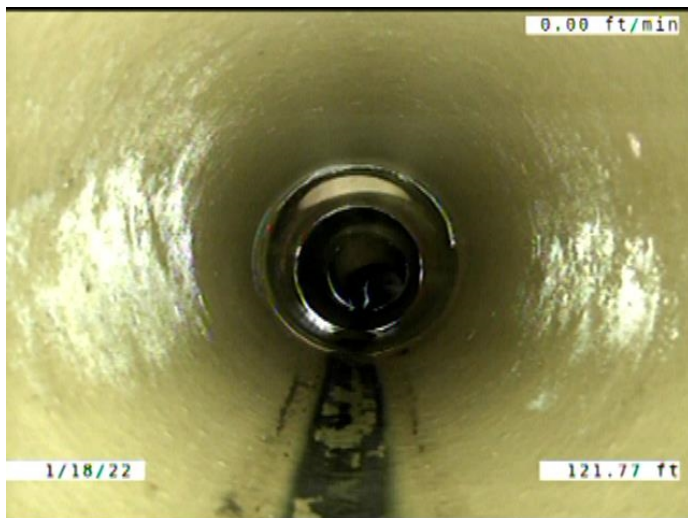
Code: **MSA**
 Description: **Miscellaneous Survey Abandoned**

Distance (ft): **121.8**
 Structural Grade: **0**
 O&M Grade: **0**
 Clock Start/From:
 Clock To:
 1st Value:
 2nd Value:
 Value Percent:
 Continuous Index:
 Within 8" of Joint: **NO**
 Remarks: **MADE IT TO THE POINT OF OVERLAP.
 REVERSAL COMPLETE**
