## Profile/Photo Observation Report

Date:	<b>04/06/2018</b>	Weather:		Coding:	<b>PACP 6.0</b>
Pipe Length (ft):	<b>189.0</b>	Owner:	<b>NA</b>	Pre Clean:	<b>No Pre-Cleaning</b>
P.O.#:		Surveyor:	<b>Mark Ruby</b>	PSR:	<b>P-506-023-010</b>
Customer:		Clean Date:	<b>01/01/1900</b>	Shape:	<b>C</b>

Street:	<b>S COLORADO ST</b>	Flow Control:	<b>Not Controlled</b>
City:	<b>Hobart, IN</b>	Year Renewed:	
Location:	<b>Yard</b>	Tape/Media #:	
Purpose:	<b>Routine Assessment</b>	Dia/Height:	<b>10"</b>
Use:	<b>Sanitary</b>	Material:	<b>VCP</b>
Drain Area:	<b>NA</b>	Lining:	
Category:	<b>NA</b>		
Comment:

Location Details:		Direction of Survey:	<b>Upstream</b>
US MH:	<b>M-506-023</b>	DS MH:	<b>M-506-010</b>
		Total Length Surveyed (ft):	<b>185.5</b>

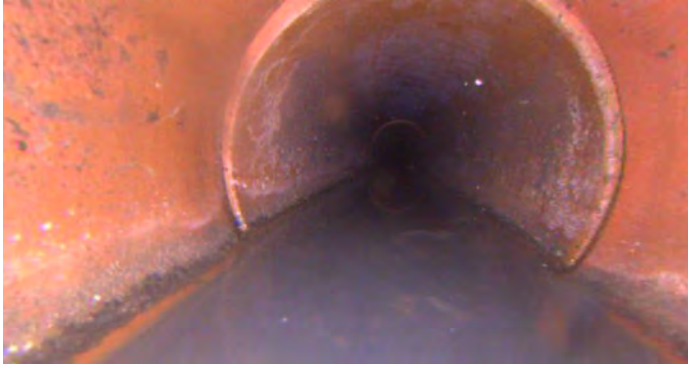
Code: **AMH**  
Description: **Manhole**

Distance (ft): **.0**  
Structural Grade: **0**  
O&M Grade: **0**  
Clock Start/From:  
Clock To:  
1st Value:  
2nd Value:  
Value Percent:  
Continuous Index:  
Within 8" of Joint: **NO**  
Remarks: **M-506-010**

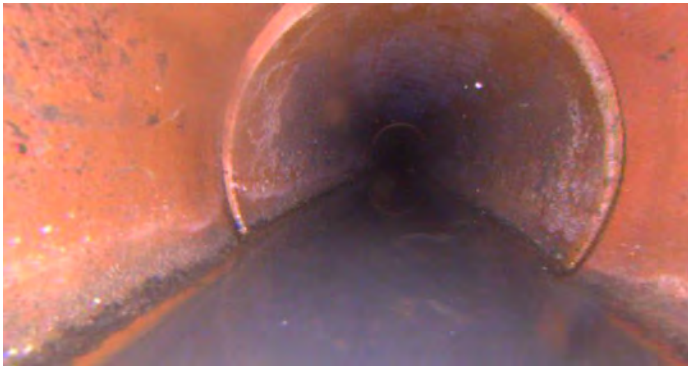
Code: **MWL**  
Description: **Water Level**

Distance (ft): **.0**  
Structural Grade: **0**  
O&M Grade: **0**  
Clock Start/From:  
Clock To:  
1st Value:  
2nd Value:  
Value Percent: **10.000**  
Continuous Index:  
Within 8" of Joint: **NO**  
Remarks:

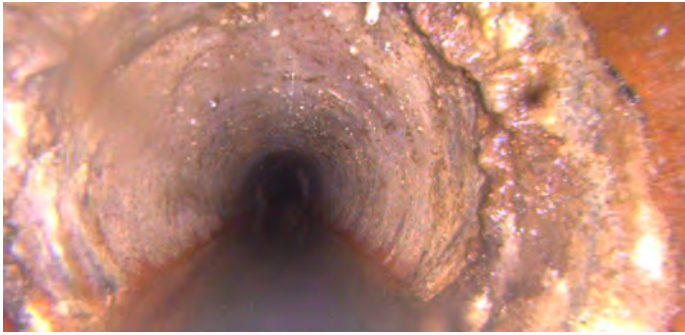
Code: **DAE**  
Description: **Deposits Attached Encrustation**

Distance (ft): **37.5**  
Structural Grade: **0**  
O&M Grade: **2**  
Clock Start/From: **8**  
Clock To: **4**  
1st Value:  
2nd Value:  
Value Percent: **10.000**  
Continuous Index:  
Within 8" of Joint: **YES**  
Remarks:

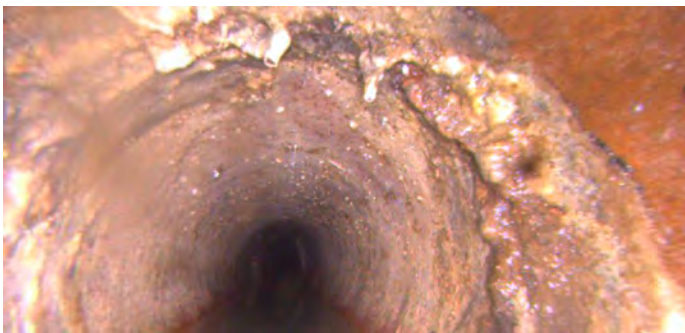
Code: **ID**  
Description: **Infil Dripper**

Distance (ft): **37.5**  
Structural Grade: **0**  
O&M Grade: **3**  
Clock Start/From: **12**  
Clock To:  
1st Value:  
2nd Value:  
Value Percent:  
Continuous Index:  
Within 8" of Joint: **YES**  
Remarks:

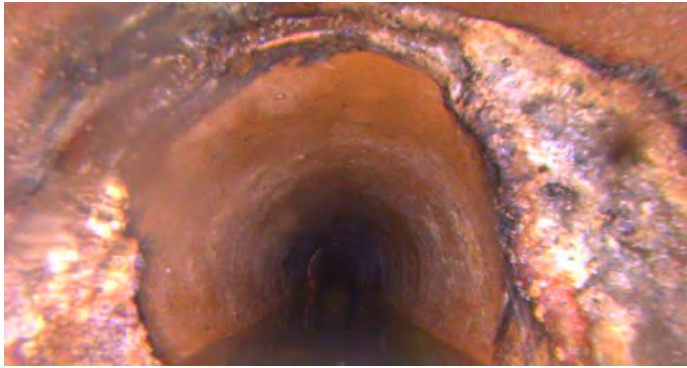
Code:	<b>DAZ</b>
Description:	<b>Deposits Attached Other</b>
Distance (ft):	<b>41.6</b>
Structural Grade:	<b>0</b>
O&M Grade:	<b>2</b>
Clock Start/From:	<b>7</b>
Clock To:	<b>5</b>
1st Value:	
2nd Value:	
Value Percent:	<b>5.000</b>
Continuous Index:	
Within 8" of Joint:	<b>YES</b>
Remarks:

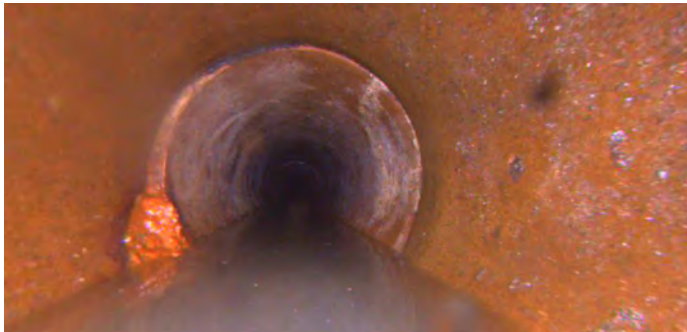
Code:	<b>DAE</b>
Description:	<b>Deposits Attached Encrustation</b>
Distance (ft):	<b>45.2</b>
Structural Grade:	<b>0</b>
O&M Grade:	<b>2</b>
Clock Start/From:	<b>8</b>
Clock To:	<b>9</b>
1st Value:	
2nd Value:	
Value Percent:	<b>5.000</b>
Continuous Index:	
Within 8" of Joint:	<b>YES</b>
Remarks:

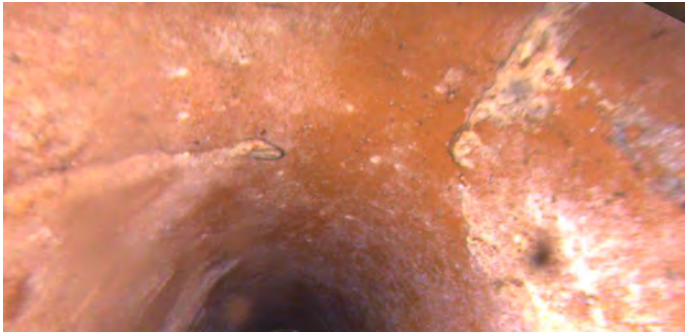
Code: **FL**  
Description: **Fracture Longitudinal**

Distance (ft): **46.0**  
Structural Grade: **3**  
O&M Grade: **0**  
Clock Start/From: **1**  
Clock To:  
1st Value:  
2nd Value:  
Value Percent:  
Continuous Index:  
Within 8" of Joint: **YES**  
Remarks:

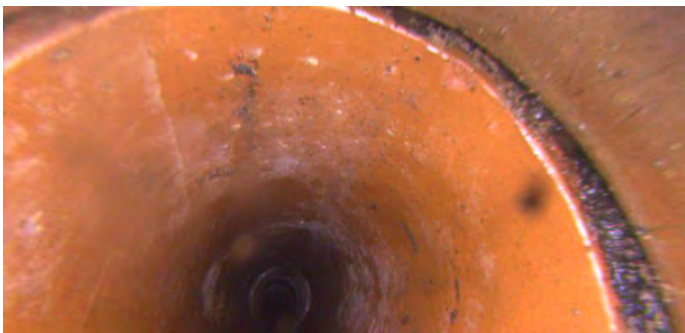
Code: **CL**  
Description: **Crack Longitudinal**

Distance (ft): **53.8**  
Structural Grade: **2**  
O&M Grade: **0**  
Clock Start/From: **11**  
Clock To:  
1st Value:  
2nd Value:  
Value Percent:  
Continuous Index:  
Within 8" of Joint: **YES**  
Remarks:

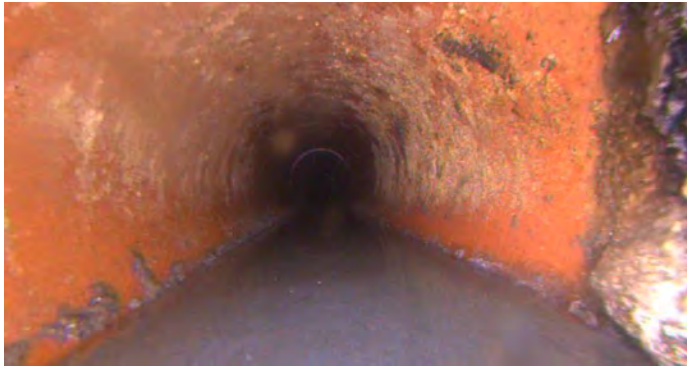
Code:	<b>DAZ</b>
Description:	<b>Deposits Attached Other</b>
Distance (ft):	<b>65.9</b>
Structural Grade:	<b>0</b>
O&M Grade:	<b>2</b>
Clock Start/From:	<b>4</b>
Clock To:	<b>5</b>
1st Value:	
2nd Value:	
Value Percent:	<b>5.000</b>
Continuous Index:	
Within 8" of Joint:	<b>YES</b>
Remarks:

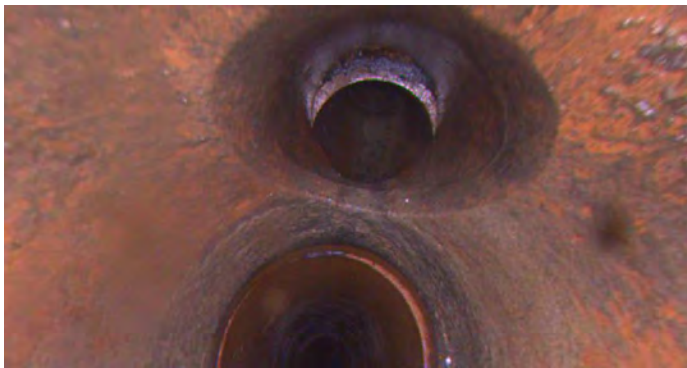
Code:	<b>TF</b>
Description:	<b>Tap Factory</b>
Distance (ft):	<b>74.7</b>
Structural Grade:	<b>0</b>
O&M Grade:	<b>0</b>
Clock Start/From:	<b>1</b>
Clock To:	
1st Value:	<b>4.000</b>
2nd Value:	
Value Percent:	
Continuous Index:	
Within 8" of Joint:	
Remarks:

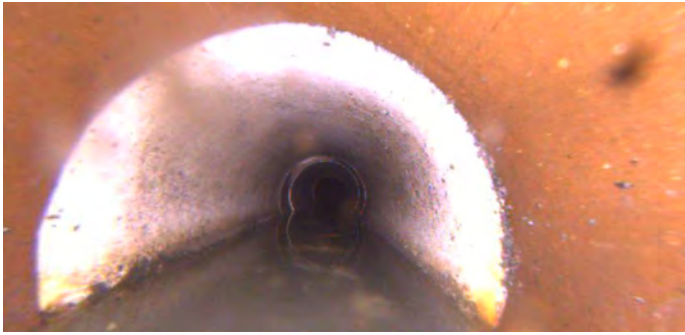
Code: **MMC**  
Description: **Material Change**

Distance (ft): **83.4**  
Structural Grade: **0**  
O&M Grade: **0**  
Clock Start/From:  
Clock To:  
1st Value:  
2nd Value:  
Value Percent:  
Continuous Index:  
Within 8" of Joint: **NO**  
Remarks: **pvc**

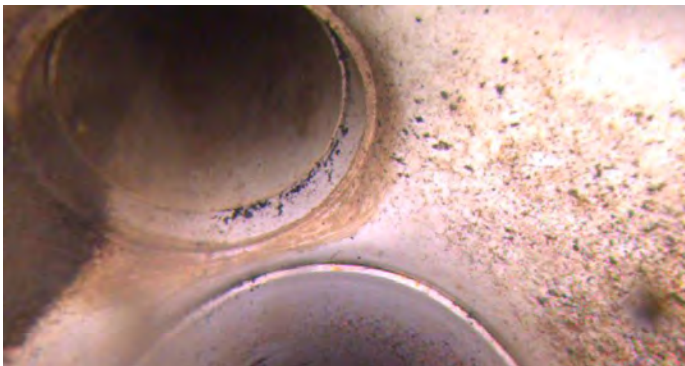
Code: **TF**  
Description: **Tap Factory**

Distance (ft): **86.2**  
Structural Grade: **0**  
O&M Grade: **0**  
Clock Start/From: **11**  
Clock To:  
1st Value: **4.000**  
2nd Value:  
Value Percent:  
Continuous Index:  
Within 8" of Joint:  
Remarks:

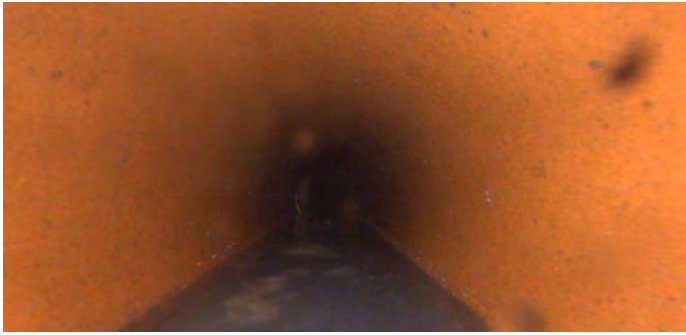
Code: **MMC**  
Description: **Material Change**

Distance (ft): **90.5**  
Structural Grade: **0**  
O&M Grade: **0**  
Clock Start/From:  
Clock To:  
1st Value:  
2nd Value:  
Value Percent:  
Continuous Index:  
Within 8" of Joint: **NO**  
Remarks: **VCP**

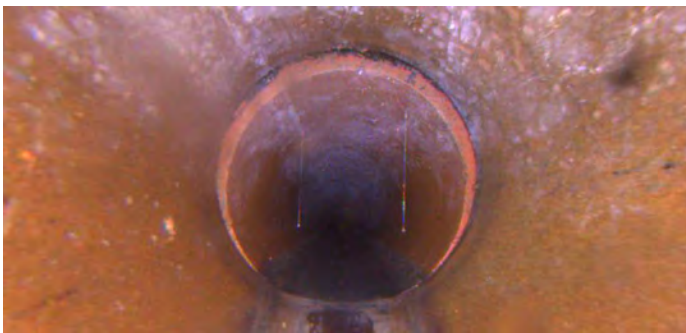
Code: **LU**  
Description: **Alignment Up**

Distance (ft): **105.5**  
Structural Grade: **0**  
O&M Grade: **1**  
Clock Start/From:  
Clock To:  
1st Value:  
2nd Value:  
Value Percent: **5.000**  
Continuous Index:  
Within 8" of Joint: **NO**  
Remarks:

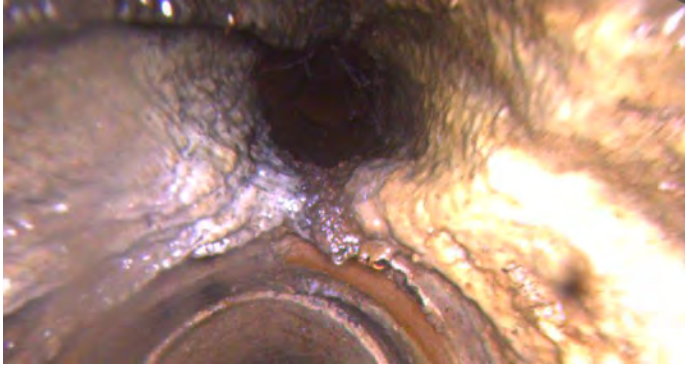
Code: **TFD**  
Description: **Tap Factory Defective**

Distance (ft): **119.4**  
Structural Grade: **0**  
O&M Grade: **2**  
Clock Start/From: **1**  
Clock To:  
1st Value: **4.000**  
2nd Value:  
Value Percent:  
Continuous Index:  
Within 8" of Joint:  
Remarks: **DAE**

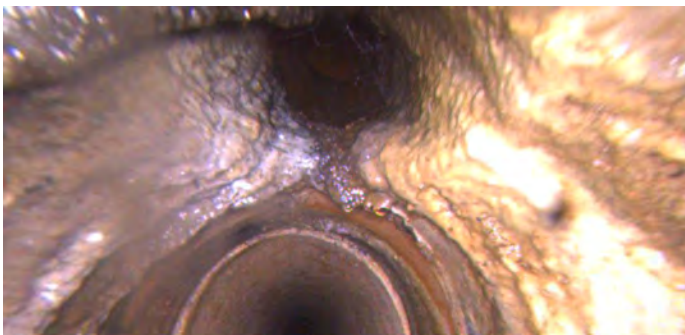
Code: **DAE**  
Description: **Deposits Attached Encrustation**

Distance (ft): **119.4**  
Structural Grade: **0**  
O&M Grade: **2**  
Clock Start/From: **8**  
Clock To: **4**  
1st Value:  
2nd Value:  
Value Percent: **10.000**  
Continuous Index:  
Within 8" of Joint: **NO**  
Remarks:

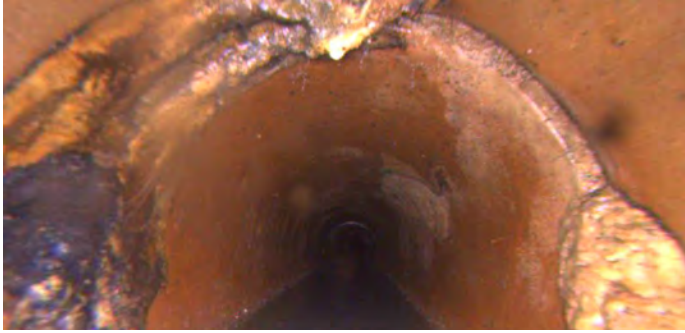
Code: ID  
Description: Infil Dripper

Distance (ft): 136.3  
Structural Grade: 0  
O&M Grade: 3  
Clock Start/From: 12  
Clock To:  
1st Value:  
2nd Value:  
Value Percent:  
Continuous Index:  
Within 8" of Joint: YES  
Remarks:

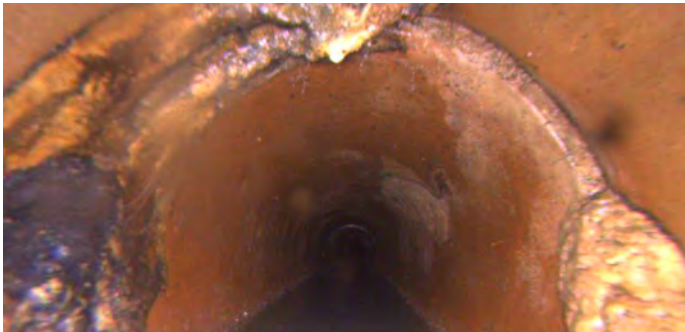
Code: DAE  
Description: Deposits Attached Encrustation

Distance (ft): 136.3  
Structural Grade: 0  
O&M Grade: 2  
Clock Start/From: 8  
Clock To: 4  
1st Value:  
2nd Value:  
Value Percent: 10.000  
Continuous Index:  
Within 8" of Joint: YES  
Remarks:

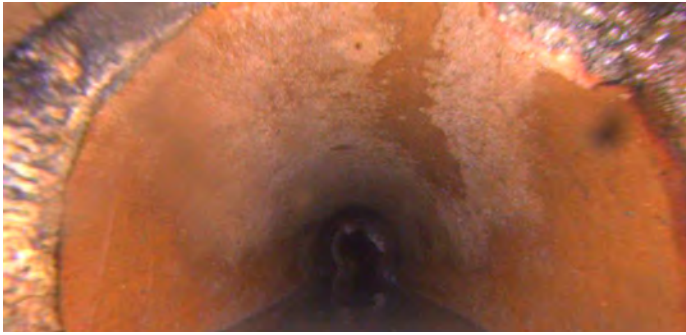
Code: **DAE**  
Description: **Deposits Attached Encrustation**

Distance (ft): **140.6**  
Structural Grade: **0**  
O&M Grade: **2**  
Clock Start/From: **8**  
Clock To: **4**  
1st Value:  
2nd Value:  
Value Percent: **5.000**  
Continuous Index:  
Within 8" of Joint: **YES**  
Remarks:

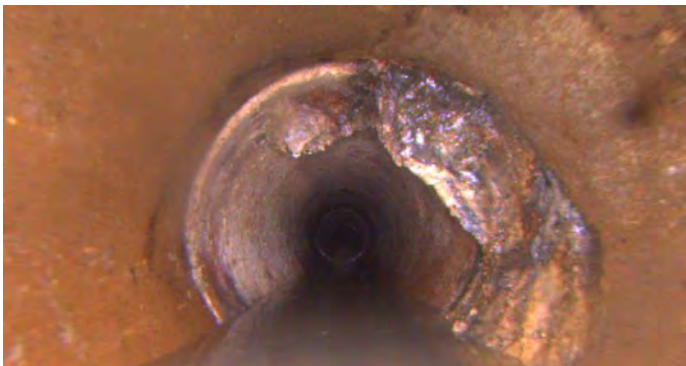
Code: **DAZ**  
Description: **Deposits Attached Other**

Distance (ft): **144.0**  
Structural Grade: **0**  
O&M Grade: **2**  
Clock Start/From: **10**  
Clock To: **5**  
1st Value:  
2nd Value:  
Value Percent: **5.000**  
Continuous Index:  
Within 8" of Joint: **YES**  
Remarks:

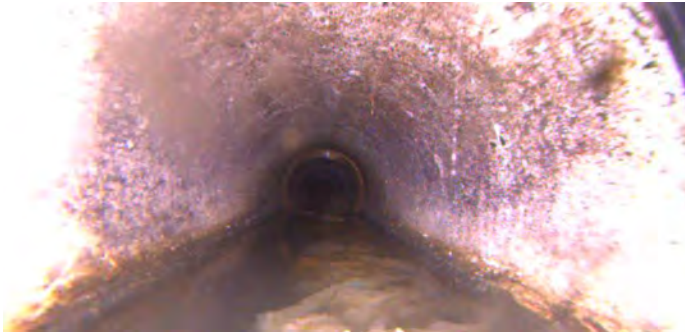
Code: **MMC**  
Description: **Material Change**

Distance (ft): **156.5**  
Structural Grade: **0**  
O&M Grade: **0**  
Clock Start/From:  
Clock To:  
1st Value:  
2nd Value:  
Value Percent:  
Continuous Index:  
Within 8" of Joint: **NO**  
Remarks: **pvc**

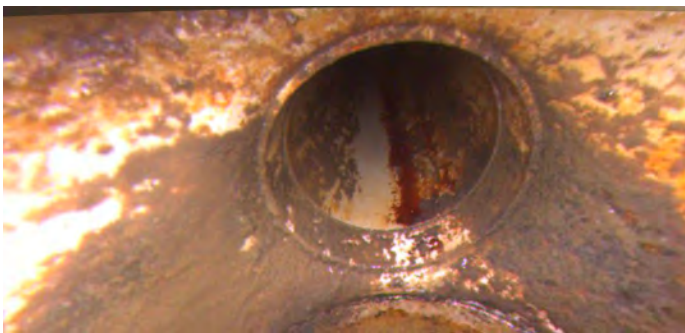
Code: **TF**  
Description: **Tap Factory**

Distance (ft): **159.5**  
Structural Grade: **0**  
O&M Grade: **0**  
Clock Start/From: **12**  
Clock To:  
1st Value: **4.000**  
2nd Value:  
Value Percent:  
Continuous Index:  
Within 8" of Joint:  
Remarks:

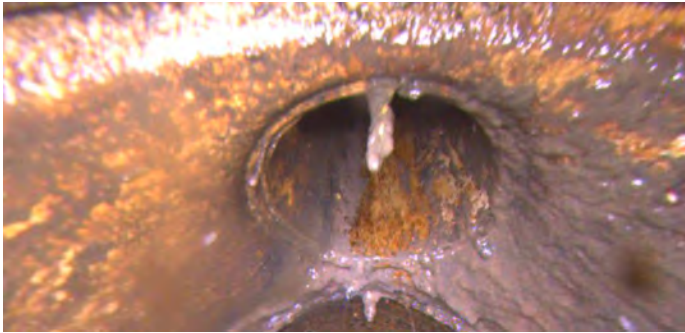
Code: **TF**  
Description: **Tap Factory**

Distance (ft): **162.1**  
Structural Grade: **0**  
O&M Grade: **0**  
Clock Start/From: **12**  
Clock To:  
1st Value: **4.000**  
2nd Value:  
Value Percent:  
Continuous Index:  
Within 8" of Joint:  
Remarks:

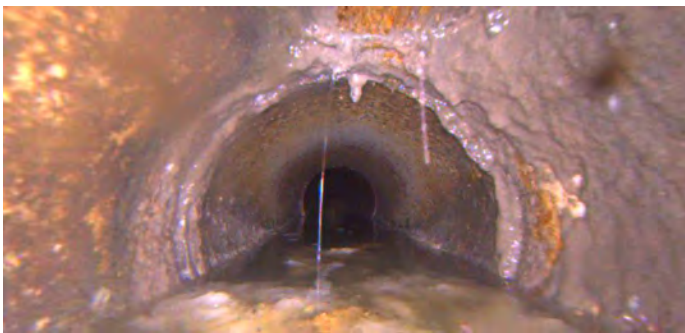
Code: **DAGS**  
Description: **Deposits Attached Grease**

Distance (ft): **162.2**  
Structural Grade: **0**  
O&M Grade: **2**  
Clock Start/From: **8**  
Clock To: **4**  
1st Value:  
2nd Value:  
Value Percent: **5.000**  
Continuous Index:  
Within 8" of Joint: **NO**  
Remarks:

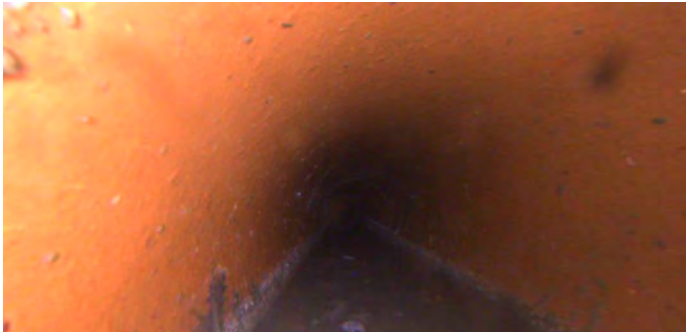
Code: **MMC**  
Description: **Material Change**

Distance (ft): **165.3**  
Structural Grade: **0**  
O&M Grade: **0**  
Clock Start/From:  
Clock To:  
1st Value:  
2nd Value:  
Value Percent:  
Continuous Index:  
Within 8" of Joint: **NO**  
Remarks: **VCP**

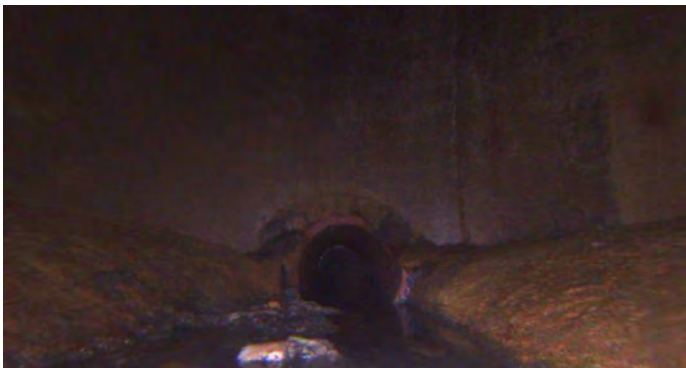
Code: **AMH**  
Description: **Manhole**

Distance (ft): **185.5**  
Structural Grade: **0**  
O&M Grade: **0**  
Clock Start/From:  
Clock To:  
1st Value:  
2nd Value:  
Value Percent:  
Continuous Index:  
Within 8" of Joint: **NO**  
Remarks: **M-506-023**
