Profile/Photo Observation Report

Date:	04/06/2018	Weather:		Coding:	PACP 6.0
Pipe Length (ft):	189.0	Owner:	NA	Pre Clean:	No Pre-Cleaning
P.O.#:		Surveyor:	Mark Ruby	PSR:	P-506-023-010
Customer:		Clean Date:	01/01/1900	Shape:	C

Street:	FOXCROFT STREET	Flow Control:	Not Controlled
City:	Hobart, IN	Year Renewed:	
Location:	Yard	Tape/Media #:	
Purpose:	Routine Assessment	Dia/Height:	10"
Use:	Sanitary	Material:	VCP
Drain Area:	NA	Lining:	
Category:	NA		
Comment:

Location Details:		Direction of Survey:	Upstream
US MH:	M-506-023	DS MH:	M-506-010
		Total Length Surveyed (ft):	185.5

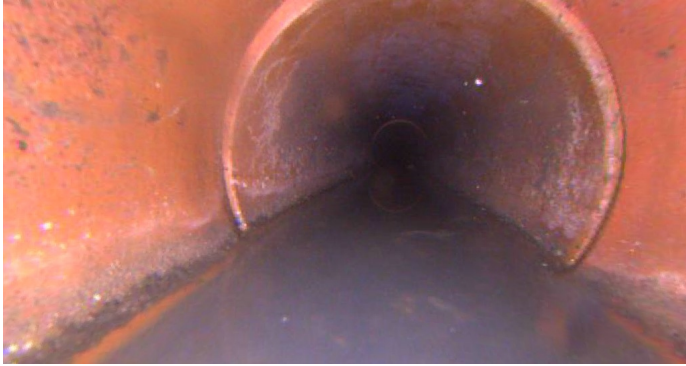
Code: **AMH**
Description: **Manhole**

Distance (ft): **.0**
Structural Grade: **0**
O&M Grade: **0**
Clock Start/From:
Clock To:
1st Value:
2nd Value:
Value Percent:
Continuous Index:
Within 8" of Joint: **NO**
Remarks: **M-506-010**

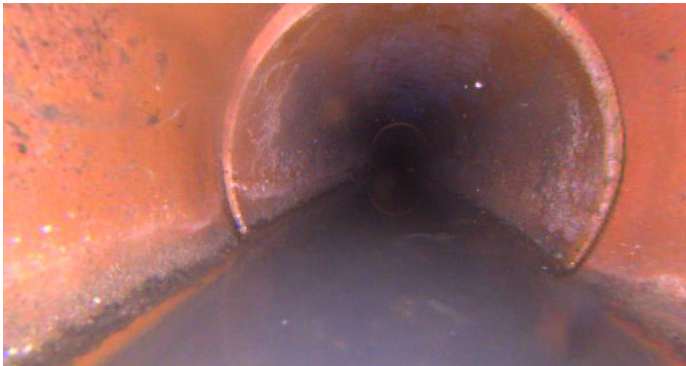
Code: **MWL**
Description: **Water Level**

Distance (ft): **.0**
Structural Grade: **0**
O&M Grade: **0**
Clock Start/From:
Clock To:
1st Value:
2nd Value:
Value Percent: **10.000**
Continuous Index:
Within 8" of Joint: **NO**
Remarks:

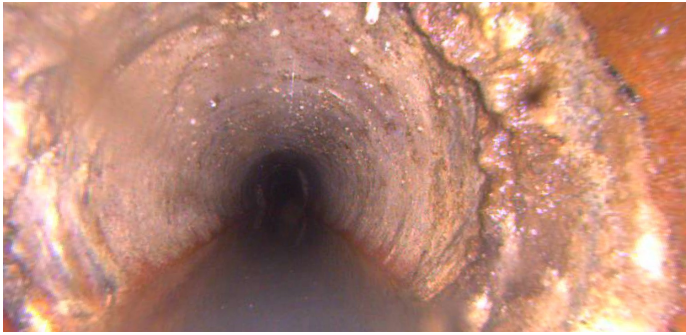
Code: **DAE**
Description: **Deposits Attached Encrustation**

Distance (ft): **37.5**
Structural Grade: **0**
O&M Grade: **2**
Clock Start/From: **8**
Clock To: **4**
1st Value:
2nd Value:
Value Percent: **10.000**
Continuous Index:
Within 8" of Joint: **YES**
Remarks:

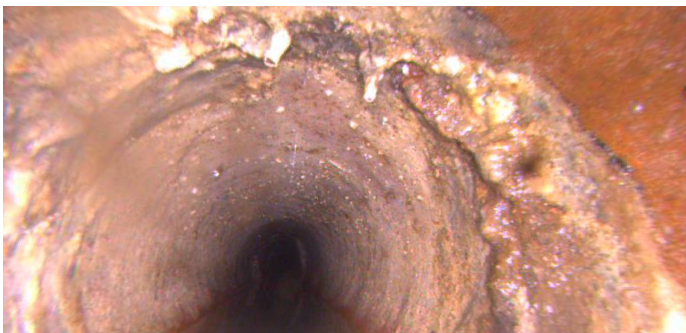
Code: **ID**
Description: **Infil Dripper**

Distance (ft): **37.5**
Structural Grade: **0**
O&M Grade: **3**
Clock Start/From: **12**
Clock To:
1st Value:
2nd Value:
Value Percent:
Continuous Index:
Within 8" of Joint: **YES**
Remarks:

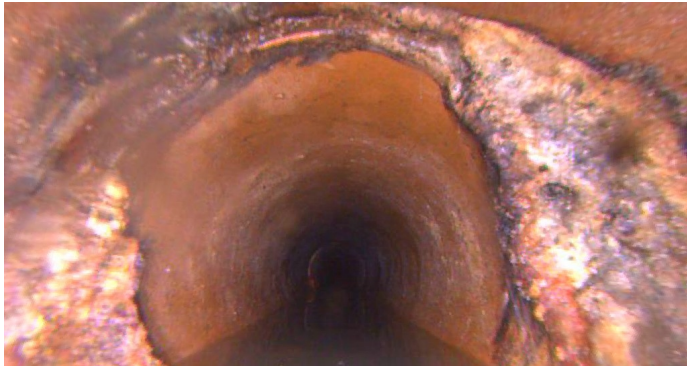
Code: **DAZ**
Description: **Deposits Attached Other**

Distance (ft): **41.6**
Structural Grade: **0**
O&M Grade: **2**
Clock Start/From: **7**
Clock To: **5**
1st Value:
2nd Value:
Value Percent: **5.000**
Continuous Index:
Within 8" of Joint: **YES**
Remarks:

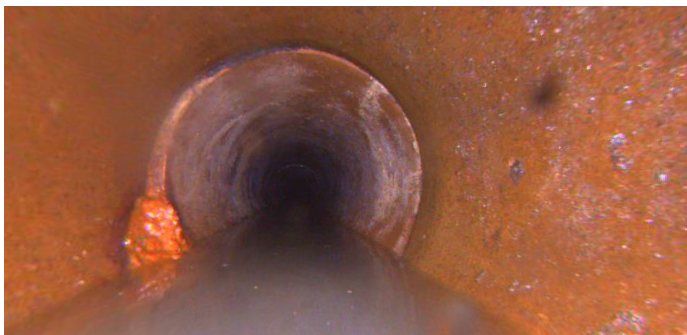
Code: **DAE**
Description: **Deposits Attached Encrustation**

Distance (ft): **45.2**
Structural Grade: **0**
O&M Grade: **2**
Clock Start/From: **8**
Clock To: **9**
1st Value:
2nd Value:
Value Percent: **5.000**
Continuous Index:
Within 8" of Joint: **YES**
Remarks:

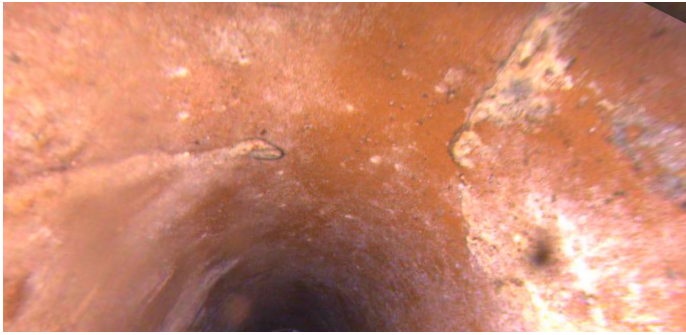
Code: **FL**
Description: **Fracture Longitudinal**

Distance (ft): **46.0**
Structural Grade: **3**
O&M Grade: **0**
Clock Start/From: **1**
Clock To:
1st Value:
2nd Value:
Value Percent:
Continuous Index:
Within 8" of Joint: **YES**
Remarks:

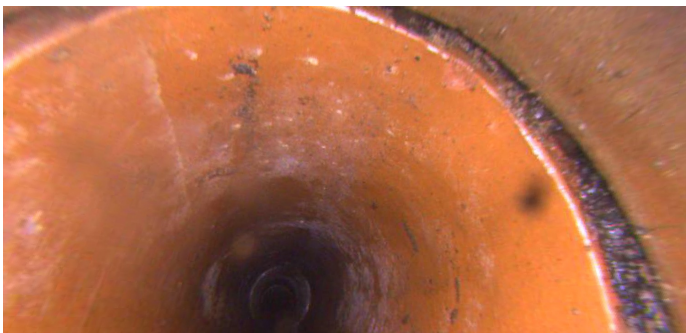
Code: **CL**
Description: **Crack Longitudinal**

Distance (ft): **53.8**
Structural Grade: **2**
O&M Grade: **0**
Clock Start/From: **11**
Clock To:
1st Value:
2nd Value:
Value Percent:
Continuous Index:
Within 8" of Joint: **YES**
Remarks:

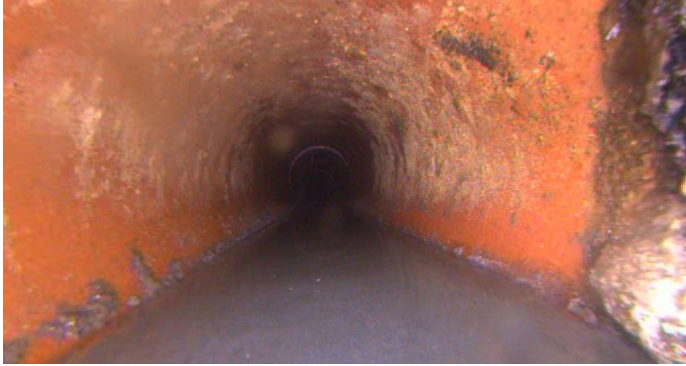
Code:	DAZ
Description:	Deposits Attached Other
Distance (ft):	65.9
Structural Grade:	0
O&M Grade:	2
Clock Start/From:	4
Clock To:	5
1st Value:	
2nd Value:	
Value Percent:	5.000
Continuous Index:	
Within 8" of Joint:	YES
Remarks:

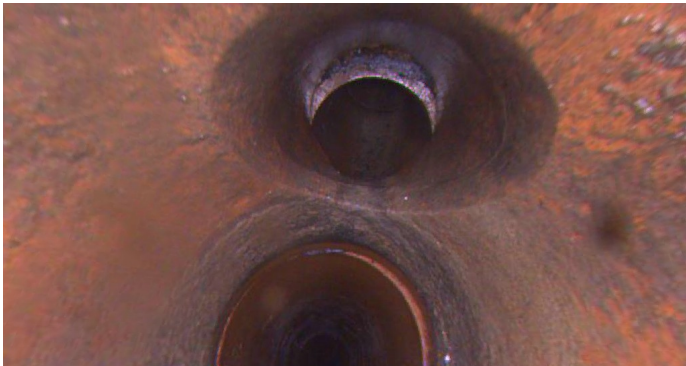
Code:	TF
Description:	Tap Factory
Distance (ft):	74.7
Structural Grade:	0
O&M Grade:	0
Clock Start/From:	1
Clock To:	
1st Value:	4.000
2nd Value:	
Value Percent:	
Continuous Index:	
Within 8" of Joint:	
Remarks:

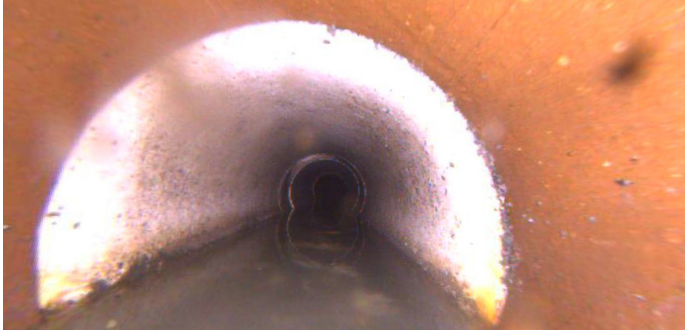
Code: **MMC**
Description: **Material Change**

Distance (ft): **83.4**
Structural Grade: **0**
O&M Grade: **0**
Clock Start/From:
Clock To:
1st Value:
2nd Value:
Value Percent:
Continuous Index:
Within 8" of Joint: **NO**
Remarks: **pvc**

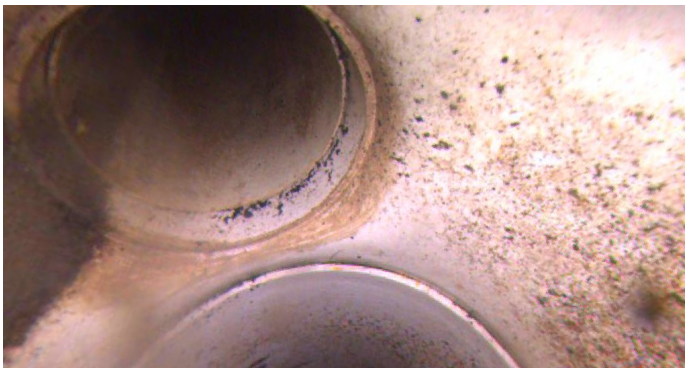
Code: **TF**
Description: **Tap Factory**

Distance (ft): **86.2**
Structural Grade: **0**
O&M Grade: **0**
Clock Start/From: **11**
Clock To:
1st Value: **4.000**
2nd Value:
Value Percent:
Continuous Index:
Within 8" of Joint:
Remarks:

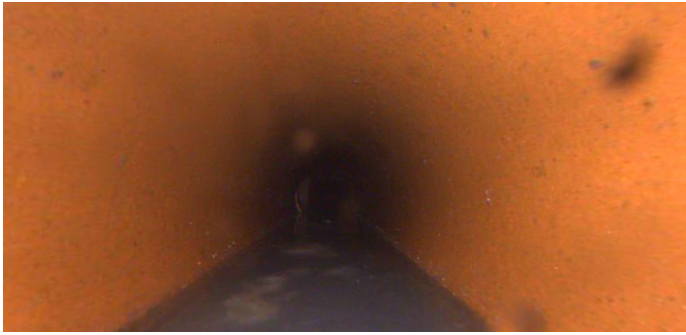
Code: **MMC**
Description: **Material Change**

Distance (ft): **90.5**
Structural Grade: **0**
O&M Grade: **0**
Clock Start/From:
Clock To:
1st Value:
2nd Value:
Value Percent:
Continuous Index:
Within 8" of Joint: **NO**
Remarks: **VCP**

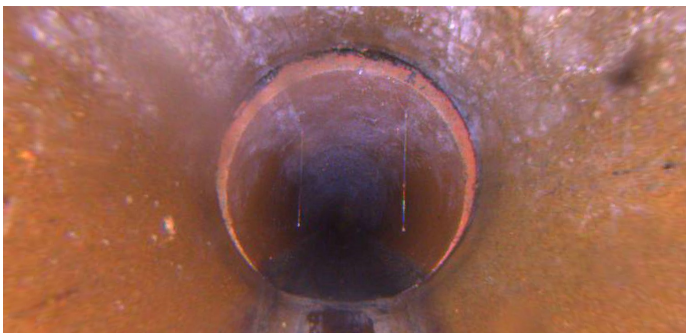
Code: **LU**
Description: **Alignment Up**

Distance (ft): **105.5**
Structural Grade: **0**
O&M Grade: **1**
Clock Start/From:
Clock To:
1st Value:
2nd Value:
Value Percent: **5.000**
Continuous Index:
Within 8" of Joint: **NO**
Remarks:

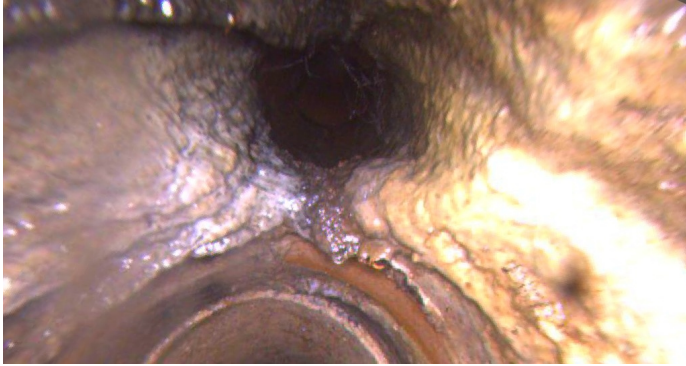
Code: **TFD**
Description: **Tap Factory Defective**

Distance (ft): **119.4**
Structural Grade: **0**
O&M Grade: **2**
Clock Start/From: **1**
Clock To:
1st Value: **4.000**
2nd Value:
Value Percent:
Continuous Index:
Within 8" of Joint:
Remarks: **DAE**

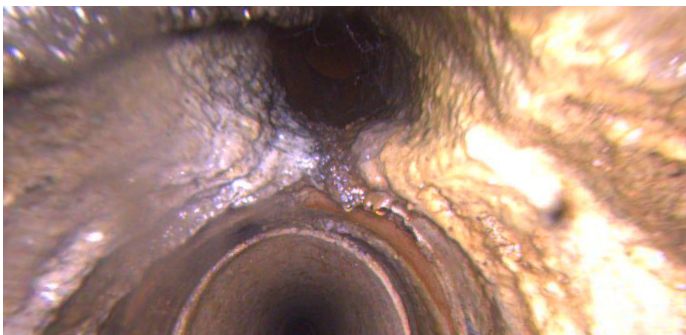
Code: **DAE**
Description: **Deposits Attached Encrustation**

Distance (ft): **119.4**
Structural Grade: **0**
O&M Grade: **2**
Clock Start/From: **8**
Clock To: **4**
1st Value:
2nd Value:
Value Percent: **10.000**
Continuous Index:
Within 8" of Joint: **NO**
Remarks:

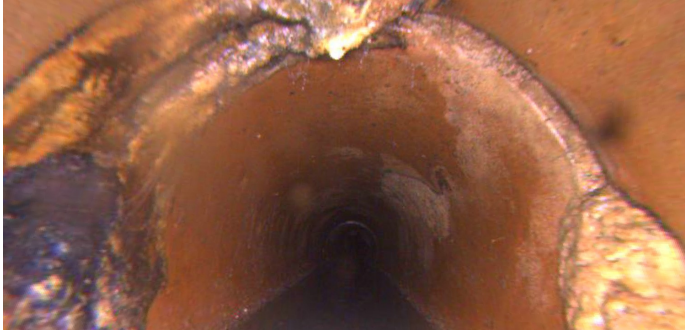
Code: ID
Description: Infil Dripper

Distance (ft): 136.3
Structural Grade: 0
O&M Grade: 3
Clock Start/From: 12
Clock To:
1st Value:
2nd Value:
Value Percent:
Continuous Index:
Within 8" of Joint: YES
Remarks:

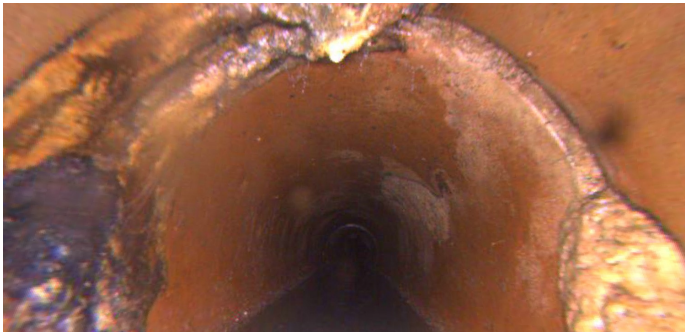
Code: DAE
Description: Deposits Attached Encrustation

Distance (ft): 136.3
Structural Grade: 0
O&M Grade: 2
Clock Start/From: 8
Clock To: 4
1st Value:
2nd Value:
Value Percent: 10.000
Continuous Index:
Within 8" of Joint: YES
Remarks:

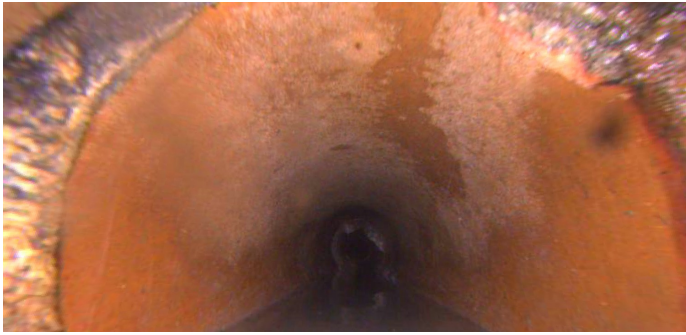
Code: **DAE**
Description: **Deposits Attached Encrustation**

Distance (ft): **140.6**
Structural Grade: **0**
O&M Grade: **2**
Clock Start/From: **8**
Clock To: **4**
1st Value:
2nd Value:
Value Percent: **5.000**
Continuous Index:
Within 8" of Joint: **YES**
Remarks:

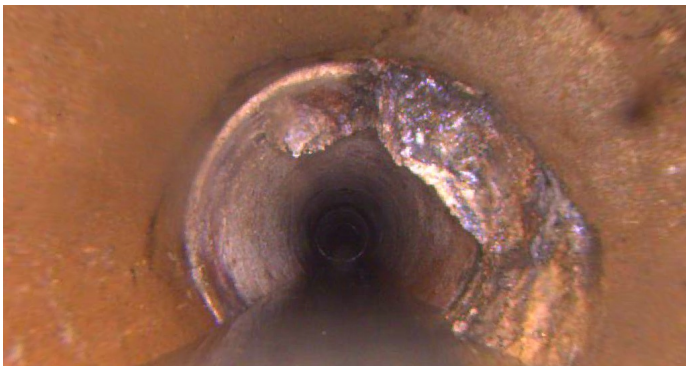
Code: **DAZ**
Description: **Deposits Attached Other**

Distance (ft): **144.0**
Structural Grade: **0**
O&M Grade: **2**
Clock Start/From: **10**
Clock To: **5**
1st Value:
2nd Value:
Value Percent: **5.000**
Continuous Index:
Within 8" of Joint: **YES**
Remarks:

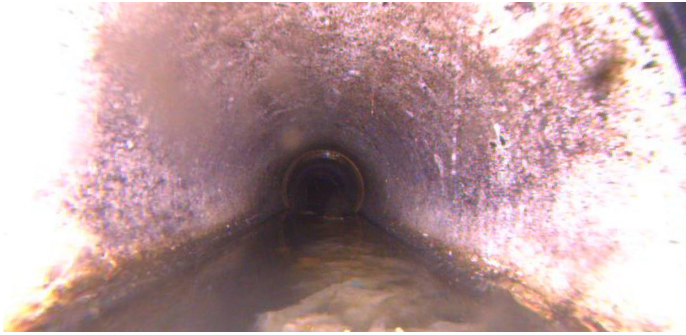
Code: **MMC**
Description: **Material Change**

Distance (ft): **156.5**
Structural Grade: **0**
O&M Grade: **0**
Clock Start/From:
Clock To:
1st Value:
2nd Value:
Value Percent:
Continuous Index:
Within 8" of Joint: **NO**
Remarks: **pvc**

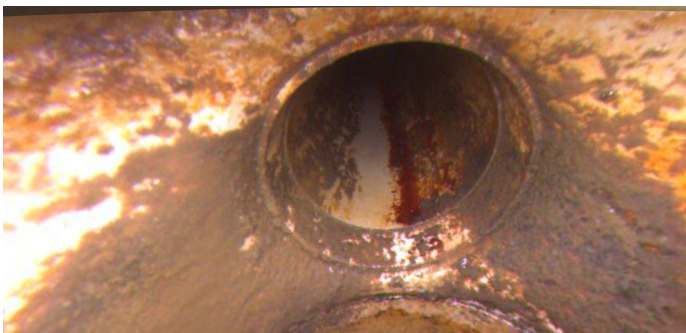
Code: **TF**
Description: **Tap Factory**

Distance (ft): **159.5**
Structural Grade: **0**
O&M Grade: **0**
Clock Start/From: **12**
Clock To:
1st Value: **4.000**
2nd Value:
Value Percent:
Continuous Index:
Within 8" of Joint:
Remarks:

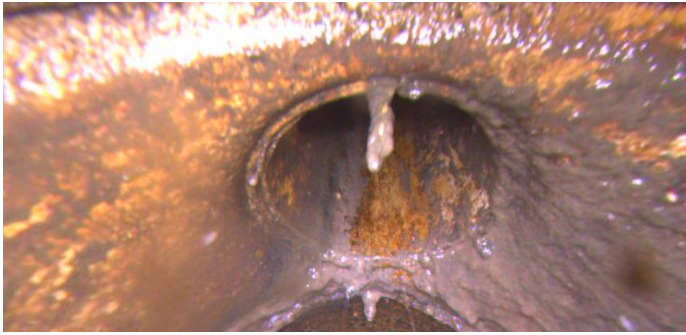
Code: **TF**
Description: **Tap Factory**

Distance (ft): **162.1**
Structural Grade: **0**
O&M Grade: **0**
Clock Start/From: **12**
Clock To:
1st Value: **4.000**
2nd Value:
Value Percent:
Continuous Index:
Within 8" of Joint:
Remarks:

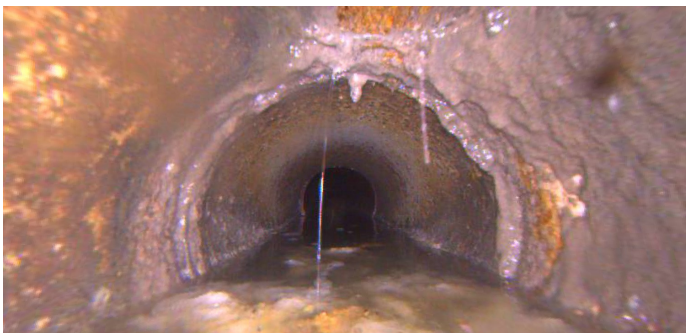
Code: **DAGS**
Description: **Deposits Attached Grease**

Distance (ft): **162.2**
Structural Grade: **0**
O&M Grade: **2**
Clock Start/From: **8**
Clock To: **4**
1st Value:
2nd Value:
Value Percent: **5.000**
Continuous Index:
Within 8" of Joint: **NO**
Remarks:

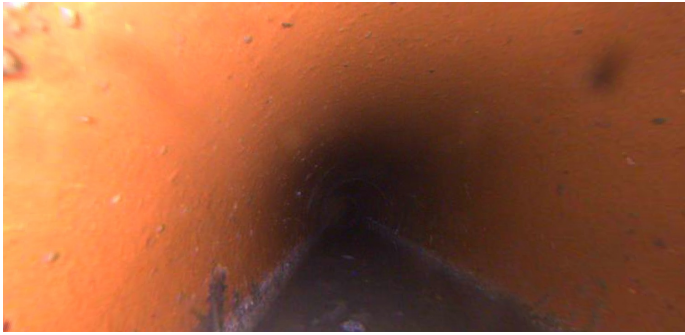
Code: **MMC**
Description: **Material Change**

Distance (ft): **165.3**
Structural Grade: **0**
O&M Grade: **0**
Clock Start/From:
Clock To:
1st Value:
2nd Value:
Value Percent:
Continuous Index:
Within 8" of Joint: **NO**
Remarks: **VCP**

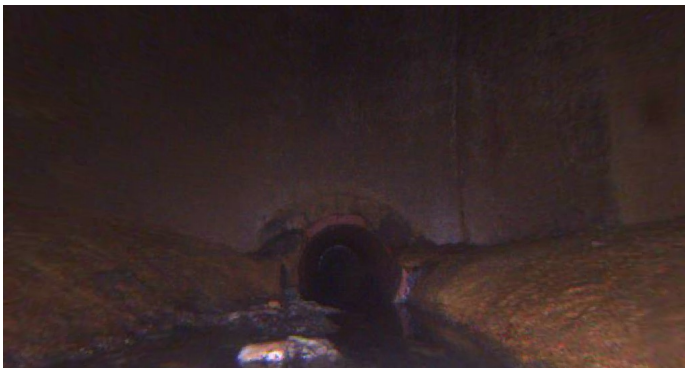
Code: **AMH**
Description: **Manhole**

Distance (ft): **185.5**
Structural Grade: **0**
O&M Grade: **0**
Clock Start/From:
Clock To:
1st Value:
2nd Value:
Value Percent:
Continuous Index:
Within 8" of Joint: **NO**
Remarks: **M-506-023**
