## Profile/Photo Observation Report

Date:	<b>04/06/2018</b>	Weather:		Coding:	<b>PACP 6.0</b>
Pipe Length (ft):	<b>190.4</b>	Owner:	<b>NA</b>	Pre Clean:	<b>No Pre-Cleaning</b>
P.O.#:		Surveyor:	<b>Mark Ruby</b>	PSR:	<b>P-506-024-023</b>
Customer:		Clean Date:	<b>01/01/1900</b>	Shape:	<b>C</b>

Street:	<b>RIVER TERR</b>	Flow Control:	<b>Not Controlled</b>
City:	<b>Hobart, IN</b>	Year Renewed:	
Location:	<b>Yard</b>	Tape/Media #:	
Purpose:	<b>Routine Assessment</b>	Dia/Height:	<b>10"</b>
Use:	<b>Sanitary</b>	Material:	<b>VCP</b>
Drain Area:	<b>NA</b>	Lining:	
Category:	<b>NA</b>		
Comment:			
Location Details:		Direction of Survey:	<b>Downstream</b>
US MH:	<b>M-506-024</b>	DS MH:	<b>M-506-023</b>
		Total Length Surveyed (ft):	<b>110.0</b>

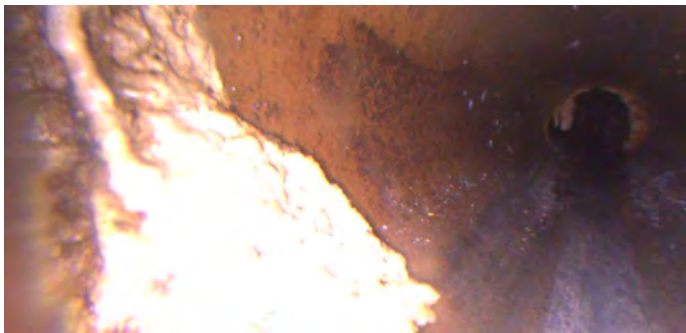
Code: **DAGS**  
Description: **Deposits Attached Grease**

Distance (ft): **.0**  
Structural Grade: **0**  
O&M Grade: **2**  
Clock Start/From: **7**  
Clock To: **9**  
1st Value:  
2nd Value:  
Value Percent: **10.000**  
Continuous Index:  
Within 8" of Joint: **NO**  
Remarks:

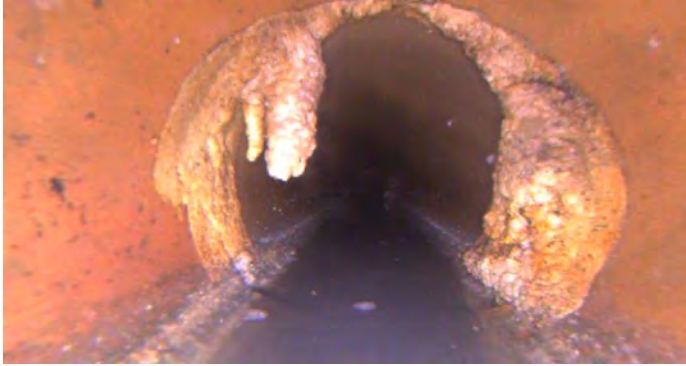
Code: **DAGS**  
Description: **Deposits Attached Grease**

Distance (ft): **4.2**  
Structural Grade: **0**  
O&M Grade: **2**  
Clock Start/From: **7**  
Clock To: **5**  
1st Value:  
2nd Value:  
Value Percent: **5.000**  
Continuous Index: **S01**  
Within 8" of Joint: **NO**  
Remarks:

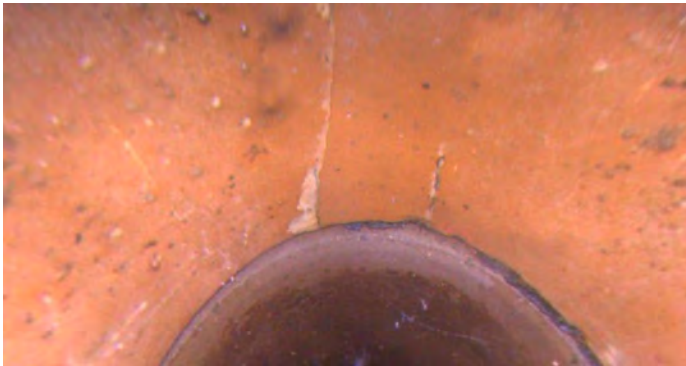
Code: **CL**  
Description: **Crack Longitudinal**

Distance (ft): **24.0**  
Structural Grade: **2**  
O&M Grade: **0**  
Clock Start/From: **10**  
Clock To:  
1st Value:  
2nd Value:  
Value Percent:  
Continuous Index:  
Within 8" of Joint:  
Remarks:

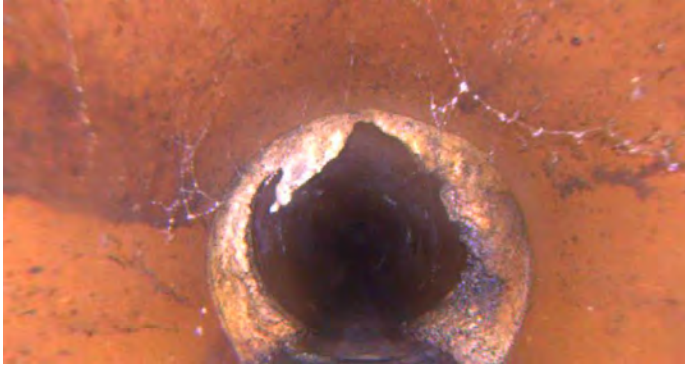
Code: **DAGS**  
Description: **Deposits Attached Grease**

Distance (ft): **27.7**  
Structural Grade: **0**  
O&M Grade: **2**  
Clock Start/From: **7**  
Clock To: **5**  
1st Value:  
2nd Value:  
Value Percent: **5.000**  
Continuous Index: **F01**  
Within 8" of Joint: **NO**  
Remarks:

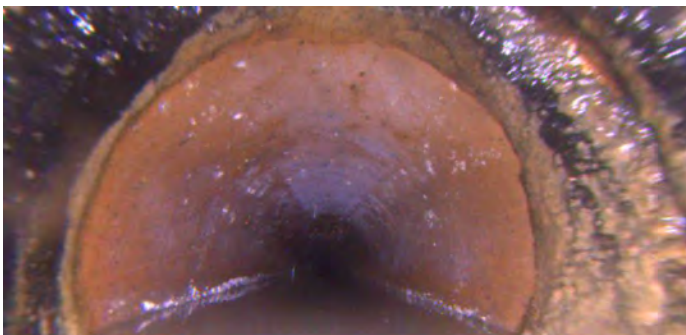
Code: **DAE**  
Description: **Deposits Attached Encrustation**

Distance (ft): **48.3**  
Structural Grade: **0**  
O&M Grade: **2**  
Clock Start/From: **8**  
Clock To: **4**  
1st Value:  
2nd Value:  
Value Percent: **5.000**  
Continuous Index:  
Within 8" of Joint: **YES**  
Remarks:

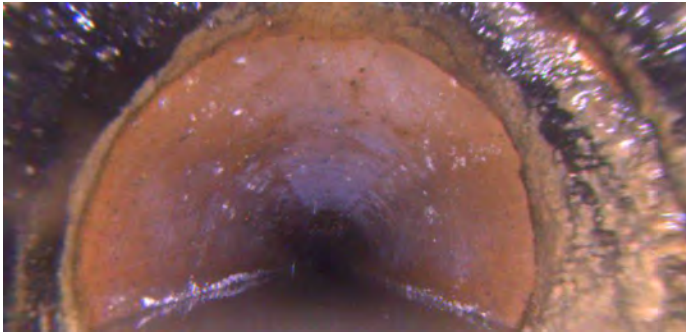
Code: **IW**  
Description: **Infil Weeper**

Distance (ft): **48.3**  
Structural Grade: **0**  
O&M Grade: **2**  
Clock Start/From: **8**  
Clock To: **4**  
1st Value:  
2nd Value:  
Value Percent:  
Continuous Index:  
Within 8" of Joint: **YES**  
Remarks:

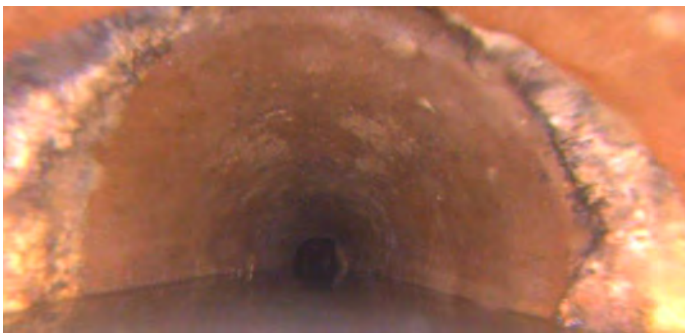
Code: **DAE**  
Description: **Deposits Attached Encrustation**

Distance (ft): **72.1**  
Structural Grade: **0**  
O&M Grade: **2**  
Clock Start/From: **8**  
Clock To: **4**  
1st Value:  
2nd Value:  
Value Percent: **5.000**  
Continuous Index:  
Within 8" of Joint: **YES**  
Remarks:

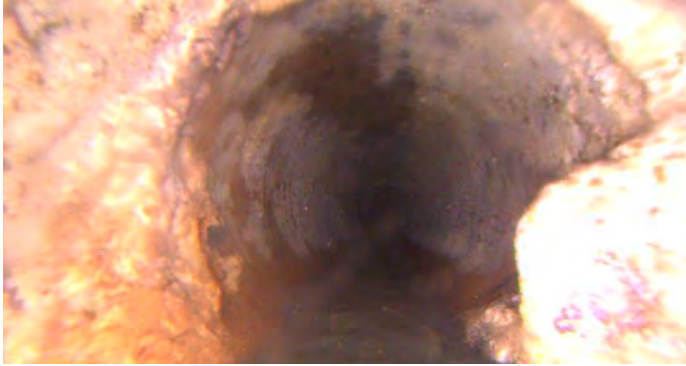
Code:	<b>DAGS</b>
Description:	<b>Deposits Attached Grease</b>
Distance (ft):	<b>91.8</b>
Structural Grade:	<b>0</b>
O&M Grade:	<b>2</b>
Clock Start/From:	<b>7</b>
Clock To:	<b>5</b>
1st Value:	
2nd Value:	
Value Percent:	<b>5.000</b>
Continuous Index:	
Within 8" of Joint:	<b>YES</b>
Remarks:

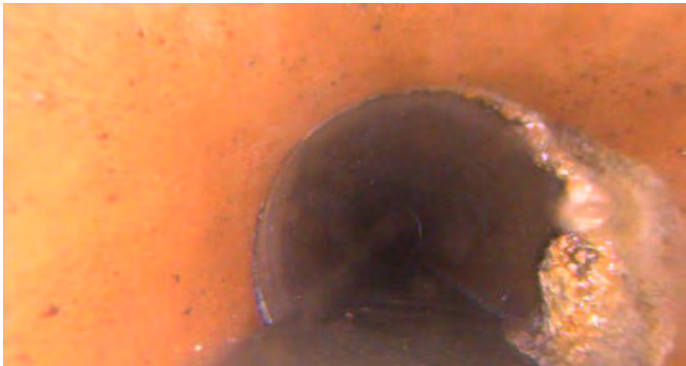
Code:	<b>DAGS</b>
Description:	<b>Deposits Attached Grease</b>
Distance (ft):	<b>103.6</b>
Structural Grade:	<b>0</b>
O&M Grade:	<b>2</b>
Clock Start/From:	<b>12</b>
Clock To:	<b>5</b>
1st Value:	
2nd Value:	
Value Percent:	<b>5.000</b>
Continuous Index:	
Within 8" of Joint:	<b>NO</b>
Remarks:

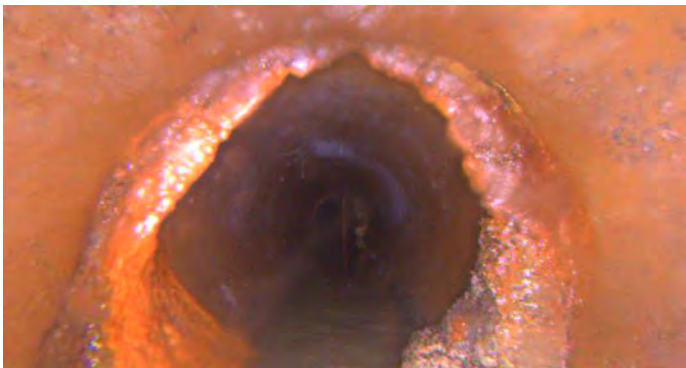
Code: **DAGS**  
Description: **Deposits Attached Grease**

Distance (ft): **110.0**  
Structural Grade: **0**  
O&M Grade: **2**  
Clock Start/From: **7**  
Clock To: **5**  
1st Value:  
2nd Value:  
Value Percent: **5.000**  
Continuous Index:  
Within 8" of Joint: **YES**  
Remarks:

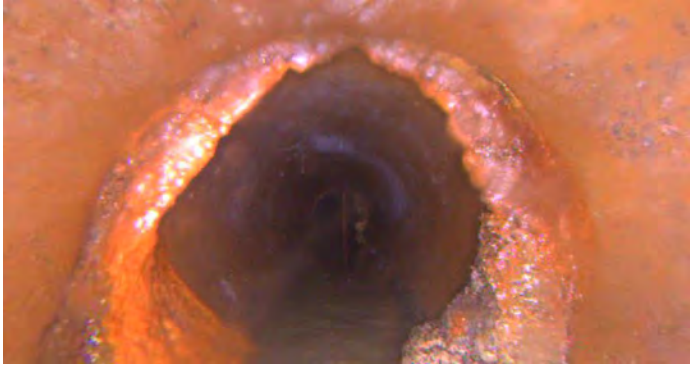
Code:	MSA
Description:	Abandoned Survey
Distance (ft):	110.0
Structural Grade:	0
O&M Grade:	0
Clock Start/From:	
Clock To:	
1st Value:	
2nd Value:	
Value Percent:	
Continuous Index:	
Within 8" of Joint:	NO
Remarks:	Debris
