Profile/Photo Observation Report

Date:	01/18/2022	Weather:		Coding:	PACP 7.0
Pipe Length (ft):	189.5	Owner:	City of Hobart	Pre Clean:	Heavy Cleaning
P.O.#:	YES502259	Surveyor:	S. Bucklin	PSR:	P-506-024-023
Customer:	City of Hobart	Clean Date:	01/16/2021	Shape:	C

Street:	River Terrace	Flow Control:	Not Controlled
City:	Hobart, IN	Year Renewed:	
Location:	Alley	Tape/Media #:	
Purpose:	Routine Assessment	Dia/Height:	10"
Use:	Sanitary Sewage Pipe	Material:	VCP
Drain Area:		Lining:	None
Category:	NA		
Comment:			
Location Details:		Direction of Survey:	Downstream
US MH:	M-506-024	DS MH:	M-506-023
		Total Length Surveyed (ft):	189.5

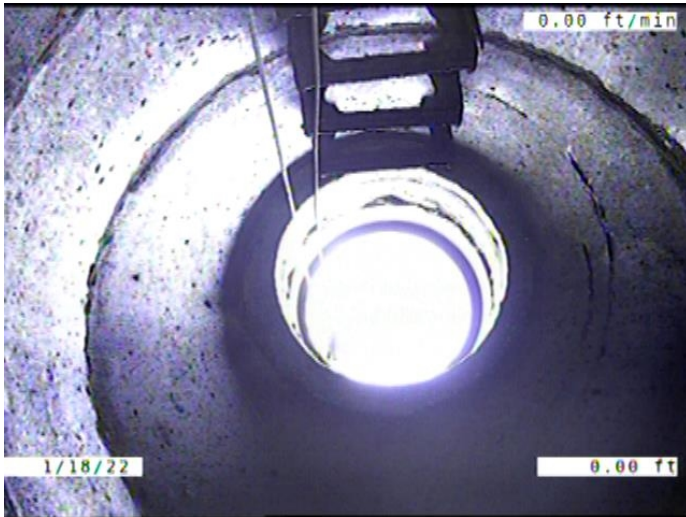
Code: **AMH**
 Description: **Manhole**

Distance (ft): **.0**
 Structural Grade: **0**
 O&M Grade: **0**
 Clock Start/From:
 Clock To:
 1st Value:
 2nd Value:
 Value Percent:
 Continuous Index:
 Within 8" of Joint: **NO**
 Remarks: **M-506-024**

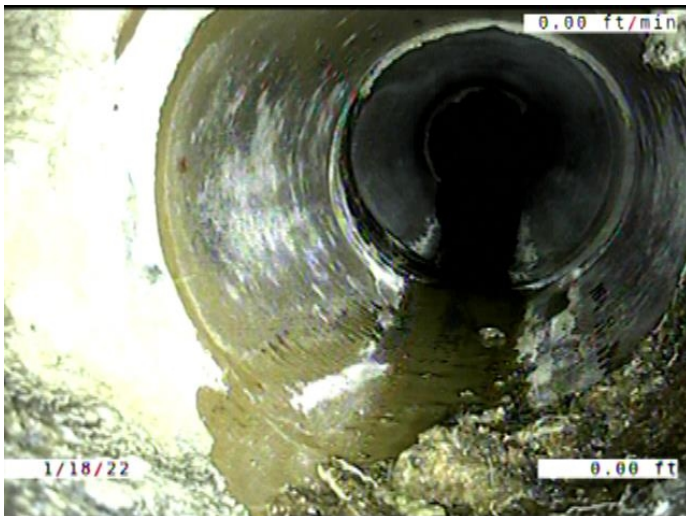
Code: **MWL**
 Description: **Miscellaneous Water Level**

Distance (ft): **.0**
 Structural Grade: **0**
 O&M Grade: **0**
 Clock Start/From:
 Clock To:
 1st Value:
 2nd Value:
 Value Percent: **5.000**
 Continuous Index:
 Within 8" of Joint: **NO**
 Remarks:

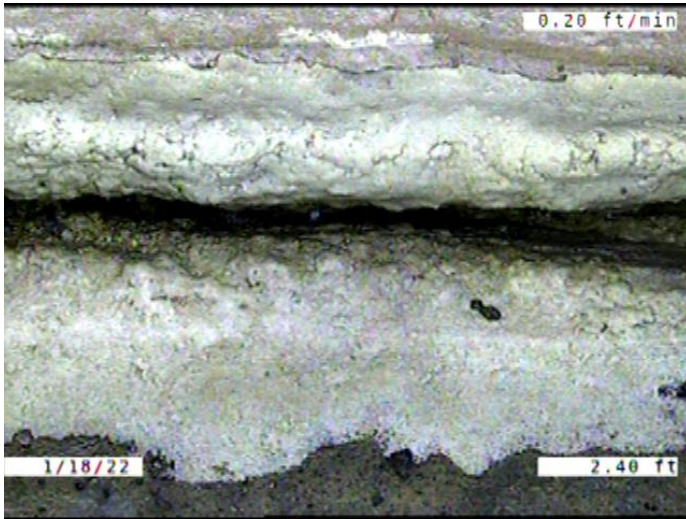
Code: **DAE**
Description: **Deposits Attached Encrustation**

Distance (ft): **2.4**
Structural Grade: **0**
O&M Grade: **2**
Clock Start/From: **7**
Clock To: **5**
1st Value:
2nd Value:
Value Percent: **5.000**
Continuous Index: **S01**
Within 8" of Joint: **YES**
Remarks:

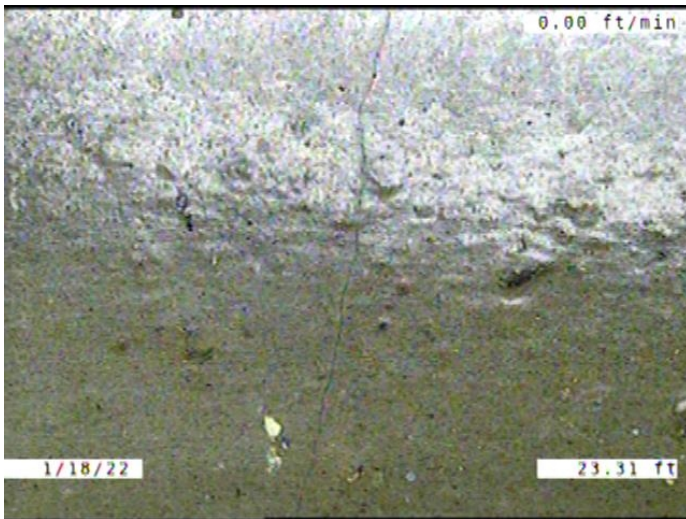
Code: **CS**
Description: **Crack Spiral**

Distance (ft): **23.3**
Structural Grade: **2**
O&M Grade: **0**
Clock Start/From: **11**
Clock To: **1**
1st Value:
2nd Value:
Value Percent:
Continuous Index:
Within 8" of Joint: **YES**
Remarks:

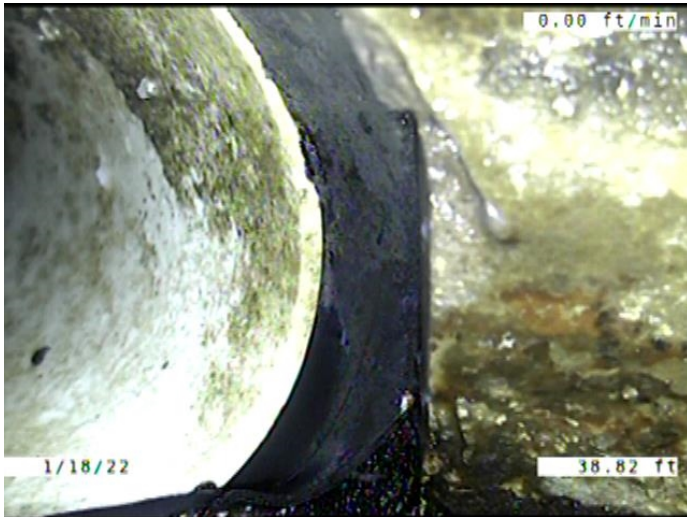
Code: **B**
 Description: **Broken**

Distance (ft): **38.8**
 Structural Grade: **4**
 O&M Grade: **0**
 Clock Start/From: **11**
 Clock To: **1**
 1st Value:
 2nd Value:
 Value Percent:
 Continuous Index:
 Within 8" of Joint: **YES**
 Remarks:

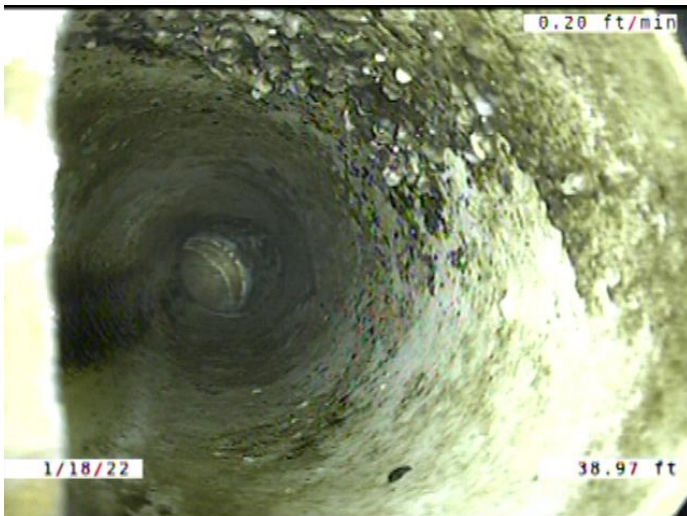
Code: **TB**
 Description: **Tap Break-in/Hammer**

Distance (ft): **39.0**
 Structural Grade: **0**
 O&M Grade: **0**
 Clock Start/From: **11**
 Clock To:
 1st Value: **4.000**
 2nd Value:
 Value Percent:
 Continuous Index:
 Within 8" of Joint: **YES**
 Remarks:

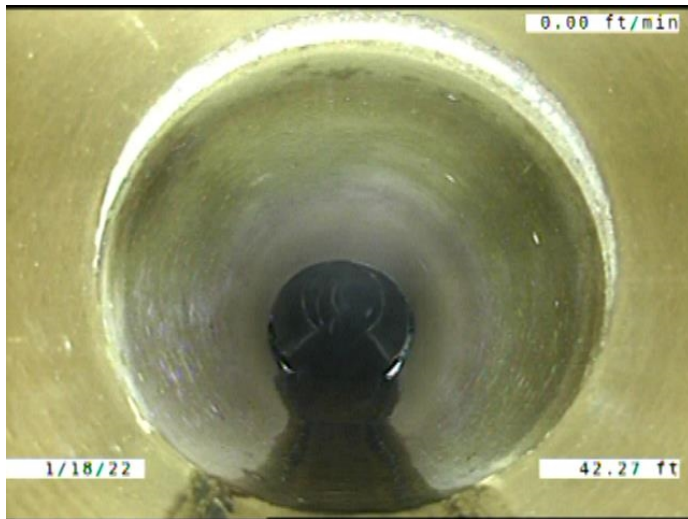
Code: **LD**
 Description: **Line Down**

Distance (ft): **42.3**
 Structural Grade: **0**
 O&M Grade: **1**
 Clock Start/From:
 Clock To:
 1st Value:
 2nd Value:
 Value Percent: **5.000**
 Continuous Index:
 Within 8" of Joint: **NO**
 Remarks:

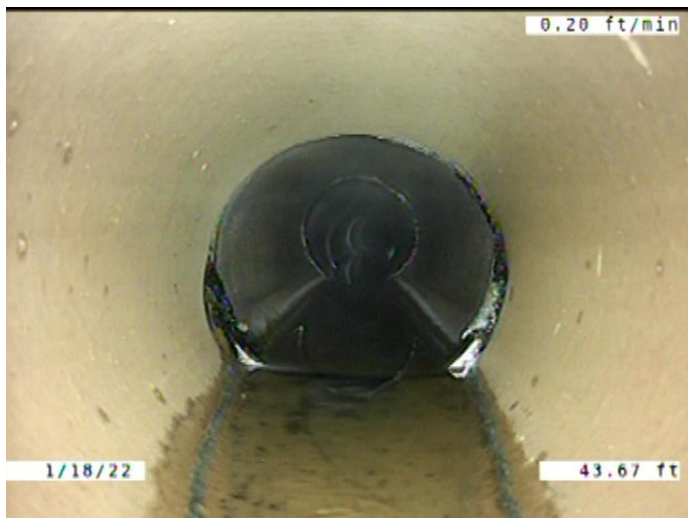
Code: **MWLS**
 Description: **Miscellaneous Water Level Sag**

Distance (ft): **43.6**
 Structural Grade: **2**
 O&M Grade: **0**
 Clock Start/From:
 Clock To:
 1st Value:
 2nd Value:
 Value Percent: **5.000**
 Continuous Index: **S02**
 Within 8" of Joint: **NO**
 Remarks:

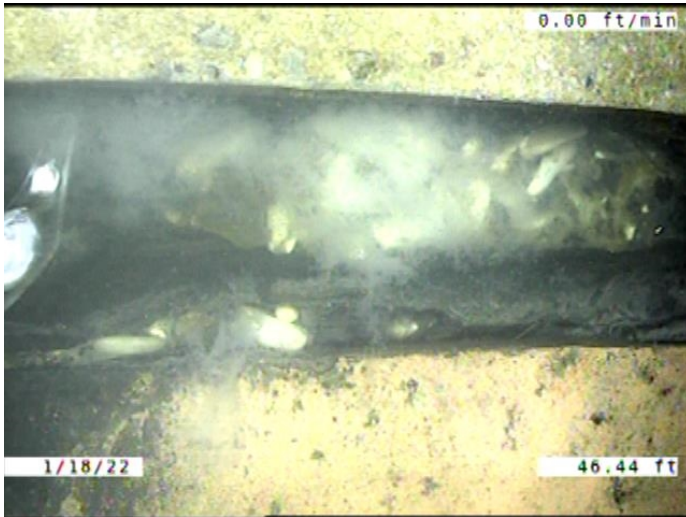
Code: **JAM**
Description: **Joint Angular Medium**

Distance (ft): **46.4**
Structural Grade: **3**
O&M Grade: **0**
Clock Start/From:
Clock To:
1st Value:
2nd Value:
Value Percent:
Continuous Index:
Within 8" of Joint: **NO**
Remarks:

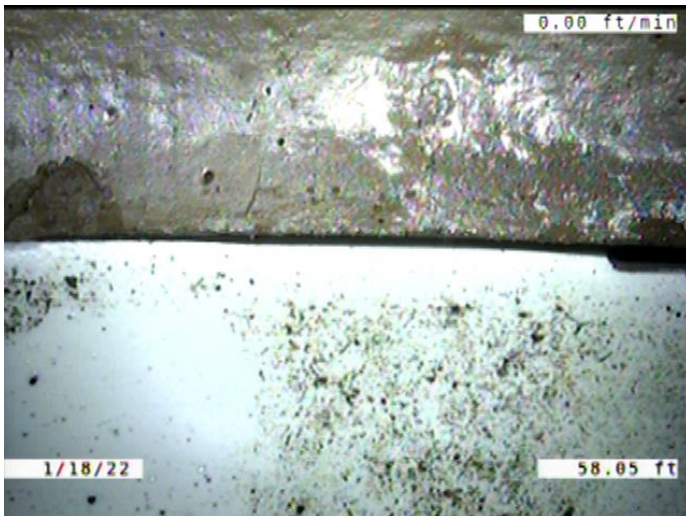
Code: **MMC**
Description: **Miscellaneous Material Change**

Distance (ft): **58.0**
Structural Grade: **0**
O&M Grade: **0**
Clock Start/From:
Clock To:
1st Value:
2nd Value:
Value Percent:
Continuous Index:
Within 8" of Joint: **NO**
Remarks: **VCP TO PVC**

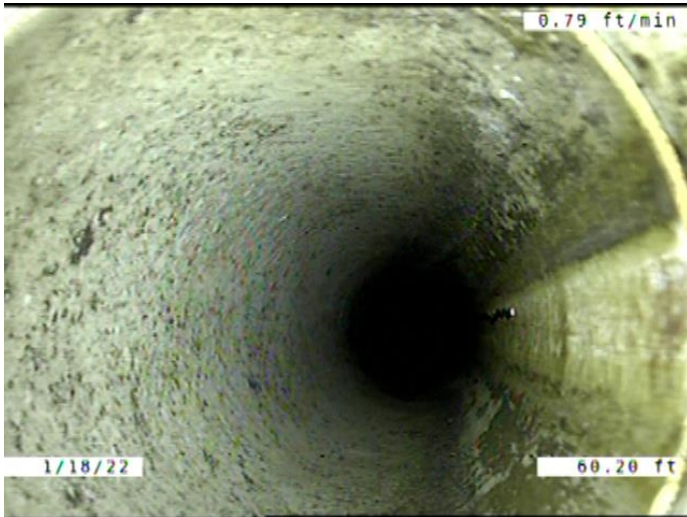
Code: **TF**
Description: **Tap Factory**

Distance (ft): **60.2**
Structural Grade: **0**
O&M Grade: **0**
Clock Start/From: **1**
Clock To:
1st Value: **4.000**
2nd Value:
Value Percent:
Continuous Index:
Within 8" of Joint: **YES**
Remarks:

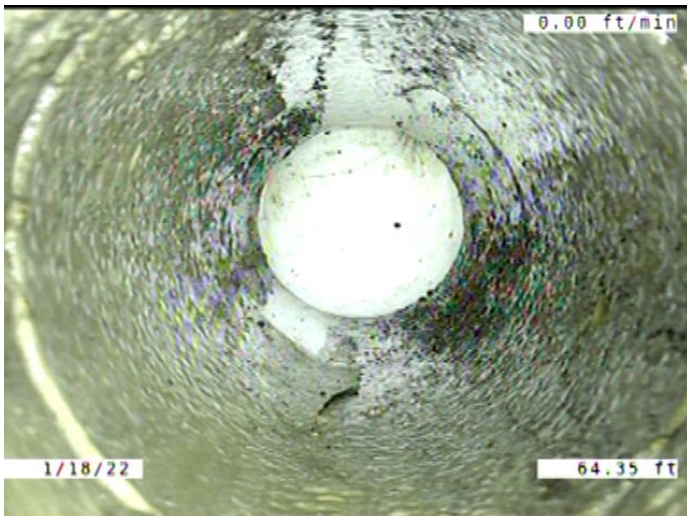
Code: **TF**
Description: **Tap Factory**

Distance (ft): **64.3**
Structural Grade: **0**
O&M Grade: **0**
Clock Start/From: **12**
Clock To:
1st Value: **4.000**
2nd Value:
Value Percent:
Continuous Index:
Within 8" of Joint: **YES**
Remarks: **CONSTANTLY RUNNING WATER.
ENCUSTATION COMING OUT OF THE**

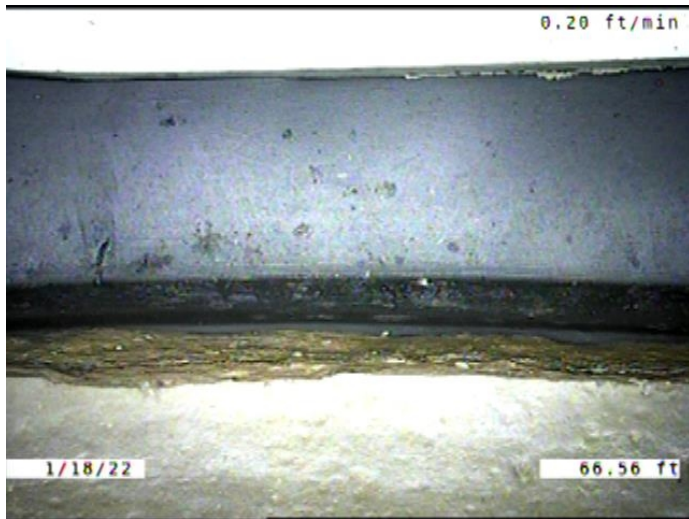
Code: **MMC**
Description: **Miscellaneous Material Change**

Distance (ft): **66.5**
Structural Grade: **0**
O&M Grade: **0**
Clock Start/From:
Clock To:
1st Value:
2nd Value:
Value Percent:
Continuous Index:
Within 8" of Joint: **NO**
Remarks: **PVC TO VCP**

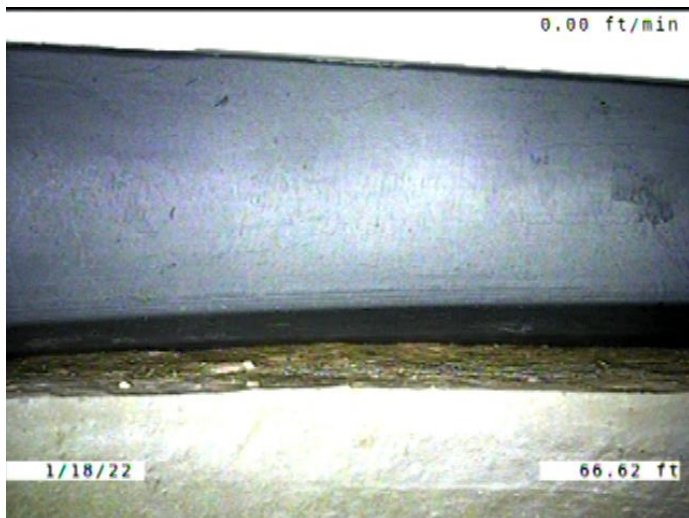
Code: **MGO**
Description: **Miscellaneous General Observation**

Distance (ft): **66.6**
Structural Grade: **0**
O&M Grade: **0**
Clock Start/From:
Clock To:
1st Value:
2nd Value:
Value Percent:
Continuous Index:
Within 8" of Joint: **NO**
Remarks: **PIPE ARE NOT TOUCHING BUT HAVE A FERNCO OVER THE REPAIRED CON**

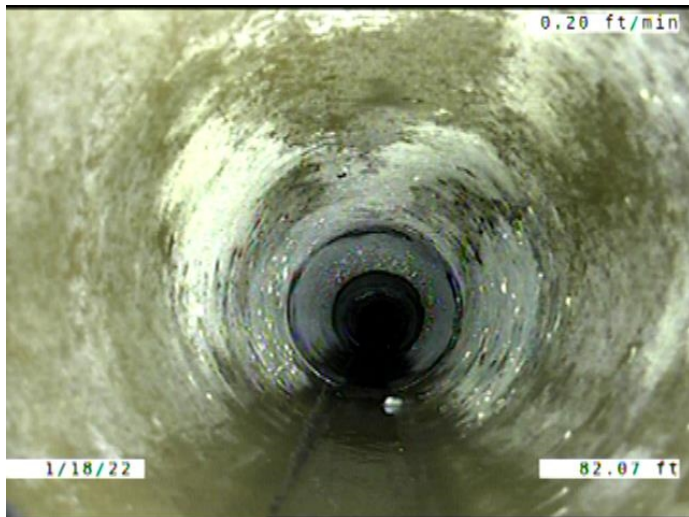
Code: **MWLS**
Description: **Miscellaneous Water Level Sag**

Distance (ft): **82.1**
Structural Grade: **2**
O&M Grade: **0**
Clock Start/From:
Clock To:
1st Value:
2nd Value:
Value Percent: **5.000**
Continuous Index: **F02**
Within 8" of Joint: **NO**
Remarks:

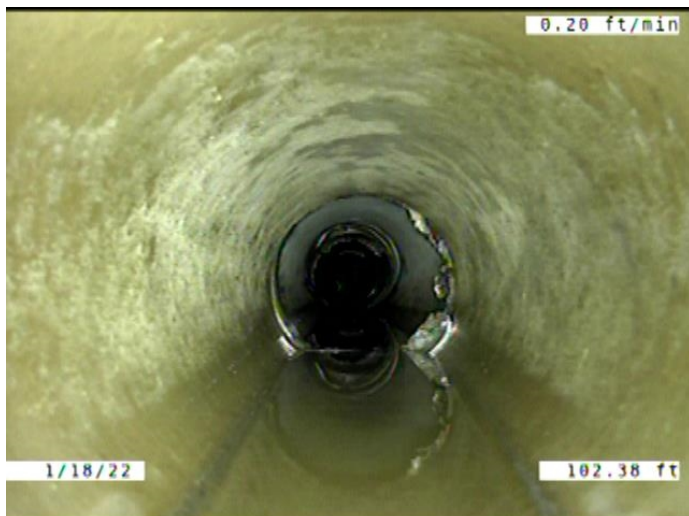
Code: **MWLS**
Description: **Miscellaneous Water Level Sag**

Distance (ft): **102.4**
Structural Grade: **2**
O&M Grade: **0**
Clock Start/From:
Clock To:
1st Value:
2nd Value:
Value Percent: **10.000**
Continuous Index: **S03**
Within 8" of Joint: **NO**
Remarks:

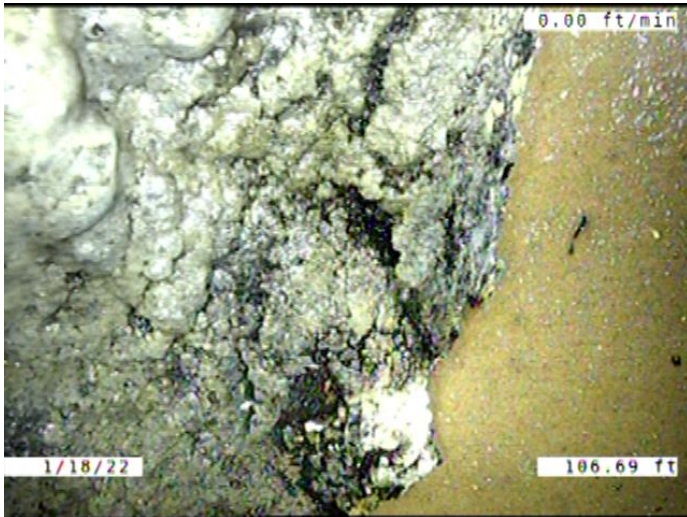
Code: **OBZ**
 Description: **Obstruction Other**

Distance (ft): **106.7**
 Structural Grade: **0**
 O&M Grade: **2**
 Clock Start/From: **3**
 Clock To: **7**
 1st Value:
 2nd Value:
 Value Percent: **5.000**
 Continuous Index:
 Within 8" of Joint: **YES**
 Remarks: **A PIECE OF ENCUSTATION THAT HAS BEEN BROKEN OFF**

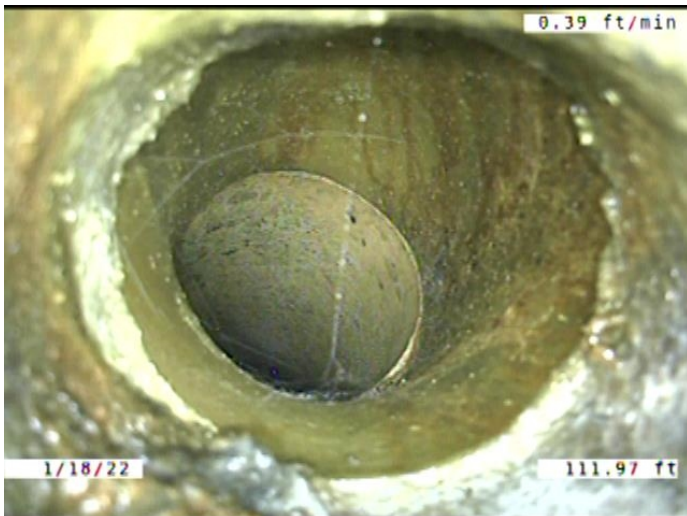
Code: **TF**
 Description: **Tap Factory**

Distance (ft): **111.9**
 Structural Grade: **0**
 O&M Grade: **0**
 Clock Start/From: **12**
 Clock To:
 1st Value: **4.000**
 2nd Value:
 Value Percent:
 Continuous Index:
 Within 8" of Joint: **YES**
 Remarks: **ENCUSTATION COMING FROM THE CONNECTION AT THE SERVICE AND**

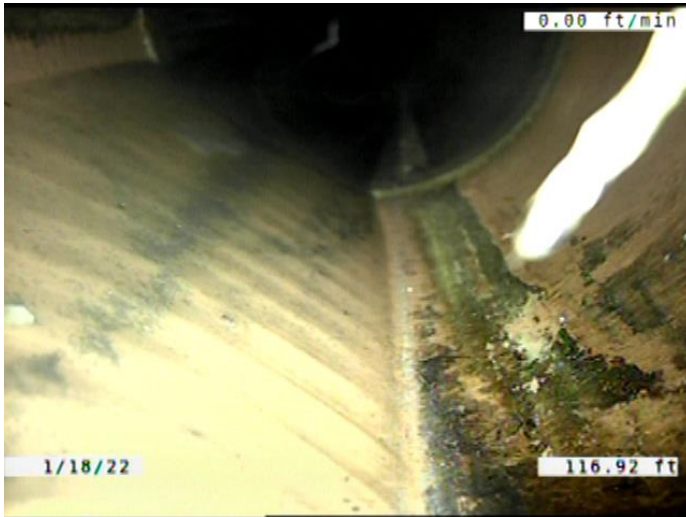
Code: **IRC**
 Description: **Infiltration Runner Connection**

Distance (ft): **116.9**
 Structural Grade: **0**
 O&M Grade: **4**
 Clock Start/From: **12**
 Clock To: **1**
 1st Value:
 2nd Value:
 Value Percent:
 Continuous Index:
 Within 8" of Joint: **YES**
 Remarks:

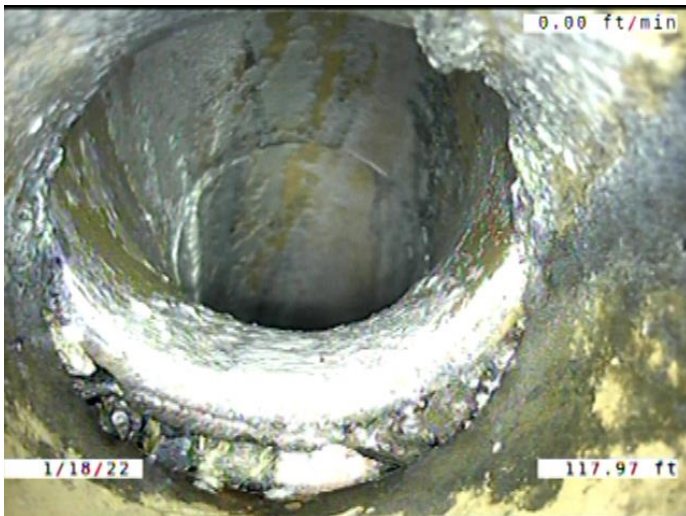
Code: **TF**
 Description: **Tap Factory**

Distance (ft): **118.0**
 Structural Grade: **0**
 O&M Grade: **0**
 Clock Start/From: **12**
 Clock To:
 1st Value: **4.000**
 2nd Value:
 Value Percent:
 Continuous Index:
 Within 8" of Joint: **YES**
 Remarks: **CONSTANTLY RUNNING WATER.
 ENCUSTATION COMING DOWN THE**

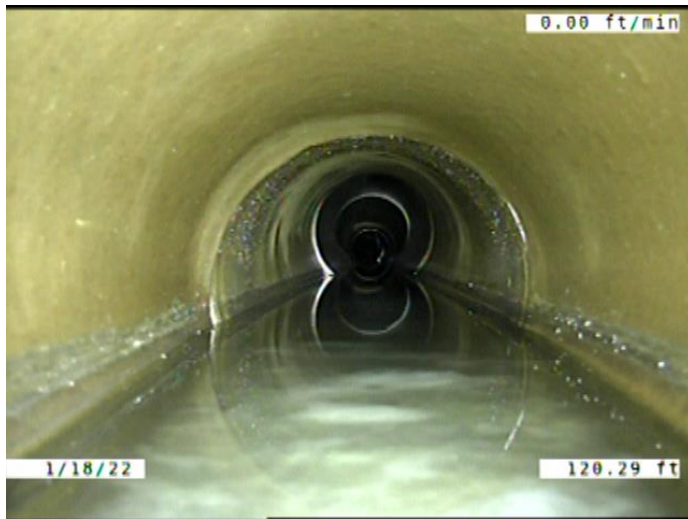
Code: **DSF**
 Description: **Deposits Settled Fine**

Distance (ft): **120.3**
 Structural Grade: **0**
 O&M Grade: **2**
 Clock Start/From: **5**
 Clock To: **7**
 1st Value:
 2nd Value:
 Value Percent: **5.000**
 Continuous Index: **S04**
 Within 8" of Joint: **YES**
 Remarks:

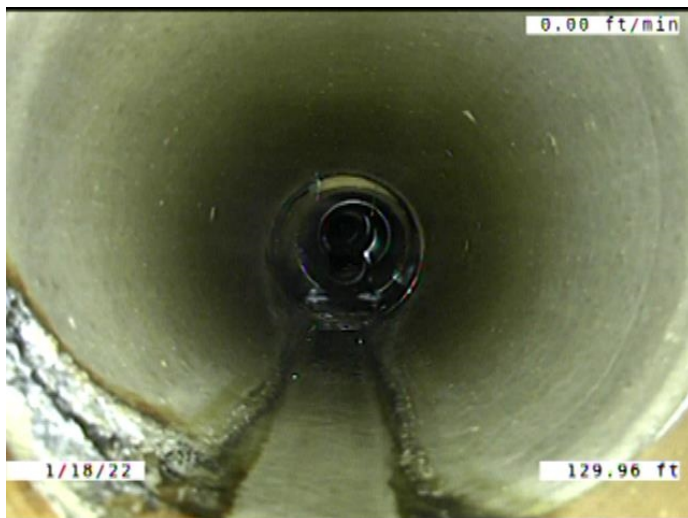
Code: **MWLS**
 Description: **Miscellaneous Water Level Sag**

Distance (ft): **130.0**
 Structural Grade: **2**
 O&M Grade: **0**
 Clock Start/From:
 Clock To:
 1st Value:
 2nd Value:
 Value Percent: **10.000**
 Continuous Index: **F03**
 Within 8" of Joint: **NO**
 Remarks:

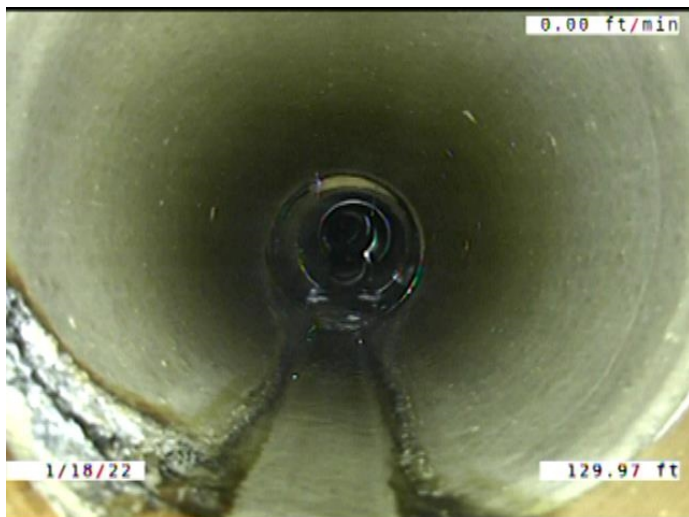
Code: **LD**
 Description: **Line Down**

Distance (ft): **130.0**
 Structural Grade: **0**
 O&M Grade: **1**
 Clock Start/From:
 Clock To:
 1st Value:
 2nd Value:
 Value Percent: **5.000**
 Continuous Index:
 Within 8" of Joint: **NO**
 Remarks:

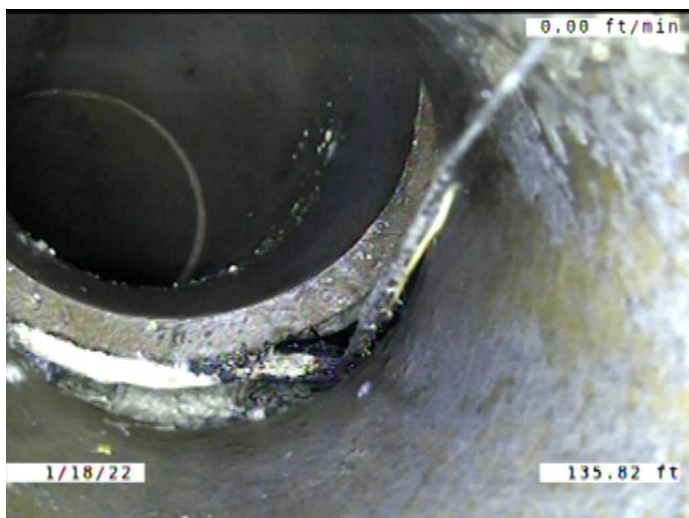
Code: **RFL**
 Description: **Roots Fine Lateral**

Distance (ft): **135.8**
 Structural Grade: **0**
 O&M Grade: **1**
 Clock Start/From: **12**
 Clock To: **1**
 1st Value:
 2nd Value:
 Value Percent:
 Continuous Index:
 Within 8" of Joint: **NO**
 Remarks:

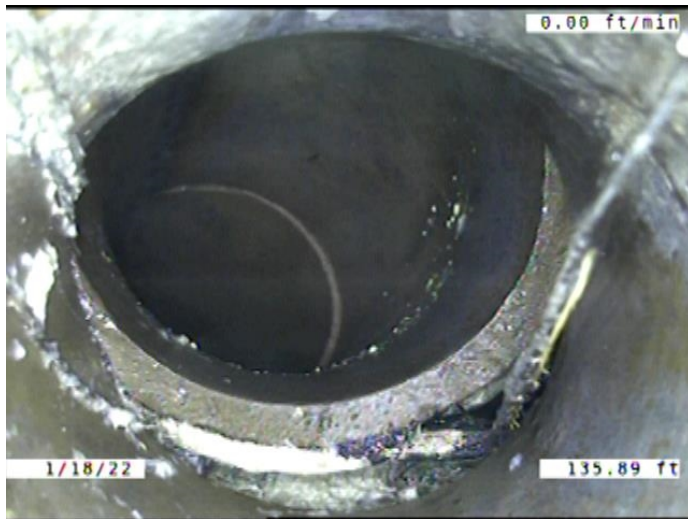
Code: **TFD**
Description: **Tap Factory Defective**

Distance (ft): **135.9**
Structural Grade: **0**
O&M Grade: **3**
Clock Start/From: **12**
Clock To:
1st Value: **4.000**
2nd Value:
Value Percent:
Continuous Index:
Within 8" of Joint: **YES**
Remarks: **MAIN BROKEN. TAP OFFSET SOIL VISIBLE**

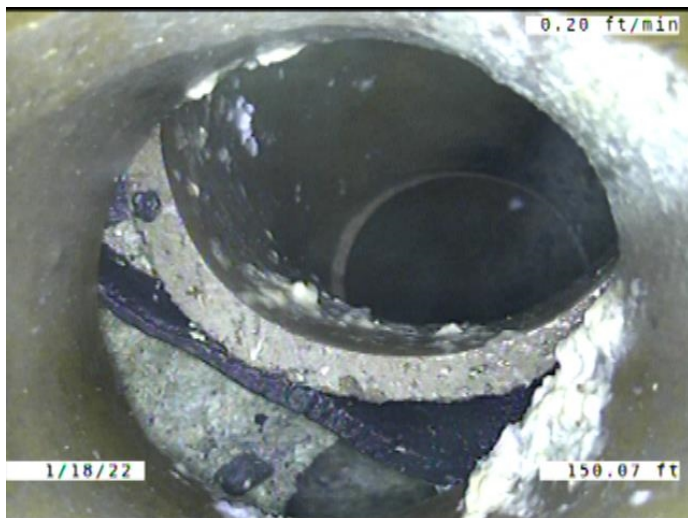
Code: **TF**
Description: **Tap Factory**

Distance (ft): **150.1**
Structural Grade: **0**
O&M Grade: **0**
Clock Start/From: **1**
Clock To:
1st Value: **4.000**
2nd Value:
Value Percent:
Continuous Index:
Within 8" of Joint: **YES**
Remarks: **TAP LARGE OFFSET. SOIL VISIBLE**

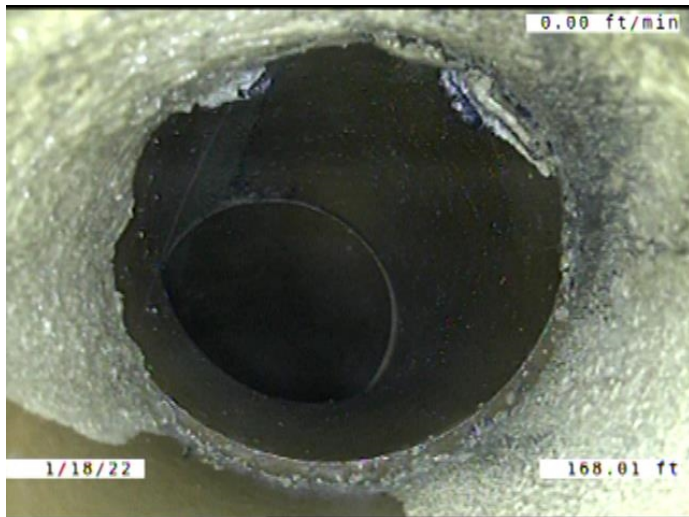
Code:	TF
Description:	Tap Factory
Distance (ft):	168.0
Structural Grade:	0
O&M Grade:	0
Clock Start/From:	12
Clock To:	
1st Value:	4.000
2nd Value:	
Value Percent:	
Continuous Index:	
Within 8" of Joint:	YES
Remarks:	ENCUSTATION COMING FROM THE MAIN TO SERVICE CONNECTION.

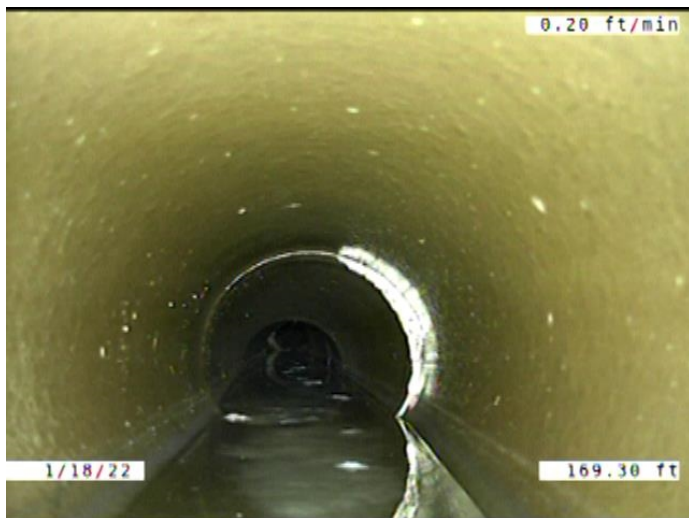
Code:	MWLS
Description:	Miscellaneous Water Level Sag
Distance (ft):	169.3
Structural Grade:	2
O&M Grade:	0
Clock Start/From:	
Clock To:	
1st Value:	
2nd Value:	
Value Percent:	15.000
Continuous Index:	S05
Within 8" of Joint:	NO
Remarks:

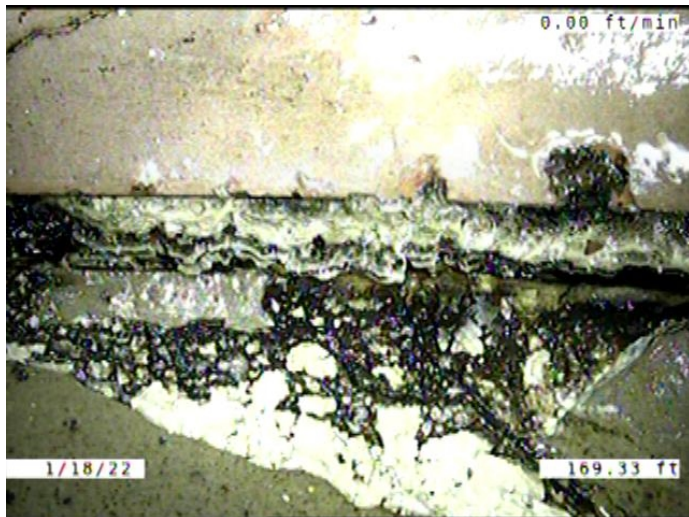
Code: **IDJ**
 Description: **Infiltration Dripper Joint**

Distance (ft): **169.3**
 Structural Grade: **0**
 O&M Grade: **3**
 Clock Start/From: **2**
 Clock To:
 1st Value:
 2nd Value:
 Value Percent:
 Continuous Index:
 Within 8" of Joint: **YES**
 Remarks:

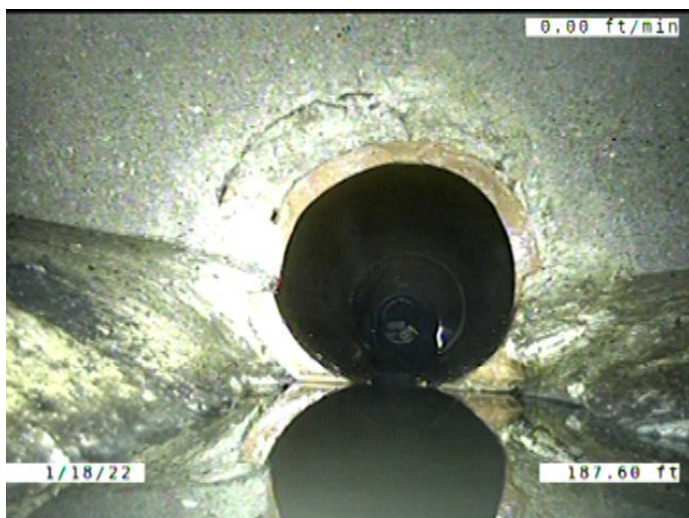
Code: **DSF**
 Description: **Deposits Settled Fine**

Distance (ft): **187.6**
 Structural Grade: **0**
 O&M Grade: **2**
 Clock Start/From: **5**
 Clock To: **7**
 1st Value:
 2nd Value:
 Value Percent: **5.000**
 Continuous Index: **F04**
 Within 8" of Joint: **YES**
 Remarks:

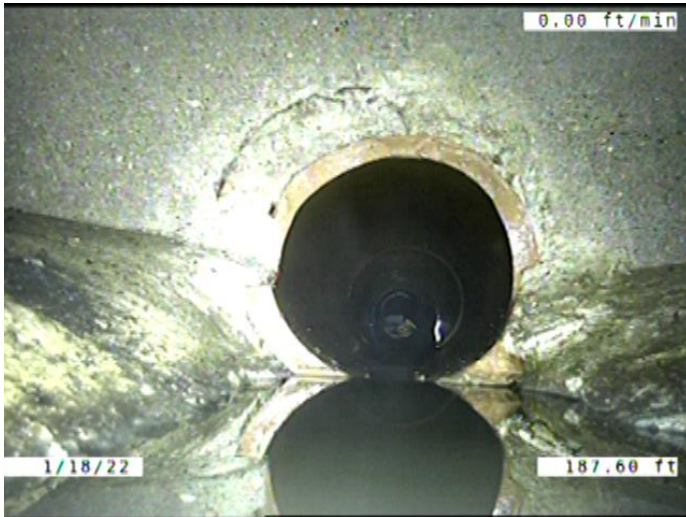
Code: **MWLS**
Description: **Miscellaneous Water Level Sag**

Distance (ft): **187.6**
Structural Grade: **2**
O&M Grade: **0**
Clock Start/From:
Clock To:
1st Value:
2nd Value:
Value Percent: **15.000**
Continuous Index: **F05**
Within 8" of Joint: **NO**
Remarks:

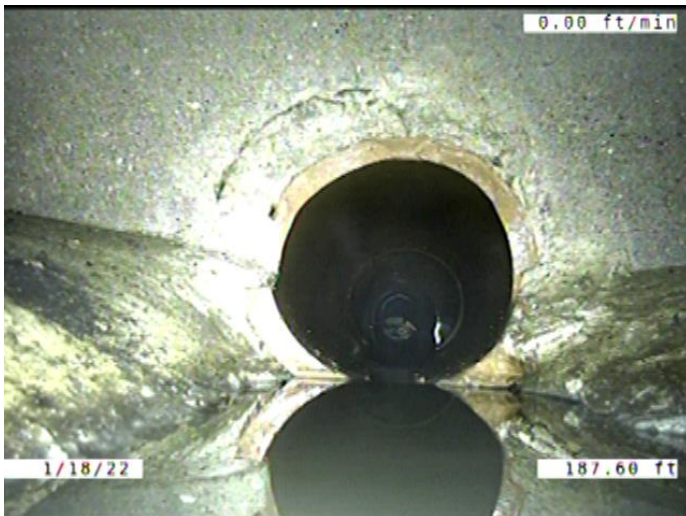
Code: **DAE**
Description: **Deposits Attached Encrustation**

Distance (ft): **187.6**
Structural Grade: **0**
O&M Grade: **2**
Clock Start/From: **7**
Clock To: **5**
1st Value:
2nd Value:
Value Percent: **5.000**
Continuous Index: **F01**
Within 8" of Joint: **YES**
Remarks:

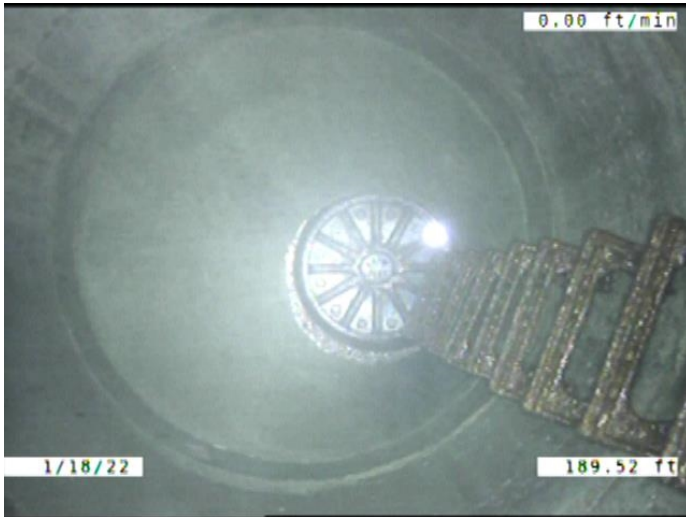
Code:	AMH
Description:	Manhole
Distance (ft):	189.5
Structural Grade:	0
O&M Grade:	0
Clock Start/From:	
Clock To:	
1st Value:	
2nd Value:	
Value Percent:	
Continuous Index:	
Within 8" of Joint:	NO
Remarks:	M-506-023
