Profile/Photo Observation Report

Date:	04/06/2018	Weather:		Coding:	PACP 6.0
Pipe Length (ft):	170.3	Owner:	NA	Pre Clean:	No Pre-Cleaning
P.O.#:		Surveyor:	Mark Ruby	PSR:	P-506-027-026
Customer:		Clean Date:	01/01/1900	Shape:	C

Street:	S COLORADO ST	Flow Control:	Not Controlled
City:	Hobart, IN	Year Renewed:	
Location:	Yard	Tape/Media #:	
Purpose:	Routine Assessment	Dia/Height:	10"
Use:	Sanitary	Material:	RCP
Drain Area:	NA	Lining:	
Category:	NA		
Comment:	P_C debris, flow direction is marked wrong.		
Location Details:		Direction of Survey:	Downstream
US MH:	M-506-026	DS MH:	M-506-027
		Total Length Surveyed (ft):	154.1

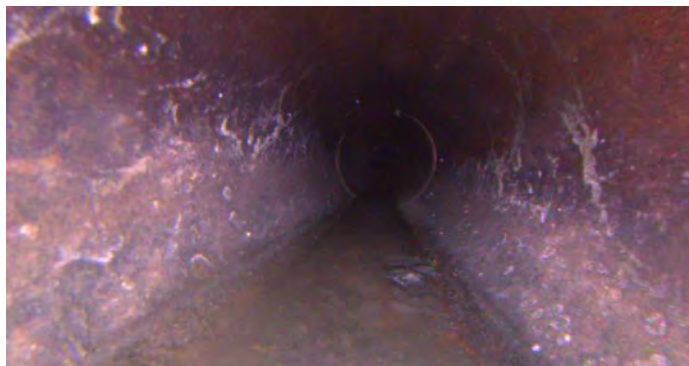
Code: **AMH**
Description: **Manhole**

Distance (ft): **.0**
Structural Grade: **0**
O&M Grade: **0**
Clock Start/From:
Clock To:
1st Value:
2nd Value:
Value Percent:
Continuous Index:
Within 8" of Joint: **NO**
Remarks: **M-506-026**

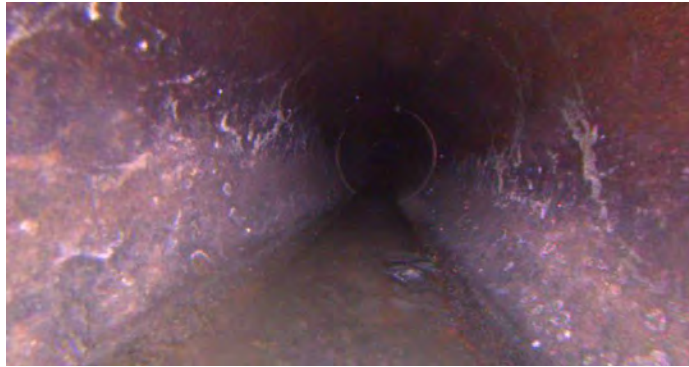
Code: **MWL**
Description: **Water Level**

Distance (ft): **.0**
Structural Grade: **0**
O&M Grade: **0**
Clock Start/From:
Clock To:
1st Value:
2nd Value:
Value Percent: **10.000**
Continuous Index:
Within 8" of Joint: **NO**
Remarks:

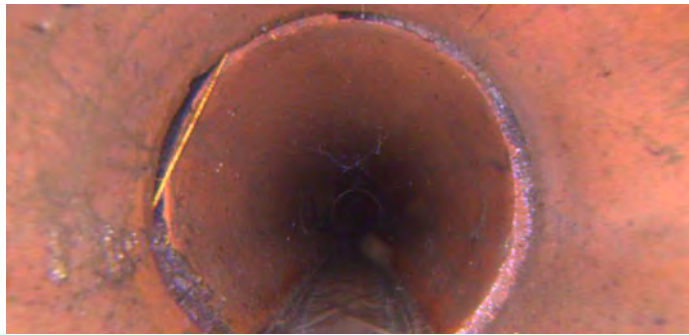
Code: **RFJ**
Description: **Roots Fine Joint**

Distance (ft): **14.8**
Structural Grade: **0**
O&M Grade: **1**
Clock Start/From: **9**
Clock To: **11**
1st Value:
2nd Value:
Value Percent:
Continuous Index:
Within 8" of Joint: **YES**
Remarks:

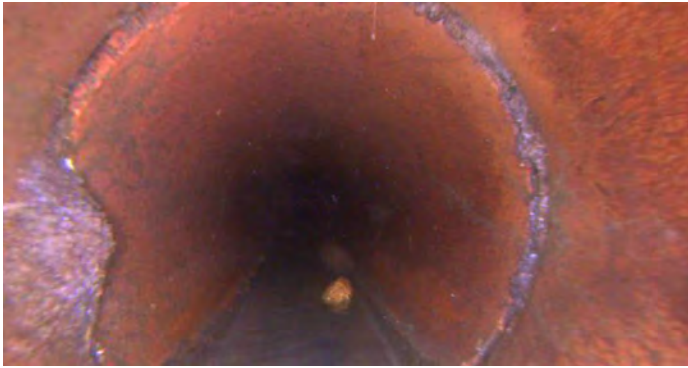
Code: **RFJ**
Description: **Roots Fine Joint**

Distance (ft): **30.9**
Structural Grade: **0**
O&M Grade: **1**
Clock Start/From: **8**
Clock To:
1st Value:
2nd Value:
Value Percent:
Continuous Index:
Within 8" of Joint: **YES**
Remarks:

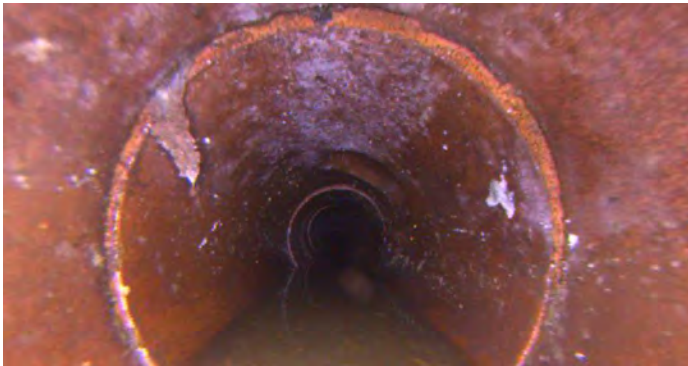
Code: **RFJ**
Description: **Roots Fine Joint**

Distance (ft): **86.7**
Structural Grade: **0**
O&M Grade: **1**
Clock Start/From: **10**
Clock To:
1st Value:
2nd Value:
Value Percent:
Continuous Index:
Within 8" of Joint: **YES**
Remarks:

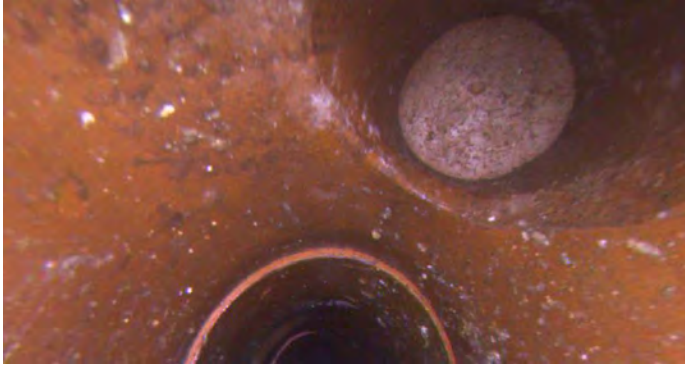
Code: **TFC**
Description: **Tap Factory Capped**

Distance (ft): **88.2**
Structural Grade: **0**
O&M Grade: **0**
Clock Start/From: **2**
Clock To:
1st Value: **4.000**
2nd Value:
Value Percent:
Continuous Index:
Within 8" of Joint:
Remarks:

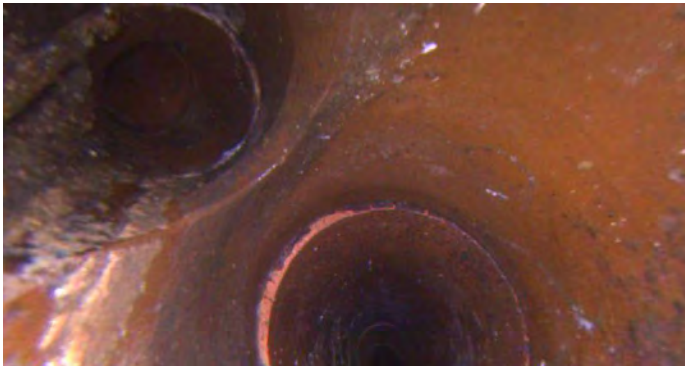
Code: **TF**
Description: **Tap Factory**

Distance (ft): **90.2**
Structural Grade: **0**
O&M Grade: **0**
Clock Start/From: **10**
Clock To:
1st Value: **4.000**
2nd Value:
Value Percent:
Continuous Index:
Within 8" of Joint:
Remarks:

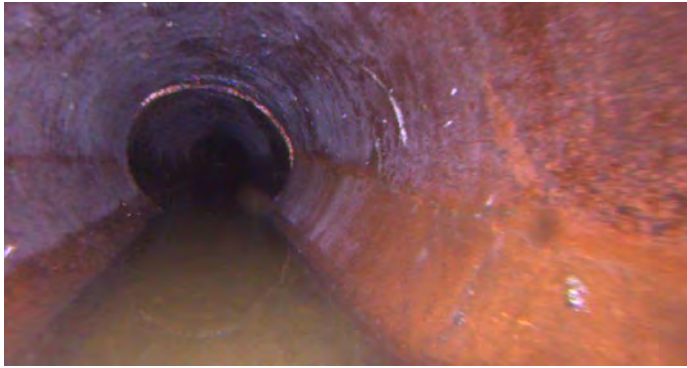
Code: **CL**
Description: **Crack Longitudinal**

Distance (ft): **97.4**
Structural Grade: **2**
O&M Grade: **0**
Clock Start/From: **4**
Clock To:
1st Value:
2nd Value:
Value Percent:
Continuous Index:
Within 8" of Joint:
Remarks:

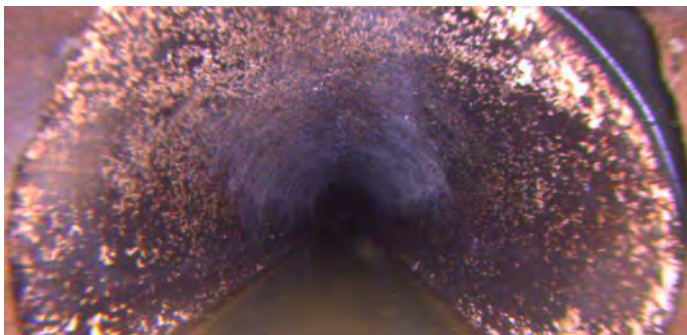
Code: **MMC**
Description: **Material Change**

Distance (ft): **98.9**
Structural Grade: **0**
O&M Grade: **0**
Clock Start/From:
Clock To:
1st Value:
2nd Value:
Value Percent:
Continuous Index:
Within 8" of Joint: **NO**
Remarks: **pvc**

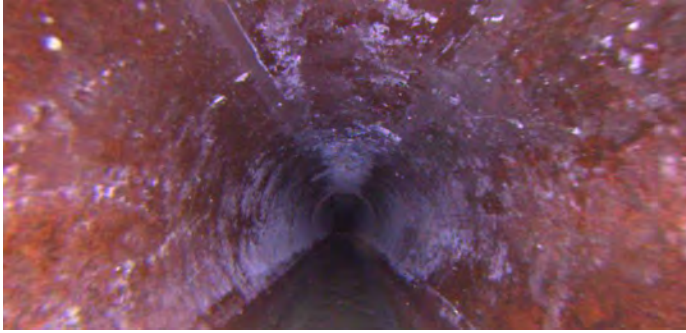
Code: **MMC**
Description: **Material Change**

Distance (ft): **111.6**
Structural Grade: **0**
O&M Grade: **0**
Clock Start/From:
Clock To:
1st Value:
2nd Value:
Value Percent:
Continuous Index:
Within 8" of Joint: **NO**
Remarks: **VCP**

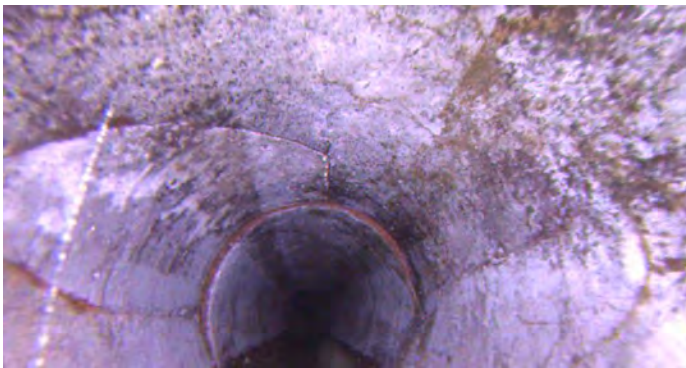
Code: **FM**
Description: **Fracture Multiple**

Distance (ft): **118.0**
Structural Grade: **4**
O&M Grade: **0**
Clock Start/From: **7**
Clock To: **5**
1st Value:
2nd Value:
Value Percent:
Continuous Index: **S01**
Within 8" of Joint:
Remarks:

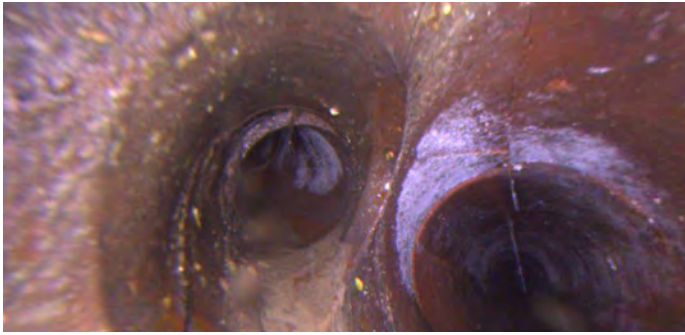
Code: **TFD**
Description: **Tap Factory Defective**

Distance (ft): **140.0**
Structural Grade: **0**
O&M Grade: **2**
Clock Start/From: **10**
Clock To:
1st Value: **4.000**
2nd Value:
Value Percent:
Continuous Index:
Within 8" of Joint:
Remarks: **RFL**

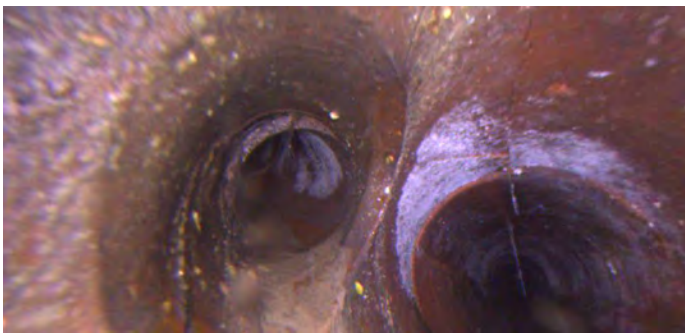
Code: **RFL**
Description: **Roots Fine Lateral**

Distance (ft): **140.0**
Structural Grade: **0**
O&M Grade: **1**
Clock Start/From: **9**
Clock To:
1st Value:
2nd Value:
Value Percent:
Continuous Index:
Within 8" of Joint: **NO**
Remarks:

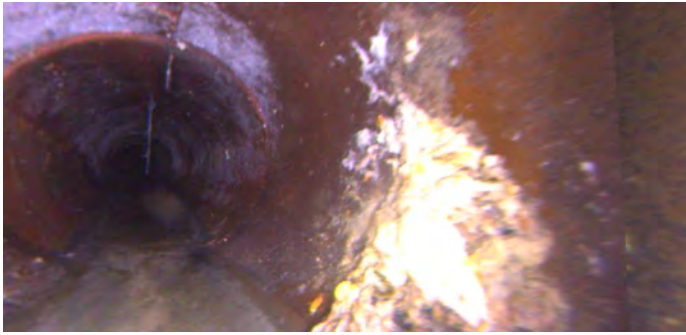
Code: **DAGS**
Description: **Deposits Attached Grease**

Distance (ft): **140.1**
Structural Grade: **0**
O&M Grade: **2**
Clock Start/From: **1**
Clock To: **4**
1st Value:
2nd Value:
Value Percent: **5.000**
Continuous Index:
Within 8" of Joint: **NO**
Remarks:

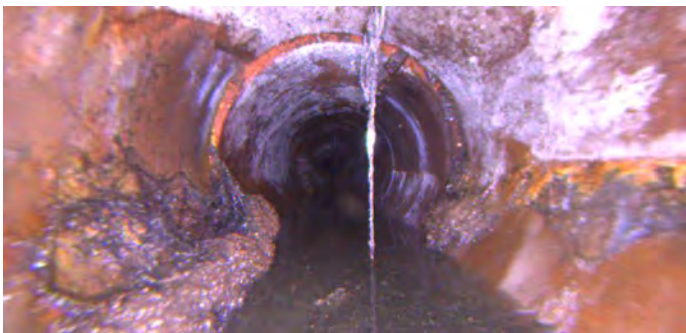
Code: **RFB**
Description: **Roots Fine Barrel**

Distance (ft): **148.5**
Structural Grade: **0**
O&M Grade: **2**
Clock Start/From: **12**
Clock To:
1st Value:
2nd Value:
Value Percent:
Continuous Index:
Within 8" of Joint: **NO**
Remarks:

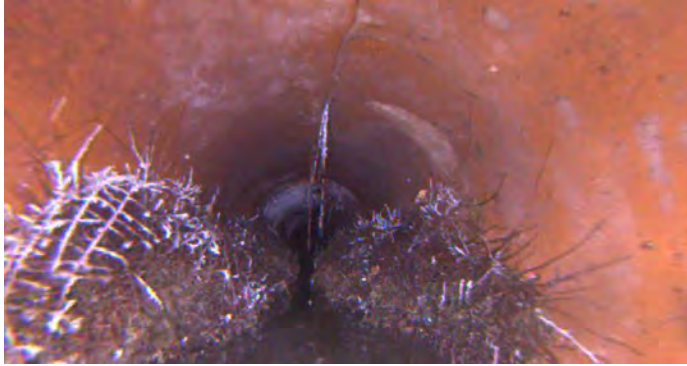
Code: **RMB**
Description: **Roots Medium Barrel**

Distance (ft): **151.3**
Structural Grade: **0**
O&M Grade: **4**
Clock Start/From: **7**
Clock To: **5**
1st Value:
2nd Value:
Value Percent: **10.000**
Continuous Index:
Within 8" of Joint: **NO**
Remarks:

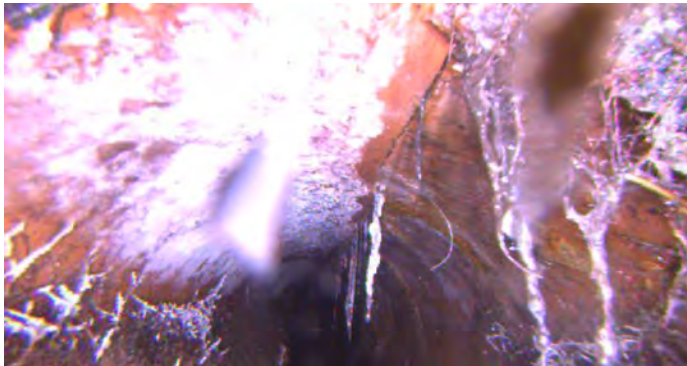
Code: **FM**
Description: **Fracture Multiple**

Distance (ft): **154.1**
Structural Grade: **4**
O&M Grade: **0**
Clock Start/From: **7**
Clock To: **5**
1st Value:
2nd Value:
Value Percent:
Continuous Index: **F01**
Within 8" of Joint:
Remarks:

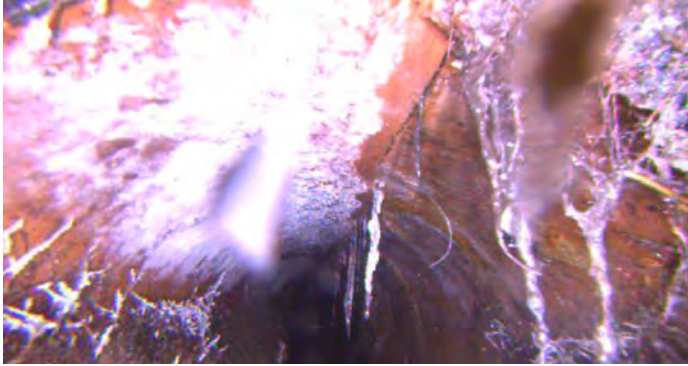
Code:	MSA
Description:	Abandoned Survey
Distance (ft):	154.1
Structural Grade:	0
O&M Grade:	0
Clock Start/From:	
Clock To:	
1st Value:	
2nd Value:	
Value Percent:	
Continuous Index:	
Within 8" of Joint:	NO
Remarks:	RMB
