Profile/Photo Observation Report

Date:	04/06/2018	Weather:		Coding:	PACP 6.0
Pipe Length (ft):	170.3	Owner:	NA	Pre Clean:	No Pre-Cleaning
P.O.#:		Surveyor:	Mark Ruby	PSR:	P-506-027-026
Customer:		Clean Date:	01/01/1900	Shape:	C

Street:	FOXCROFT STREET	Flow Control:	Not Controlled
City:	Hobart, IN	Year Renewed:	
Location:	Yard	Tape/Media #:	
Purpose:	Routine Assessment	Dia/Height:	10"
Use:	Sanitary	Material:	RCP
Drain Area:	NA	Lining:	
Category:	NA		
Comment:	P_C debris, flow direction is marked wrong.		
Location Details:		Direction of Survey:	Downstream
US MH:	M-506-026	DS MH:	M-506-027
		Total Length Surveyed (ft):	154.1

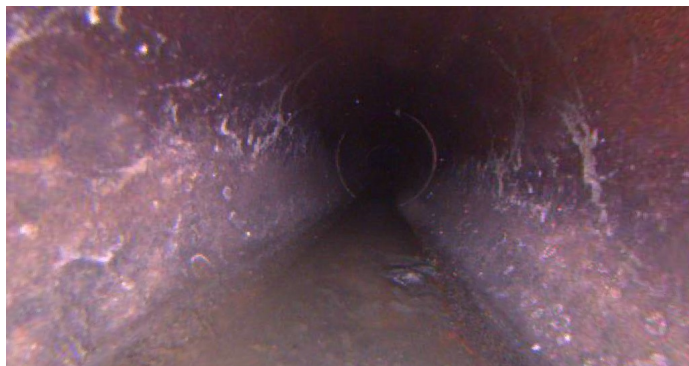
Code: **AMH**
 Description: **Manhole**

Distance (ft): **.0**
 Structural Grade: **0**
 O&M Grade: **0**
 Clock Start/From:
 Clock To:
 1st Value:
 2nd Value:
 Value Percent:
 Continuous Index:
 Within 8" of Joint: **NO**
 Remarks: **M-506-026**

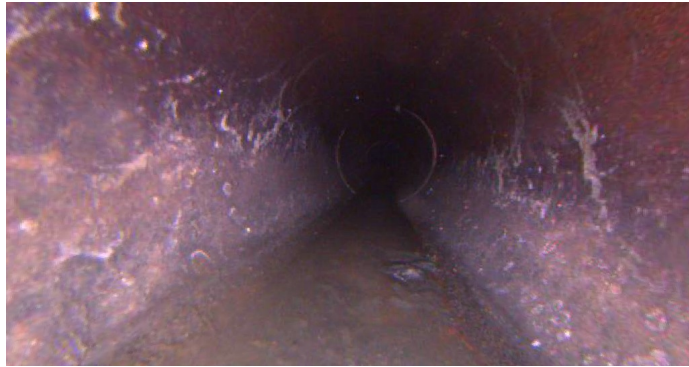
Code: **MWL**
Description: **Water Level**

Distance (ft): **.0**
Structural Grade: **0**
O&M Grade: **0**
Clock Start/From:
Clock To:
1st Value:
2nd Value:
Value Percent: **10.000**
Continuous Index:
Within 8" of Joint: **NO**
Remarks:

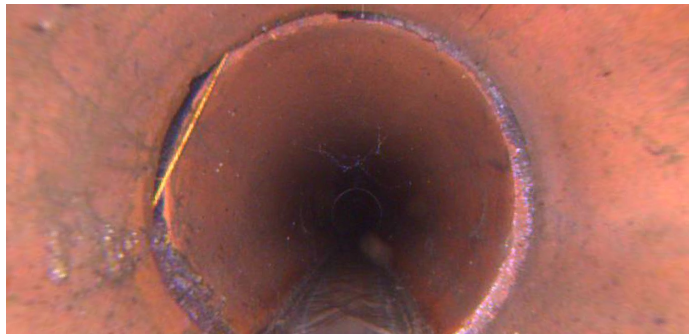
Code: **RFJ**
Description: **Roots Fine Joint**

Distance (ft): **14.8**
Structural Grade: **0**
O&M Grade: **1**
Clock Start/From: **9**
Clock To: **11**
1st Value:
2nd Value:
Value Percent:
Continuous Index:
Within 8" of Joint: **YES**
Remarks:

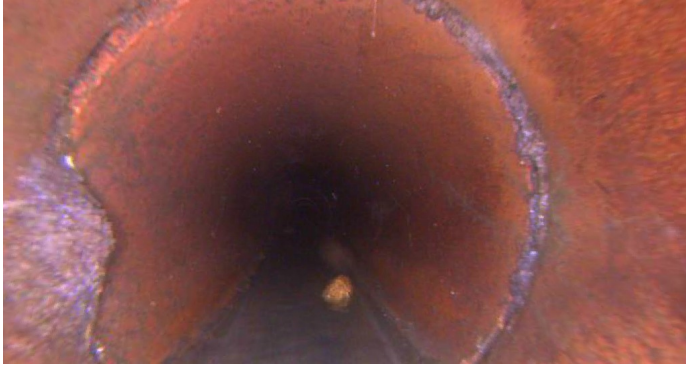
Code: **RFJ**
Description: **Roots Fine Joint**

Distance (ft): **30.9**
Structural Grade: **0**
O&M Grade: **1**
Clock Start/From: **8**
Clock To:
1st Value:
2nd Value:
Value Percent:
Continuous Index:
Within 8" of Joint: **YES**
Remarks:

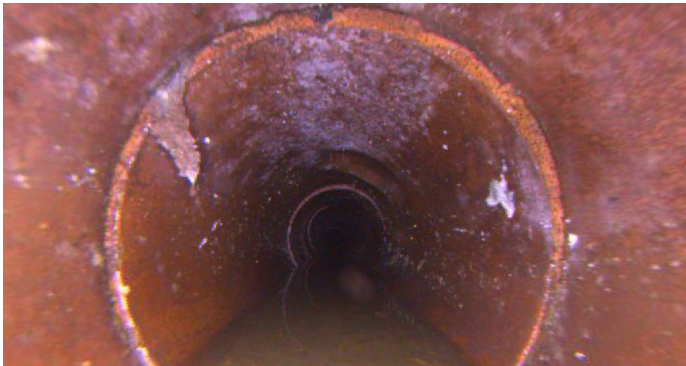
Code: **RFJ**
Description: **Roots Fine Joint**

Distance (ft): **86.7**
Structural Grade: **0**
O&M Grade: **1**
Clock Start/From: **10**
Clock To:
1st Value:
2nd Value:
Value Percent:
Continuous Index:
Within 8" of Joint: **YES**
Remarks:

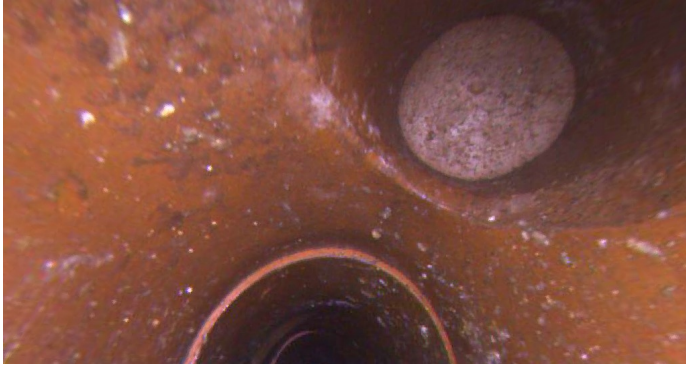
Code: **TFC**
Description: **Tap Factory Capped**

Distance (ft): **88.2**
Structural Grade: **0**
O&M Grade: **0**
Clock Start/From: **2**
Clock To:
1st Value: **4.000**
2nd Value:
Value Percent:
Continuous Index:
Within 8" of Joint:
Remarks:

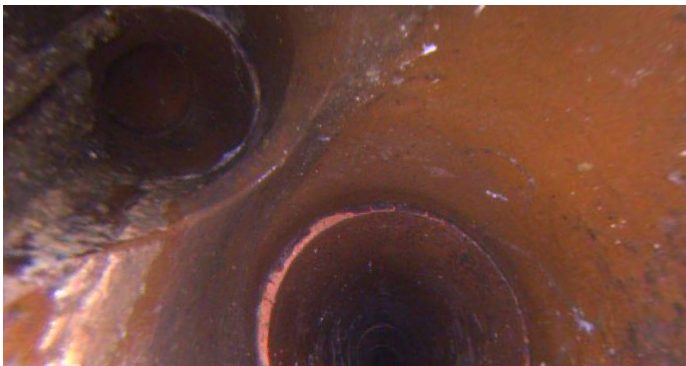
Code: **TF**
Description: **Tap Factory**

Distance (ft): **90.2**
Structural Grade: **0**
O&M Grade: **0**
Clock Start/From: **10**
Clock To:
1st Value: **4.000**
2nd Value:
Value Percent:
Continuous Index:
Within 8" of Joint:
Remarks:

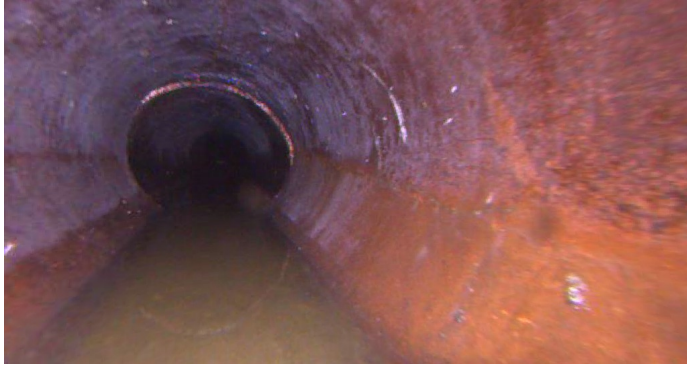
Code: **CL**
Description: **Crack Longitudinal**

Distance (ft): **97.4**
Structural Grade: **2**
O&M Grade: **0**
Clock Start/From: **4**
Clock To:
1st Value:
2nd Value:
Value Percent:
Continuous Index:
Within 8" of Joint:
Remarks:

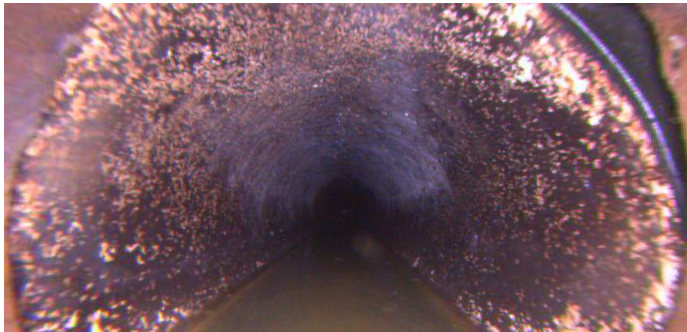
Code: **MMC**
Description: **Material Change**

Distance (ft): **98.9**
Structural Grade: **0**
O&M Grade: **0**
Clock Start/From:
Clock To:
1st Value:
2nd Value:
Value Percent:
Continuous Index:
Within 8" of Joint: **NO**
Remarks: **pvc**

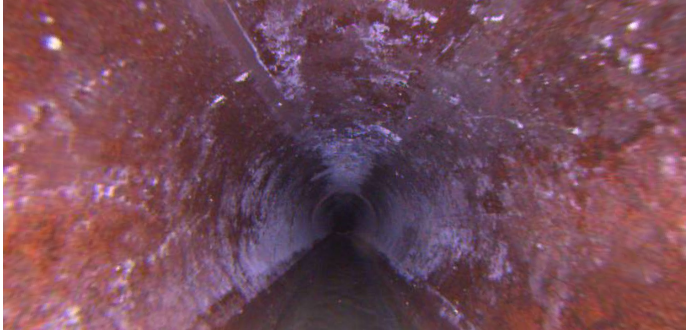
Code: **MMC**
Description: **Material Change**

Distance (ft): **111.6**
Structural Grade: **0**
O&M Grade: **0**
Clock Start/From:
Clock To:
1st Value:
2nd Value:
Value Percent:
Continuous Index:
Within 8" of Joint: **NO**
Remarks: **VCP**

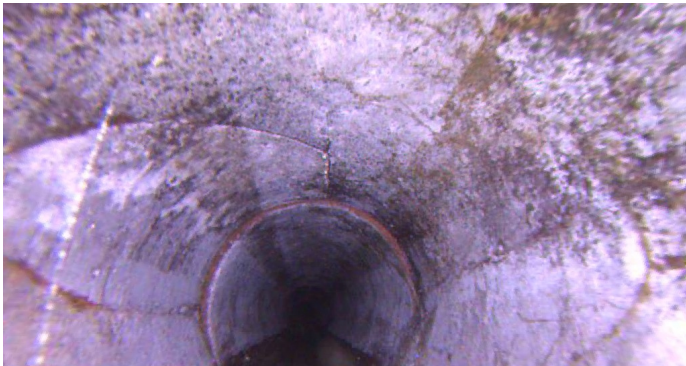
Code: **FM**
Description: **Fracture Multiple**

Distance (ft): **118.0**
Structural Grade: **4**
O&M Grade: **0**
Clock Start/From: **7**
Clock To: **5**
1st Value:
2nd Value:
Value Percent:
Continuous Index: **S01**
Within 8" of Joint:
Remarks:

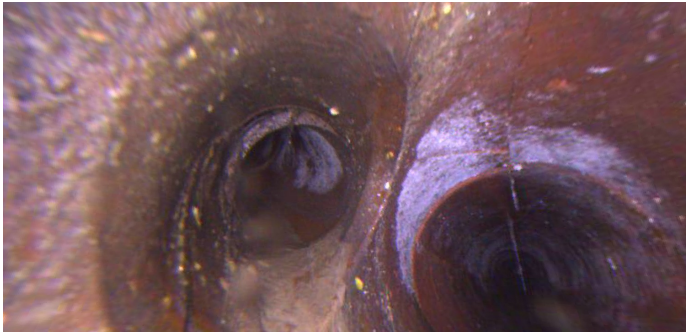
Code: **TFD**
Description: **Tap Factory Defective**

Distance (ft): **140.0**
Structural Grade: **0**
O&M Grade: **2**
Clock Start/From: **10**
Clock To:
1st Value: **4.000**
2nd Value:
Value Percent:
Continuous Index:
Within 8" of Joint:
Remarks: **RFL**

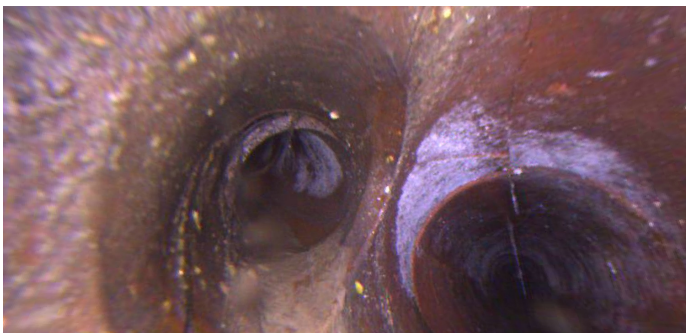
Code: **RFL**
Description: **Roots Fine Lateral**

Distance (ft): **140.0**
Structural Grade: **0**
O&M Grade: **1**
Clock Start/From: **9**
Clock To:
1st Value:
2nd Value:
Value Percent:
Continuous Index:
Within 8" of Joint: **NO**
Remarks:

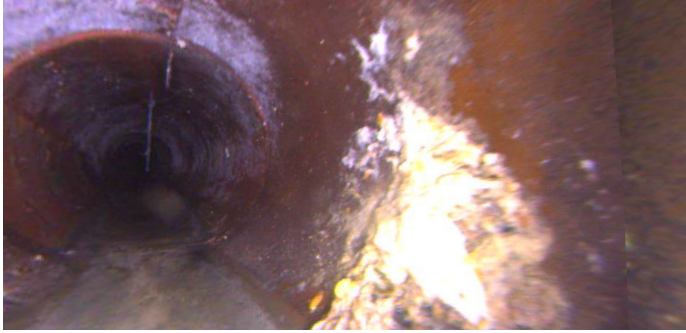
Code: **DAGS**
Description: **Deposits Attached Grease**

Distance (ft): **140.1**
Structural Grade: **0**
O&M Grade: **2**
Clock Start/From: **1**
Clock To: **4**
1st Value:
2nd Value:
Value Percent: **5.000**
Continuous Index:
Within 8" of Joint: **NO**
Remarks:

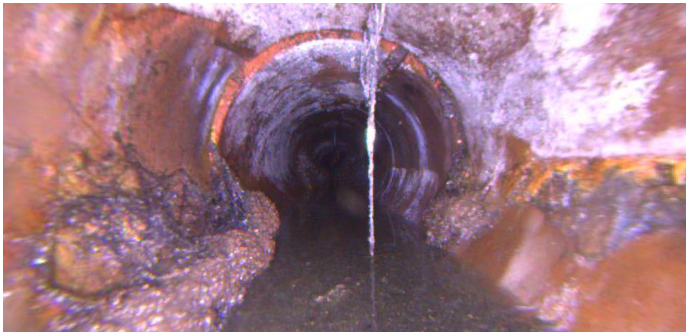
Code: **RFB**
Description: **Roots Fine Barrel**

Distance (ft): **148.5**
Structural Grade: **0**
O&M Grade: **2**
Clock Start/From: **12**
Clock To:
1st Value:
2nd Value:
Value Percent:
Continuous Index:
Within 8" of Joint: **NO**
Remarks:

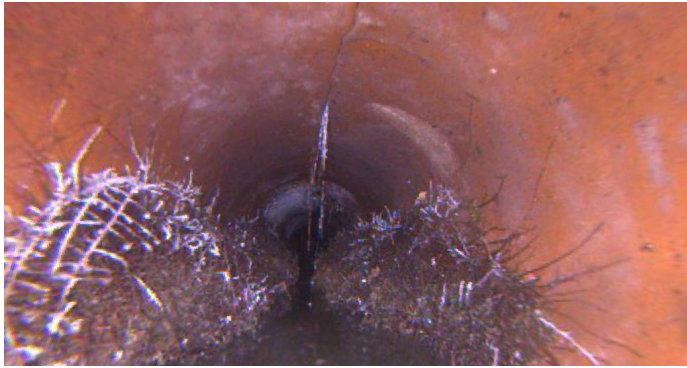
Code:	RMB
Description:	Roots Medium Barrel
Distance (ft):	151.3
Structural Grade:	0
O&M Grade:	4
Clock Start/From:	7
Clock To:	5
1st Value:	
2nd Value:	
Value Percent:	10.000
Continuous Index:	
Within 8" of Joint:	NO
Remarks:

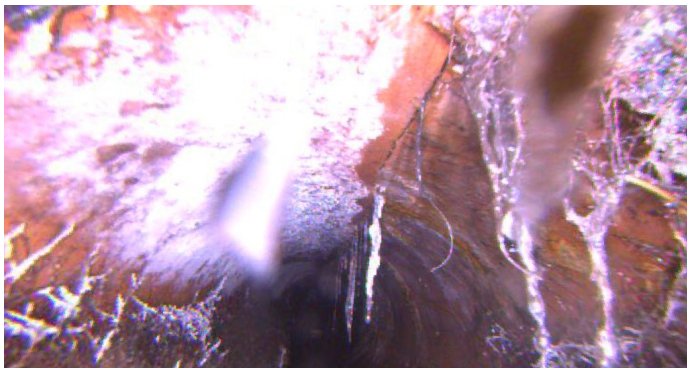
Code:	FM
Description:	Fracture Multiple
Distance (ft):	154.1
Structural Grade:	4
O&M Grade:	0
Clock Start/From:	7
Clock To:	5
1st Value:	
2nd Value:	
Value Percent:	
Continuous Index:	F01
Within 8" of Joint:	
Remarks:

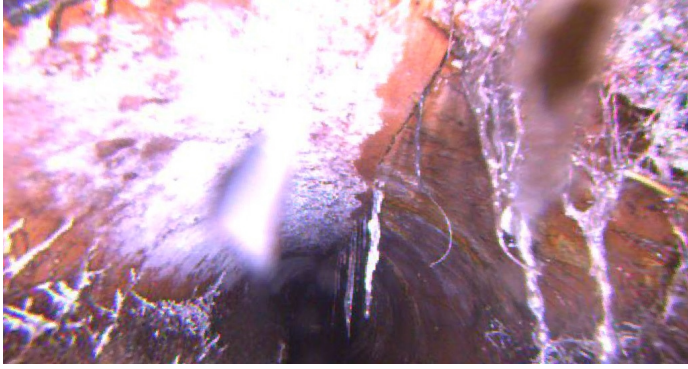
Code:	MSA
Description:	Abandoned Survey
Distance (ft):	154.1
Structural Grade:	0
O&M Grade:	0
Clock Start/From:	
Clock To:	
1st Value:	
2nd Value:	
Value Percent:	
Continuous Index:	
Within 8" of Joint:	NO
Remarks:	RMB
