Profile/Photo Observation Report

Date:	01/18/2022	Weather:		Coding:	PACP 7.0
Pipe Length (ft):	169.4	Owner:	City of Hobart	Pre Clean:	Heavy Cleaning
P.O.#:	YES502259	Surveyor:	S. Bucklin	PSR:	P-506-027-026
Customer:	City of Hobart	Clean Date:	01/16/2021	Shape:	C

Street:	South Colorado Street	Flow Control:	Not Controlled
City:	Hobart, IN	Year Renewed:	
Location:	Alley	Tape/Media #:	
Purpose:	Routine Assessment	Dia/Height:	10"
Use:	Sanitary Sewage Pipe	Material:	VCP
Drain Area:		Lining:	None
Category:	NA		
Comment:			
Location Details:		Direction of Survey:	Upstream
US MH:	M-506-026	DS MH:	M-506-027
		Total Length Surveyed (ft):	169.4

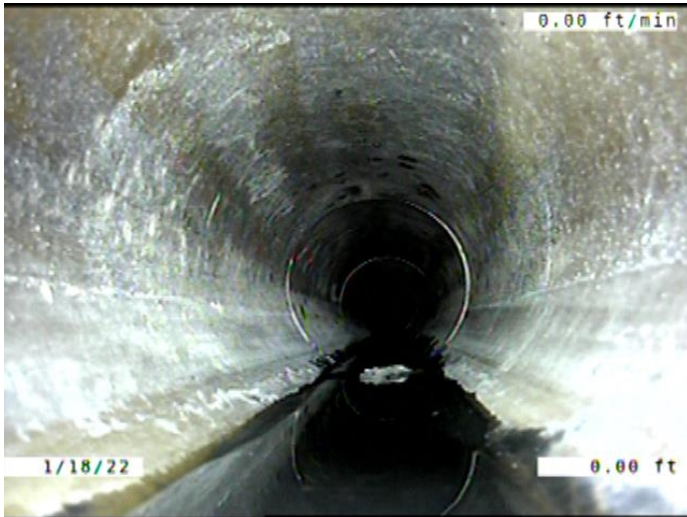
Code: **DSF**
 Description: **Deposits Settled Fine**

Distance (ft): **.0**
 Structural Grade: **0**
 O&M Grade: **2**
 Clock Start/From: **5**
 Clock To: **7**
 1st Value:
 2nd Value:
 Value Percent: **5.000**
 Continuous Index: **S01**
 Within 8" of Joint: **YES**
 Remarks:

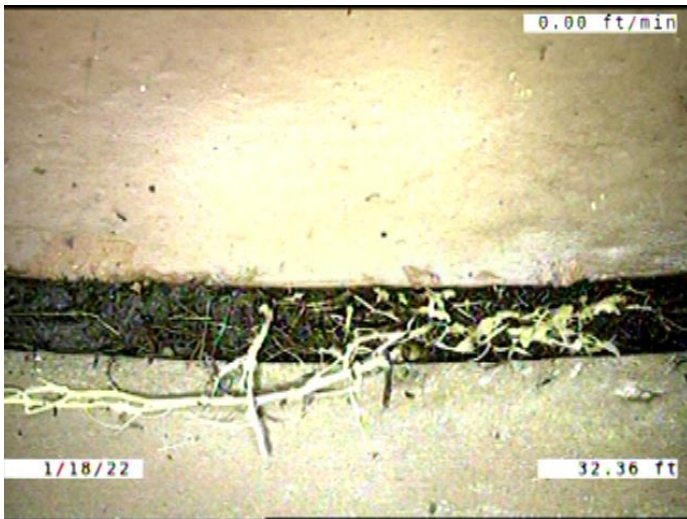
Code: **RFJ**
 Description: **Roots Fine Joint**

Distance (ft): **32.4**
 Structural Grade: **0**
 O&M Grade: **1**
 Clock Start/From: **8**
 Clock To: **4**
 1st Value:
 2nd Value:
 Value Percent:
 Continuous Index: **S02**
 Within 8" of Joint: **YES**
 Remarks:

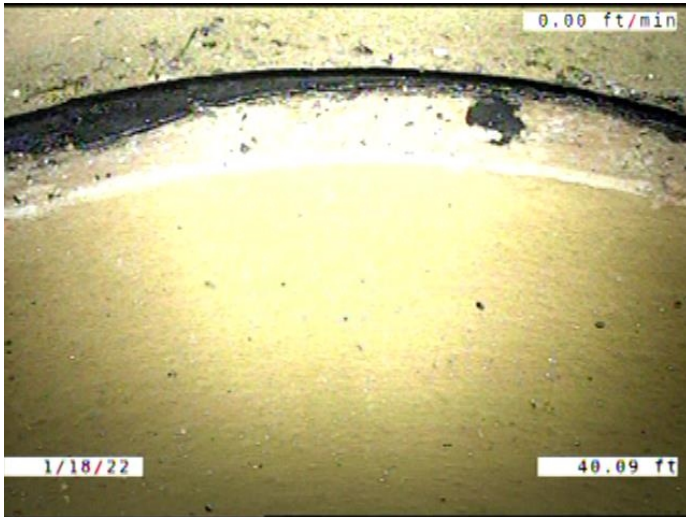
Code: **JOM**
Description: **Joint Offset Medium**

Distance (ft): **40.1**
Structural Grade: **3**
O&M Grade: **0**
Clock Start/From:
Clock To:
1st Value:
2nd Value:
Value Percent:
Continuous Index:
Within 8" of Joint: **NO**
Remarks:

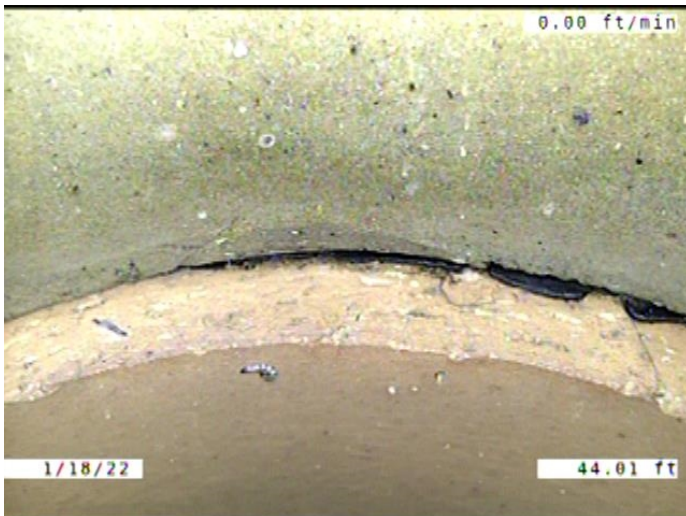
Code: **JOM**
Description: **Joint Offset Medium**

Distance (ft): **44.0**
Structural Grade: **3**
O&M Grade: **0**
Clock Start/From:
Clock To:
1st Value:
2nd Value:
Value Percent:
Continuous Index:
Within 8" of Joint: **NO**
Remarks:

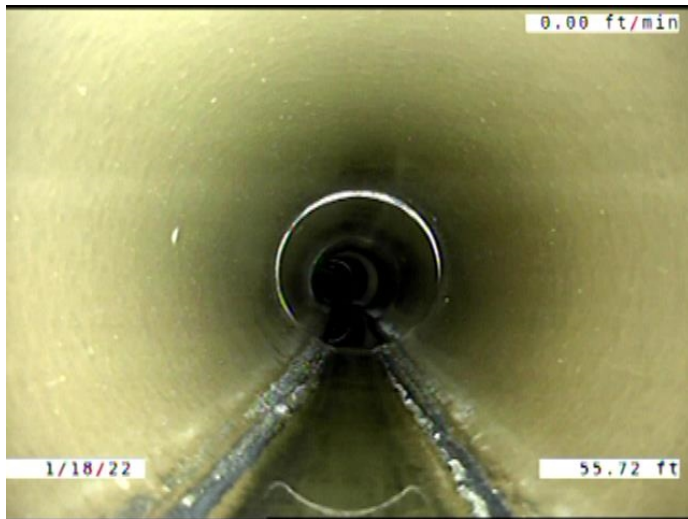
Code: **RFJ**
 Description: **Roots Fine Joint**

Distance (ft): **55.7**
 Structural Grade: **0**
 O&M Grade: **1**
 Clock Start/From: **8**
 Clock To: **4**
 1st Value:
 2nd Value:
 Value Percent:
 Continuous Index: **F02**
 Within 8" of Joint: **YES**
 Remarks:

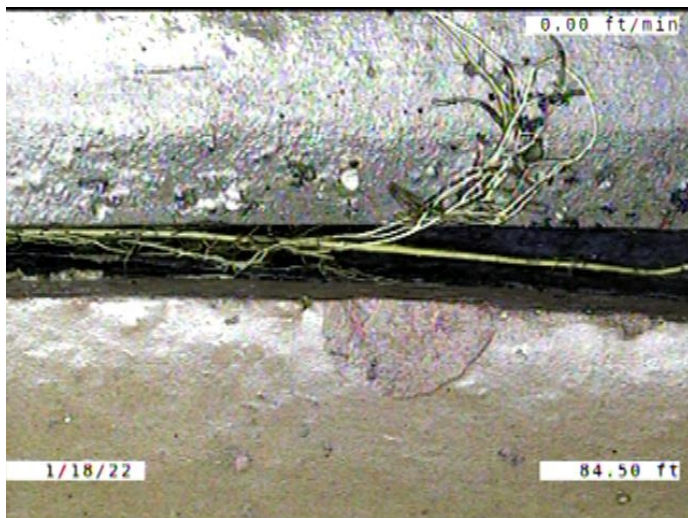
Code: **RFJ**
 Description: **Roots Fine Joint**

Distance (ft): **84.5**
 Structural Grade: **0**
 O&M Grade: **1**
 Clock Start/From: **8**
 Clock To: **4**
 1st Value:
 2nd Value:
 Value Percent:
 Continuous Index: **S03**
 Within 8" of Joint: **YES**
 Remarks:

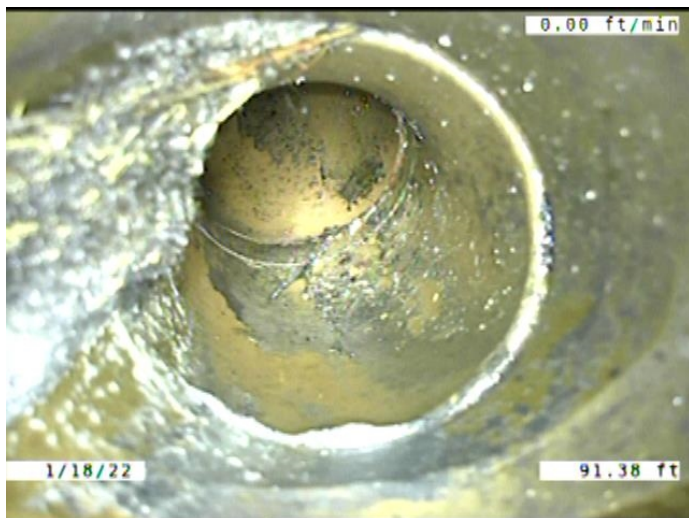
Code: **TF**
Description: **Tap Factory**

Distance (ft): **91.4**
Structural Grade: **0**
O&M Grade: **0**
Clock Start/From: **11**
Clock To:
1st Value: **4.000**
2nd Value:
Value Percent:
Continuous Index:
Within 8" of Joint: **YES**
Remarks: **ROOTS COMING FROM THE MAIN TO SERVICE CONNECTION.**

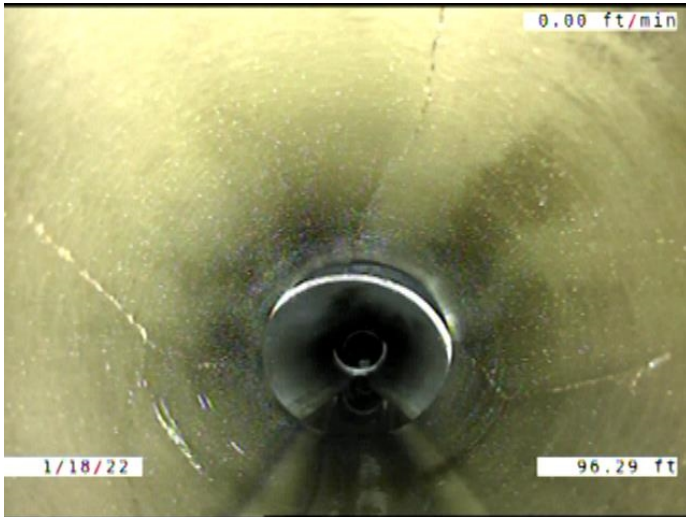
Code: **FH3**
 Description: **Fracture Longitudinal Hinge, 3**

Distance (ft): **96.3**
 Structural Grade: **4**
 O&M Grade: **0**
 Clock Start/From: **9**
 Clock To: **3**
 1st Value:
 2nd Value:
 Value Percent:
 Continuous Index:
 Within 8" of Joint: **YES**
 Remarks:

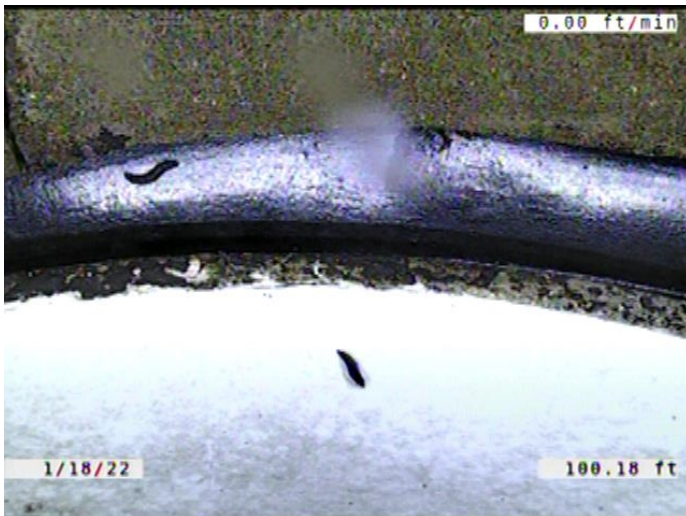
Code: **JOL**
 Description: **Joint Offset Large**

Distance (ft): **100.2**
 Structural Grade: **4**
 O&M Grade: **0**
 Clock Start/From:
 Clock To:
 1st Value: **1.000**
 2nd Value:
 Value Percent:
 Continuous Index:
 Within 8" of Joint: **NO**
 Remarks:

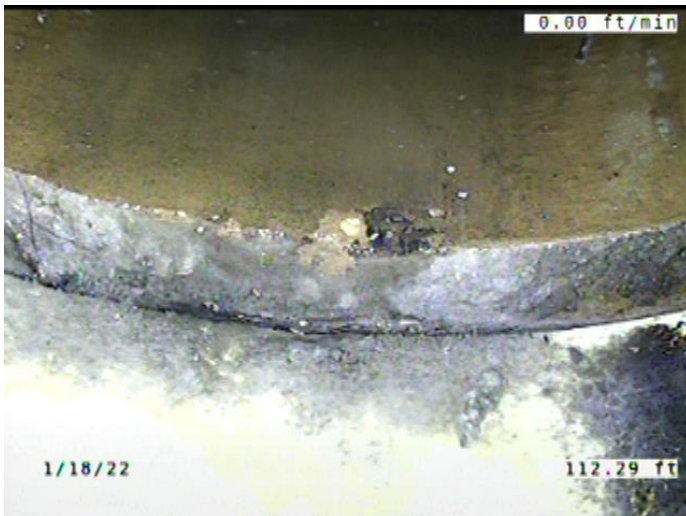
Code: **JOM**
Description: **Joint Offset Medium**

Distance (ft): **112.3**
Structural Grade: **3**
O&M Grade: **0**
Clock Start/From:
Clock To:
1st Value:
2nd Value:
Value Percent:
Continuous Index:
Within 8" of Joint: **NO**
Remarks:

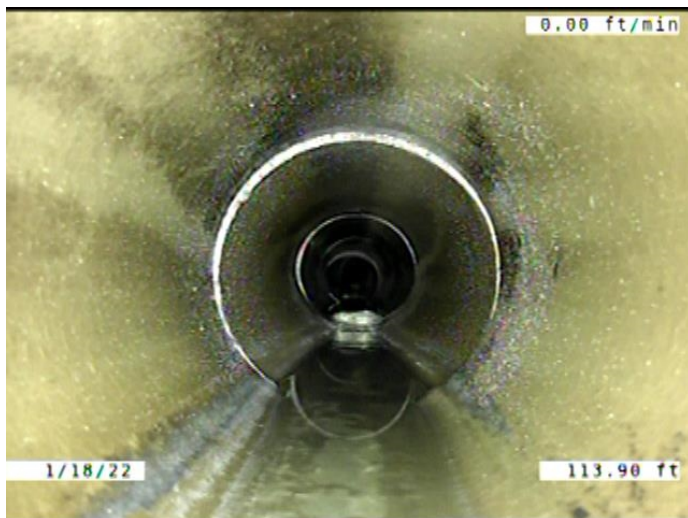
Code: **RFJ**
Description: **Roots Fine Joint**

Distance (ft): **113.9**
Structural Grade: **0**
O&M Grade: **1**
Clock Start/From: **8**
Clock To: **4**
1st Value:
2nd Value:
Value Percent:
Continuous Index: **F03**
Within 8" of Joint: **YES**
Remarks:

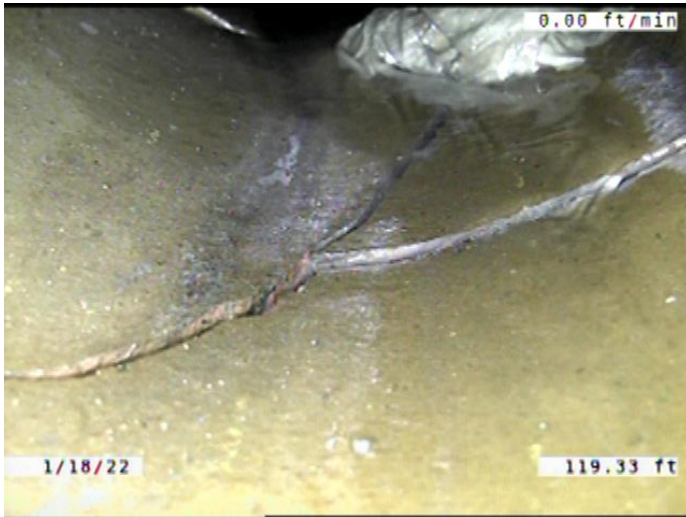
Code: **B**
 Description: **Broken**

Distance (ft): **119.3**
 Structural Grade: **4**
 O&M Grade: **0**
 Clock Start/From: **12**
 Clock To: **12**
 1st Value:
 2nd Value:
 Value Percent:
 Continuous Index: **S04**
 Within 8" of Joint: **YES**
 Remarks:

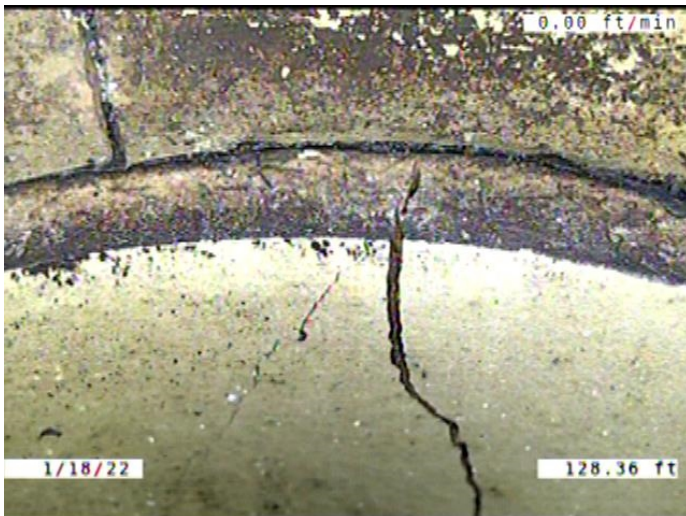
Code: **JOMD**
 Description: **Joint Offset Medium Defective**

Distance (ft): **128.4**
 Structural Grade: **3**
 O&M Grade: **0**
 Clock Start/From:
 Clock To:
 1st Value:
 2nd Value:
 Value Percent:
 Continuous Index:
 Within 8" of Joint: **NO**
 Remarks:

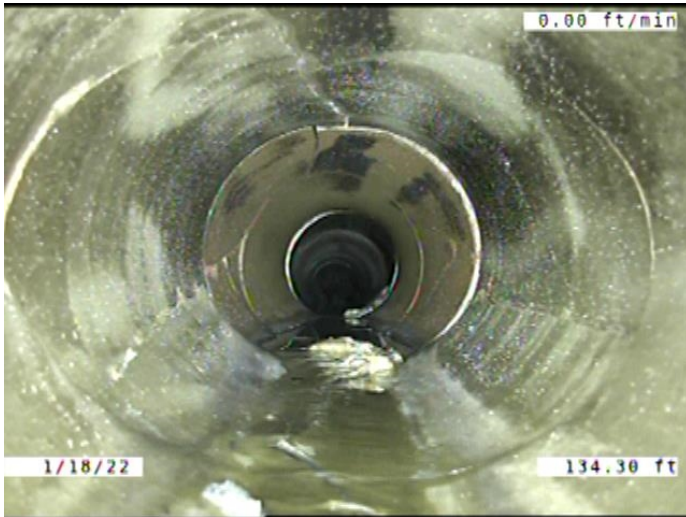
Code: **DR**
 Description: **Deformed Rigid**

Distance (ft): **134.3**
 Structural Grade: **4**
 O&M Grade: **0**
 Clock Start/From:
 Clock To:
 1st Value:
 2nd Value:
 Value Percent: **5.000**
 Continuous Index:
 Within 8" of Joint: **NO**
 Remarks:

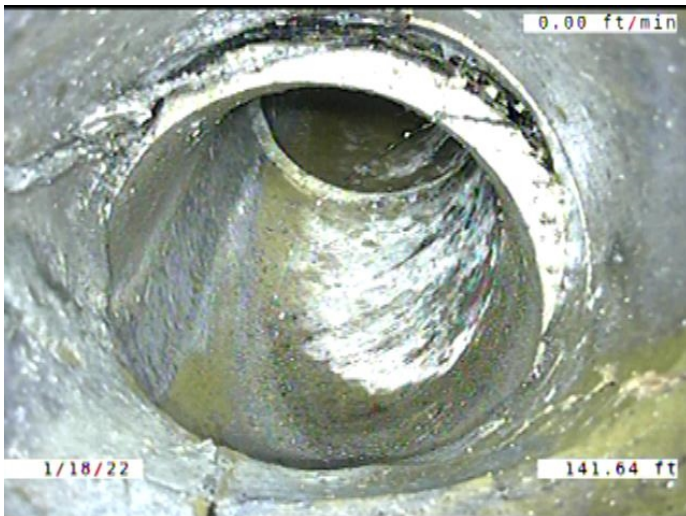
Code: **TFD**
 Description: **Tap Factory Defective**

Distance (ft): **141.6**
 Structural Grade: **0**
 O&M Grade: **3**
 Clock Start/From: **10**
 Clock To:
 1st Value: **4.000**
 2nd Value:
 Value Percent:
 Continuous Index:
 Within 8" of Joint: **YES**
 Remarks: **BROKEN. ROOTS COMING FROM THE MAIN TO SERVICE CONNECTION**

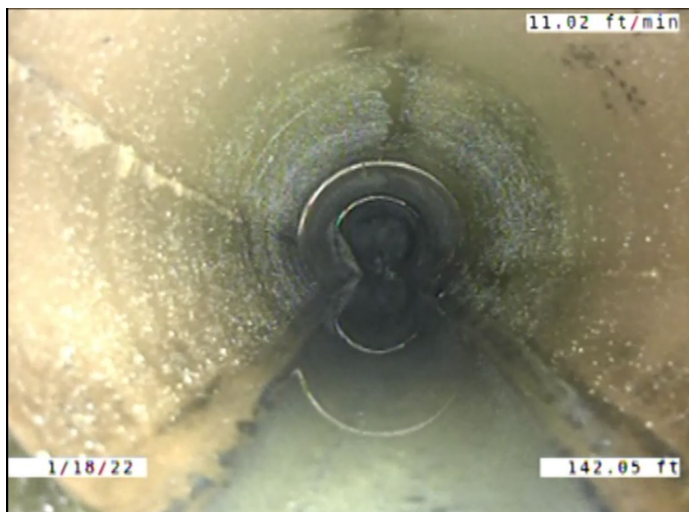
Code: **FH3**
Description: **Fracture Longitudinal Hinge, 3**

Distance (ft): **142.1**
Structural Grade: **4**
O&M Grade: **0**
Clock Start/From: **9**
Clock To: **3**
1st Value:
2nd Value:
Value Percent:
Continuous Index: **S06**
Within 8" of Joint: **YES**
Remarks:

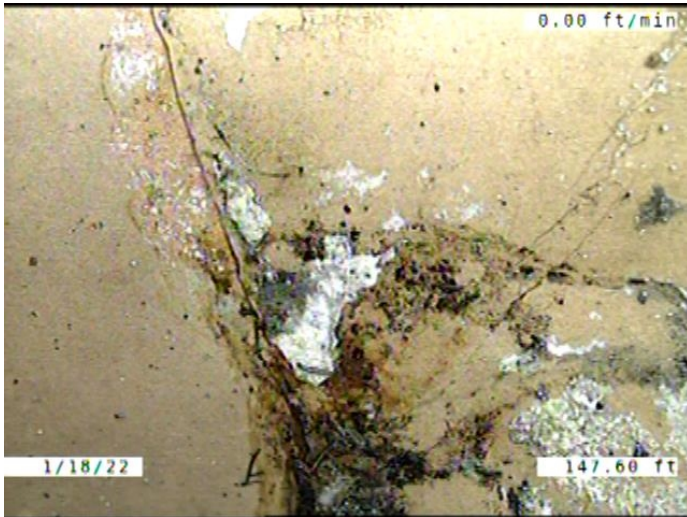
Code: **DAE**
 Description: **Deposits Attached Encrustation**

Distance (ft): **147.6**
 Structural Grade: **0**
 O&M Grade: **2**
 Clock Start/From: **3**
 Clock To: **5**
 1st Value:
 2nd Value:
 Value Percent: **5.000**
 Continuous Index:
 Within 8" of Joint: **YES**
 Remarks:

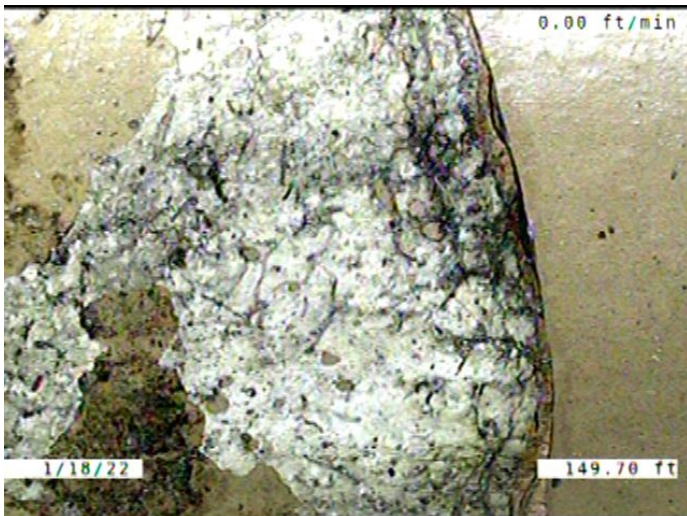
Code: **DAE**
 Description: **Deposits Attached Encrustation**

Distance (ft): **149.7**
 Structural Grade: **0**
 O&M Grade: **2**
 Clock Start/From: **7**
 Clock To: **11**
 1st Value:
 2nd Value:
 Value Percent: **5.000**
 Continuous Index:
 Within 8" of Joint: **YES**
 Remarks:

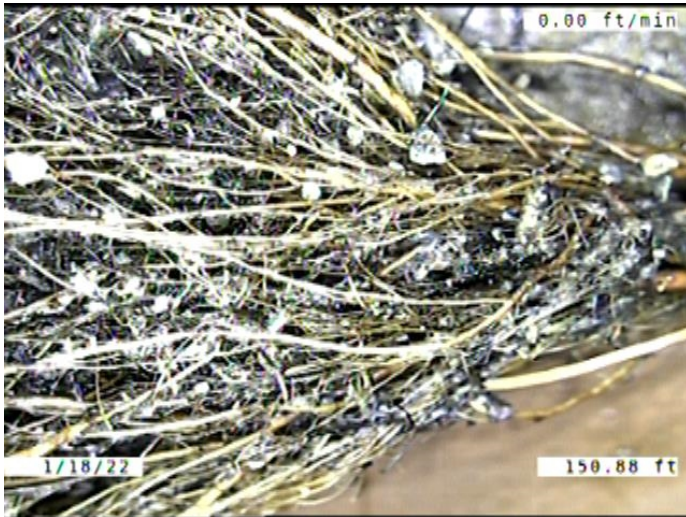
Code: **RMJ**
 Description: **Roots Medium Joint**

Distance (ft): **150.9**
 Structural Grade: **0**
 O&M Grade: **3**
 Clock Start/From: **7**
 Clock To: **5**
 1st Value:
 2nd Value:
 Value Percent: **5.000**
 Continuous Index:
 Within 8" of Joint: **YES**
 Remarks:

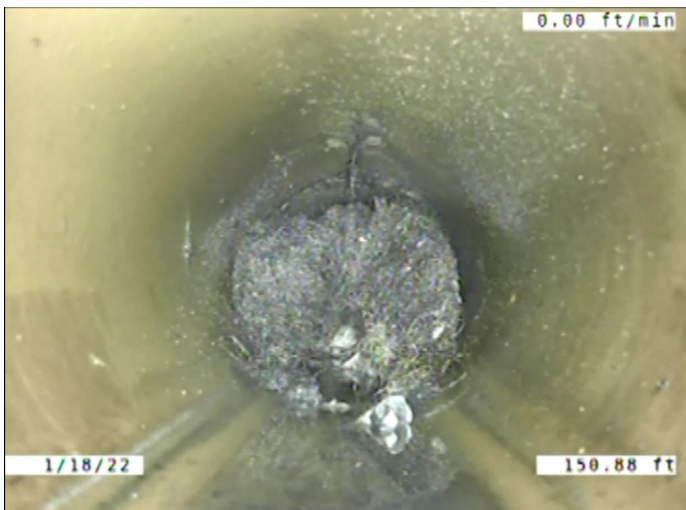
Code: **FH3**
 Description: **Fracture Longitudinal Hinge, 3**

Distance (ft): **150.9**
 Structural Grade: **4**
 O&M Grade: **0**
 Clock Start/From: **9**
 Clock To: **3**
 1st Value:
 2nd Value:
 Value Percent:
 Continuous Index: **F06**
 Within 8" of Joint: **YES**
 Remarks:

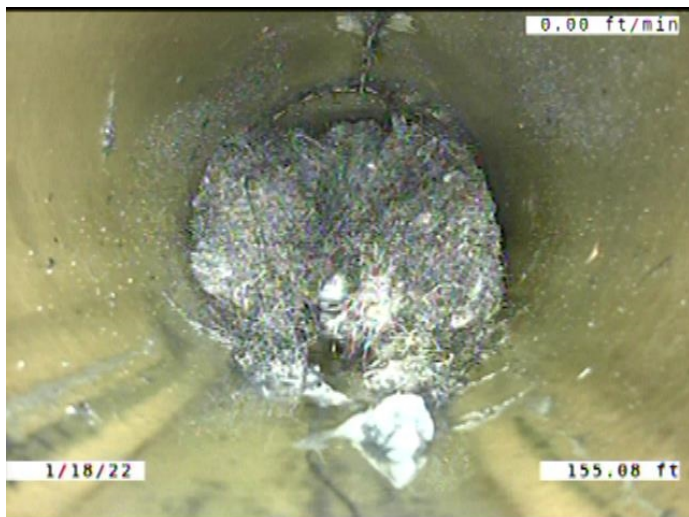
Code: **RBJ**
 Description: **Roots Ball Joint**

Distance (ft): **155.1**
 Structural Grade: **0**
 O&M Grade: **4**
 Clock Start/From: **12**
 Clock To: **12**
 1st Value:
 2nd Value:
 Value Percent: **95.000**
 Continuous Index:
 Within 8" of Joint: **YES**
 Remarks:

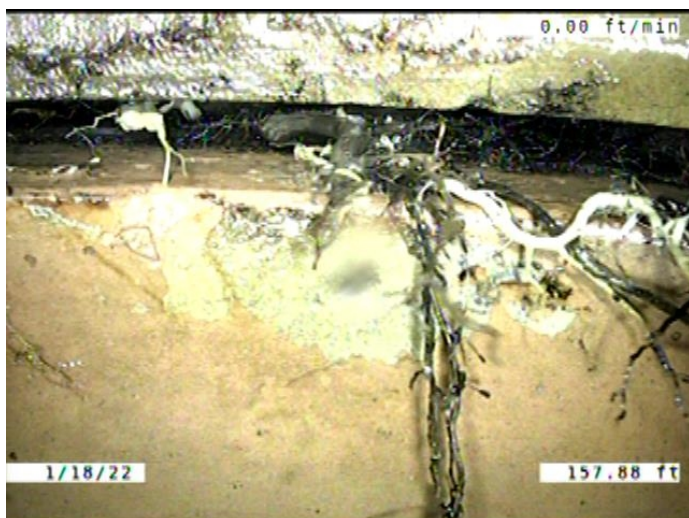
Code: **RFJ**
 Description: **Roots Fine Joint**

Distance (ft): **157.9**
 Structural Grade: **0**
 O&M Grade: **1**
 Clock Start/From: **7**
 Clock To: **5**
 1st Value:
 2nd Value:
 Value Percent:
 Continuous Index: **S05**
 Within 8" of Joint: **YES**
 Remarks:

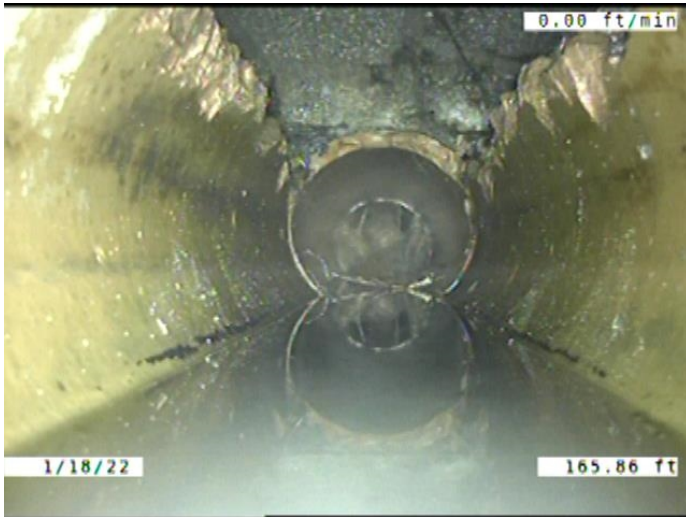
Code: **RFJ**
Description: **Roots Fine Joint**

Distance (ft): **165.9**
Structural Grade: **0**
O&M Grade: **1**
Clock Start/From: **7**
Clock To: **5**
1st Value:
2nd Value:
Value Percent:
Continuous Index: **F05**
Within 8" of Joint: **YES**
Remarks:

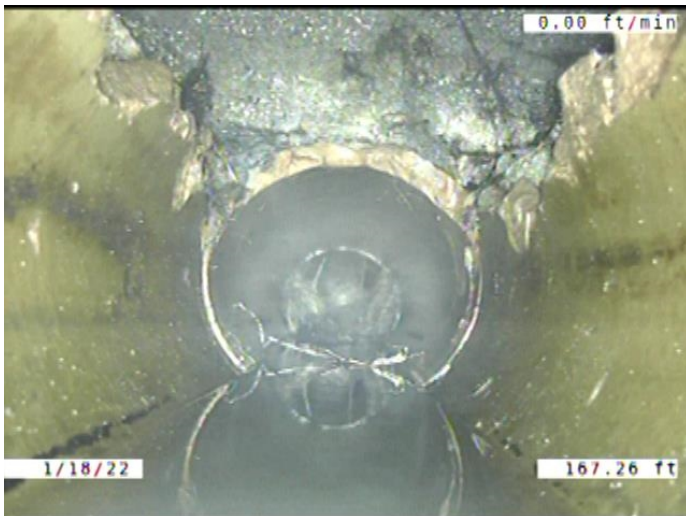
Code: **DSF**
Description: **Deposits Settled Fine**

Distance (ft): **167.3**
Structural Grade: **0**
O&M Grade: **2**
Clock Start/From: **5**
Clock To: **7**
1st Value:
2nd Value:
Value Percent: **5.000**
Continuous Index: **F01**
Within 8" of Joint: **YES**
Remarks:
