Profile/Photo Observation Report

Date:	04/06/2018	Weather:		Coding:	PACP 6.0
Pipe Length (ft):	77.1	Owner:	NA	Pre Clean:	No Pre-Cleaning
P.O.#:		Surveyor:	Jen Costello	PSR:	P-506-029-026
Customer:		Clean Date:	01/01/1900	Shape:	C

Street:	S COLORADO ST	Flow Control:	Not Controlled
City:	Hobart, IN	Year Renewed:	
Location:	Yard	Tape/Media #:	
Purpose:	Routine Assessment	Dia/Height:	10"
Use:	Sanitary	Material:	CP
Drain Area:	NA	Lining:	
Category:	NA		
Comment:			
Location Details:		Direction of Survey:	Upstream
US MH:	M-506-026	DS MH:	M-506-029
		Total Length Surveyed (ft):	7.8

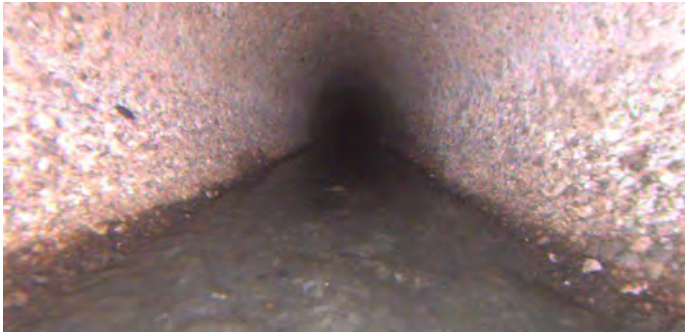
Code:	MWL
Description:	Water Level

Distance (ft):	.0
Structural Grade:	0
O&M Grade:	0
Clock Start/From:	
Clock To:	
1st Value:	
2nd Value:	
Value Percent:	10.000
Continuous Index:	
Within 8" of Joint:	NO
Remarks:

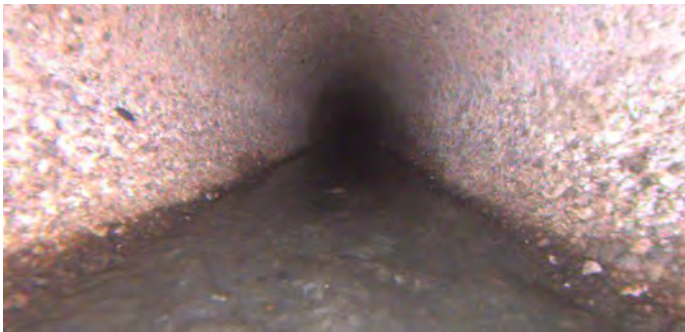
Code:	VC
Description:	Vermin Cockroach

Distance (ft):	.0
Structural Grade:	0
O&M Grade:	1
Clock Start/From:	
Clock To:	
1st Value:	
2nd Value:	
Value Percent:	
Continuous Index:	
Within 8" of Joint:	
Remarks:

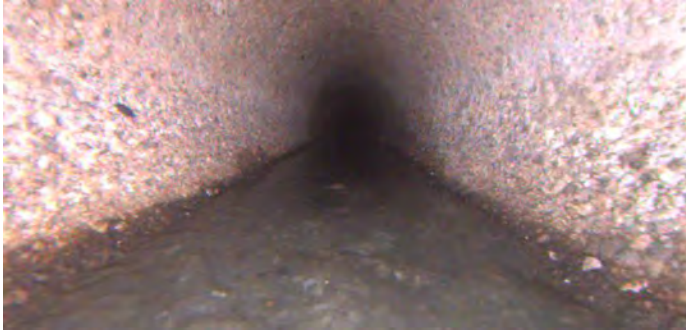
Code: **SAP**
Description: **Surface Aggregate Projecting**

Distance (ft): **.0**
Structural Grade: **3**
O&M Grade: **0**
Clock Start/From: **8**
Clock To: **4**
1st Value:
2nd Value:
Value Percent:
Continuous Index: **S01**
Within 8" of Joint:
Remarks:

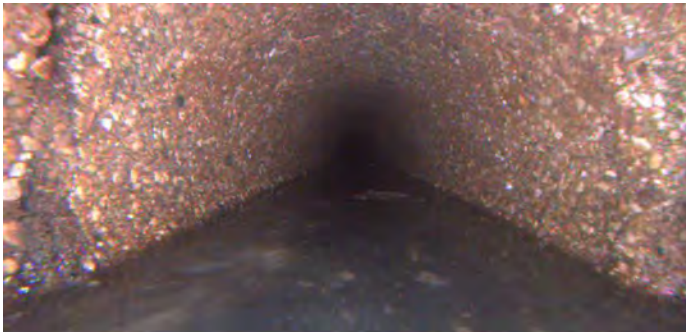
Code: **SAP**
Description: **Surface Aggregate Projecting**

Distance (ft): **7.8**
Structural Grade: **3**
O&M Grade: **0**
Clock Start/From: **8**
Clock To: **4**
1st Value:
2nd Value:
Value Percent:
Continuous Index: **F01**
Within 8" of Joint:
Remarks:

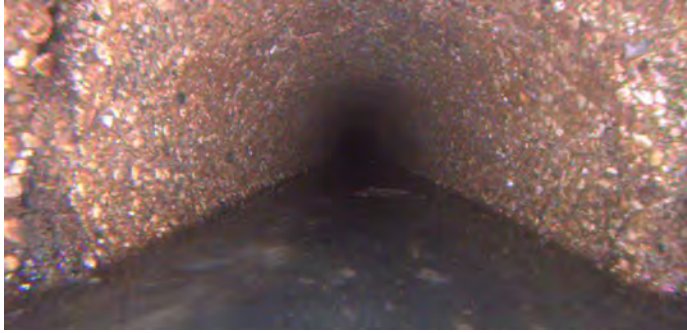
Code:	MSA
Description:	Abandoned Survey
Distance (ft):	7.8
Structural Grade:	0
O&M Grade:	0
Clock Start/From:	
Clock To:	
1st Value:	
2nd Value:	
Value Percent:	
Continuous Index:	
Within 8" of Joint:	NO
Remarks:	DEBRIS UNDER WATER
