## Profile/Photo Observation Report

Street:	<b>FOXCROFT STREET</b>	Flow Control:	<b>Not Controlled</b>
City:	<b>Hobart, IN</b>	Year Renewed:	
Location:	<b>Yard</b>	Tape/Media #:	
Purpose:	<b>Routine Assessment</b>	Dia/Height:	<b>10"</b>
Use:	<b>Sanitary</b>	Material:	<b>CP</b>
Drain Area:	<b>NA</b>	Lining:	
Category:	<b>NA</b>		
Comment:			
Location Details:		Direction of Survey:	<b>Upstream</b>
US MH:	<b>M-506-026</b>	DS MH:	<b>M-506-029</b>
		Total Length Surveyed (ft):	<b>7.8</b>

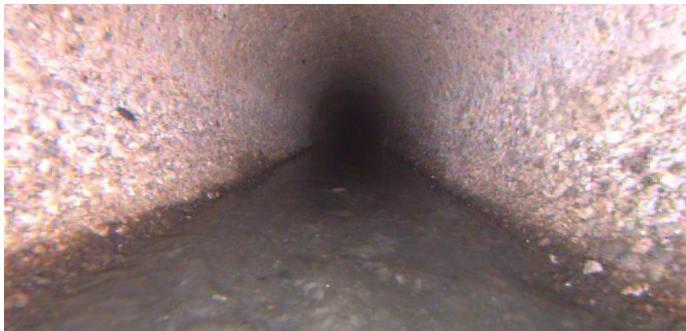
Code: **AMH**  
Description: **Manhole**

Distance (ft): **.0**  
Structural Grade: **0**  
O&M Grade: **0**  
Clock Start/From:  
Clock To:  
1st Value:  
2nd Value:  
Value Percent:  
Continuous Index:  
Within 8" of Joint: **NO**  
Remarks: **M-506-029**

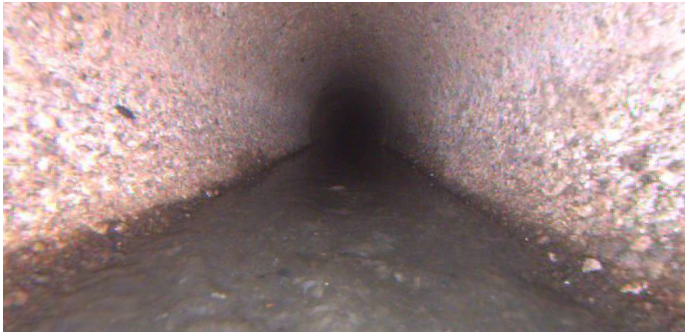
Code:	<b>MWL</b>
Description:	<b>Water Level</b>

Distance (ft):	<b>.0</b>
Structural Grade:	<b>0</b>
O&M Grade:	<b>0</b>
Clock Start/From:	
Clock To:	
1st Value:	
2nd Value:	
Value Percent:	<b>10.000</b>
Continuous Index:	
Within 8" of Joint:	<b>NO</b>
Remarks:

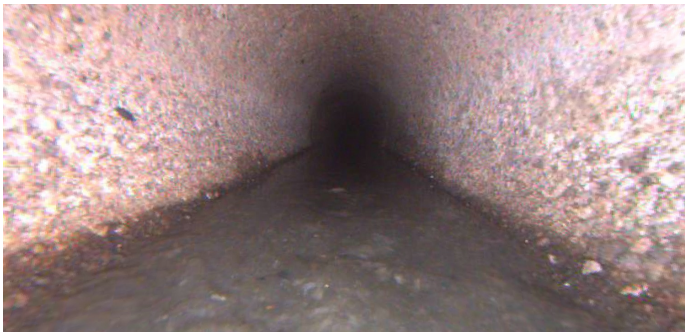
Code:	<b>VC</b>
Description:	<b>Vermin Cockroach</b>

Distance (ft):	<b>.0</b>
Structural Grade:	<b>0</b>
O&M Grade:	<b>1</b>
Clock Start/From:	
Clock To:	
1st Value:	
2nd Value:	
Value Percent:	
Continuous Index:	
Within 8" of Joint:	
Remarks:

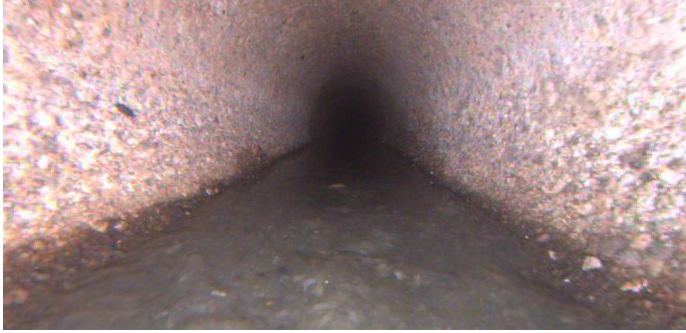
Code: **SAP**  
Description: **Surface Aggregate Projecting**

Distance (ft): **.0**  
Structural Grade: **3**  
O&M Grade: **0**  
Clock Start/From: **8**  
Clock To: **4**  
1st Value:  
2nd Value:  
Value Percent:  
Continuous Index: **S01**  
Within 8" of Joint:  
Remarks:

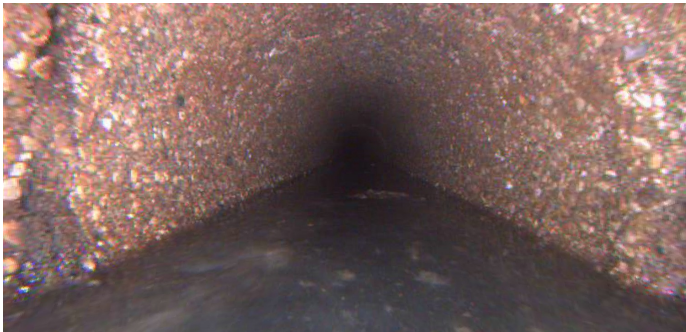
Code: **SAP**  
Description: **Surface Aggregate Projecting**

Distance (ft): **7.8**  
Structural Grade: **3**  
O&M Grade: **0**  
Clock Start/From: **8**  
Clock To: **4**  
1st Value:  
2nd Value:  
Value Percent:  
Continuous Index: **F01**  
Within 8" of Joint:  
Remarks:

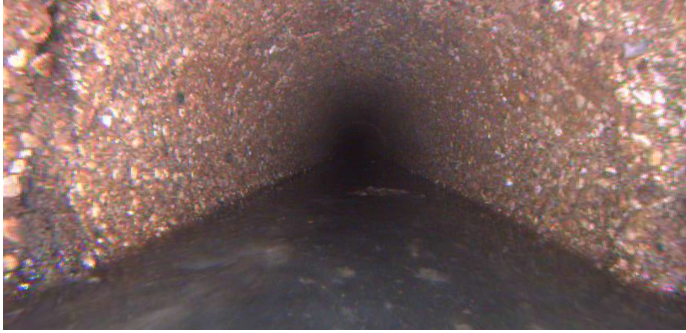
Code:	<b>MSA</b>
Description:	<b>Abandoned Survey</b>
Distance (ft):	<b>7.8</b>
Structural Grade:	<b>0</b>
O&M Grade:	<b>0</b>
Clock Start/From:	
Clock To:	
1st Value:	
2nd Value:	
Value Percent:	
Continuous Index:	
Within 8" of Joint:	<b>NO</b>
Remarks:	<b>DEBRIS UNDER WATER</b>
