## Profile/Photo Observation Report

Date:	<b>04/06/2018</b>	Weather:		Coding:	<b>PACP 6.0</b>
Pipe Length (ft):	<b>77.1</b>	Owner:	<b>NA</b>	Pre Clean:	<b>No Pre-Cleaning</b>
P.O.#:		Surveyor:	<b>Byrd Fitzgerald</b>	PSR:	<b>P-506-029-026</b>
Customer:		Clean Date:	<b>01/01/1900</b>	Shape:	<b>C</b>

Street:	<b>S COLORADO ST</b>	Flow Control:	<b>Not Controlled</b>
City:	<b>Hobart, IN</b>	Year Renewed:	
Location:	<b>Yard</b>	Tape/Media #:	
Purpose:	<b>Routine Assessment</b>	Dia/Height:	<b>10"</b>
Use:	<b>Sanitary</b>	Material:	<b>RCP</b>
Drain Area:	<b>NA</b>	Lining:	
Category:	<b>NA</b>		
Comment:	<b>P_C debris, flow direction is marked wrong.</b>		
Location Details:		Direction of Survey:	<b>Downstream</b>
US MH:	<b>M-506-026</b>	DS MH:	<b>M-506-029</b>
		Total Length Surveyed (ft):	<b>29.6</b>

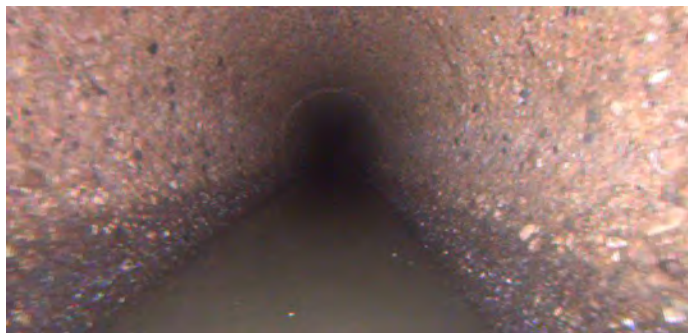
Code: **AMH**  
Description: **Manhole**

Distance (ft): **.0**  
Structural Grade: **0**  
O&M Grade: **0**  
Clock Start/From:  
Clock To:  
1st Value:  
2nd Value:  
Value Percent:  
Continuous Index:  
Within 8" of Joint: **NO**  
Remarks: **M-506-026**

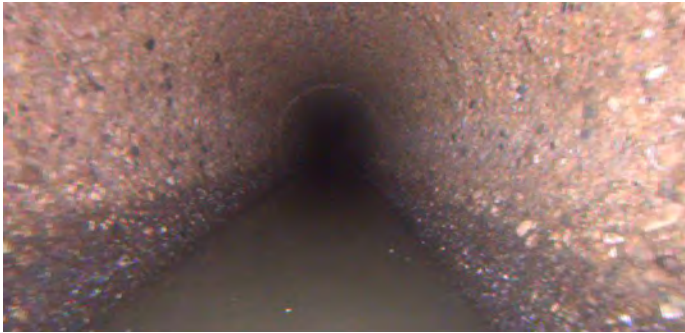
Code:	<b>MWL</b>
Description:	<b>Water Level</b>

Distance (ft):	<b>.0</b>
Structural Grade:	<b>0</b>
O&M Grade:	<b>0</b>
Clock Start/From:	
Clock To:	
1st Value:	
2nd Value:	
Value Percent:	<b>5.000</b>
Continuous Index:	
Within 8" of Joint:	<b>NO</b>
Remarks:

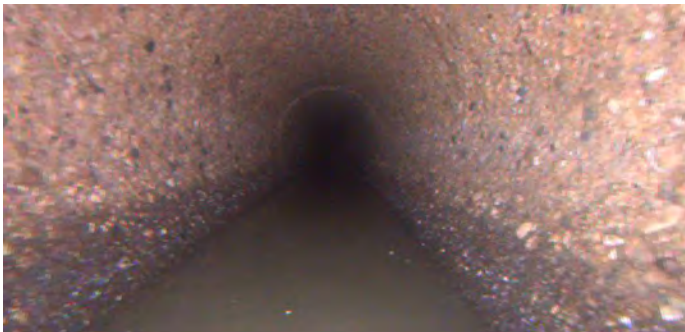
Code:	<b>SAV</b>
Description:	<b>Surface Aggregate Visible</b>

Distance (ft):	<b>.0</b>
Structural Grade:	<b>3</b>
O&M Grade:	<b>0</b>
Clock Start/From:	<b>7</b>
Clock To:	<b>5</b>
1st Value:	
2nd Value:	
Value Percent:	
Continuous Index:	<b>S01</b>
Within 8" of Joint:	<b>NO</b>
Remarks:

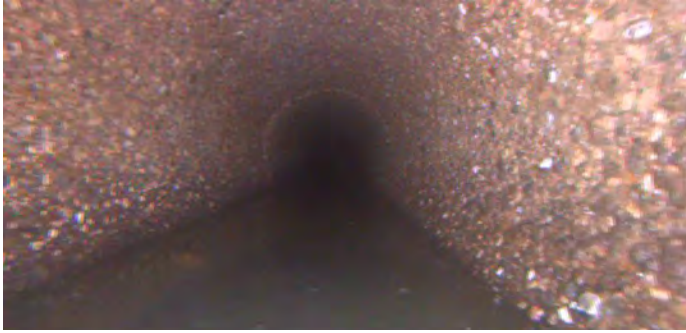
Code: **MSA**  
Description: **Abandoned Survey**

Distance (ft): **29.6**  
Structural Grade: **0**  
O&M Grade: **0**  
Clock Start/From:  
Clock To:  
1st Value:  
2nd Value:  
Value Percent:  
Continuous Index:  
Within 8" of Joint: **NO**  
Remarks: **no blockage**

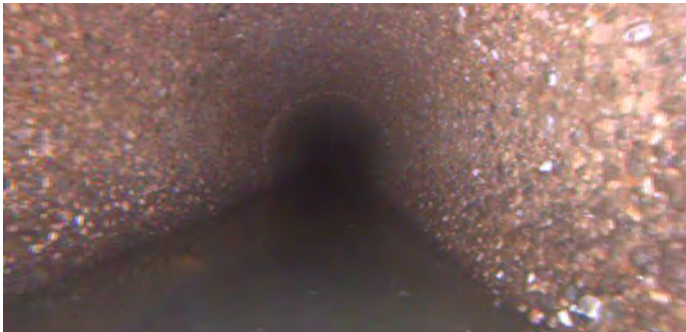
Code: **SAV**  
Description: **Surface Aggregate Visible**

Distance (ft): **29.6**  
Structural Grade: **3**  
O&M Grade: **0**  
Clock Start/From: **7**  
Clock To: **5**  
1st Value:  
2nd Value:  
Value Percent:  
Continuous Index: **F01**  
Within 8" of Joint: **NO**  
Remarks:
