Profile/Photo Observation Report

Date:	01/18/2022	Weather:		Coding:	PACP 7.0
Pipe Length (ft):	75.2	Owner:	City of Hobart	Pre Clean:	Heavy Cleaning
P.O.#:	YES502259	Surveyor:	S. Bucklin	PSR:	P-506-029-026
Customer:	City of Hobart	Clean Date:	01/16/2021	Shape:	C

Street:	South Colorado Street	Flow Control:	Not Controlled
City:	Hobart, IN	Year Renewed:	
Location:	Local rural streets with light traffic, t	Tape/Media #:	
Purpose:	Routine Assessment	Dia/Height:	10"
Use:	Sanitary Sewage Pipe	Material:	CP
Drain Area:		Lining:	None
Category:	NA		
Comment:			
Location Details:		Direction of Survey:	Upstream
US MH:	M-506-026	DS MH:	M-506-029
		Total Length Surveyed (ft):	75.2

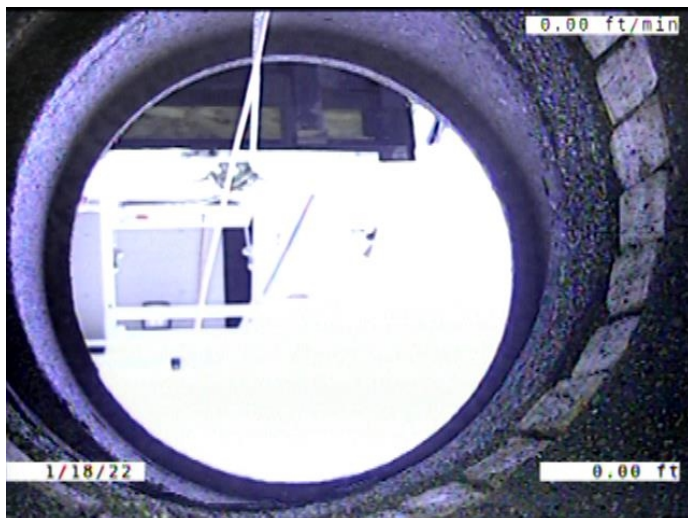
Code: **AMH**
Description: **Manhole**

Distance (ft): **.0**
Structural Grade: **0**
O&M Grade: **0**
Clock Start/From:
Clock To:
1st Value:
2nd Value:
Value Percent:
Continuous Index:
Within 8" of Joint: **NO**
Remarks: **M-506-029**

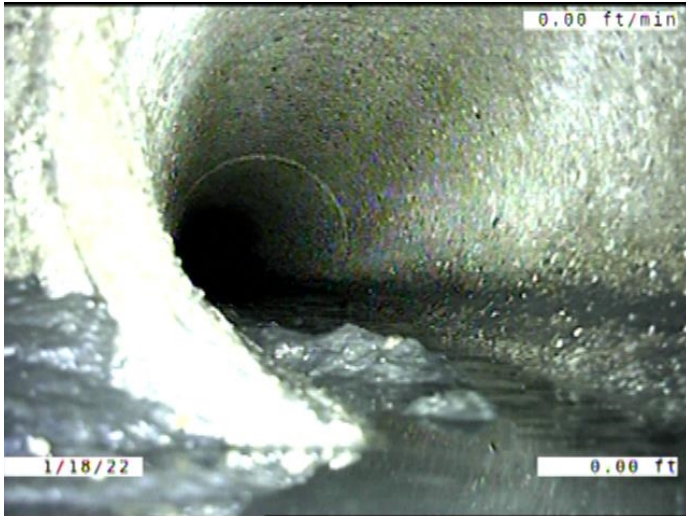
Code: **MWL**
Description: **Miscellaneous Water Level**

Distance (ft): **.0**
Structural Grade: **0**
O&M Grade: **0**
Clock Start/From:
Clock To:
1st Value:
2nd Value:
Value Percent: **5.000**
Continuous Index:
Within 8" of Joint: **NO**
Remarks:

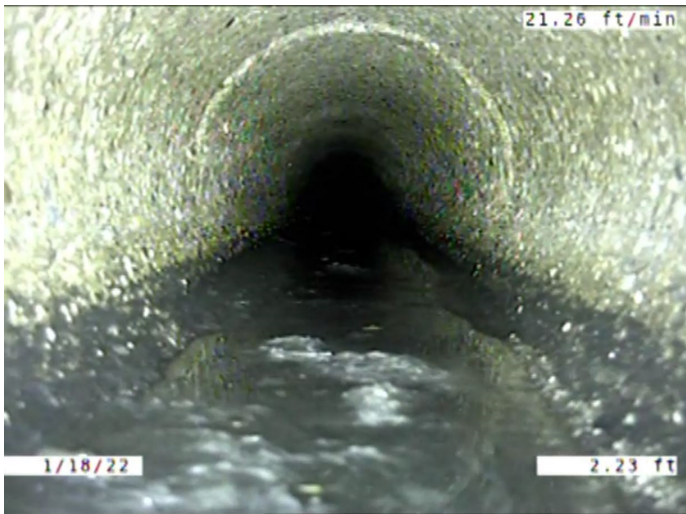
Code: **SAV**
Description: **Surface Damage Aggregate Visible**

Distance (ft): **2.2**
Structural Grade: **2**
O&M Grade: **0**
Clock Start/From: **8**
Clock To: **4**
1st Value:
2nd Value:
Value Percent:
Continuous Index: **S02**
Within 8" of Joint: **NO**
Remarks:

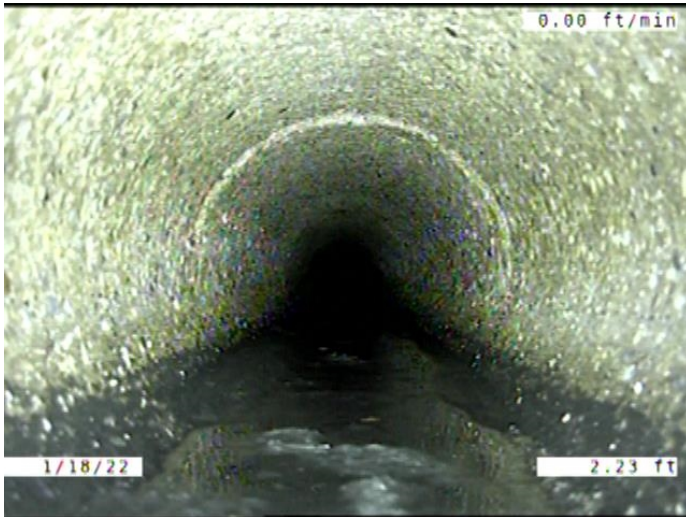
Code: **DSF**
Description: **Deposits Settled Fine**

Distance (ft): **2.2**
Structural Grade: **0**
O&M Grade: **2**
Clock Start/From: **5**
Clock To: **7**
1st Value:
2nd Value:
Value Percent: **5.000**
Continuous Index: **S01**
Within 8" of Joint: **YES**
Remarks:

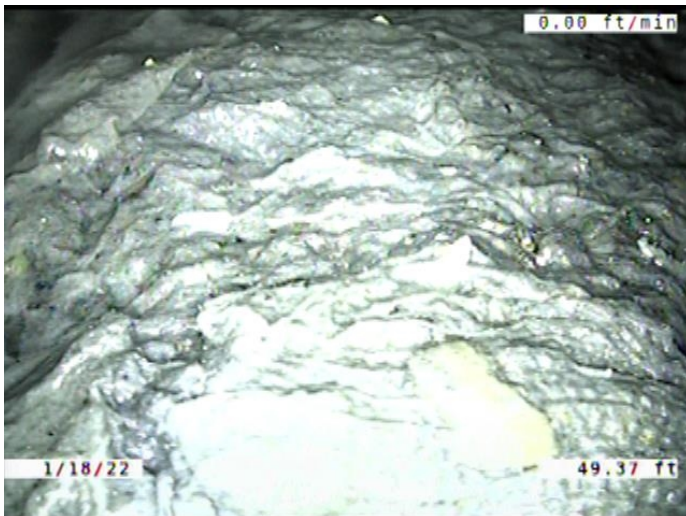
Code: **DAR**
Description: **Deposits Attached Ragging**

Distance (ft): **49.4**
Structural Grade: **0**
O&M Grade: **2**
Clock Start/From: **5**
Clock To: **7**
1st Value:
2nd Value:
Value Percent: **5.000**
Continuous Index:
Within 8" of Joint: **YES**
Remarks:

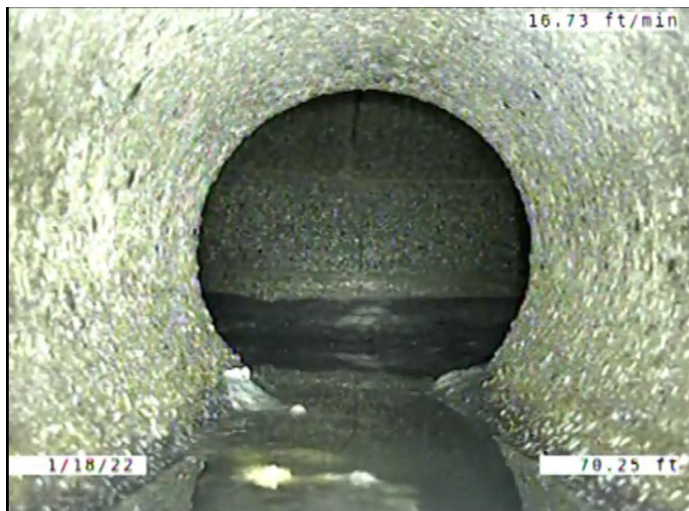
Code: **SAV**
 Description: **Surface Damage Aggregate Visible**

Distance (ft): **70.3**
 Structural Grade: **2**
 O&M Grade: **0**
 Clock Start/From: **8**
 Clock To: **4**
 1st Value:
 2nd Value:
 Value Percent:
 Continuous Index: **F02**
 Within 8" of Joint: **NO**
 Remarks:

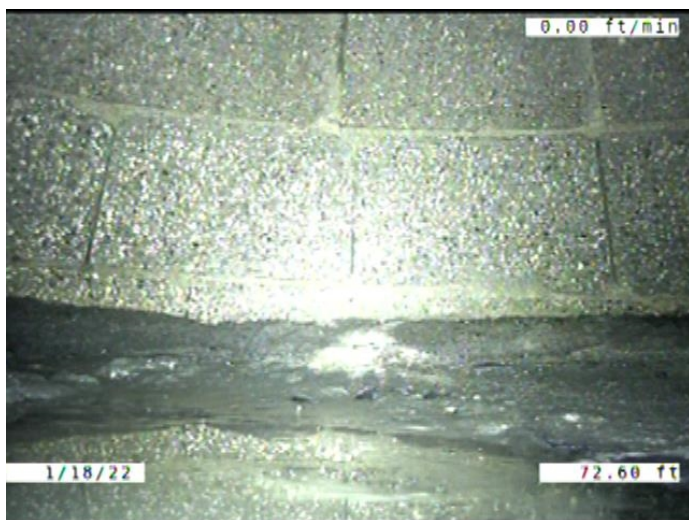
Code: **DSF**
 Description: **Deposits Settled Fine**

Distance (ft): **72.6**
 Structural Grade: **0**
 O&M Grade: **2**
 Clock Start/From: **5**
 Clock To: **7**
 1st Value:
 2nd Value:
 Value Percent: **5.000**
 Continuous Index: **F01**
 Within 8" of Joint: **YES**
 Remarks:

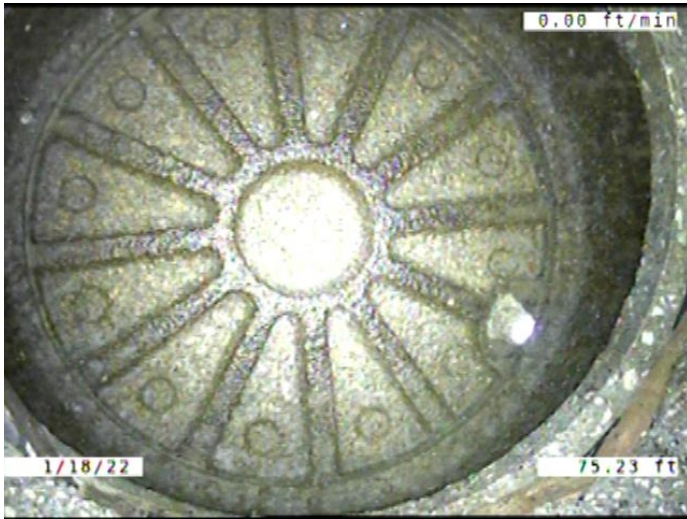
Code:	AMH
Description:	Manhole
Distance (ft):	75.2
Structural Grade:	0
O&M Grade:	0
Clock Start/From:	
Clock To:	
1st Value:	
2nd Value:	
Value Percent:	
Continuous Index:	
Within 8" of Joint:	NO
Remarks:	M-506-026
