## Profile/Photo Observation Report

Date:	<b>01/19/2022</b>	Weather:		Coding:	<b>PACP 7.0</b>
Pipe Length (ft):	<b>148.7</b>	Owner:	<b>City of Hobart</b>	Pre Clean:	<b>Heavy Cleaning</b>
P.O.#:	<b>YES502259</b>	Surveyor:	<b>S. Bucklin</b>	PSR:	<b>P-506-028-027</b>
Customer:	<b>City of Hobart</b>	Clean Date:	<b>01/18/2022</b>	Shape:	<b>C</b>

Street:	<b>River Terrace</b>	Flow Control:	<b>Not Controlled</b>
City:	<b>Hobart, IN</b>	Year Renewed:	
Location:	<b>Alley</b>	Tape/Media #:	
Purpose:	<b>Routine Assessment</b>	Dia/Height:	<b>10"</b>
Use:	<b>Sanitary Sewage Pipe</b>	Material:	<b>VCP</b>
Drain Area:		Lining:	<b>None</b>
Category:	<b>NA</b>		
Comment:

Location Details:		Direction of Survey:	<b>Downstream</b>
US MH:	<b>M-506-027</b>	DS MH:	<b>M-506-028</b>
		Total Length Surveyed (ft):	<b>148.7</b>

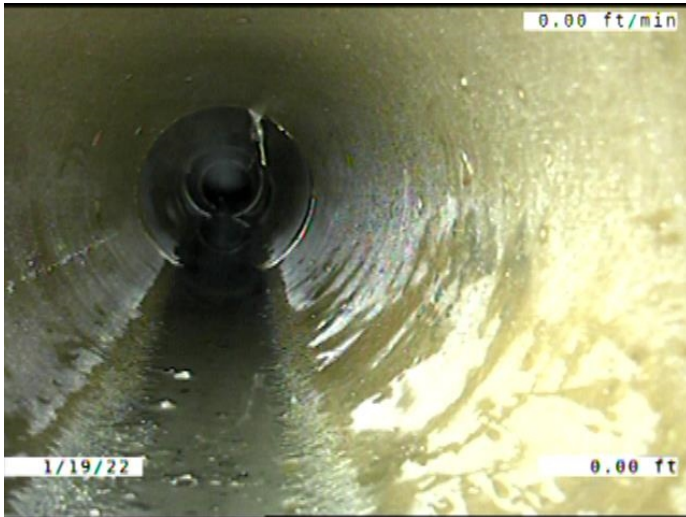
Code: **DSF**  
 Description: **Deposits Settled Fine**

Distance (ft): **.0**  
 Structural Grade: **0**  
 O&M Grade: **2**  
 Clock Start/From: **5**  
 Clock To: **7**  
 1st Value:  
 2nd Value:  
 Value Percent: **5.000**  
 Continuous Index: **S01**  
 Within 8" of Joint: **YES**  
 Remarks:

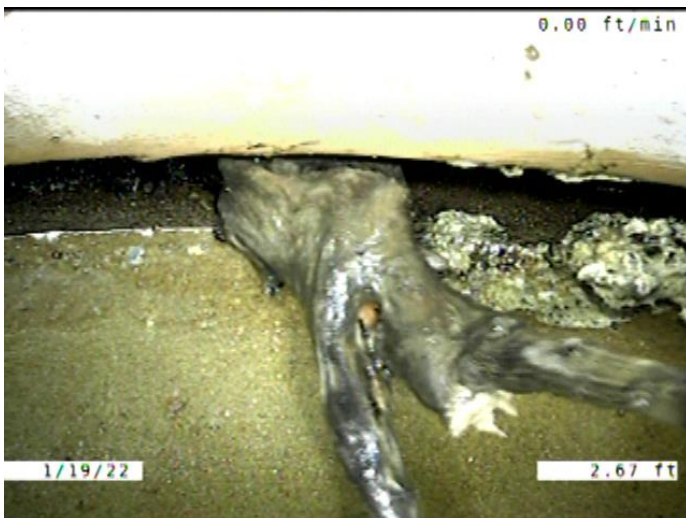
Code: **RTJ**  
 Description: **Roots Tap Joint**

Distance (ft): **2.7**  
 Structural Grade: **0**  
 O&M Grade: **2**  
 Clock Start/From: **12**  
 Clock To: **1**  
 1st Value:  
 2nd Value:  
 Value Percent: **5.000**  
 Continuous Index:  
 Within 8" of Joint: **YES**  
 Remarks:

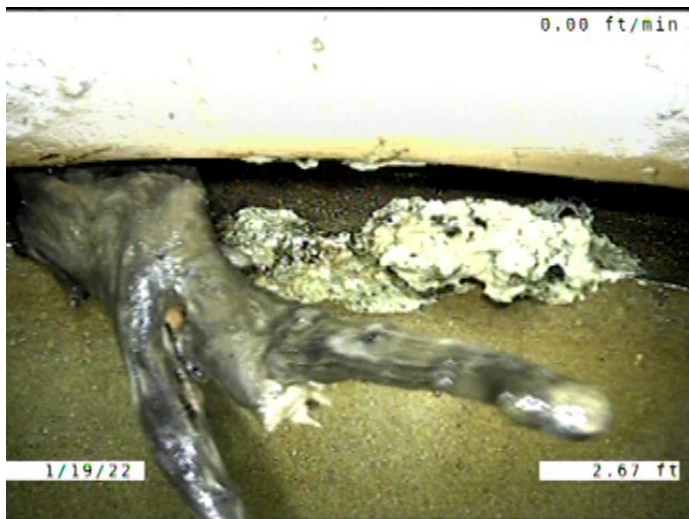
Code: **DAE**  
Description: **Deposits Attached Encrustation**

Distance (ft): **2.7**  
Structural Grade: **0**  
O&M Grade: **2**  
Clock Start/From: **1**  
Clock To:  
1st Value:  
2nd Value:  
Value Percent: **5.000**  
Continuous Index:  
Within 8" of Joint: **YES**  
Remarks:

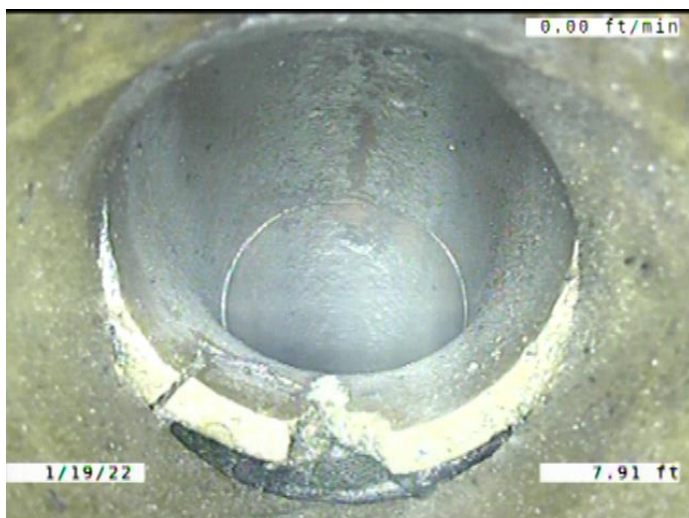
Code: **TF**  
Description: **Tap Factory**

Distance (ft): **7.9**  
Structural Grade: **0**  
O&M Grade: **0**  
Clock Start/From: **12**  
Clock To:  
1st Value: **4.000**  
2nd Value:  
Value Percent:  
Continuous Index:  
Within 8" of Joint: **YES**  
Remarks: **SERVICE LINE BROKEN AND OFFSET**

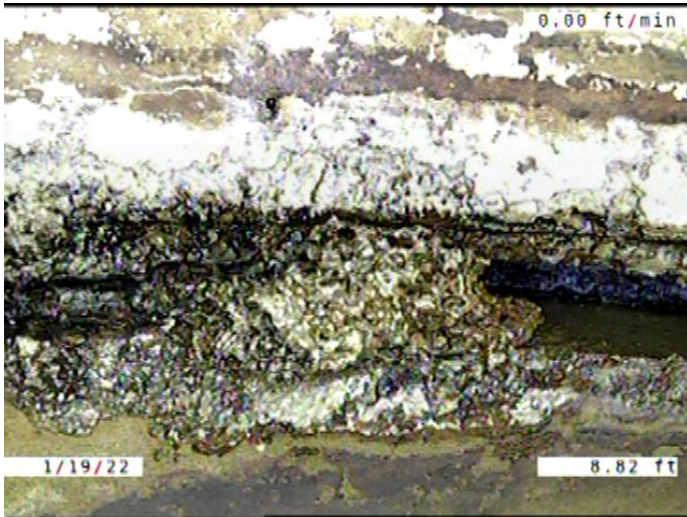
Code: **DAE**  
 Description: **Deposits Attached Encrustation**

Distance (ft): **8.8**  
 Structural Grade: **0**  
 O&M Grade: **2**  
 Clock Start/From: **8**  
 Clock To: **4**  
 1st Value:  
 2nd Value:  
 Value Percent: **5.000**  
 Continuous Index:  
 Within 8" of Joint: **YES**  
 Remarks:

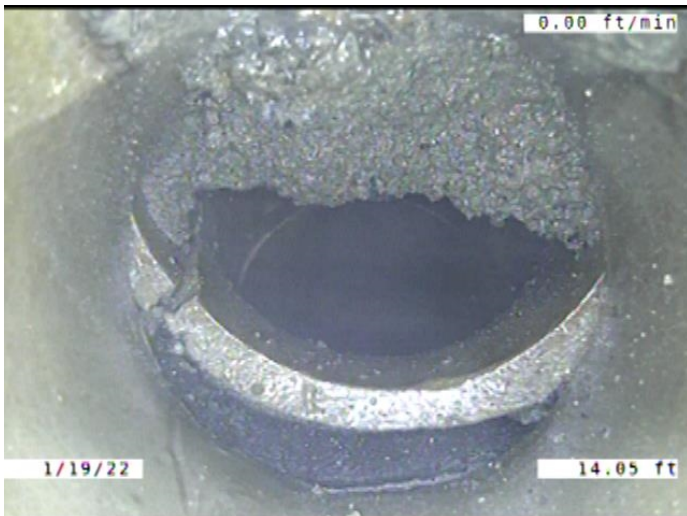
Code: **TF**  
 Description: **Tap Factory**

Distance (ft): **14.0**  
 Structural Grade: **0**  
 O&M Grade: **0**  
 Clock Start/From: **12**  
 Clock To:  
 1st Value: **4.000**  
 2nd Value:  
 Value Percent:  
 Continuous Index:  
 Within 8" of Joint: **YES**  
 Remarks: **SERVICE LINE BROKEN AND LARGE OFFSET. SOIL VISIBLE**

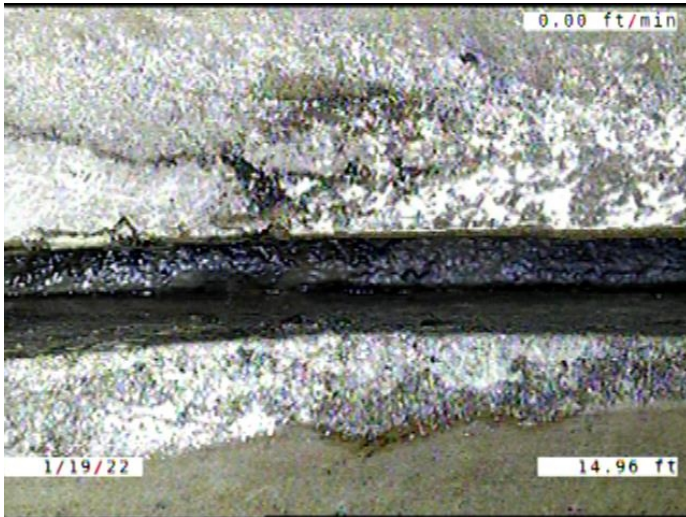
Code: **ISJ**  
 Description: **Infiltration Stain Joint**

Distance (ft): **15.0**  
 Structural Grade: **0**  
 O&M Grade: **1**  
 Clock Start/From: **9**  
 Clock To: **11**  
 1st Value:  
 2nd Value:  
 Value Percent:  
 Continuous Index:  
 Within 8" of Joint: **YES**  
 Remarks:

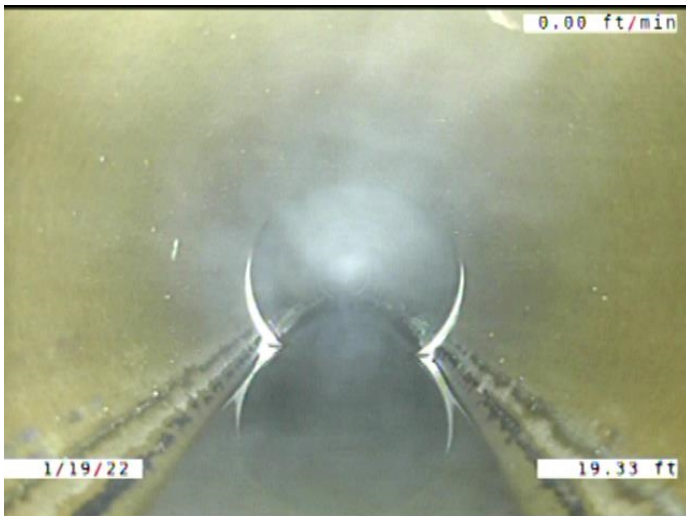
Code: **MWLS**  
 Description: **Miscellaneous Water Level Sag**

Distance (ft): **19.3**  
 Structural Grade: **2**  
 O&M Grade: **0**  
 Clock Start/From:  
 Clock To:  
 1st Value:  
 2nd Value:  
 Value Percent: **5.000**  
 Continuous Index: **S02**  
 Within 8" of Joint: **NO**  
 Remarks:

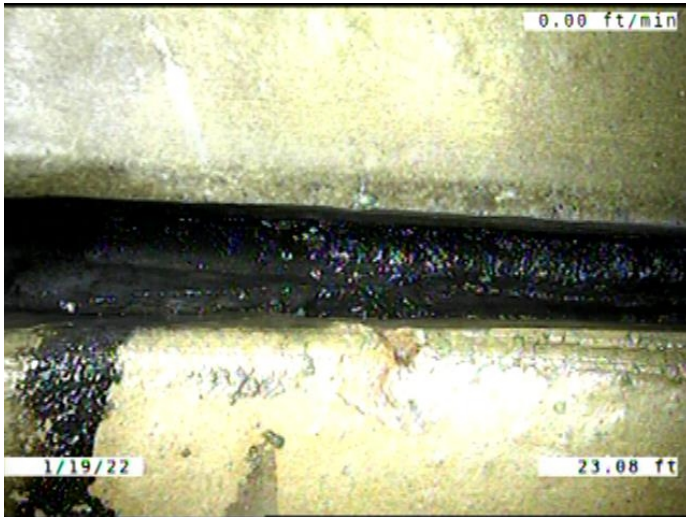
Code: **JAM**  
 Description: **Joint Angular Medium**

Distance (ft): **23.1**  
 Structural Grade: **3**  
 O&M Grade: **0**  
 Clock Start/From:  
 Clock To:  
 1st Value:  
 2nd Value:  
 Value Percent:  
 Continuous Index:  
 Within 8" of Joint: **NO**  
 Remarks:

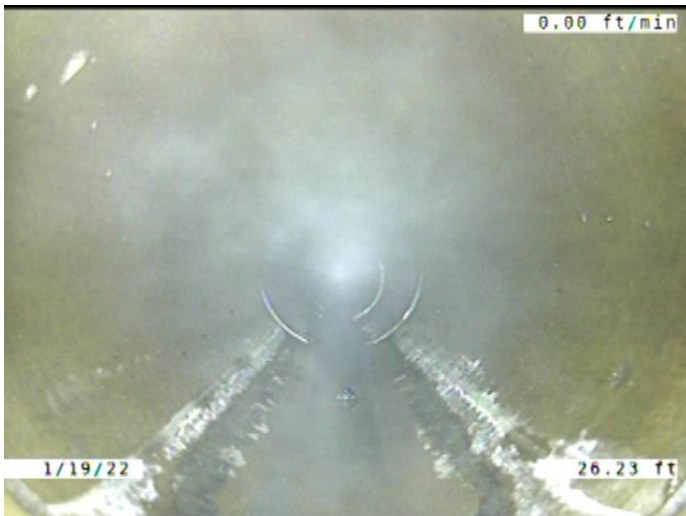
Code: **MWLS**  
 Description: **Miscellaneous Water Level Sag**

Distance (ft): **26.2**  
 Structural Grade: **2**  
 O&M Grade: **0**  
 Clock Start/From:  
 Clock To:  
 1st Value:  
 2nd Value:  
 Value Percent: **5.000**  
 Continuous Index: **F02**  
 Within 8" of Joint: **NO**  
 Remarks:

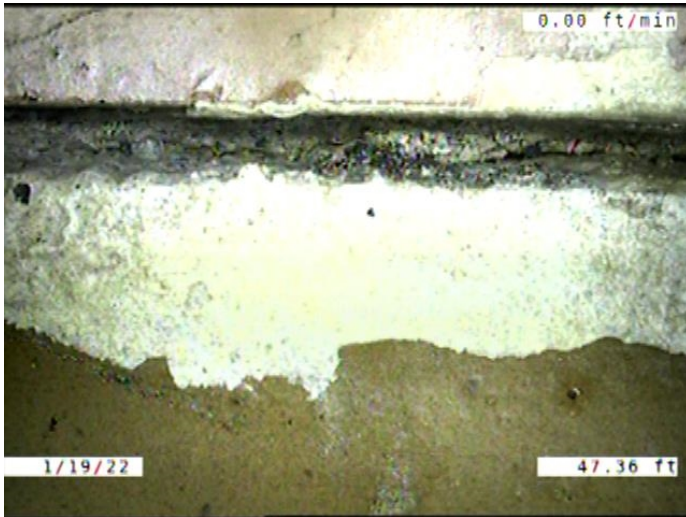
Code: **DAE**  
 Description: **Deposits Attached Encrustation**

Distance (ft): **47.4**  
 Structural Grade: **0**  
 O&M Grade: **2**  
 Clock Start/From: **1**  
 Clock To: **3**  
 1st Value:  
 2nd Value:  
 Value Percent: **5.000**  
 Continuous Index:  
 Within 8" of Joint: **YES**  
 Remarks:

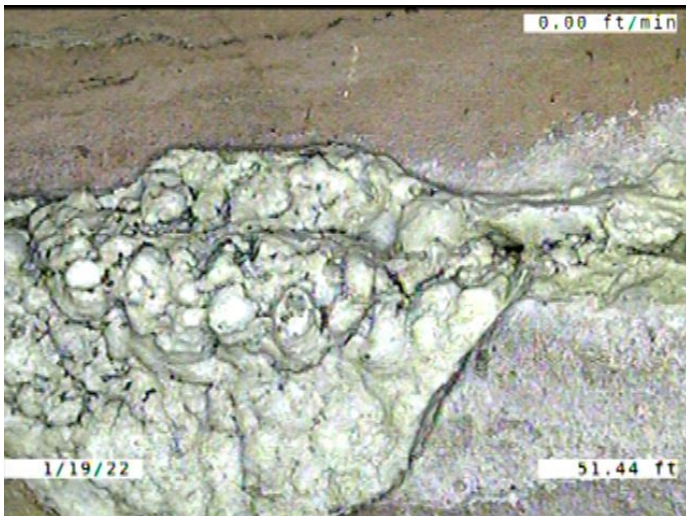
Code: **DAE**  
 Description: **Deposits Attached Encrustation**

Distance (ft): **51.4**  
 Structural Grade: **0**  
 O&M Grade: **2**  
 Clock Start/From: **8**  
 Clock To: **4**  
 1st Value:  
 2nd Value:  
 Value Percent: **5.000**  
 Continuous Index: **S03**  
 Within 8" of Joint: **YES**  
 Remarks:

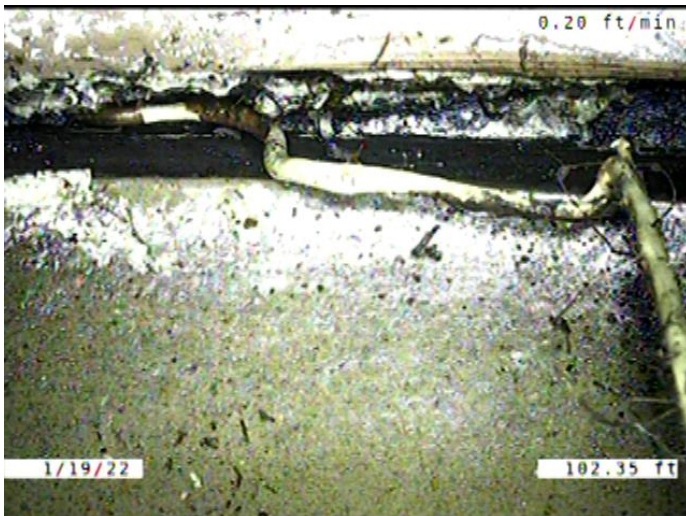
Code: **RFJ**  
 Description: **Roots Fine Joint**

Distance (ft): **102.3**  
 Structural Grade: **0**  
 O&M Grade: **1**  
 Clock Start/From: **12**  
 Clock To:  
 1st Value:  
 2nd Value:  
 Value Percent:  
 Continuous Index:  
 Within 8" of Joint: **YES**  
 Remarks:

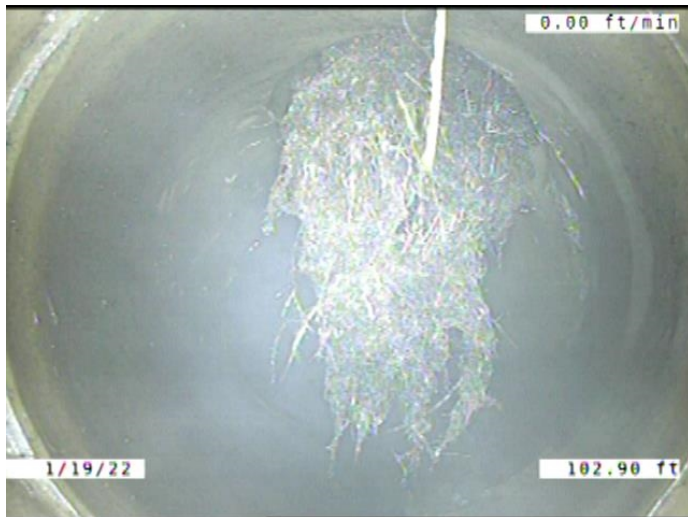
Code: **RML**  
Description: **Roots Medium Lateral**

Distance (ft): **102.9**  
Structural Grade: **0**  
O&M Grade: **3**  
Clock Start/From: **12**  
Clock To: **2**  
1st Value:  
2nd Value:  
Value Percent: **50.000**  
Continuous Index:  
Within 8" of Joint: **NO**  
Remarks:

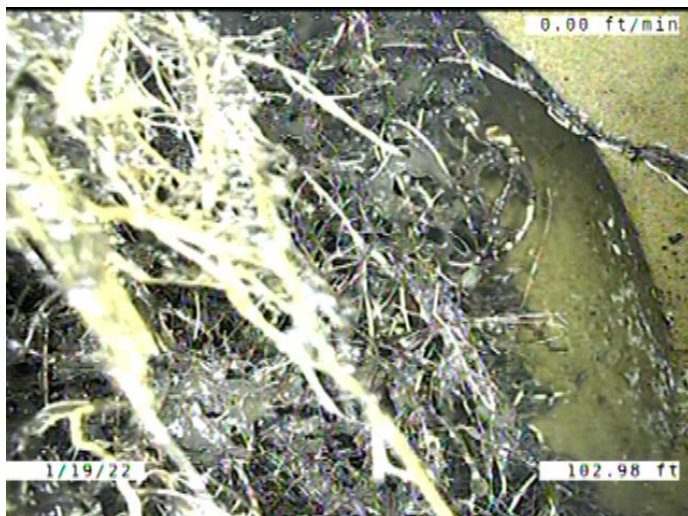
Code: **TFD**  
Description: **Tap Factory Defective**

Distance (ft): **103.0**  
Structural Grade: **0**  
O&M Grade: **3**  
Clock Start/From: **1**  
Clock To:  
1st Value: **4.000**  
2nd Value:  
Value Percent:  
Continuous Index:  
Within 8" of Joint: **YES**  
Remarks: **LOOKS TO BE 100% PLUGGED WITH ROOTS. ROOTS GROWING FROM TH**

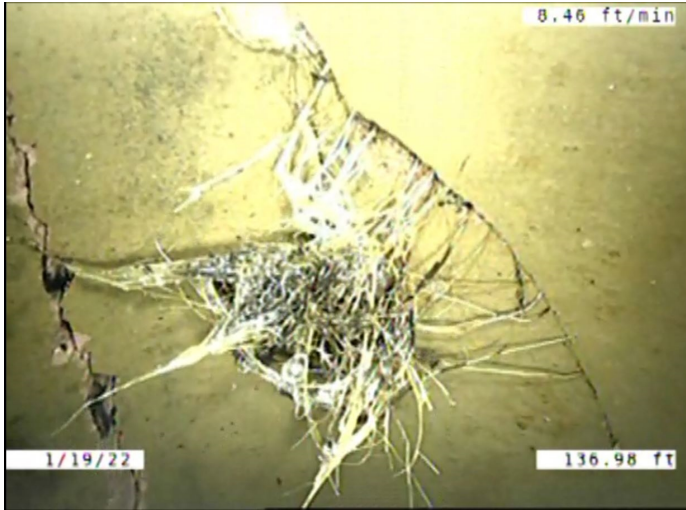
Code: **RMB**  
Description: **Roots Medium Barrel**

Distance (ft): **137.0**  
Structural Grade: **0**  
O&M Grade: **4**  
Clock Start/From: **10**  
Clock To:  
1st Value:  
2nd Value:  
Value Percent: **5.000**  
Continuous Index:  
Within 8" of Joint: **NO**  
Remarks:

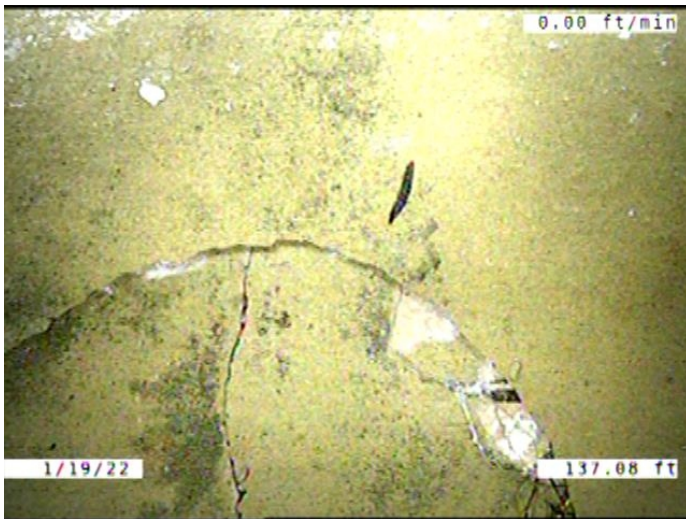
Code: **B**  
Description: **Broken**

Distance (ft): **137.1**  
Structural Grade: **4**  
O&M Grade: **0**  
Clock Start/From: **12**  
Clock To: **12**  
1st Value:  
2nd Value:  
Value Percent:  
Continuous Index: **S04**  
Within 8" of Joint: **YES**  
Remarks:

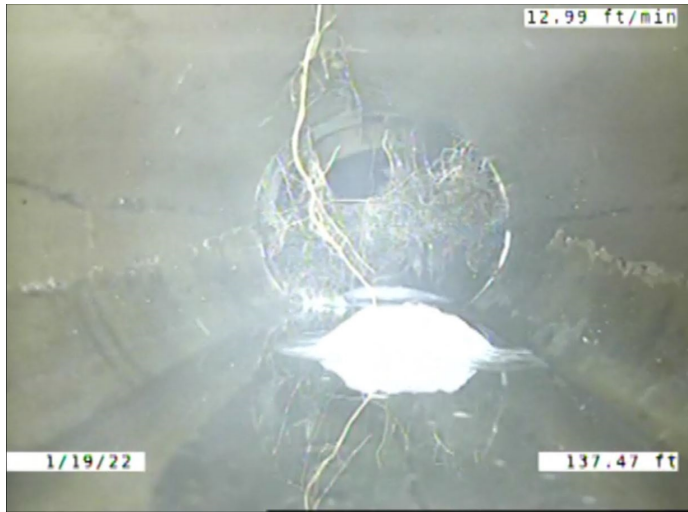
Code:	<b>RMB</b>
Description:	<b>Roots Medium Barrel</b>
Distance (ft):	<b>137.5</b>
Structural Grade:	<b>0</b>
O&M Grade:	<b>4</b>
Clock Start/From:	<b>12</b>
Clock To:	
1st Value:	
2nd Value:	
Value Percent:	<b>5.000</b>
Continuous Index:	
Within 8" of Joint:	<b>NO</b>
Remarks:

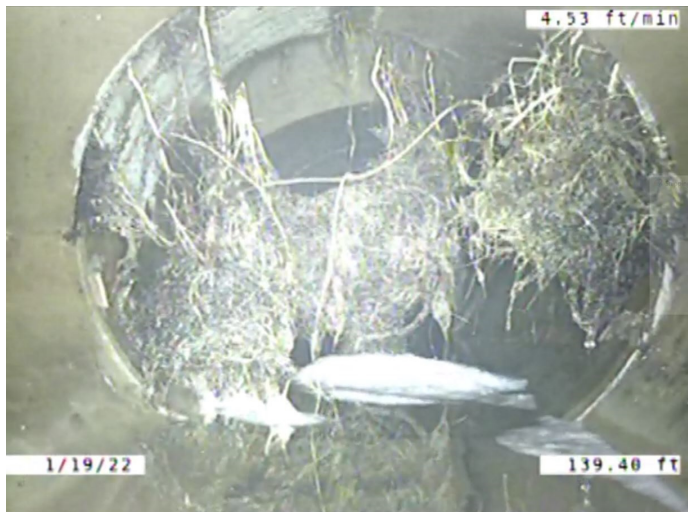
Code:	<b>RMJ</b>
Description:	<b>Roots Medium Joint</b>
Distance (ft):	<b>139.4</b>
Structural Grade:	<b>0</b>
O&M Grade:	<b>3</b>
Clock Start/From:	<b>9</b>
Clock To:	<b>3</b>
1st Value:	
2nd Value:	
Value Percent:	<b>10.000</b>
Continuous Index:	
Within 8" of Joint:	<b>YES</b>
Remarks:

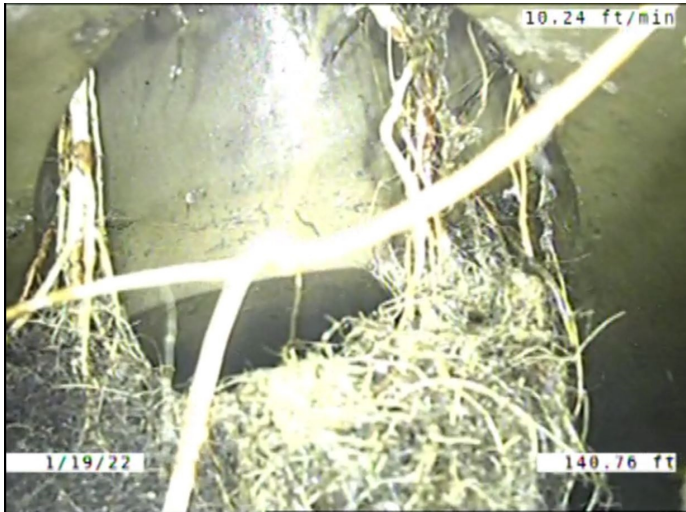
Code: **RML**  
 Description: **Roots Medium Lateral**

Distance (ft): **140.8**  
 Structural Grade: **0**  
 O&M Grade: **3**  
 Clock Start/From: **10**  
 Clock To: **12**  
 1st Value:  
 2nd Value:  
 Value Percent: **20.000**  
 Continuous Index:  
 Within 8" of Joint: **NO**  
 Remarks:

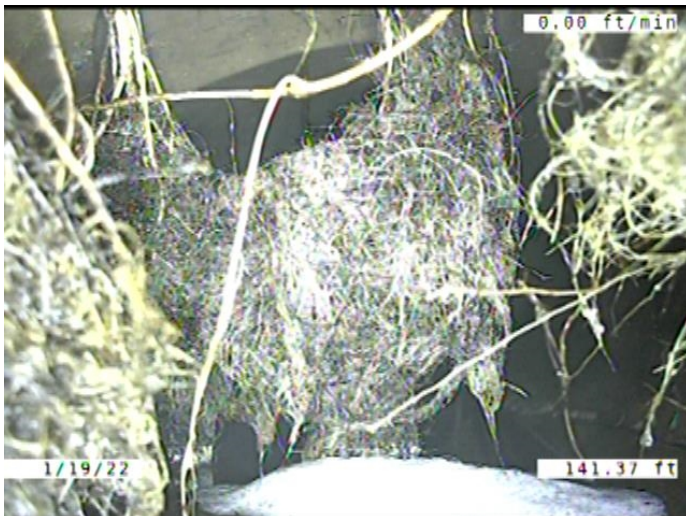
Code: **RML**  
 Description: **Roots Medium Lateral**

Distance (ft): **141.4**  
 Structural Grade: **0**  
 O&M Grade: **3**  
 Clock Start/From: **10**  
 Clock To: **12**  
 1st Value:  
 2nd Value:  
 Value Percent: **35.000**  
 Continuous Index:  
 Within 8" of Joint: **NO**  
 Remarks:

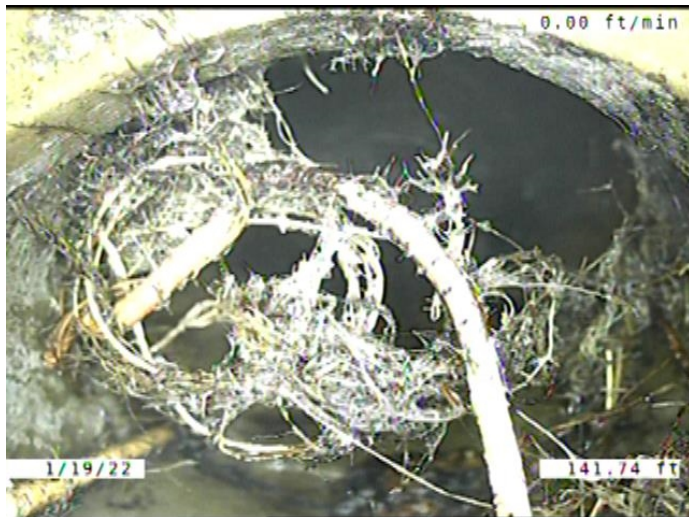
Code:	<b>TFD</b>
Description:	<b>Tap Factory Defective</b>
Distance (ft):	<b>141.7</b>
Structural Grade:	<b>0</b>
O&M Grade:	<b>3</b>
Clock Start/From:	<b>11</b>
Clock To:	
1st Value:	<b>4.000</b>
2nd Value:	
Value Percent:	
Continuous Index:	
Within 8" of Joint:	<b>YES</b>
Remarks:	<b>BROKEN. ROOTS GROWING FROM THE TAP INTO THE MAIN.</b>

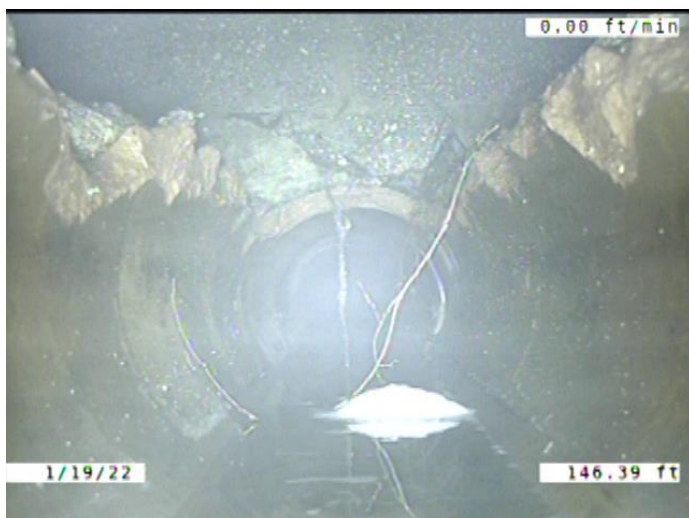
Code:	<b>DSF</b>
Description:	<b>Deposits Settled Fine</b>
Distance (ft):	<b>146.4</b>
Structural Grade:	<b>0</b>
O&M Grade:	<b>2</b>
Clock Start/From:	<b>5</b>
Clock To:	<b>7</b>
1st Value:	
2nd Value:	
Value Percent:	<b>5.000</b>
Continuous Index:	<b>F01</b>
Within 8" of Joint:	<b>YES</b>
Remarks:

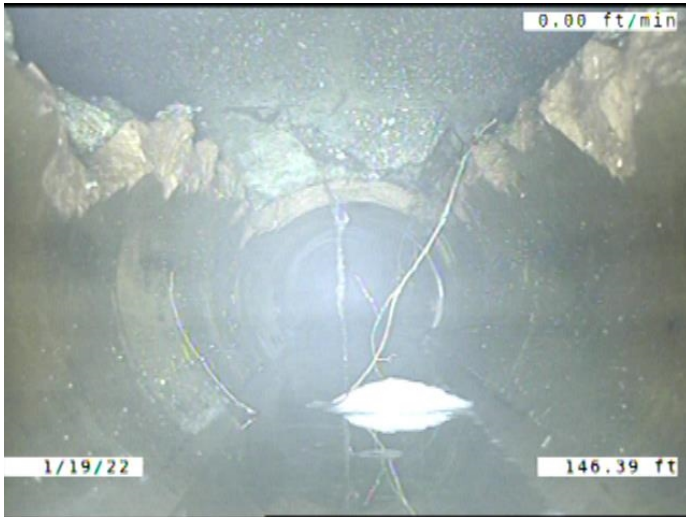
Code: **DAE**  
 Description: **Deposits Attached Encrustation**

Distance (ft): **146.4**  
 Structural Grade: **0**  
 O&M Grade: **2**  
 Clock Start/From: **8**  
 Clock To: **4**  
 1st Value:  
 2nd Value:  
 Value Percent: **5.000**  
 Continuous Index: **F03**  
 Within 8" of Joint: **YES**  
 Remarks:

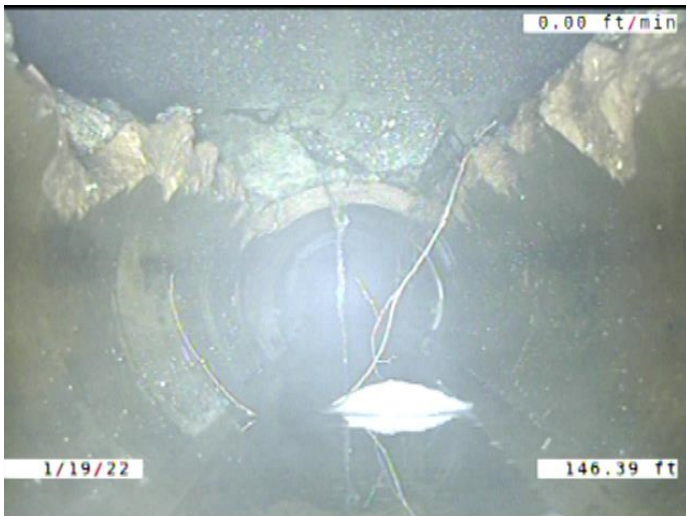
Code: **B**  
 Description: **Broken**

Distance (ft): **146.4**  
 Structural Grade: **4**  
 O&M Grade: **0**  
 Clock Start/From: **12**  
 Clock To: **12**  
 1st Value:  
 2nd Value:  
 Value Percent:  
 Continuous Index: **F04**  
 Within 8" of Joint: **YES**  
 Remarks:
