## Profile/Photo Observation Report

Street:	<b>FOXCROFT STREET</b>	Flow Control:	<b>Not Controlled</b>
City:	<b>Hobart, IN</b>	Year Renewed:	
Location:	<b>Yard</b>	Tape/Media #:	
Purpose:	<b>Routine Assessment</b>	Dia/Height:	<b>10"</b>
Use:	<b>Sanitary</b>	Material:	<b>VCP</b>
Drain Area:	<b>NA</b>	Lining:	
Category:	<b>NA</b>		
Comment:			
Location Details:		Direction of Survey:	<b>Downstream</b>
US MH:	<b>M-506-029</b>	DS MH:	<b>M-506-030</b>
		Total Length Surveyed (ft):	<b>82.7</b>

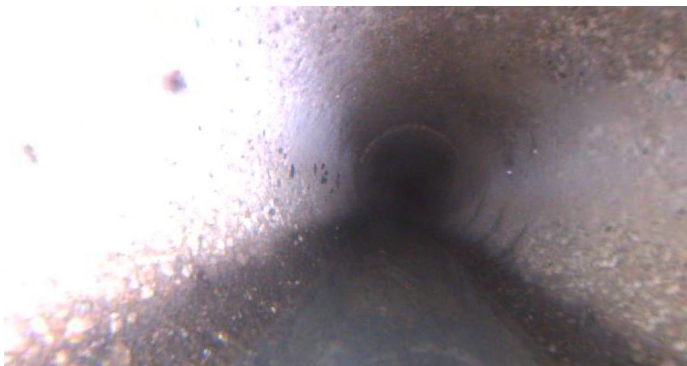
Code: **AMH**  
Description: **Manhole**

Distance (ft): **.0**  
Structural Grade: **0**  
O&M Grade: **0**  
Clock Start/From:  
Clock To:  
1st Value:  
2nd Value:  
Value Percent:  
Continuous Index:  
Within 8" of Joint: **NO**  
Remarks: **M-506-029**

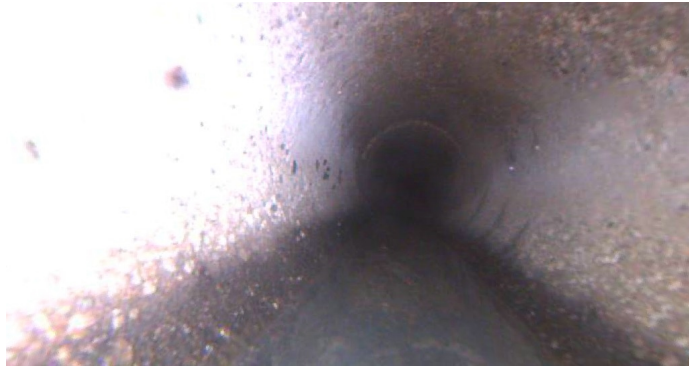
Code: **MWL**  
Description: **Water Level**

Distance (ft): **.0**  
Structural Grade: **0**  
O&M Grade: **0**  
Clock Start/From:  
Clock To:  
1st Value:  
2nd Value:  
Value Percent: **10.000**  
Continuous Index:  
Within 8" of Joint: **NO**  
Remarks:

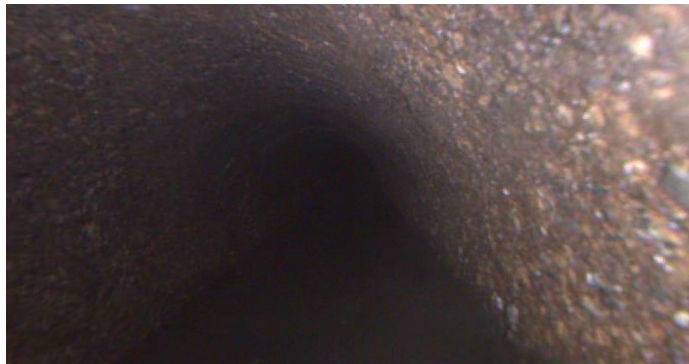
Code: **MSA**  
Description: **Abandoned Survey**

Distance (ft): **82.7**  
Structural Grade: **0**  
O&M Grade: **0**  
Clock Start/From:  
Clock To:  
1st Value:  
2nd Value:  
Value Percent:  
Continuous Index:  
Within 8" of Joint: **NO**  
Remarks: **No blockage**
