Profile/Photo Observation Report

Date:	04/06/2018	Weather:		Coding:	PACP 6.0
Pipe Length (ft):	250.5	Owner:	NA	Pre Clean:	No Pre-Cleaning
P.O.#:		Surveyor:	Mark Ruby	PSR:	P-506-030-029
Customer:		Clean Date:	01/01/1900	Shape:	C

Street:	RIVER TERR	Flow Control:	Not Controlled
City:	Hobart, IN	Year Renewed:	
Location:	Yard	Tape/Media #:	
Purpose:	Routine Assessment	Dia/Height:	10"
Use:	Sanitary	Material:	VCP
Drain Area:	NA	Lining:	
Category:	NA		
Comment:			
Location Details:		Direction of Survey:	Upstream
US MH:	M-506-029	DS MH:	M-506-030
		Total Length Surveyed (ft):	241.3

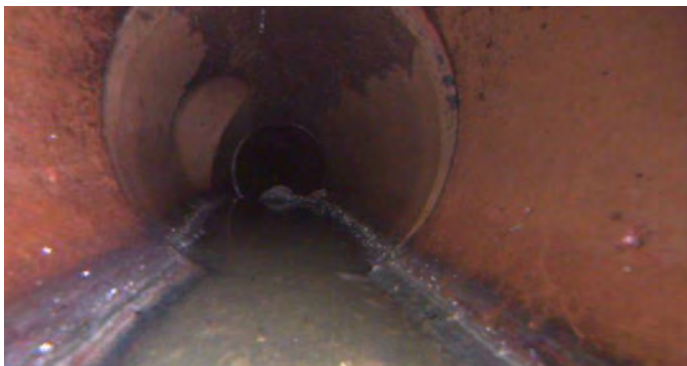
Code: **AMH**
Description: **Manhole**

Distance (ft): **.0**
Structural Grade: **0**
O&M Grade: **0**
Clock Start/From:
Clock To:
1st Value:
2nd Value:
Value Percent:
Continuous Index:
Within 8" of Joint: **NO**
Remarks: **M-506-030**

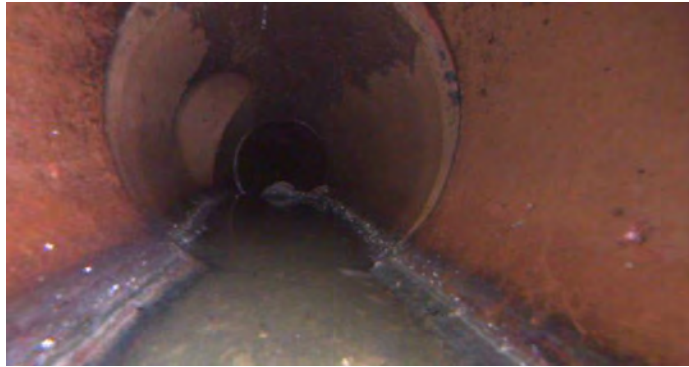
Code: **MWL**
Description: **Water Level**

Distance (ft): **.0**
Structural Grade: **0**
O&M Grade: **0**
Clock Start/From:
Clock To:
1st Value:
2nd Value:
Value Percent: **10.000**
Continuous Index:
Within 8" of Joint: **NO**
Remarks:

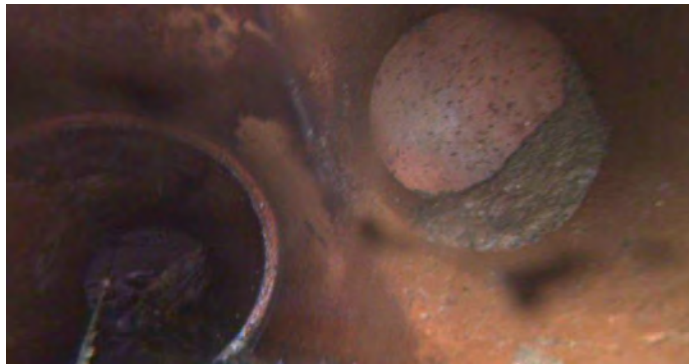
Code: **TFC**
Description: **Tap Factory Capped**

Distance (ft): **2.7**
Structural Grade: **0**
O&M Grade: **0**
Clock Start/From: **9**
Clock To:
1st Value: **4.000**
2nd Value:
Value Percent:
Continuous Index:
Within 8" of Joint:
Remarks: **Photo taken from rear camera.**

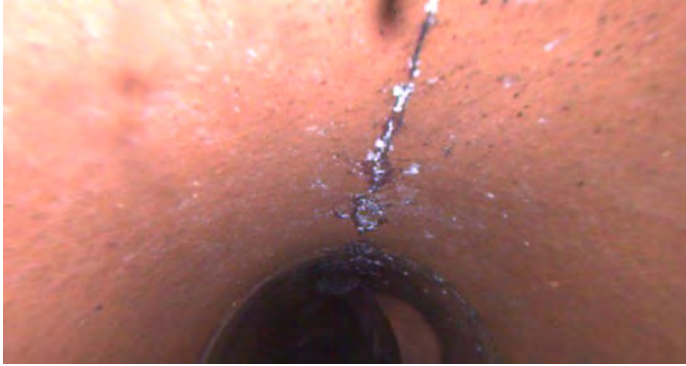
Code: **FL**
Description: **Fracture Longitudinal**

Distance (ft): **14.4**
Structural Grade: **3**
O&M Grade: **0**
Clock Start/From: **12**
Clock To:
1st Value:
2nd Value:
Value Percent:
Continuous Index:
Within 8" of Joint: **YES**
Remarks:

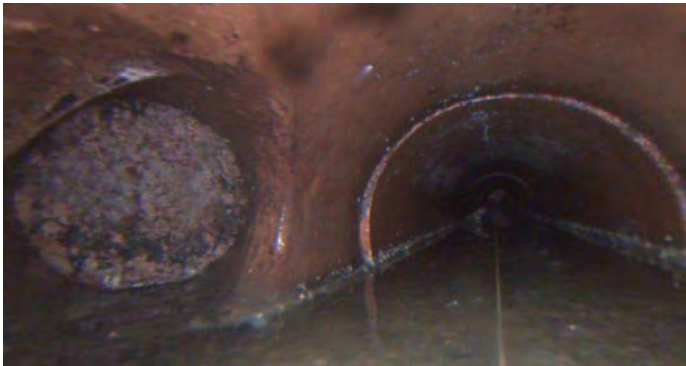
Code: **TFC**
Description: **Tap Factory Capped**

Distance (ft): **16.3**
Structural Grade: **0**
O&M Grade: **0**
Clock Start/From: **5**
Clock To:
1st Value: **4.000**
2nd Value:
Value Percent:
Continuous Index:
Within 8" of Joint:
Remarks: **Photo taken from rear camera.**

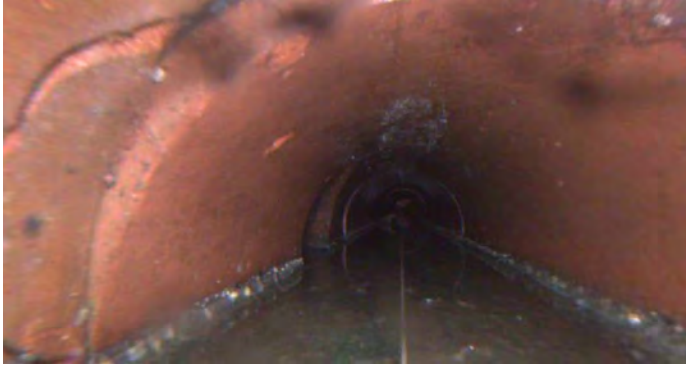
Code: **FS**
Description: **Fracture Spiral**

Distance (ft): **17.5**
Structural Grade: **3**
O&M Grade: **0**
Clock Start/From: **5**
Clock To: **1**
1st Value:
2nd Value:
Value Percent:
Continuous Index:
Within 8" of Joint:
Remarks: **Photo taken from rear camera.**

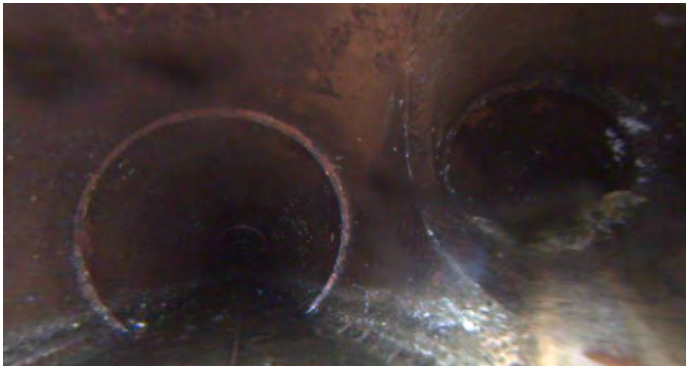
Code: **TF**
Description: **Tap Factory**

Distance (ft): **53.6**
Structural Grade: **0**
O&M Grade: **0**
Clock Start/From: **8**
Clock To:
1st Value: **4.000**
2nd Value:
Value Percent:
Continuous Index:
Within 8" of Joint:
Remarks: **Photo taken from rear camera.**

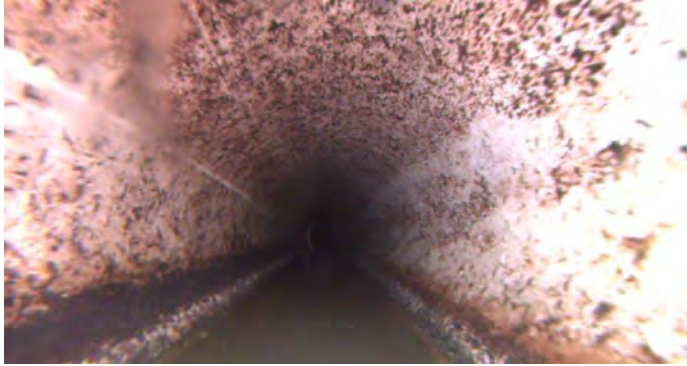
Code: **MMC**
Description: **Material Change**

Distance (ft): **88.2**
Structural Grade: **0**
O&M Grade: **0**
Clock Start/From:
Clock To:
1st Value:
2nd Value:
Value Percent:
Continuous Index:
Within 8" of Joint: **NO**
Remarks: **PVC**

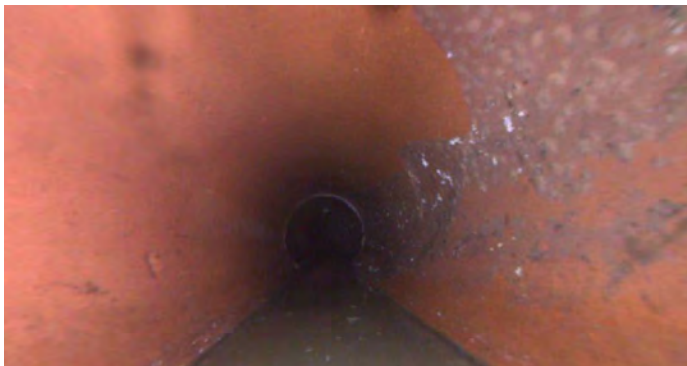
Code: **MMC**
Description: **Material Change**

Distance (ft): **94.8**
Structural Grade: **0**
O&M Grade: **0**
Clock Start/From:
Clock To:
1st Value:
2nd Value:
Value Percent:
Continuous Index:
Within 8" of Joint: **NO**
Remarks: **VCP**

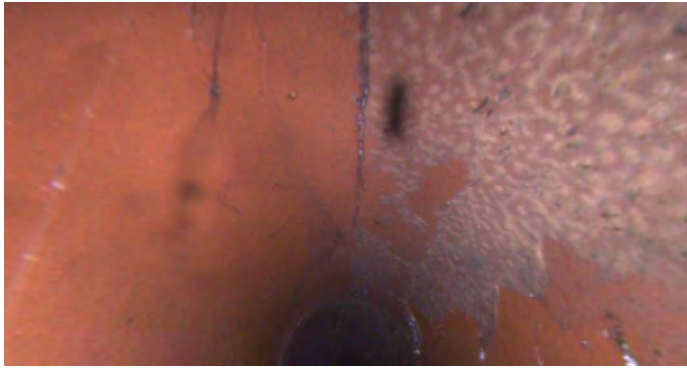
Code: **CL**
Description: **Crack Longitudinal**

Distance (ft): **99.5**
Structural Grade: **2**
O&M Grade: **0**
Clock Start/From: **12**
Clock To:
1st Value:
2nd Value:
Value Percent:
Continuous Index:
Within 8" of Joint:
Remarks:

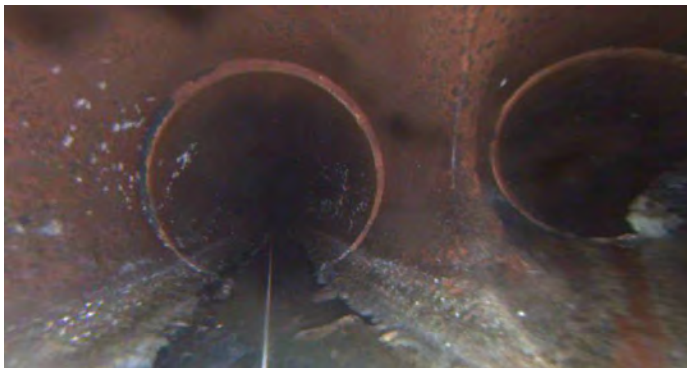
Code: **TF**
Description: **Tap Factory**

Distance (ft): **129.8**
Structural Grade: **0**
O&M Grade: **0**
Clock Start/From: **8**
Clock To:
1st Value: **4.000**
2nd Value:
Value Percent:
Continuous Index:
Within 8" of Joint:
Remarks: **Photo taken from rear camera.**

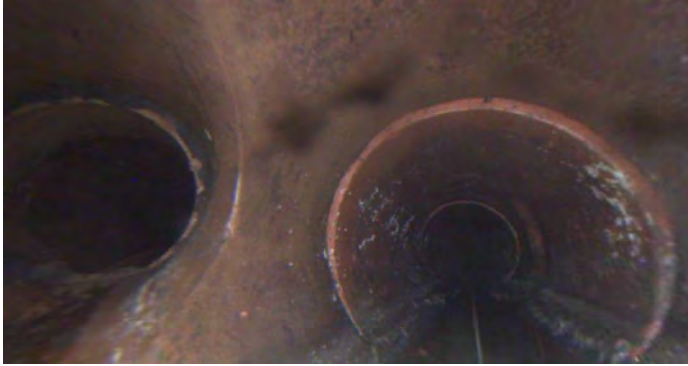
Code: **TF**
Description: **Tap Factory**

Distance (ft): **131.6**
Structural Grade: **0**
O&M Grade: **0**
Clock Start/From: **4**
Clock To:
1st Value: **4.000**
2nd Value:
Value Percent:
Continuous Index:
Within 8" of Joint:
Remarks: **Photo taken from rear camera.**

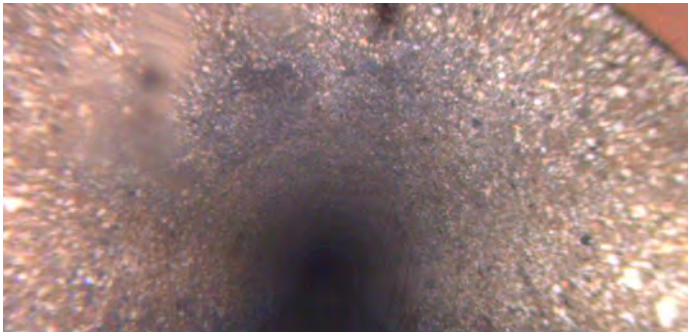
Code: **MMC**
Description: **Material Change**

Distance (ft): **136.4**
Structural Grade: **0**
O&M Grade: **0**
Clock Start/From:
Clock To:
1st Value:
2nd Value:
Value Percent:
Continuous Index:
Within 8" of Joint: **NO**
Remarks: **cp**

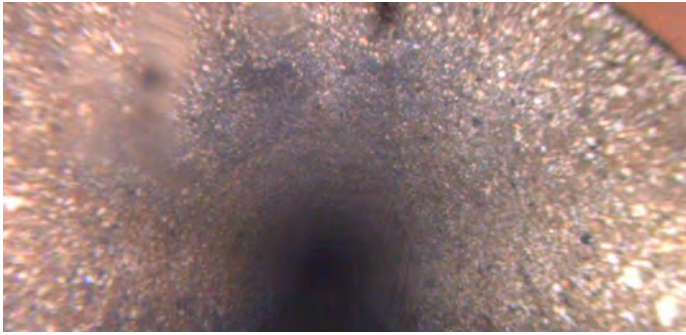
Code: **SAP**
Description: **Surface Aggregate Projecting**

Distance (ft): **136.4**
Structural Grade: **3**
O&M Grade: **0**
Clock Start/From: **7**
Clock To: **5**
1st Value:
2nd Value:
Value Percent:
Continuous Index: **S01**
Within 8" of Joint:
Remarks:

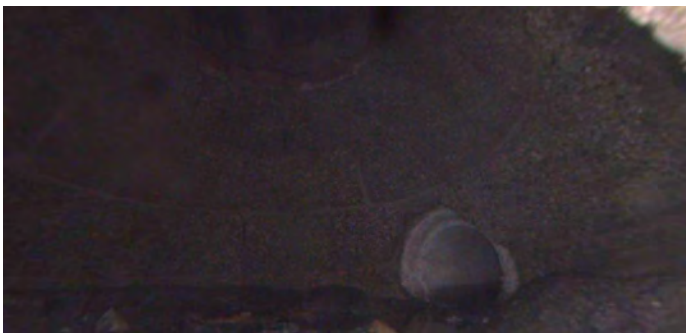
Code: **SAP**
Description: **Surface Aggregate Projecting**

Distance (ft): **240.6**
Structural Grade: **3**
O&M Grade: **0**
Clock Start/From: **7**
Clock To: **5**
1st Value:
2nd Value:
Value Percent:
Continuous Index: **F01**
Within 8" of Joint:
Remarks:

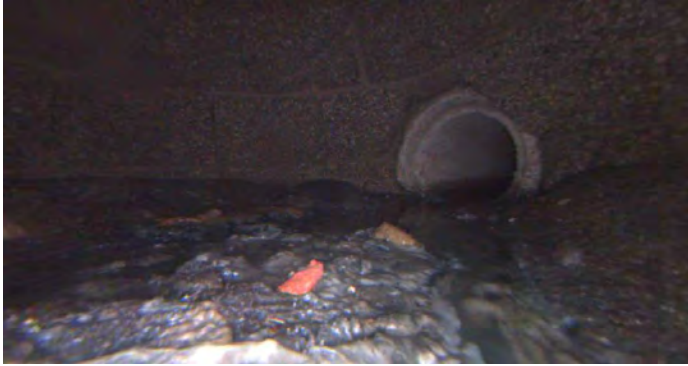
Code:	AMH
Description:	Manhole
Distance (ft):	241.3
Structural Grade:	0
O&M Grade:	0
Clock Start/From:	
Clock To:	
1st Value:	
2nd Value:	
Value Percent:	
Continuous Index:	
Within 8" of Joint:	NO
Remarks:	M-506-029
