Profile/Photo Observation Report

| Street: | FOXCROFT STREET | Flow Control: | Not Controlled |
| City: | Hobart, IN | Year Renewed: | |

| US MH: | M-506-029 | DS MH: | M-506-030 |

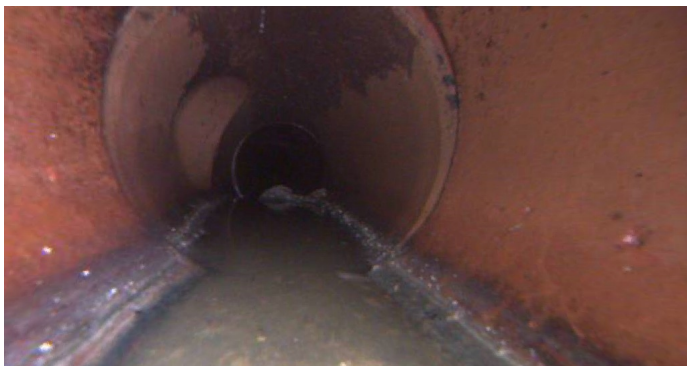
Code: **AMH**
 Description: **Manhole**

Distance (ft): **.0**
 Structural Grade: **0**
 O&M Grade: **0**
 Clock Start/From:
 Clock To:
 1st Value:
 2nd Value:
 Value Percent:
 Continuous Index:
 Within 8" of Joint: **NO**
 Remarks: **M-506-030**

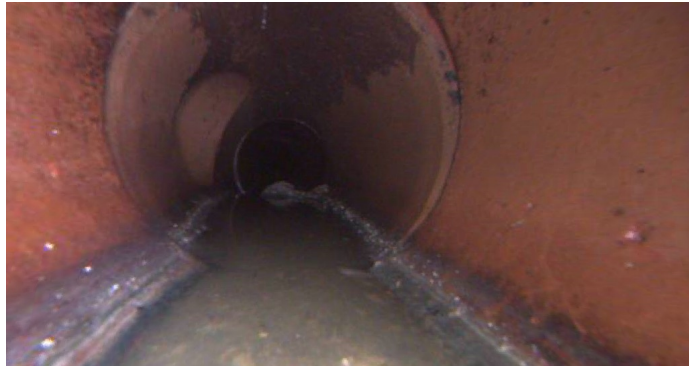
Code: **MWL**
Description: **Water Level**

Distance (ft): **.0**
Structural Grade: **0**
O&M Grade: **0**
Clock Start/From:
Clock To:
1st Value:
2nd Value:
Value Percent: **10.000**
Continuous Index:
Within 8" of Joint: **NO**
Remarks:

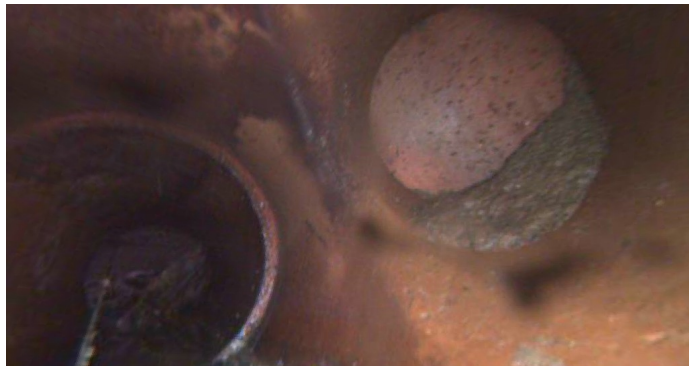
Code: **TFC**
Description: **Tap Factory Capped**

Distance (ft): **2.7**
Structural Grade: **0**
O&M Grade: **0**
Clock Start/From: **9**
Clock To:
1st Value: **4.000**
2nd Value:
Value Percent:
Continuous Index:
Within 8" of Joint:
Remarks: **Photo taken from rear camera.**

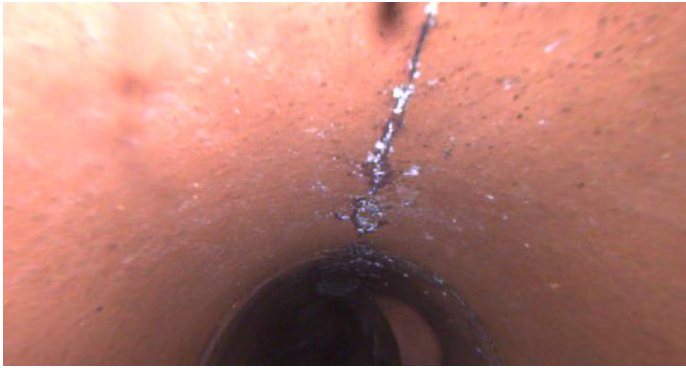
| | Position | Code | Observation | Video (sec) | Grade |
|--|---|---|---|---|---|
| | 14.4 | FL | Fracture Longitudinal | 78 | S 3 |

| Description: | Fracture Longitudinal |
| Distance (ft): | 14.4 |
| Structural Grade: | 3 |
| Clock Start/From: | 12 |
| Within 8" of Joint: | YES |

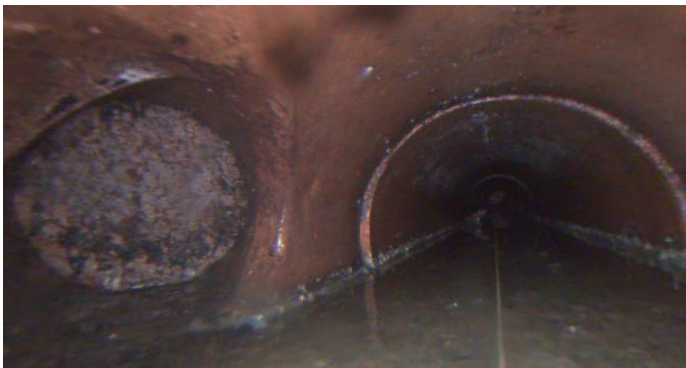
| Description: | Tap Factory Capped |
| Distance (ft): | 16.3 |
| Clock Start/From: | 5 |

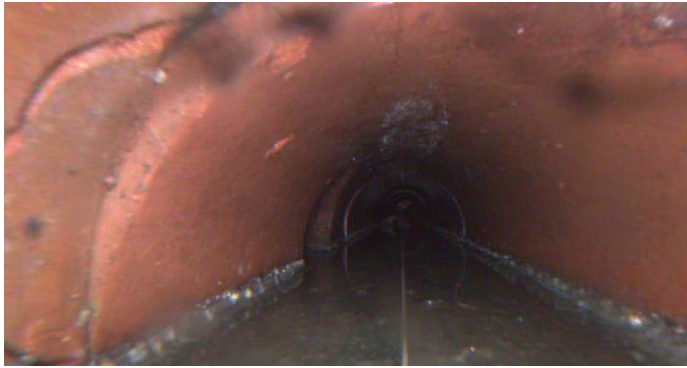
| | Position | Code | Observation | Video (sec) | Grade |
|--|---|---|---|---|---|
| | 17.5 | FS | Fracture Spiral | 113 | S 3 |

Code: **FS**
Description: **Fracture Spiral**

Distance (ft): **17.5**
Structural Grade: **3**
O&M Grade: **0**
Clock Start/From: **5**
Clock To: **1**

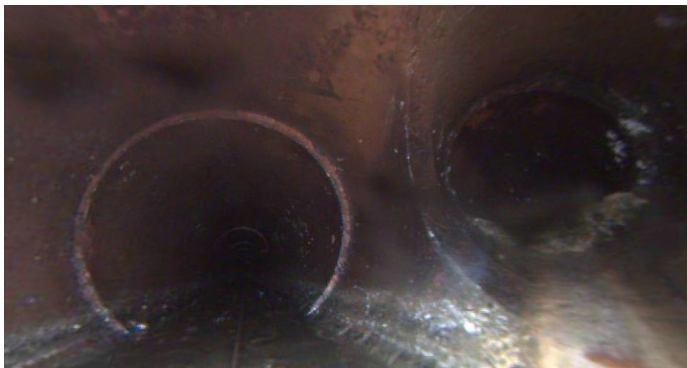
Code: **TF**
Description: **Tap Factory**

Distance (ft): **53.6**
Structural Grade: **0**
O&M Grade: **0**
Clock Start/From: **8**
Clock To:

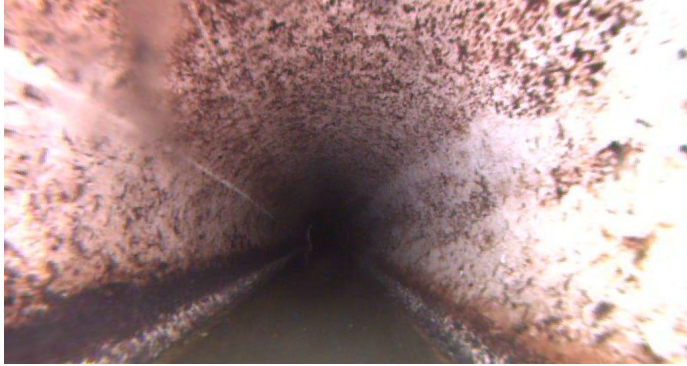
Code: **MMC**
Description: **Material Change**

Distance (ft): **88.2**
Structural Grade: **0**
O&M Grade: **0**
Clock Start/From:
Clock To:
1st Value:
2nd Value:
Value Percent:
Continuous Index:
Within 8" of Joint: **NO**
Remarks: **PVC**

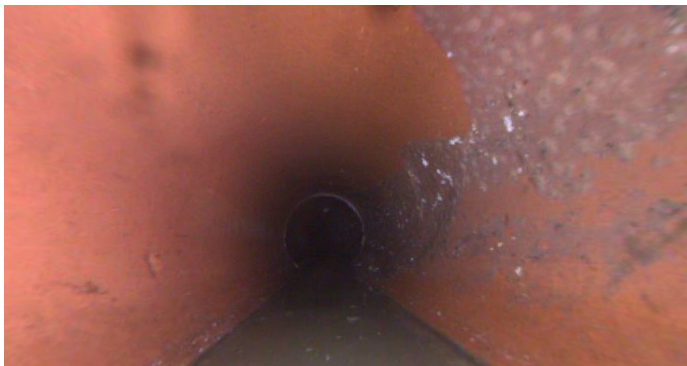
Code: **MMC**
Description: **Material Change**

Distance (ft): **94.8**
Structural Grade: **0**
O&M Grade: **0**
Clock Start/From:
Clock To:
1st Value:
2nd Value:
Value Percent:
Continuous Index:
Within 8" of Joint: **NO**
Remarks: **VCP**

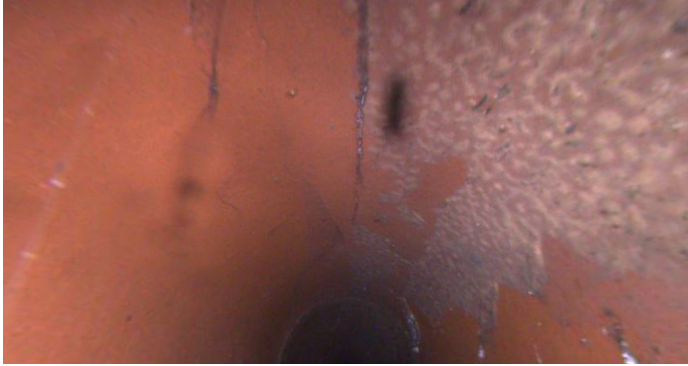
| | Position | Code | Observation | Video (sec) | Grade |
|--|---|---|---|---|---|
| | 99.5 | CL | Crack Longitudinal | 328 | S 2 |

Code: **CL**
Description: **Crack Longitudinal**

Distance (ft): **99.5**
Structural Grade: **2**
O&M Grade: **0**
Clock Start/From: **12**
Clock To:
1st Value:
2nd Value:
Value Percent:
Continuous Index:
Within 8" of Joint:
Remarks:

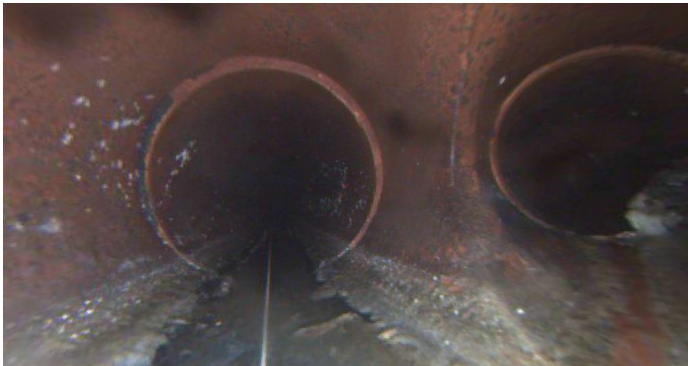
Code: **TF**
Description: **Tap Factory**

Distance (ft): **129.8**
Structural Grade: **0**
O&M Grade: **0**
Clock Start/From: **8**
Clock To:
1st Value: **4.000**
2nd Value:
Value Percent:
Continuous Index:
Within 8" of Joint:
Remarks: **Photo taken from rear camera.**

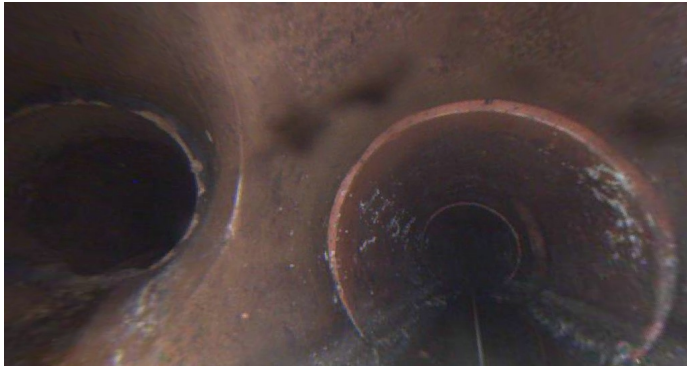
Code: **TF**
Description: **Tap Factory**

Distance (ft): **131.6**
Structural Grade: **0**
O&M Grade: **0**
Clock Start/From: **4**
Clock To:
1st Value: **4.000**
2nd Value:
Value Percent:
Continuous Index:
Within 8" of Joint:
Remarks: **Photo taken from rear camera.**

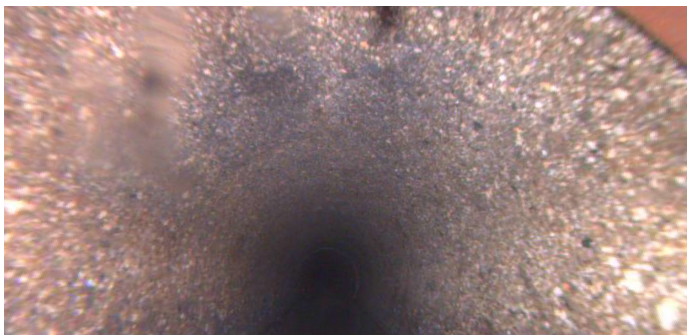
Code: **MMC**
Description: **Material Change**

Distance (ft): **136.4**
Structural Grade: **0**
O&M Grade: **0**
Clock Start/From:
Clock To:
1st Value:
2nd Value:
Value Percent:
Continuous Index:
Within 8" of Joint: **NO**
Remarks: **cp**

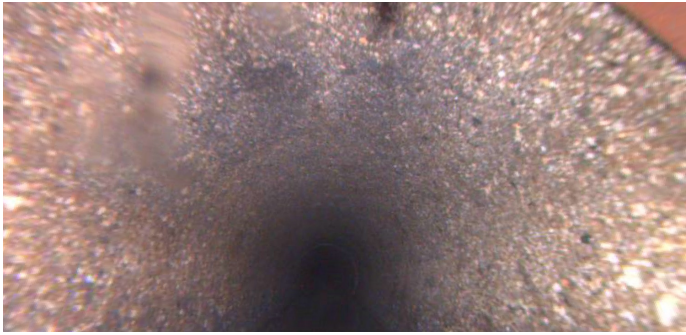
| | Position | Code | Observation | Video (sec) | Grade |
|--|---|---|---|---|---|
| | 136.4 | SAP(S01) | Surface Aggregate Projecting | 455 | S 3 |

Code: **SAP**
Description: **Surface Aggregate Projecting**

Distance (ft): **136.4**
Structural Grade: **3**
O&M Grade: **0**
Clock Start/From: **7**
Clock To: **5**
1st Value:
2nd Value:
Value Percent:
Continuous Index: **S01**
Within 8" of Joint:
Remarks:

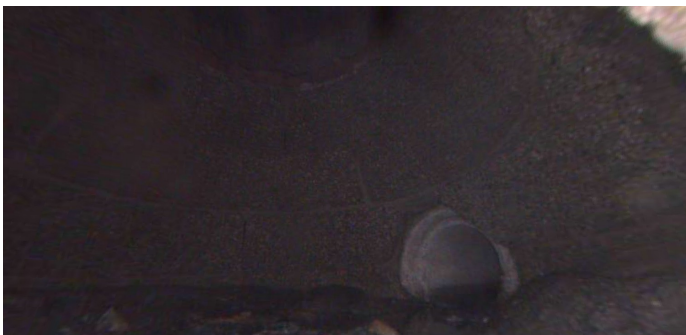
| | Position | Code | Observation | Video (sec) | Grade |
|--|---|---|---|---|---|
| | 240.6 | SAP(F01) | Surface Aggregate Projecting | 676 | S 3 |

Code: **SAP**
Description: **Surface Aggregate Projecting**

Distance (ft): **240.6**
Structural Grade: **3**
O&M Grade: **0**
Clock Start/From: **7**
Clock To: **5**
1st Value:
2nd Value:
Value Percent:
Continuous Index: **F01**
Within 8" of Joint:
Remarks:

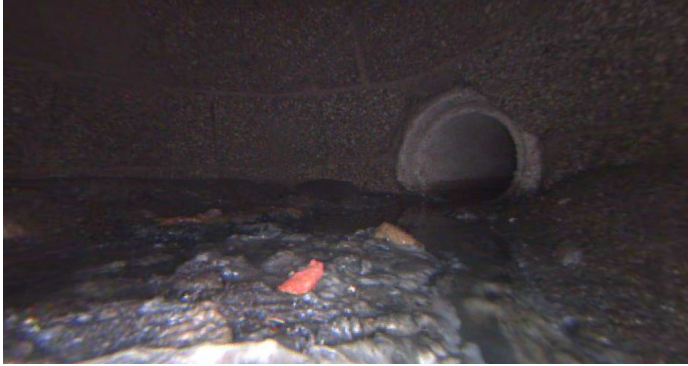
| Description: | Manhole |
| Distance (ft): | 241.3 |
| Remarks: | M-506-029 |
