## Profile/Photo Observation Report

Street:	<b>RIVER TERR</b>	Flow Control:	<b>Not Controlled</b>
City:	<b>Hobart, IN</b>	Year Renewed:	
Location:	<b>Yard</b>	Tape/Media #:	
Purpose:	<b>Routine Assessment</b>	Dia/Height:	<b>10"</b>
Use:	<b>Sanitary</b>	Material:	<b>VCP</b>
Drain Area:	<b>NA</b>	Lining:	
Category:	<b>NA</b>		
Comment:	<b>Flow direction is marked wrong.</b>		
Location Details:		Direction of Survey:	<b>Upstream</b>
US MH:	<b>M-506-030</b>	DS MH:	<b>M-506-031</b>
		Total Length Surveyed (ft):	<b>91.9</b>

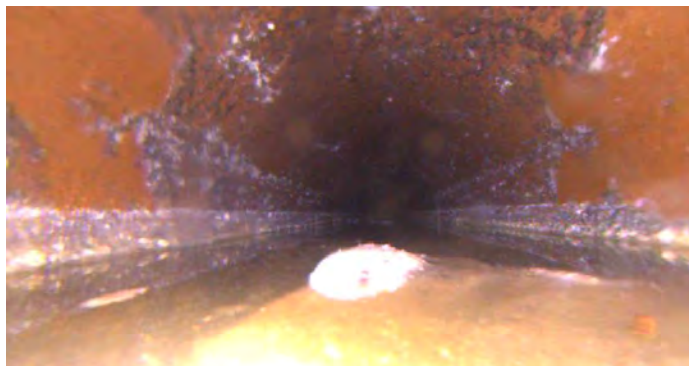
Code: **AMH**  
 Description: **Manhole**

Distance (ft): **.0**  
 Structural Grade: **0**  
 O&M Grade: **0**  
 Clock Start/From:  
 Clock To:  
 1st Value:  
 2nd Value:  
 Value Percent:  
 Continuous Index:  
 Within 8" of Joint: **NO**  
 Remarks: **M-506-031**

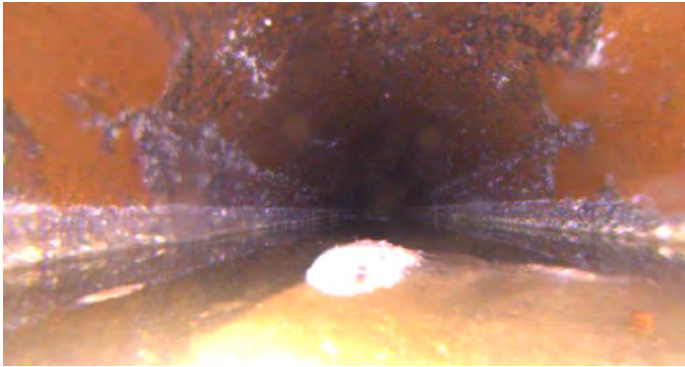
Code:	<b>MWL</b>
Description:	<b>Water Level</b>

Distance (ft):	<b>.0</b>
Structural Grade:	<b>0</b>
O&M Grade:	<b>0</b>
Clock Start/From:	
Clock To:	
1st Value:	
2nd Value:	
Value Percent:	<b>10.000</b>
Continuous Index:	
Within 8" of Joint:	<b>NO</b>
Remarks:

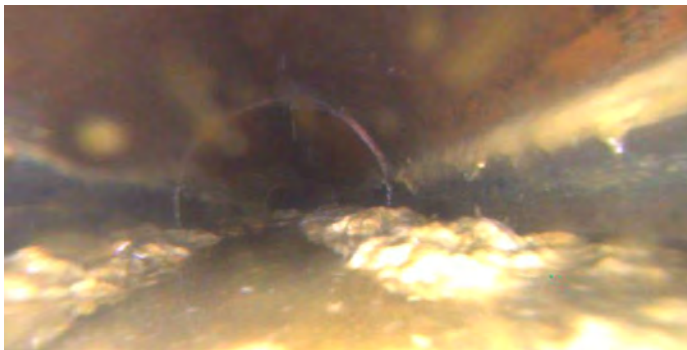
Code:	<b>MCU</b>
Description:	<b>Camera Underwater</b>
Distance (ft):	<b>67.2</b>
Structural Grade:	<b>0</b>
O&M Grade:	<b>4</b>
Clock Start/From:	
Clock To:	
1st Value:	
2nd Value:	
Value Percent:	
Continuous Index:	<b>F01</b>
Within 8" of Joint:	<b>NO</b>
Remarks:
