Profile/Photo Observation Report

Date:	04/06/2018	Weather:		Coding:	PACP 6.0
Pipe Length (ft):	108.6	Owner:	NA	Pre Clean:	No Pre-Cleaning
P.O.#:		Surveyor:	Mark Ruby	PSR:	P-506-031-030
Customer:		Clean Date:	01/01/1900	Shape:	C

Street:	FOXCROFT STREET	Flow Control:	Not Controlled
City:	Hobart, IN	Year Renewed:	
Location:	Yard	Tape/Media #:	
Purpose:	Routine Assessment	Dia/Height:	10"
Use:	Sanitary	Material:	VCP
Drain Area:	NA	Lining:	
Category:	NA		
Comment:	Flow direction is marked wrong.		
Location Details:		Direction of Survey:	Upstream
US MH:	M-506-030	DS MH:	M-506-031
		Total Length Surveyed (ft):	91.9

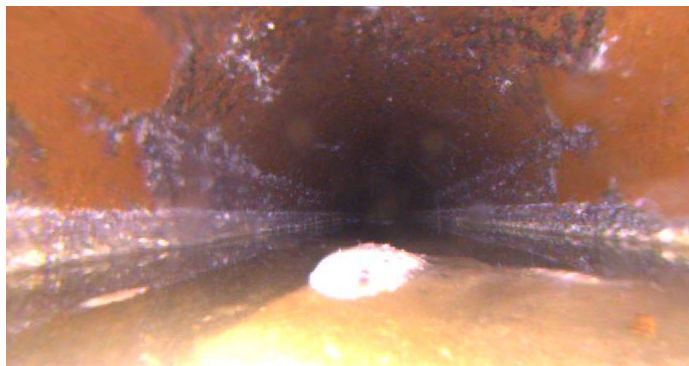
Code: **AMH**
 Description: **Manhole**

Distance (ft): **.0**
 Structural Grade: **0**
 O&M Grade: **0**
 Clock Start/From:
 Clock To:
 1st Value:
 2nd Value:
 Value Percent:
 Continuous Index:
 Within 8" of Joint: **NO**
 Remarks: **M-506-031**

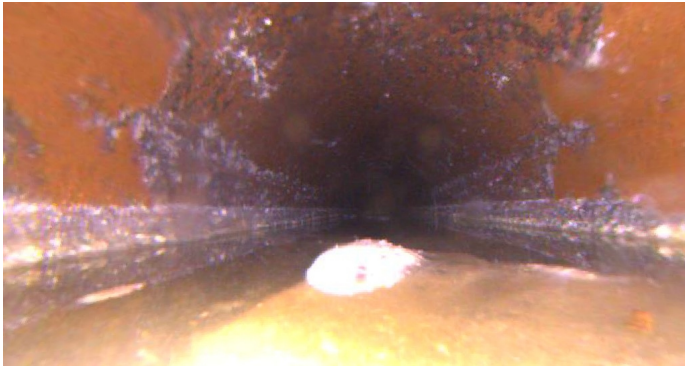
Code:	MWL
Description:	Water Level

Distance (ft):	.0
Structural Grade:	0
O&M Grade:	0
Clock Start/From:	
Clock To:	
1st Value:	
2nd Value:	
Value Percent:	10.000
Continuous Index:	
Within 8" of Joint:	NO
Remarks:

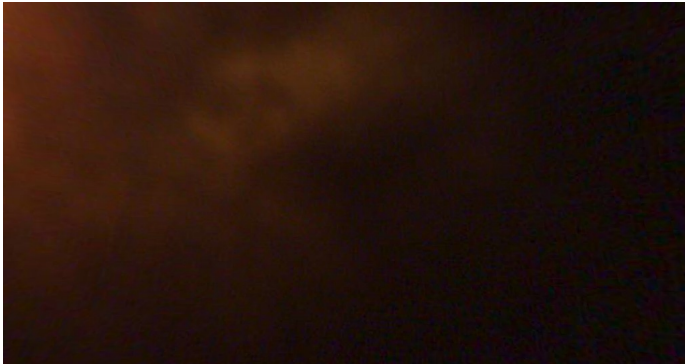
Code:	MCU
Description:	Camera Underwater

Distance (ft):	10.5
Structural Grade:	0
O&M Grade:	4
Clock Start/From:	
Clock To:	
1st Value:	
2nd Value:	
Value Percent:	
Continuous Index:	
Within 8" of Joint:	NO
Remarks:

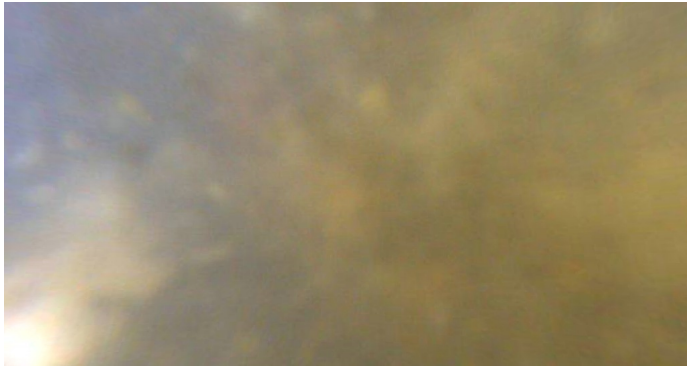
Code: **MCU**
Description: **Camera Underwater**

Distance (ft): **22.8**
Structural Grade: **0**
O&M Grade: **4**
Clock Start/From:
Clock To:
1st Value:
2nd Value:
Value Percent:
Continuous Index: **S01**
Within 8" of Joint: **NO**
Remarks:

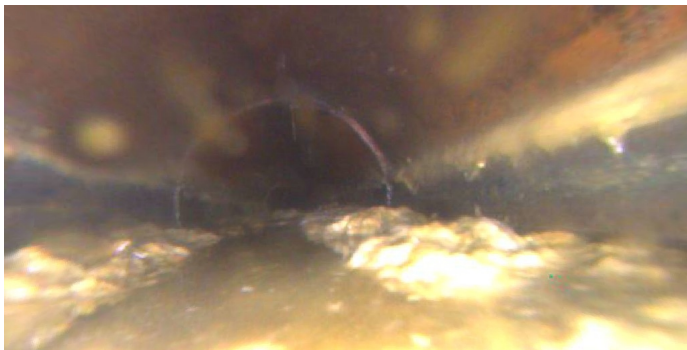
Code: **MCU**
Description: **Camera Underwater**

Distance (ft): **67.2**
Structural Grade: **0**
O&M Grade: **4**
Clock Start/From:
Clock To:
1st Value:
2nd Value:
Value Percent:
Continuous Index: **F01**
Within 8" of Joint: **NO**
Remarks:

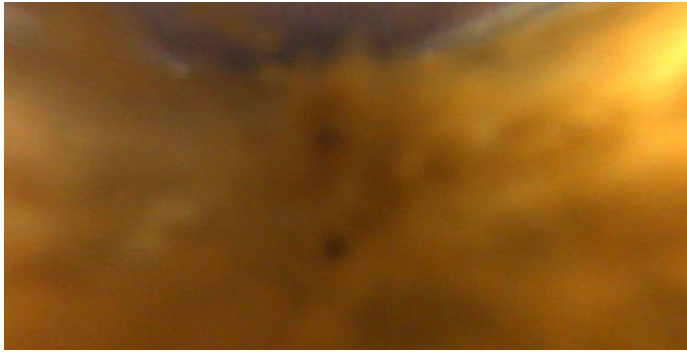
Code: **MCU**
Description: **Camera Underwater**

Distance (ft): **73.9**
Structural Grade: **0**
O&M Grade: **4**
Clock Start/From:
Clock To:
1st Value:
2nd Value:
Value Percent:
Continuous Index: **S02**
Within 8" of Joint: **NO**
Remarks:
