## Profile/Photo Observation Report

Street:	<b>W 8TH ST &amp; CARDINAL CT</b>	Flow Control:	<b>Not Controlled</b>
City:	<b>Hobart, IN</b>	Year Renewed:	
Location:	<b>Yard</b>	Tape/Media #:	
Purpose:	<b>Routine Assessment</b>	Dia/Height:	<b>10"</b>
Use:	<b>Sanitary</b>	Material:	<b>VCP</b>
Drain Area:	<b>NA</b>	Lining:	
Category:	<b>NA</b>		
Comment:			
Location Details:		Direction of Survey:	<b>Downstream</b>
US MH:	<b>M-506-033</b>	DS MH:	<b>M-506-007</b>
		Total Length Surveyed (ft):	<b>5.0</b>

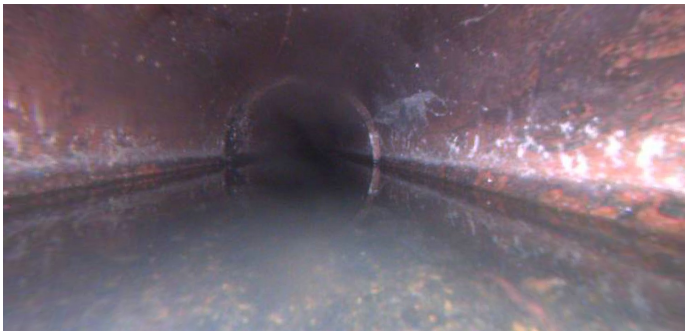
Code: **AMH**  
Description: **Manhole**

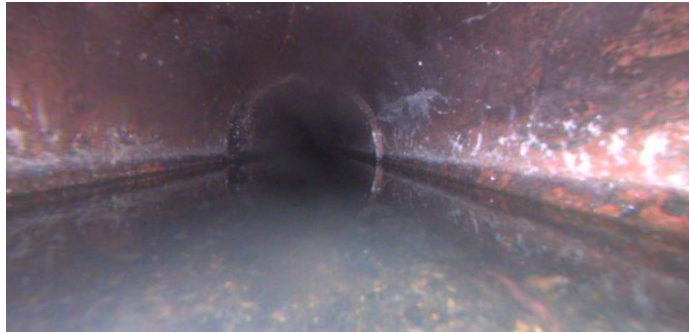
Code: **MWL**  
Description: **Water Level**

Distance (ft): **.0**  
Structural Grade: **0**  
O&M Grade: **0**  
Clock Start/From:  
Clock To:  
1st Value:  
2nd Value:  
Value Percent: **40.000**  
Continuous Index:  
Within 8" of Joint: **NO**  
Remarks:

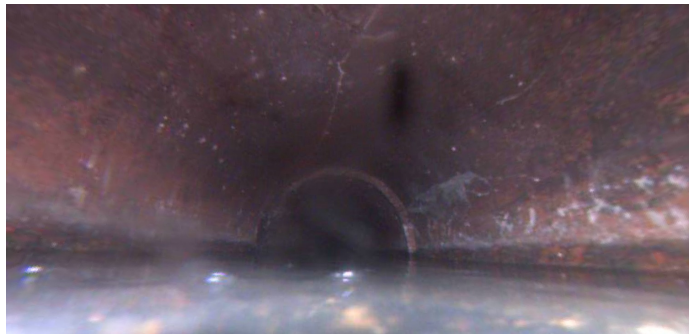
Code: **CL**  
Description: **Crack Longitudinal**

Distance (ft): **2.8**  
Structural Grade: **2**  
O&M Grade: **0**  
Clock Start/From: **12**  
Clock To:  
1st Value:  
2nd Value:  
Value Percent:  
Continuous Index:  
Within 8" of Joint:  
Remarks:

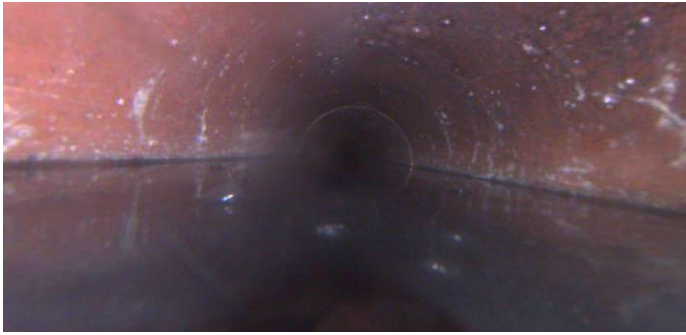
Code: **CM**  
Description: **Crack Multiple**

Distance (ft): **5.0**  
Structural Grade: **3**  
O&M Grade: **0**  
Clock Start/From: **8**  
Clock To: **4**  
1st Value:  
2nd Value:  
Value Percent:  
Continuous Index:  
Within 8" of Joint:  
Remarks:

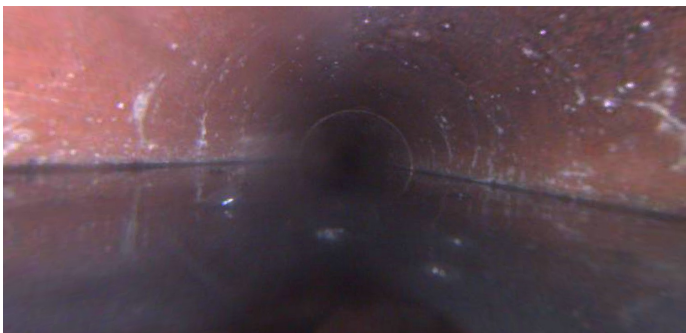
Code: **MWL**  
Description: **Water Level**

Distance (ft): **5.0**  
Structural Grade: **0**  
O&M Grade: **0**  
Clock Start/From:  
Clock To:  
1st Value:  
2nd Value:  
Value Percent: **40.000**  
Continuous Index:  
Within 8" of Joint: **NO**  
Remarks:

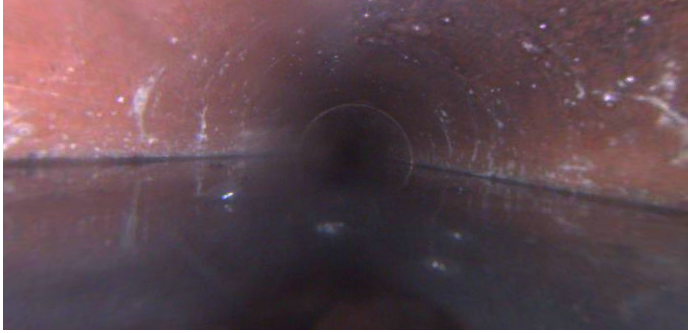
Code:	<b>MSA</b>
Description:	<b>Abandoned Survey</b>
Distance (ft):	<b>5.0</b>
Structural Grade:	<b>0</b>
O&M Grade:	<b>0</b>
Clock Start/From:	
Clock To:	
1st Value:	
2nd Value:	
Value Percent:	
Continuous Index:	
Within 8" of Joint:	<b>NO</b>
Remarks:	<b>debris under water</b>
