Profile/Photo Observation Report

Date:	04/06/2018	Weather:		Coding:	PACP 6.0
Pipe Length (ft):	134.6	Owner:	NA	Pre Clean:	No Pre-Cleaning
P.O.#:		Surveyor:	Jen Costello	PSR:	P-506-007-033
Customer:		Clean Date:	01/01/1900	Shape:	C

Street:	FOXCROFT STREET	Flow Control:	Not Controlled
City:	Hobart, IN	Year Renewed:	
Location:	Yard	Tape/Media #:	
Purpose:	Routine Assessment	Dia/Height:	10"
Use:	Sanitary	Material:	VCP
Drain Area:	NA	Lining:	
Category:	NA		
Comment:

Location Details:		Direction of Survey:	Downstream
US MH:	M-506-033	DS MH:	M-506-007
		Total Length Surveyed (ft):	5.0

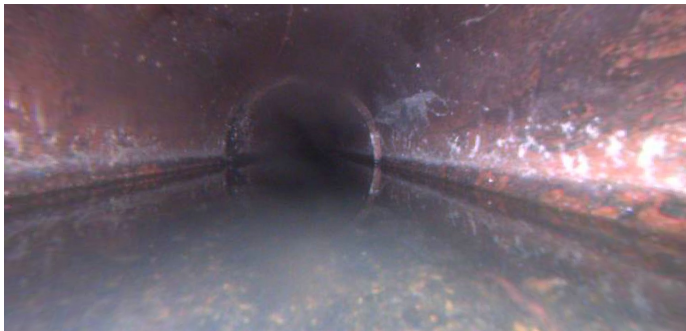
Code: **AMH**
Description: **Manhole**

Distance (ft): **.0**
Structural Grade: **0**
O&M Grade: **0**
Clock Start/From:
Clock To:
1st Value:
2nd Value:
Value Percent:
Continuous Index:
Within 8" of Joint: **NO**
Remarks: **M-506-033**

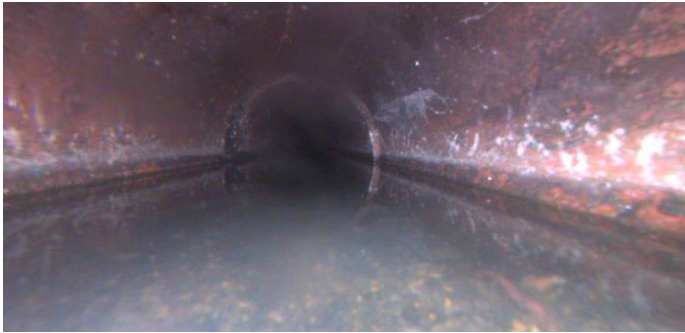
Code:	MWL
Description:	Water Level

Distance (ft):	.0
Structural Grade:	0
O&M Grade:	0
Clock Start/From:	
Clock To:	
1st Value:	
2nd Value:	
Value Percent:	40.000
Continuous Index:	
Within 8" of Joint:	NO
Remarks:

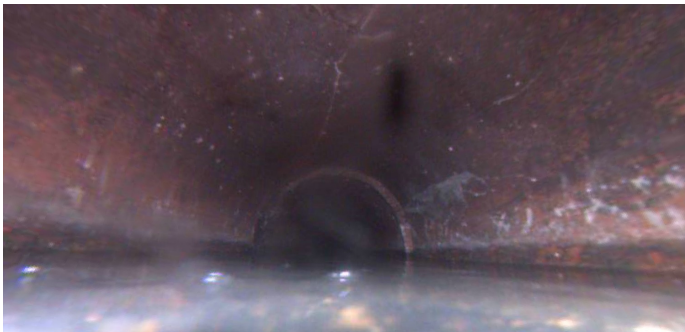
Code:	CL
Description:	Crack Longitudinal

Distance (ft):	2.8
Structural Grade:	2
O&M Grade:	0
Clock Start/From:	12
Clock To:	
1st Value:	
2nd Value:	
Value Percent:	
Continuous Index:	
Within 8" of Joint:	
Remarks:

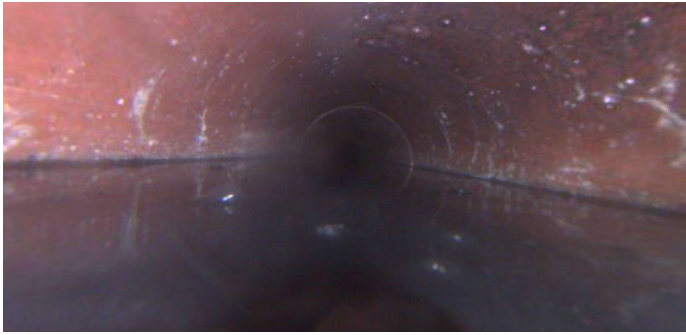
Code: **CM**
Description: **Crack Multiple**

Distance (ft): **5.0**
Structural Grade: **3**
O&M Grade: **0**
Clock Start/From: **8**
Clock To: **4**
1st Value:
2nd Value:
Value Percent:
Continuous Index:
Within 8" of Joint:
Remarks:

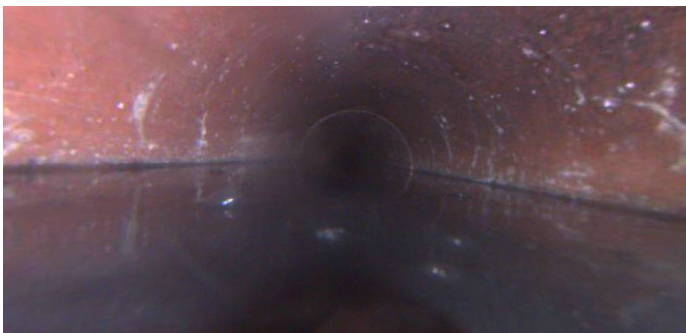
Code: **MWL**
Description: **Water Level**

Distance (ft): **5.0**
Structural Grade: **0**
O&M Grade: **0**
Clock Start/From:
Clock To:
1st Value:
2nd Value:
Value Percent: **40.000**
Continuous Index:
Within 8" of Joint: **NO**
Remarks:

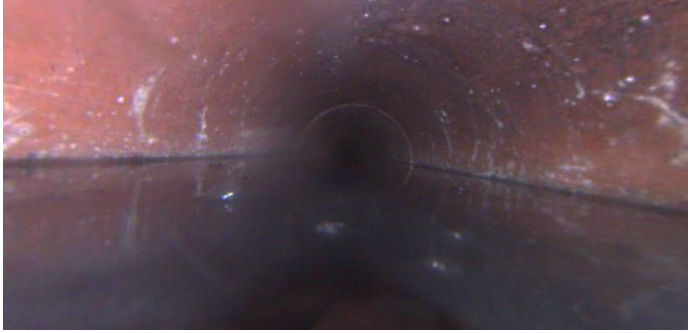
Code:	MSA
Description:	Abandoned Survey
Distance (ft):	5.0
Structural Grade:	0
O&M Grade:	0
Clock Start/From:	
Clock To:	
1st Value:	
2nd Value:	
Value Percent:	
Continuous Index:	
Within 8" of Joint:	NO
Remarks:	debris under water
