## Profile/Photo Observation Report

Date:	<b>01/19/2022</b>	Weather:		Coding:	<b>PACP 7.0</b>
Pipe Length (ft):	<b>159.4</b>	Owner:	<b>City of Hobart</b>	Pre Clean:	<b>Heavy Cleaning</b>
P.O.#:	<b>YES502259</b>	Surveyor:	<b>S. Bucklin</b>	PSR:	<b>P-506-007-033</b>
Customer:	<b>City of Hobart</b>	Clean Date:	<b>01/18/2022</b>	Shape:	<b>C</b>

Street:	<b>West 8th Street</b>	Flow Control:	<b>Not Controlled</b>
City:	<b>Hobart, IN</b>	Year Renewed:	
Location:	<b>Local rural streets with light traffic, t</b>	Tape/Media #:	
Purpose:	<b>Routine Assessment</b>	Dia/Height:	<b>10"</b>
Use:	<b>Sanitary Sewage Pipe</b>	Material:	<b>VCP</b>
Drain Area:		Lining:	<b>None</b>
Category:	<b>NA</b>		
Comment:			
Location Details:		Direction of Survey:	<b>Downstream</b>
US MH:	<b>M-506-033</b>	DS MH:	<b>M-506-007</b>
		Total Length Surveyed (ft):	<b>159.4</b>

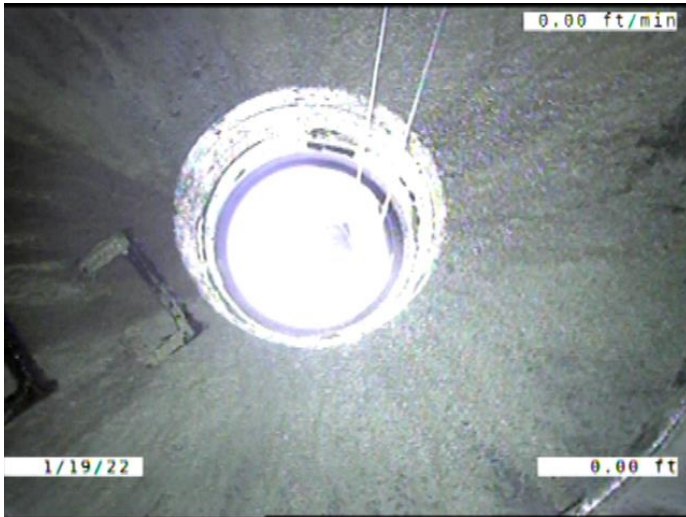
Code: **AMH**  
 Description: **Manhole**

Distance (ft): **.0**  
 Structural Grade: **0**  
 O&M Grade: **0**  
 Clock Start/From:  
 Clock To:  
 1st Value:  
 2nd Value:  
 Value Percent:  
 Continuous Index:  
 Within 8" of Joint: **NO**  
 Remarks: **M-506-033**

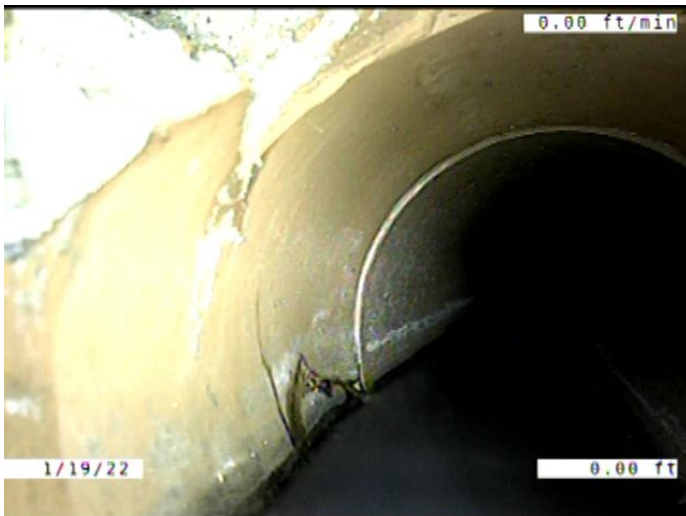
Code: **MWL**  
 Description: **Miscellaneous Water Level**

Distance (ft): **.0**  
 Structural Grade: **0**  
 O&M Grade: **0**  
 Clock Start/From:  
 Clock To:  
 1st Value:  
 2nd Value:  
 Value Percent: **5.000**  
 Continuous Index:  
 Within 8" of Joint: **NO**  
 Remarks:

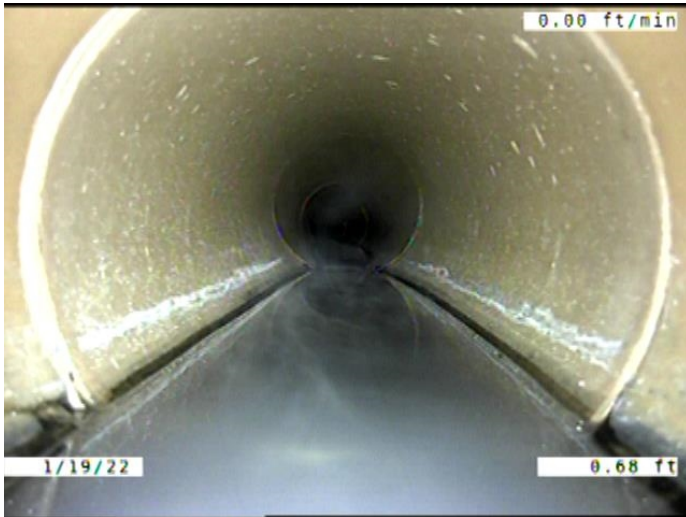
Code: **MWLS**  
Description: **Miscellaneous Water Level Sag**

Distance (ft): **.7**  
Structural Grade: **2**  
O&M Grade: **0**  
Clock Start/From:  
Clock To:  
1st Value:  
2nd Value:  
Value Percent: **5.000**  
Continuous Index: **S01**  
Within 8" of Joint: **NO**  
Remarks:

Code: **SSS**  
Description: **Surface Damage Surface Spalling**

Distance (ft): **.7**  
Structural Grade: **2**  
O&M Grade: **0**  
Clock Start/From: **9**  
Clock To:  
1st Value:  
2nd Value:  
Value Percent:  
Continuous Index:  
Within 8" of Joint: **NO**  
Remarks:

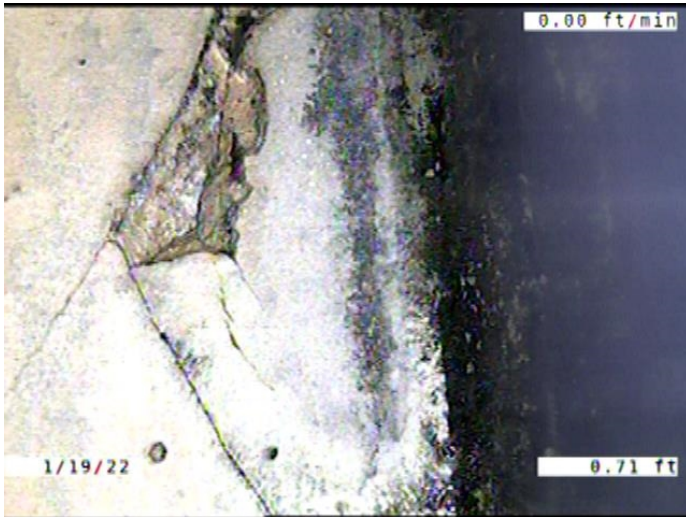
Code: **CM**  
 Description: **Crack Multiple**

Distance (ft): **.7**  
 Structural Grade: **3**  
 O&M Grade: **0**  
 Clock Start/From: **8**  
 Clock To: **11**  
 1st Value:  
 2nd Value:  
 Value Percent:  
 Continuous Index:  
 Within 8" of Joint: **YES**  
 Remarks:

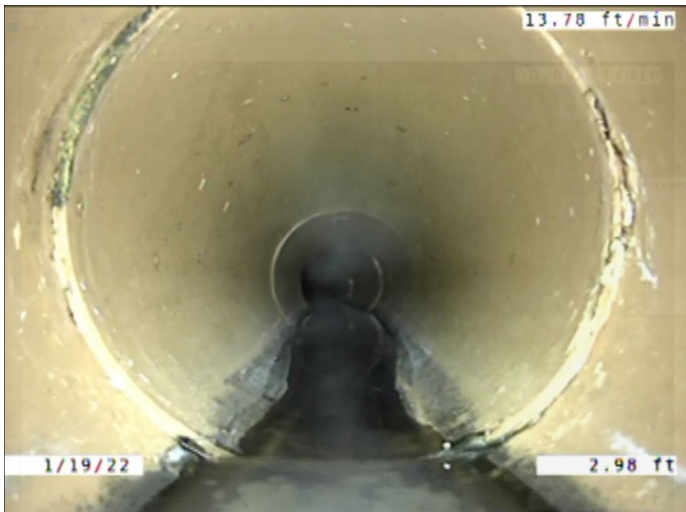
Code: **IS**  
 Description: **Infiltration Stain**

Distance (ft): **3.0**  
 Structural Grade: **0**  
 O&M Grade: **1**  
 Clock Start/From: **2**  
 Clock To: **3**  
 1st Value:  
 2nd Value:  
 Value Percent:  
 Continuous Index:  
 Within 8" of Joint: **YES**  
 Remarks:

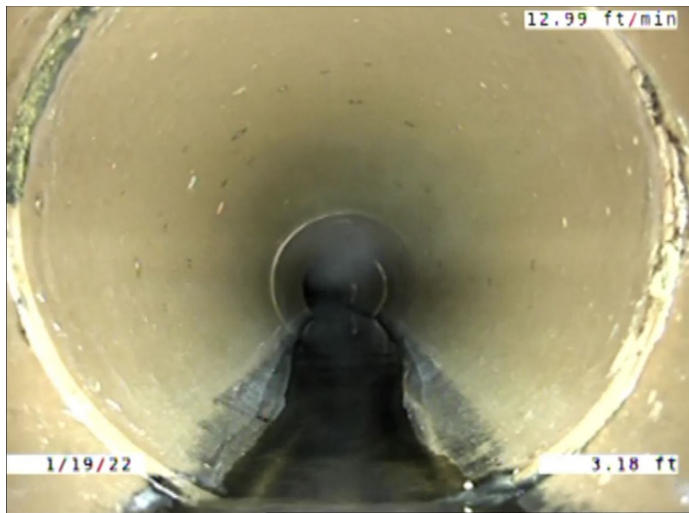
Code: **IS**  
Description: **Infiltration Stain**

Distance (ft): **3.2**  
Structural Grade: **0**  
O&M Grade: **1**  
Clock Start/From: **9**  
Clock To: **11**  
1st Value:  
2nd Value:  
Value Percent:  
Continuous Index:  
Within 8" of Joint: **YES**  
Remarks:

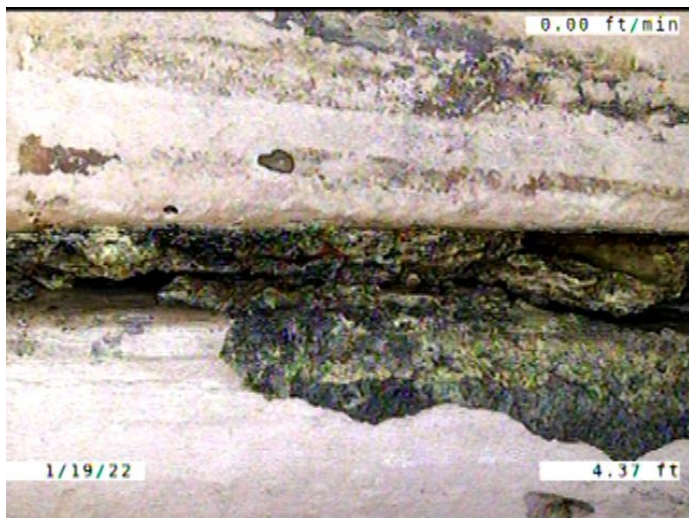
Code: **DAE**  
Description: **Deposits Attached Encrustation**

Distance (ft): **4.4**  
Structural Grade: **0**  
O&M Grade: **2**  
Clock Start/From: **7**  
Clock To: **5**  
1st Value:  
2nd Value:  
Value Percent: **5.000**  
Continuous Index: **S02**  
Within 8" of Joint: **YES**  
Remarks:

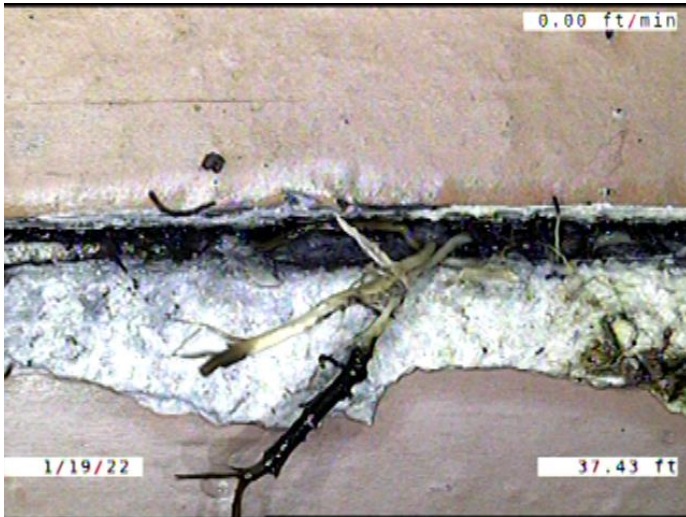
Code: **RFJ**  
 Description: **Roots Fine Joint**

Distance (ft): **37.4**  
 Structural Grade: **0**  
 O&M Grade: **1**  
 Clock Start/From: **8**  
 Clock To: **11**  
 1st Value:  
 2nd Value:  
 Value Percent:  
 Continuous Index:  
 Within 8" of Joint: **YES**  
 Remarks:

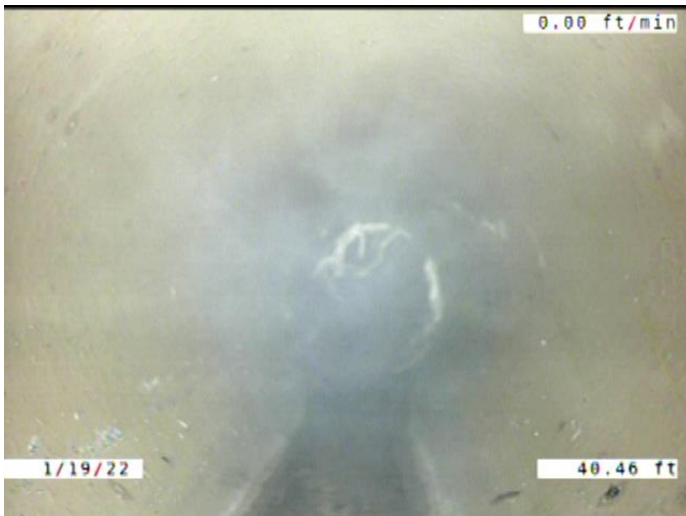
Code: **MWLS**  
 Description: **Miscellaneous Water Level Sag**

Distance (ft): **40.5**  
 Structural Grade: **2**  
 O&M Grade: **0**  
 Clock Start/From:  
 Clock To:  
 1st Value:  
 2nd Value:  
 Value Percent: **5.000**  
 Continuous Index: **F01**  
 Within 8" of Joint: **NO**  
 Remarks:

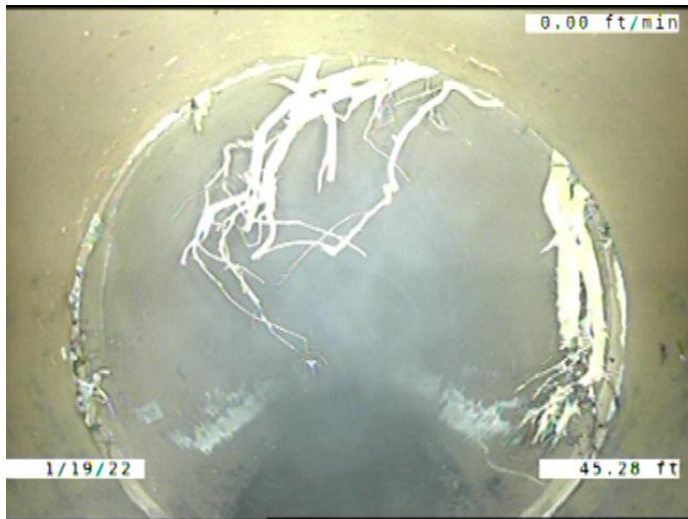
Code: **RFJ**  
 Description: **Roots Fine Joint**

Distance (ft): **45.3**  
 Structural Grade: **0**  
 O&M Grade: **1**  
 Clock Start/From: **8**  
 Clock To: **4**  
 1st Value:  
 2nd Value:  
 Value Percent:  
 Continuous Index:  
 Within 8" of Joint: **YES**  
 Remarks:

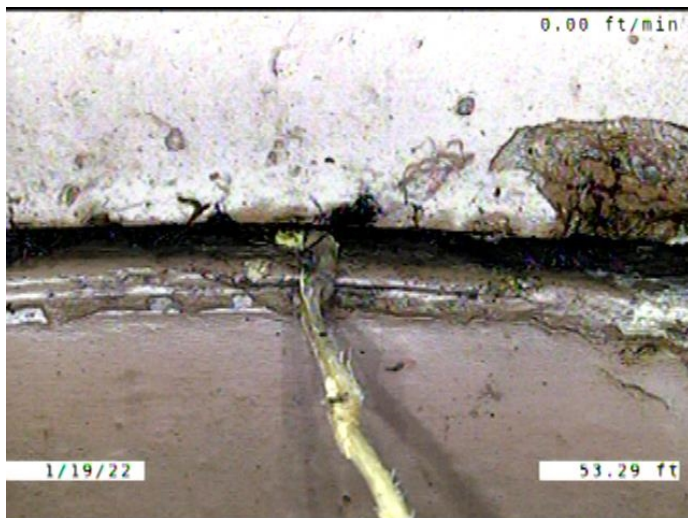
Code: **RFJ**  
 Description: **Roots Fine Joint**

Distance (ft): **53.3**  
 Structural Grade: **0**  
 O&M Grade: **1**  
 Clock Start/From: **9**  
 Clock To: **3**  
 1st Value:  
 2nd Value:  
 Value Percent:  
 Continuous Index:  
 Within 8" of Joint: **YES**  
 Remarks:

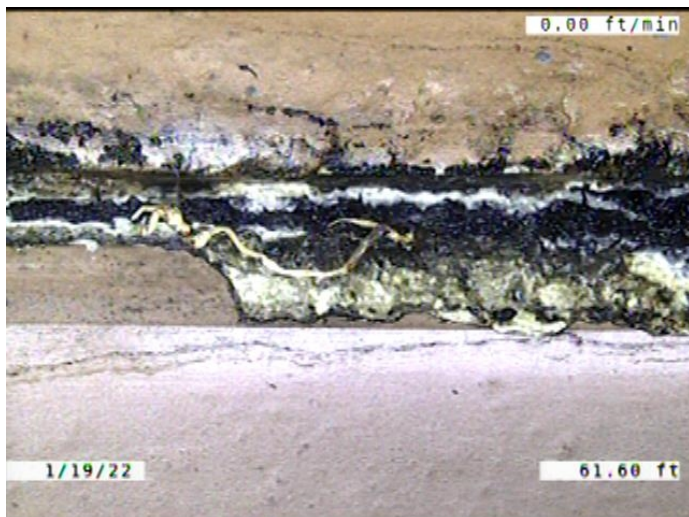
Code: **RFJ**  
 Description: **Roots Fine Joint**

Distance (ft): **61.6**  
 Structural Grade: **0**  
 O&M Grade: **1**  
 Clock Start/From: **9**  
 Clock To: **11**  
 1st Value:  
 2nd Value:  
 Value Percent:  
 Continuous Index:  
 Within 8" of Joint: **YES**  
 Remarks:

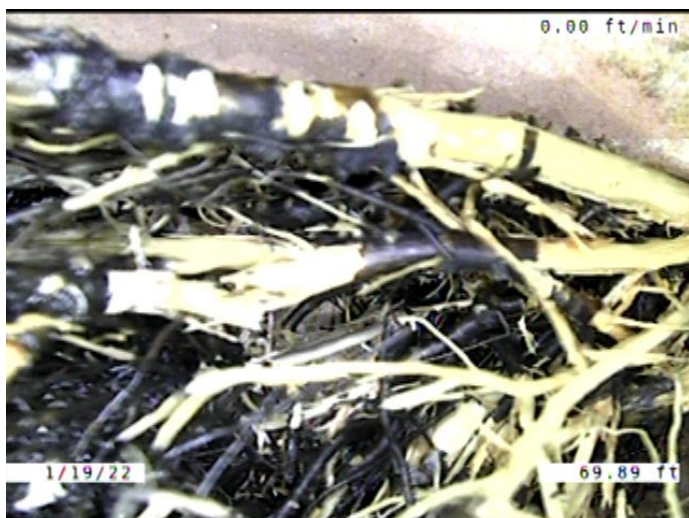
Code: **RMJ**  
 Description: **Roots Medium Joint**

Distance (ft): **69.9**  
 Structural Grade: **0**  
 O&M Grade: **3**  
 Clock Start/From: **8**  
 Clock To: **4**  
 1st Value:  
 2nd Value:  
 Value Percent: **10.000**  
 Continuous Index:  
 Within 8" of Joint: **YES**  
 Remarks:

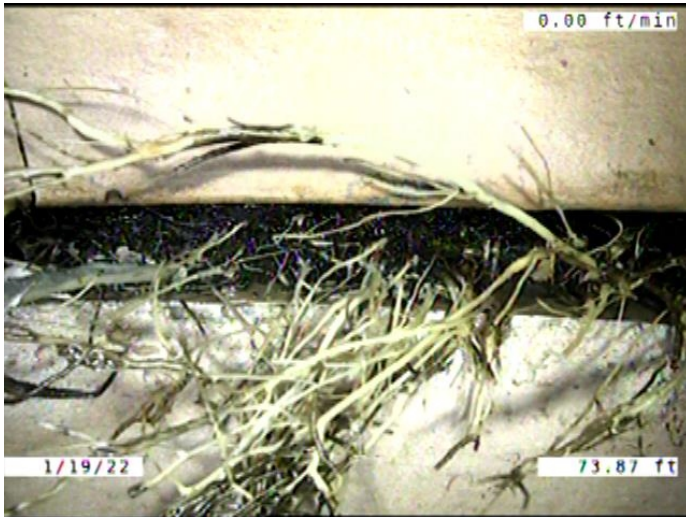
Code: **RFJ**  
 Description: **Roots Fine Joint**

Distance (ft): **73.9**  
 Structural Grade: **0**  
 O&M Grade: **1**  
 Clock Start/From: **8**  
 Clock To: **11**  
 1st Value:  
 2nd Value:  
 Value Percent:  
 Continuous Index:  
 Within 8" of Joint: **YES**  
 Remarks:

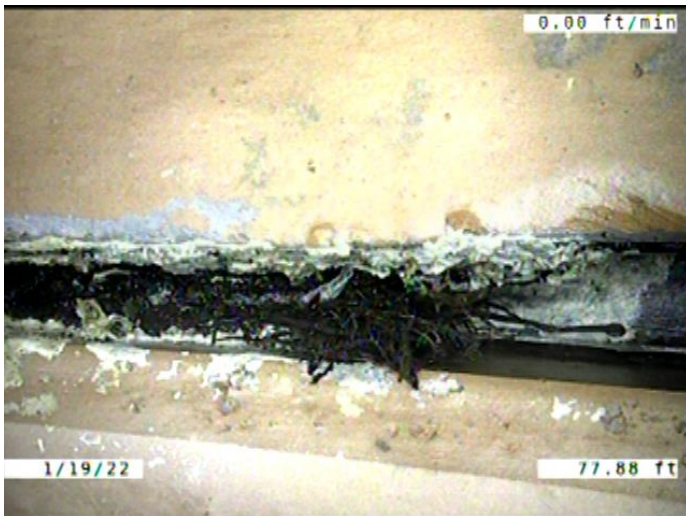
Code: **RFJ**  
 Description: **Roots Fine Joint**

Distance (ft): **77.9**  
 Structural Grade: **0**  
 O&M Grade: **1**  
 Clock Start/From: **2**  
 Clock To: **3**  
 1st Value:  
 2nd Value:  
 Value Percent:  
 Continuous Index:  
 Within 8" of Joint: **YES**  
 Remarks:

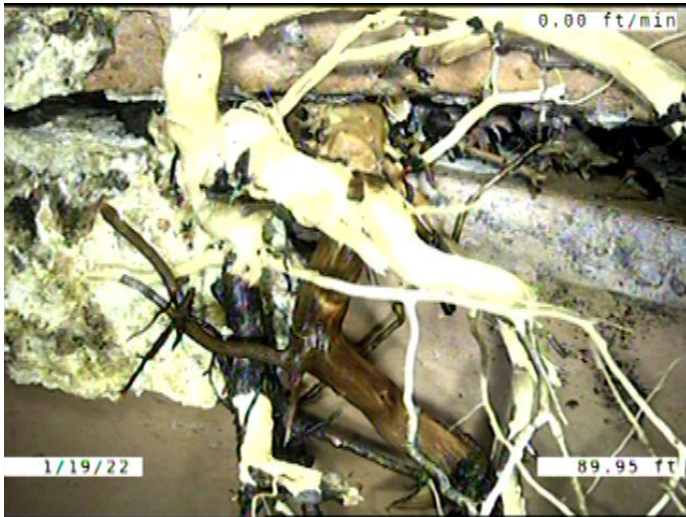
Code: **RMJ**  
 Description: **Roots Medium Joint**

Distance (ft): **89.9**  
 Structural Grade: **0**  
 O&M Grade: **3**  
 Clock Start/From: **2**  
 Clock To: **3**  
 1st Value:  
 2nd Value:  
 Value Percent: **5.000**  
 Continuous Index:  
 Within 8" of Joint: **YES**  
 Remarks:

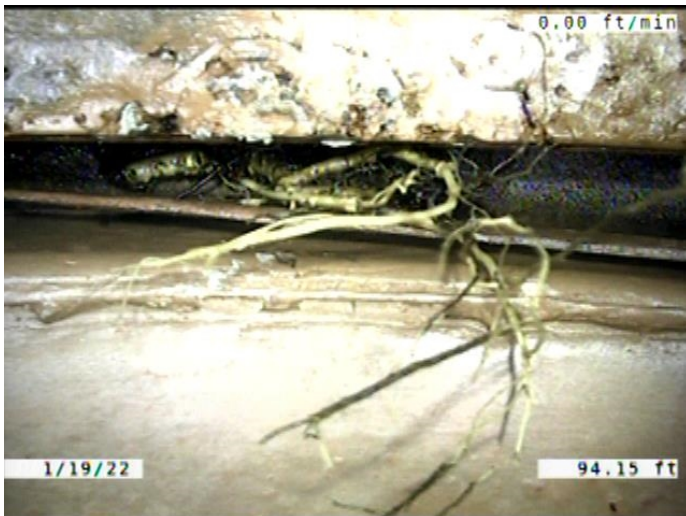
Code: **RFJ**  
 Description: **Roots Fine Joint**

Distance (ft): **94.1**  
 Structural Grade: **0**  
 O&M Grade: **1**  
 Clock Start/From: **9**  
 Clock To:  
 1st Value:  
 2nd Value:  
 Value Percent:  
 Continuous Index:  
 Within 8" of Joint: **YES**  
 Remarks:

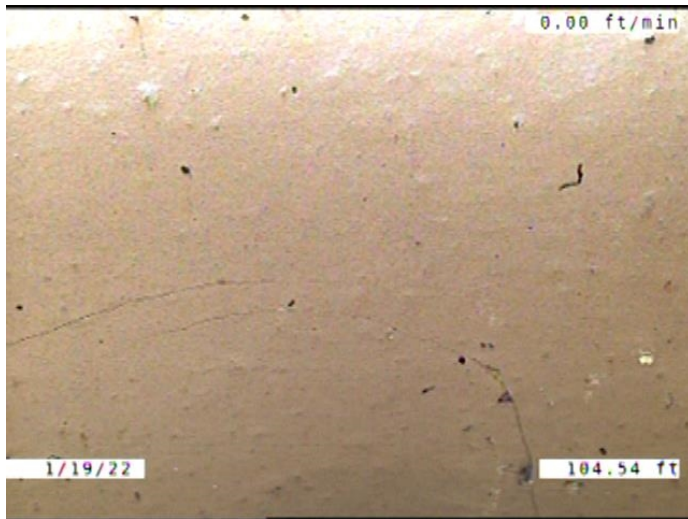
Code: **CM**  
Description: **Crack Multiple**

Distance (ft): **104.5**  
Structural Grade: **3**  
O&M Grade: **0**  
Clock Start/From: **7**  
Clock To: **11**  
1st Value:  
2nd Value:  
Value Percent:  
Continuous Index:  
Within 8" of Joint: **YES**  
Remarks:

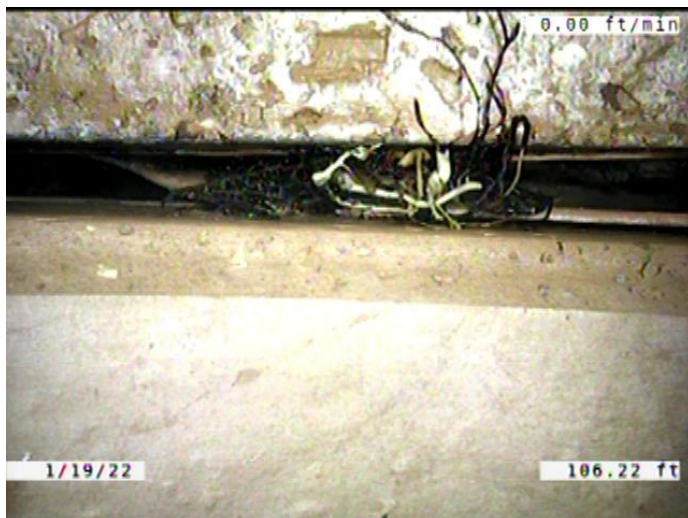
Code: **RFJ**  
Description: **Roots Fine Joint**

Distance (ft): **106.2**  
Structural Grade: **0**  
O&M Grade: **1**  
Clock Start/From: **9**  
Clock To:  
1st Value:  
2nd Value:  
Value Percent:  
Continuous Index:  
Within 8" of Joint: **YES**  
Remarks:

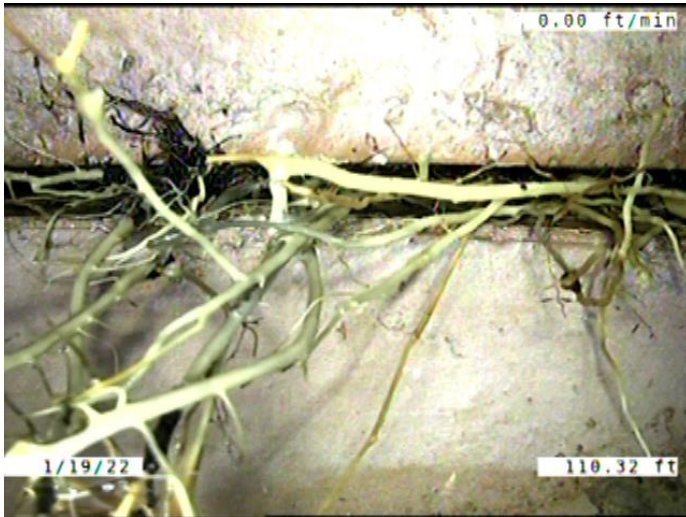
Code:	<b>RFJ</b>
Description:	<b>Roots Fine Joint</b>
Distance (ft):	<b>110.3</b>
Structural Grade:	<b>0</b>
O&M Grade:	<b>1</b>
Clock Start/From:	<b>9</b>
Clock To:	<b>3</b>
1st Value:	
2nd Value:	
Value Percent:	
Continuous Index:	
Within 8" of Joint:	<b>YES</b>
Remarks:

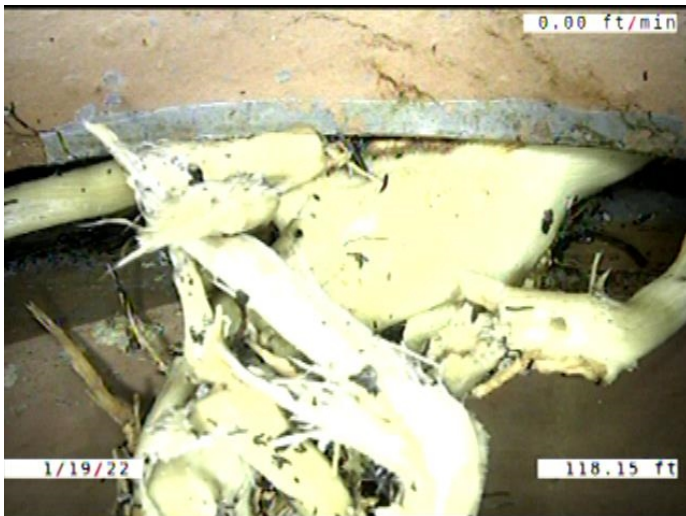
Code:	<b>RTJ</b>
Description:	<b>Roots Tap Joint</b>
Distance (ft):	<b>118.1</b>
Structural Grade:	<b>0</b>
O&M Grade:	<b>2</b>
Clock Start/From:	<b>10</b>
Clock To:	<b>4</b>
1st Value:	
2nd Value:	
Value Percent:	<b>10.000</b>
Continuous Index:	
Within 8" of Joint:	<b>YES</b>
Remarks:

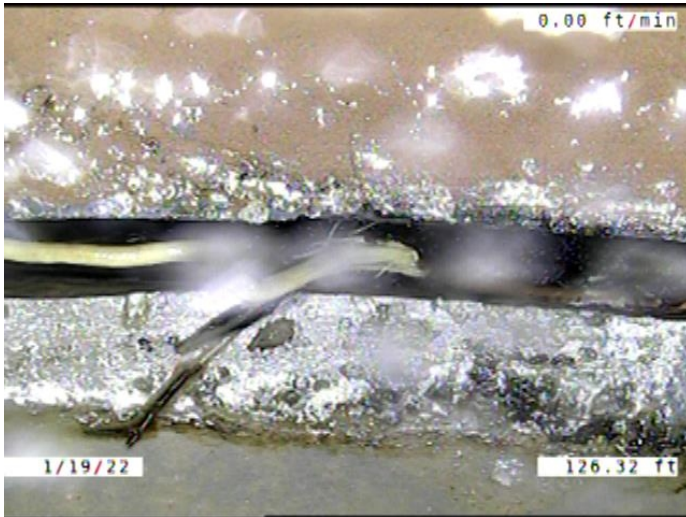
Code: **RFJ**  
 Description: **Roots Fine Joint**

Distance (ft): **126.3**  
 Structural Grade: **0**  
 O&M Grade: **1**  
 Clock Start/From: **8**  
 Clock To: **4**  
 1st Value:  
 2nd Value:  
 Value Percent:  
 Continuous Index:  
 Within 8" of Joint: **YES**  
 Remarks:

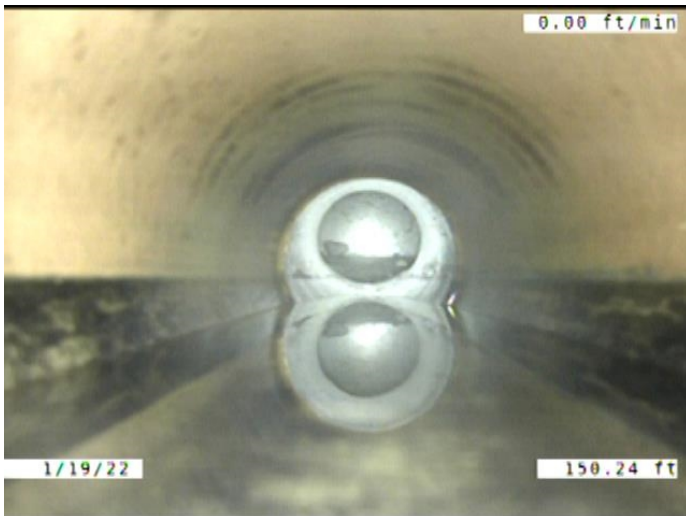
Code: **MWLS**  
 Description: **Miscellaneous Water Level Sag**

Distance (ft): **150.2**  
 Structural Grade: **2**  
 O&M Grade: **0**  
 Clock Start/From:  
 Clock To:  
 1st Value:  
 2nd Value:  
 Value Percent: **15.000**  
 Continuous Index:  
 Within 8" of Joint: **NO**  
 Remarks:

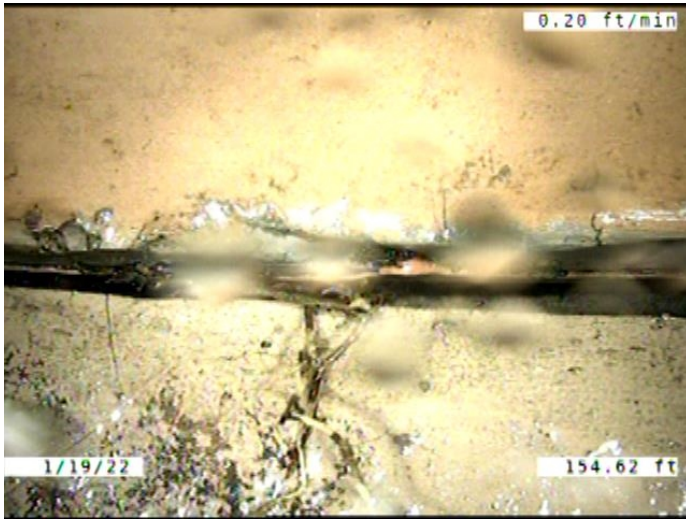
Code: **RFJ**  
 Description: **Roots Fine Joint**

Distance (ft): **154.6**  
 Structural Grade: **0**  
 O&M Grade: **1**  
 Clock Start/From: **1**  
 Clock To: **2**  
 1st Value:  
 2nd Value:  
 Value Percent:  
 Continuous Index:  
 Within 8" of Joint: **YES**  
 Remarks:

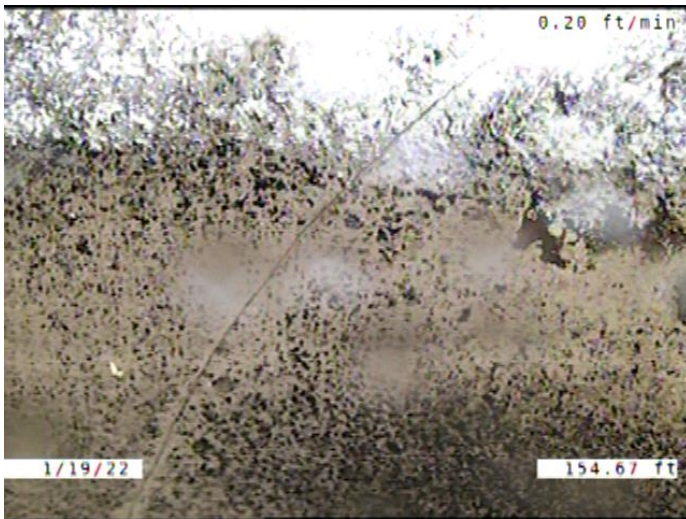
Code: **CM**  
 Description: **Crack Multiple**

Distance (ft): **154.7**  
 Structural Grade: **3**  
 O&M Grade: **0**  
 Clock Start/From: **10**  
 Clock To: **1**  
 1st Value:  
 2nd Value:  
 Value Percent:  
 Continuous Index:  
 Within 8" of Joint: **YES**  
 Remarks:

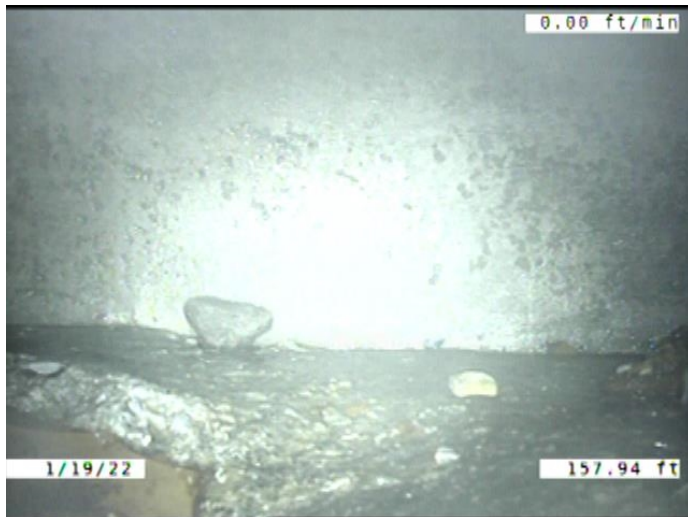
Code: **DAE**  
Description: **Deposits Attached Encrustation**

Distance (ft): **157.9**  
Structural Grade: **0**  
O&M Grade: **2**  
Clock Start/From: **7**  
Clock To: **5**  
1st Value:  
2nd Value:  
Value Percent: **5.000**  
Continuous Index: **F02**  
Within 8" of Joint: **YES**  
Remarks:

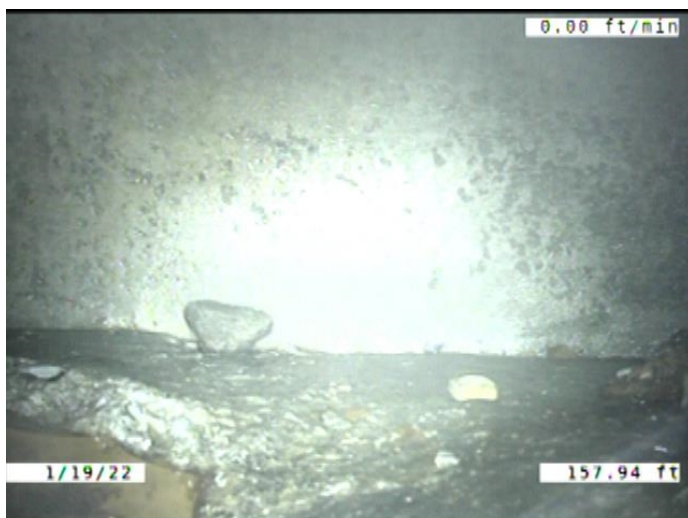
Code: **MGO**  
Description: **Miscellaneous General Observation**

Distance (ft): **157.9**  
Structural Grade: **0**  
O&M Grade: **0**  
Clock Start/From:  
Clock To:  
1st Value:  
2nd Value:  
Value Percent:  
Continuous Index:  
Within 8" of Joint: **NO**  
Remarks: **6 1/2 % INCLINE INTO THE  
DOWNSTREAM MANHOLE.**
