Profile/Photo Observation Report

Street:	FOXCROFT STREET	Flow Control:	Not Controlled
City:	Hobart, IN	Year Renewed:	
Location:	Light Highway	Tape/Media #:	
Purpose:	Routine Assessment	Dia/Height:	8"
Use:	Sanitary	Material:	VCP
Drain Area:	NA	Lining:	
Category:	NA		
Comment:	Flow direction wrong

Location Details:		Direction of Survey:	Downstream
US MH:	M-507-001	DS MH:	M-507-094
		Total Length Surveyed (ft):	108.1

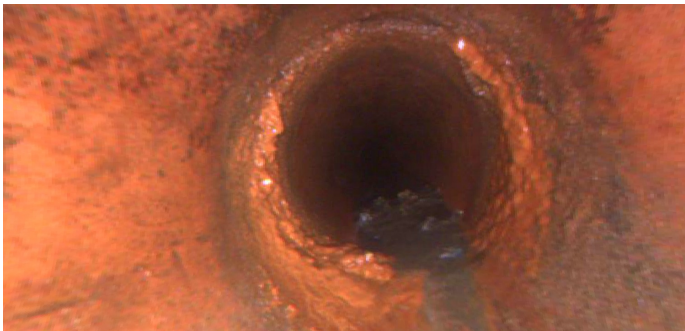
Code: **AMH**
Description: **Manhole**

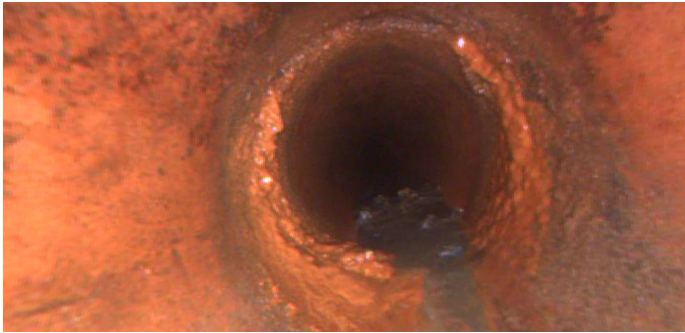
Code:	MWL
Description:	Water Level

Distance (ft):	.0
Structural Grade:	0
O&M Grade:	0
Clock Start/From:	
Clock To:	
1st Value:	
2nd Value:	
Value Percent:	5.000
Continuous Index:	
Within 8" of Joint:	NO
Remarks:

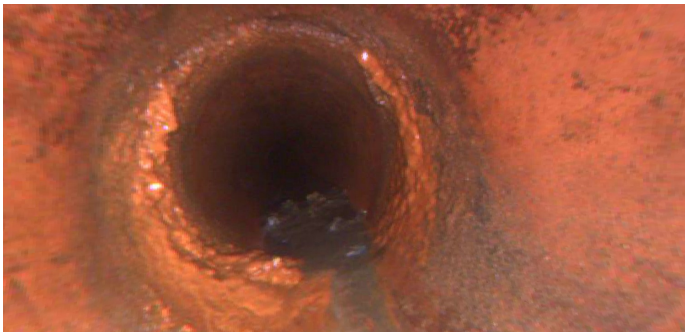
Code:	DAE
Description:	Deposits Attached Encrustation

Distance (ft):	.0
Structural Grade:	0
O&M Grade:	2
Clock Start/From:	7
Clock To:	5
1st Value:	
2nd Value:	
Value Percent:	5.000
Continuous Index:	
Within 8" of Joint:	YES
Remarks:

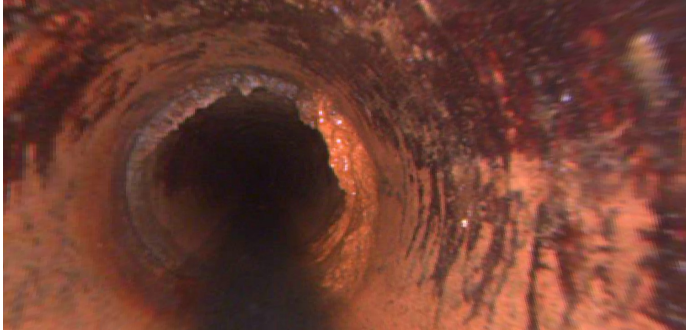
Code: **DAE**
Description: **Deposits Attached Encrustation**

Distance (ft): **22.2**
Structural Grade: **0**
O&M Grade: **2**
Clock Start/From: **7**
Clock To: **5**
1st Value:
2nd Value:
Value Percent: **5.000**
Continuous Index: **S01**
Within 8" of Joint: **YES**
Remarks: **wandering**

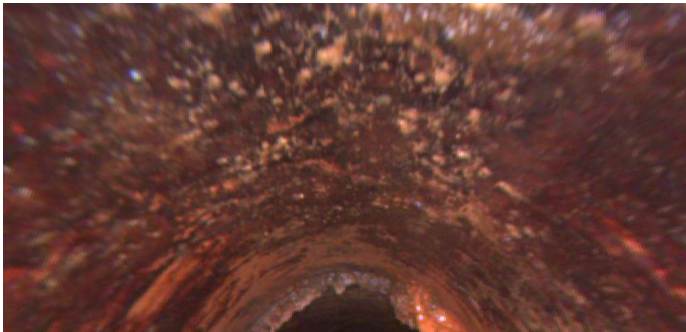
Code: **IS**
Description: **Infil Stain**

Distance (ft): **22.2**
Structural Grade: **0**
O&M Grade: **0**
Clock Start/From: **7**
Clock To: **5**
1st Value:
2nd Value:
Value Percent:
Continuous Index: **S02**
Within 8" of Joint:
Remarks: **wandering**

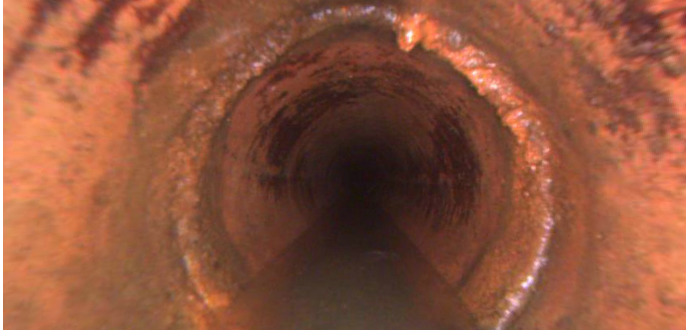
Code: ID
Description: Infil Dripper

Distance (ft): 38.4
Structural Grade: 0
O&M Grade: 3
Clock Start/From: 12
Clock To:
1st Value:
2nd Value:
Value Percent:
Continuous Index:
Within 8" of Joint: YES
Remarks:

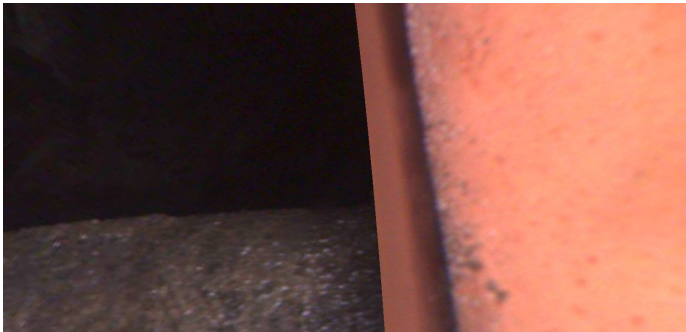
Code: IS
Description: Infil Stain

Distance (ft): 106.2
Structural Grade: 0
O&M Grade: 0
Clock Start/From: 7
Clock To: 5
1st Value:
2nd Value:
Value Percent:
Continuous Index: F02
Within 8" of Joint:
Remarks: wandering

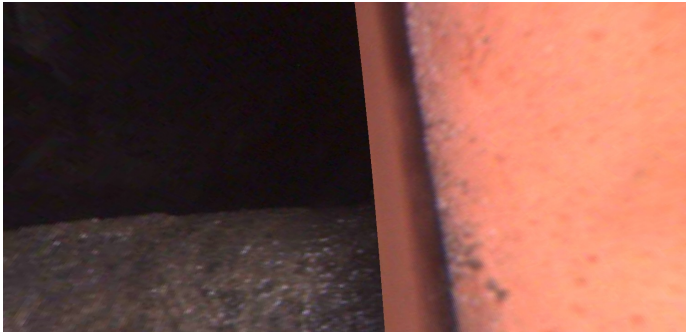
Code: **DAE**
Description: **Deposits Attached Encrustation**

Distance (ft): **106.2**
Structural Grade: **0**
O&M Grade: **2**
Clock Start/From: **7**
Clock To: **5**
1st Value:
2nd Value:
Value Percent: **5.000**
Continuous Index: **F01**
Within 8" of Joint: **YES**
Remarks: **wandering**

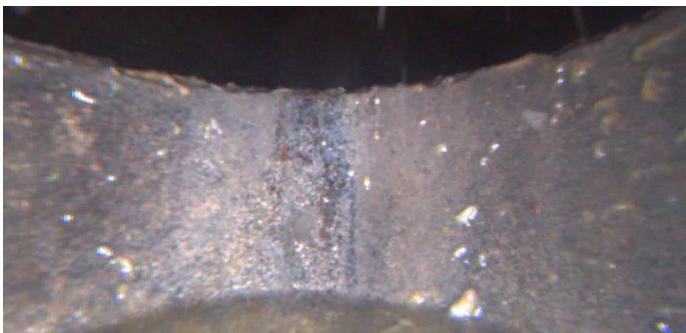
Code: **AMH**
Description: **Manhole**

Distance (ft): **108.1**
Structural Grade: **0**
O&M Grade: **0**
Clock Start/From:
Clock To:
1st Value:
2nd Value:
Value Percent:
Continuous Index:
Within 8" of Joint: **NO**
Remarks: **M-507-094**
