Profile/Photo Observation Report

Date:	03/27/2018	Weather:		Coding:	PACP 6.0
Pipe Length (ft):	243.1	Owner:	NA	Pre Clean:	No Pre-Cleaning
P.O.#:		Surveyor:	Jen Costello	PSR:	P-507-002-003
Customer:		Clean Date:	01/01/1900	Shape:	C

Street:	OFF S DELAWARE ST	Flow Control:	Not Controlled
City:	Hobart, IN	Year Renewed:	
Location:	Light Highway	Tape/Media #:	
Purpose:	Routine Assessment	Dia/Height:	8"
Use:	Sanitary	Material:	VCP
Drain Area:	NA	Lining:	
Category:	NA		
Comment:

Location Details:		Direction of Survey:	Downstream
US MH:	M-507-002	DS MH:	M-507-003
		Total Length Surveyed (ft):	158.7

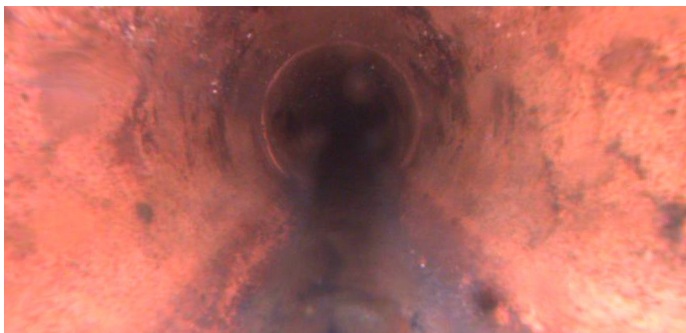
Code: **AMH**
Description: **Manhole**

Distance (ft): **.0**
Structural Grade: **0**
O&M Grade: **0**
Clock Start/From:
Clock To:
1st Value:
2nd Value:
Value Percent:
Continuous Index:
Within 8" of Joint: **NO**
Remarks: **M-507-002**

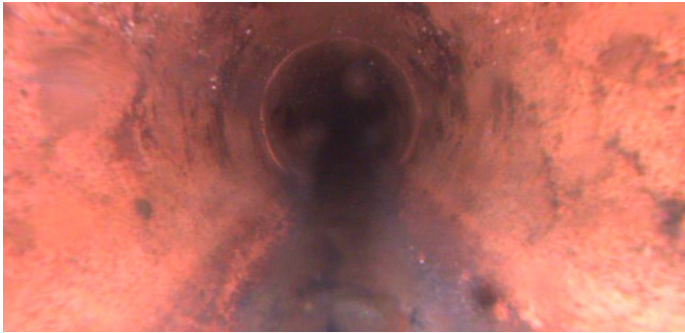
Code:	MWL
Description:	Water Level

Distance (ft):	.0
Structural Grade:	0
O&M Grade:	0
Clock Start/From:	
Clock To:	
1st Value:	
2nd Value:	
Value Percent:	5.000
Continuous Index:	
Within 8" of Joint:	NO
Remarks:

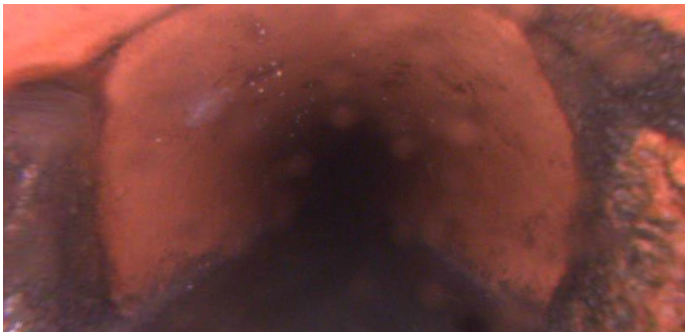
Code:	IW
Description:	Infil Weeper

Distance (ft):	7.2
Structural Grade:	0
O&M Grade:	2
Clock Start/From:	8
Clock To:	4
1st Value:	
2nd Value:	
Value Percent:	
Continuous Index:	
Within 8" of Joint:	YES
Remarks:

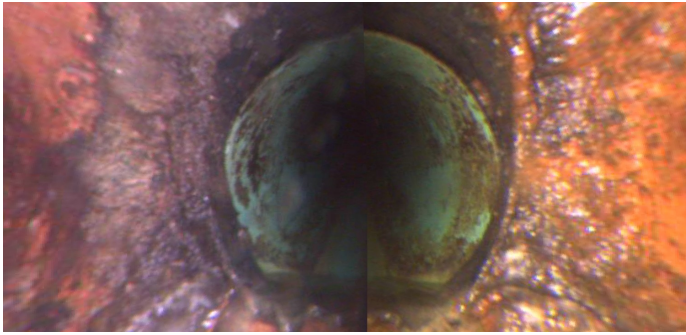
Code: **TBA**
Description: **Tap Break-in Active**

Distance (ft): **38.6**
Structural Grade: **0**
O&M Grade: **0**
Clock Start/From: **3**
Clock To:
1st Value: **4.000**
2nd Value:
Value Percent:
Continuous Index:
Within 8" of Joint:
Remarks:

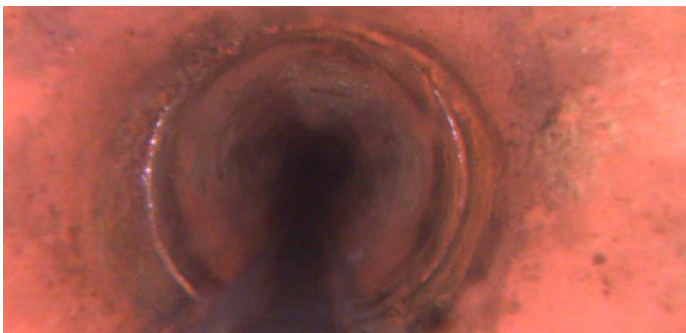
Code: **IW**
Description: **Infil Weeper**

Distance (ft): **56.9**
Structural Grade: **0**
O&M Grade: **2**
Clock Start/From: **8**
Clock To: **4**
1st Value:
2nd Value:
Value Percent:
Continuous Index:
Within 8" of Joint: **YES**
Remarks:

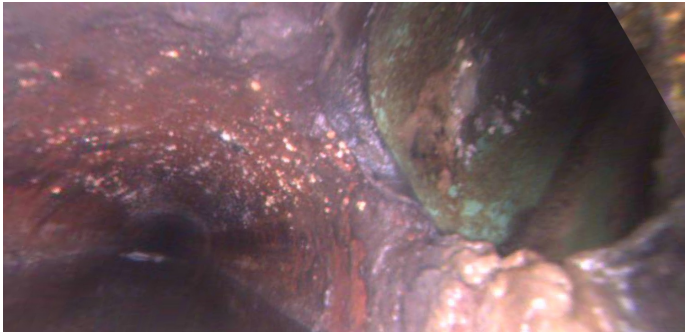
Code: **TBA**
Description: **Tap Break-in Active**

Distance (ft): **108.6**
Structural Grade: **0**
O&M Grade: **0**
Clock Start/From: **2**
Clock To:
1st Value: **4.000**
2nd Value:
Value Percent:
Continuous Index:
Within 8" of Joint:
Remarks:

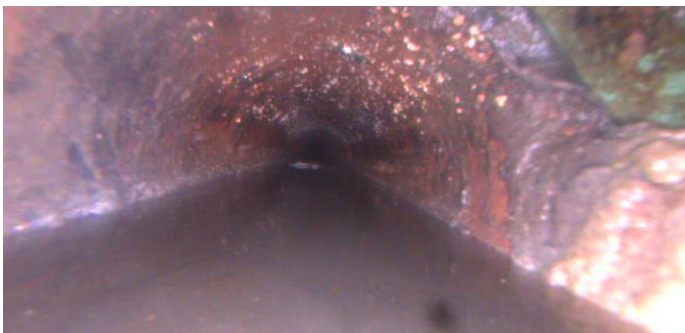
Code: **DAGS**
Description: **Deposits Attached Grease**

Distance (ft): **108.6**
Structural Grade: **0**
O&M Grade: **2**
Clock Start/From: **8**
Clock To: **4**
1st Value:
2nd Value:
Value Percent: **5.000**
Continuous Index:
Within 8" of Joint: **NO**
Remarks:

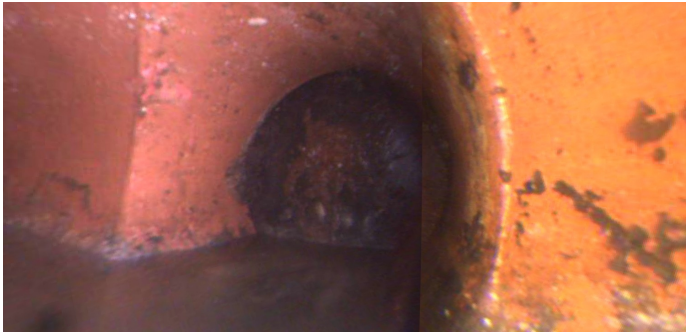
Code: **TFC**
Description: **Tap Factory Capped**

Distance (ft): **117.6**
Structural Grade: **0**
O&M Grade: **0**
Clock Start/From: **3**
Clock To:
1st Value: **4.000**
2nd Value:
Value Percent:
Continuous Index:
Within 8" of Joint:
Remarks:

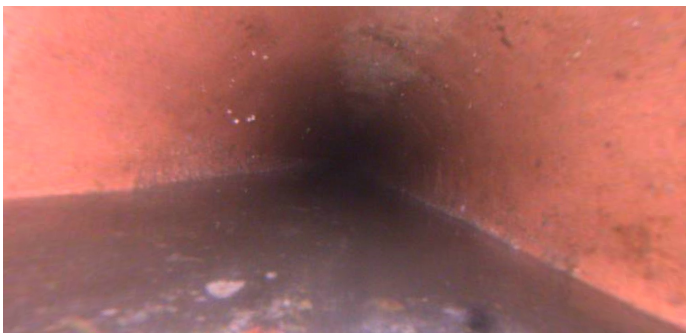
Code: **MWL**
Description: **Water Level**

Distance (ft): **139.3**
Structural Grade: **0**
O&M Grade: **0**
Clock Start/From:
Clock To:
1st Value:
2nd Value:
Value Percent: **40.000**
Continuous Index:
Within 8" of Joint: **NO**
Remarks:

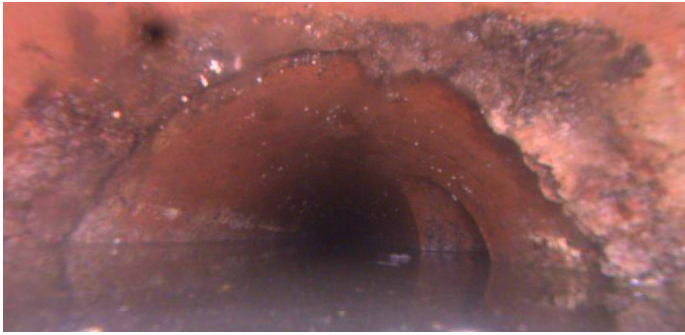
Code: **DAE**
Description: **Deposits Attached Encrustation**

Distance (ft): **154.1**
Structural Grade: **0**
O&M Grade: **2**
Clock Start/From: **8**
Clock To: **4**
1st Value:
2nd Value:
Value Percent: **10.000**
Continuous Index:
Within 8" of Joint: **YES**
Remarks:

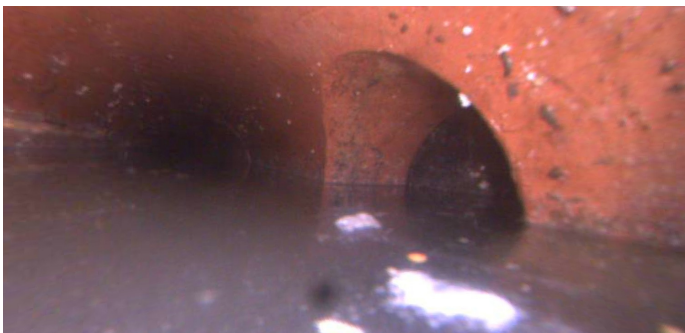
Code: **TFC**
Description: **Tap Factory Capped**

Distance (ft): **154.7**
Structural Grade: **0**
O&M Grade: **0**
Clock Start/From: **2**
Clock To:
1st Value: **4.000**
2nd Value:
Value Percent:
Continuous Index:
Within 8" of Joint:
Remarks:

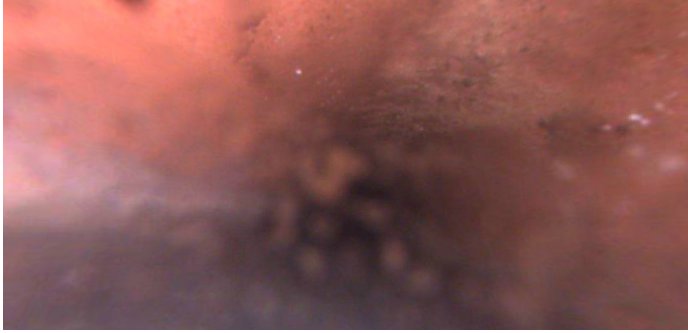
Code:	MSA
Description:	Abandoned Survey
Distance (ft):	158.7
Structural Grade:	0
O&M Grade:	0
Clock Start/From:	
Clock To:	
1st Value:	
2nd Value:	
Value Percent:	
Continuous Index:	
Within 8" of Joint:	NO
Remarks:	HIGH WATER
