Profile/Photo Observation Report

Date:	10/11/2018	Weather:		Coding:	PACP 6.0
Pipe Length (ft):	243.1	Owner:	NA	Pre Clean:	Not Known
P.O.#:		Surveyor:	Selasie Honu	PSR:	P-507-002-003
Customer:		Clean Date:	01/01/1900	Shape:	C

Street:	OFF S DELAWARE ST	Flow Control:	Not Controlled
City:	Hobart, IN	Year Renewed:	
Location:	Light Highway	Tape/Media #:	
Purpose:	Routine Assessment	Dia/Height:	8"
Use:	Sanitary	Material:	PVC
Drain Area:	NA	Lining:	
Category:	NA		
Comment:

Location Details:		Direction of Survey:	Downstream
US MH:	M-507-002	DS MH:	M-507-003
		Total Length Surveyed (ft):	233.4

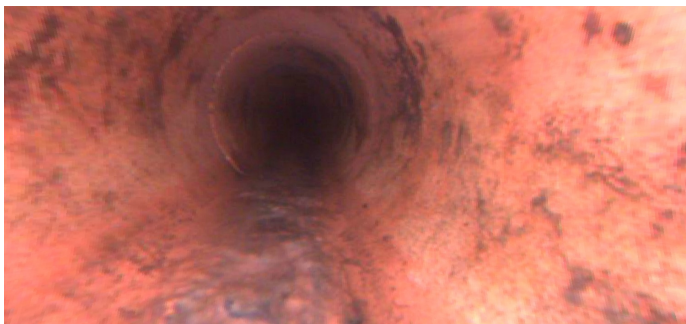
Code: **AMH**
Description: **Manhole**

Distance (ft): **.0**
Structural Grade: **0**
O&M Grade: **0**
Clock Start/From:
Clock To:
1st Value:
2nd Value:
Value Percent:
Continuous Index:
Within 8" of Joint: **NO**
Remarks: **M-507-002**

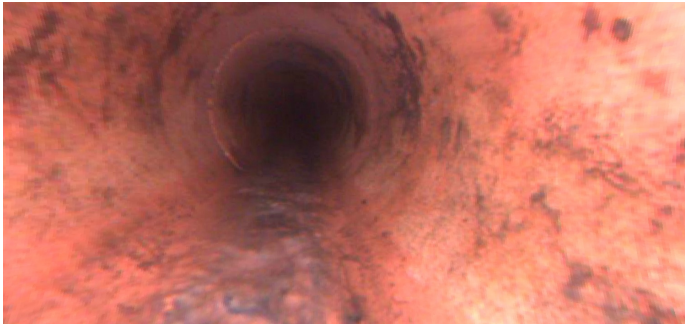
Code:	MWL
Description:	Water Level

Distance (ft):	.0
Structural Grade:	0
O&M Grade:	0
Clock Start/From:	
Clock To:	
1st Value:	
2nd Value:	
Value Percent:	5.000
Continuous Index:	
Within 8" of Joint:	NO
Remarks:

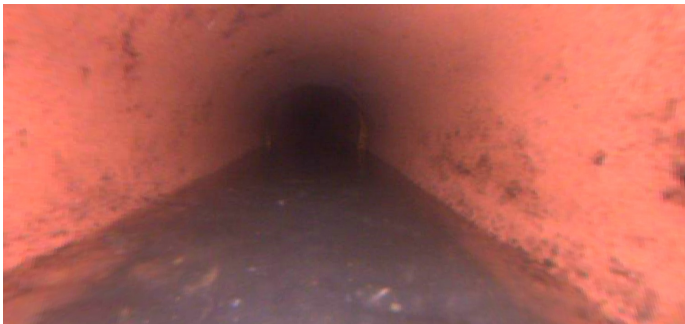
Code:	DAE
Description:	Deposits Attached Encrustation

Distance (ft):	5.6
Structural Grade:	0
O&M Grade:	2
Clock Start/From:	8
Clock To:	4
1st Value:	
2nd Value:	
Value Percent:	10.000
Continuous Index:	
Within 8" of Joint:	YES
Remarks:

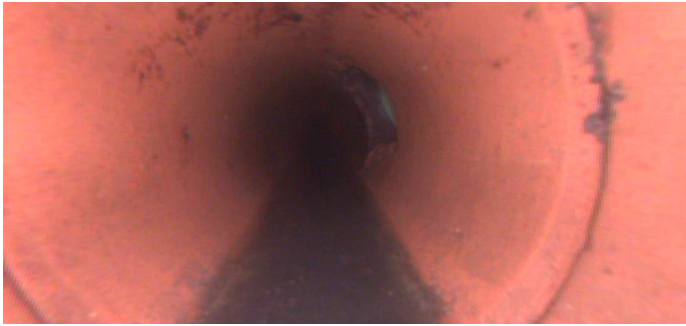
Code: **TF**
Description: **Tap Factory**

Distance (ft): **36.5**
Structural Grade: **0**
O&M Grade: **0**
Clock Start/From: **3**
Clock To:
1st Value: **4.000**
2nd Value:
Value Percent:
Continuous Index:
Within 8" of Joint:
Remarks:

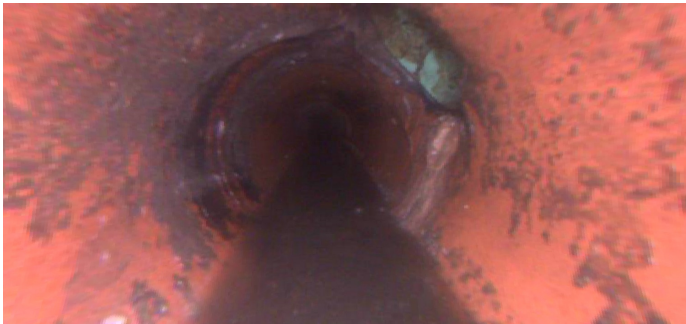
Code: **TF**
Description: **Tap Factory**

Distance (ft): **106.1**
Structural Grade: **0**
O&M Grade: **0**
Clock Start/From: **2**
Clock To:
1st Value: **4.000**
2nd Value:
Value Percent:
Continuous Index:
Within 8" of Joint:
Remarks:

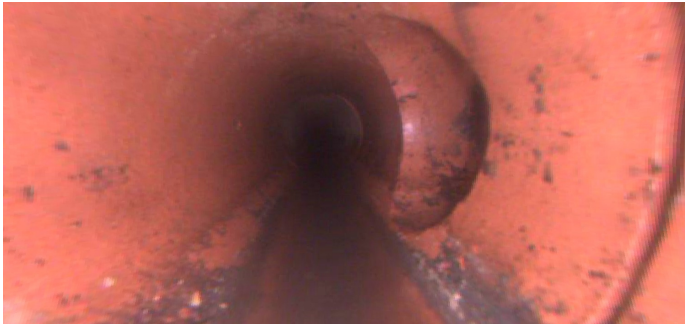
Code: **TF**
Description: **Tap Factory**

Distance (ft): **115.1**
Structural Grade: **0**
O&M Grade: **0**
Clock Start/From: **3**
Clock To:
1st Value: **4.000**
2nd Value:
Value Percent:
Continuous Index:
Within 8" of Joint:
Remarks:

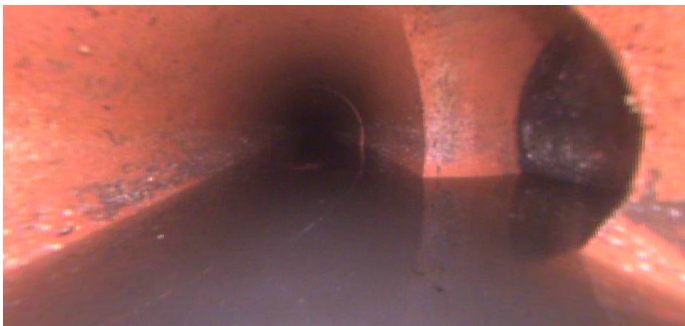
Code: **TF**
Description: **Tap Factory**

Distance (ft): **151.8**
Structural Grade: **0**
O&M Grade: **0**
Clock Start/From: **3**
Clock To:
1st Value: **4.000**
2nd Value:
Value Percent:
Continuous Index:
Within 8" of Joint:
Remarks:

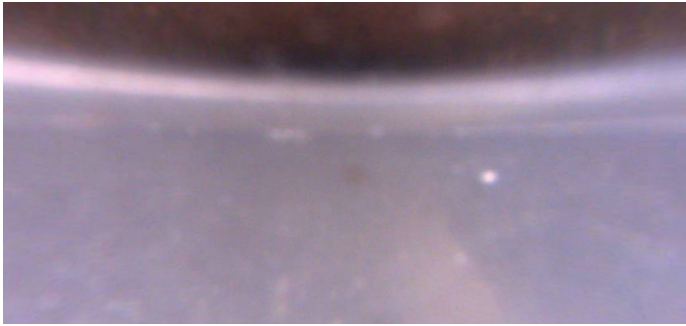
Code: **MWLS**
Description: **Water Level Sag**

Distance (ft): **192.9**
Structural Grade: **2**
O&M Grade: **3**
Clock Start/From:
Clock To:
1st Value:
2nd Value:
Value Percent: **20.000**
Continuous Index: **S01**
Within 8" of Joint: **NO**
Remarks:

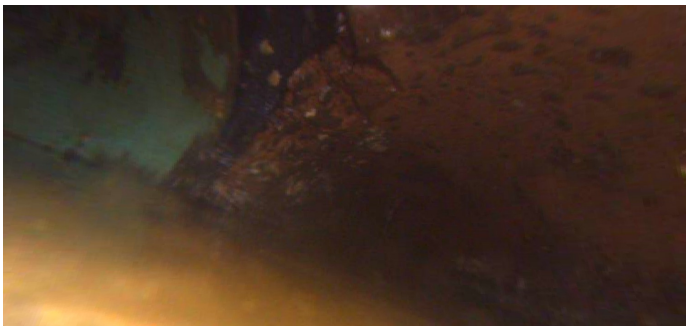
Code: **MGO**
Description: **General Observation**

Distance (ft): **215.4**
Structural Grade: **0**
O&M Grade: **0**
Clock Start/From:
Clock To:
1st Value:
2nd Value:
Value Percent:
Continuous Index:
Within 8" of Joint: **NO**
Remarks: **switching to rear view**

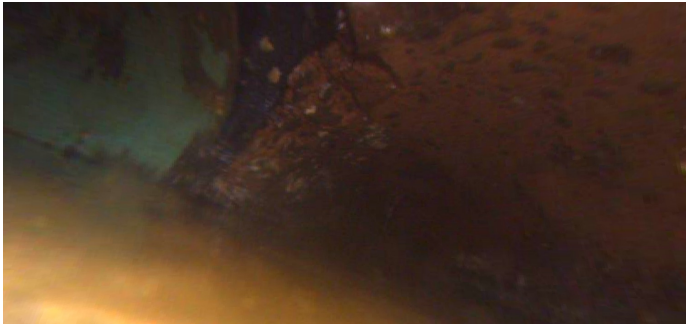
Code: **TF**
Description: **Tap Factory**

Distance (ft): **215.4**
Structural Grade: **0**
O&M Grade: **0**
Clock Start/From: **9**
Clock To:
1st Value: **4.000**
2nd Value:
Value Percent:
Continuous Index:
Within 8" of Joint:
Remarks:

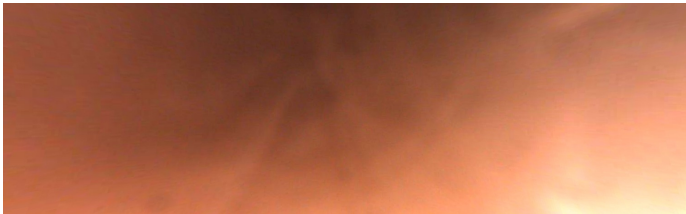
Code: **MWLS**
Description: **Water Level Sag**

Distance (ft): **233.4**
Structural Grade: **2**
O&M Grade: **3**
Clock Start/From:
Clock To:
1st Value:
2nd Value:
Value Percent: **20.000**
Continuous Index: **F01**
Within 8" of Joint: **NO**
Remarks:
