## Profile/Photo Observation Report

Street:	OFF S DELAWARE ST	Flow Control:	Not Controlled
City:	Hobart, IN	Year Renewed:	
Location:	Light Highway	Tape/Media #:	
Purpose:	Routine Assessment	Dia/Height:	12"
Use:	Sanitary	Material:	VCP
Drain Area:	NA	Lining:	
Category:	NA		
Comment:

Location Details:		Direction of Survey:	Downstream
US MH:	M-507-003	DS MH:	M-507-004
		Total Length Surveyed (ft):	10.3

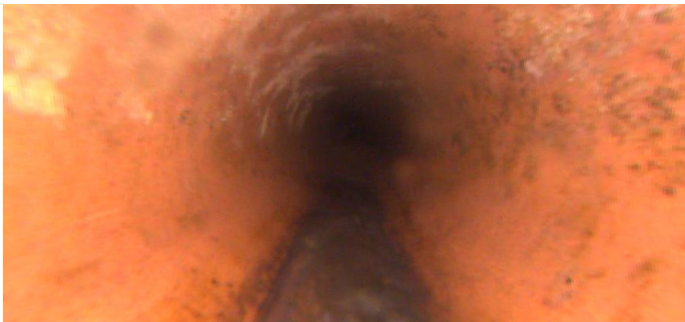
Code: **AMH**  
Description: **Manhole**

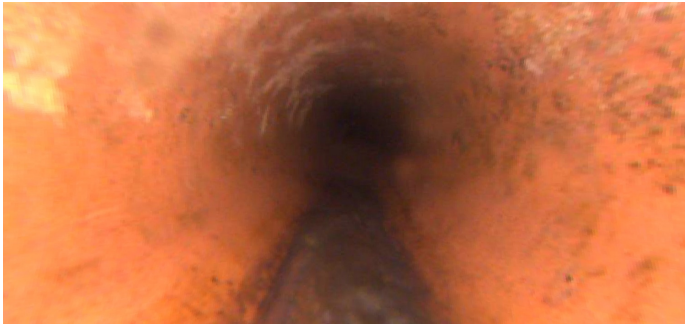
Code:	<b>MWL</b>
Description:	<b>Water Level</b>

Distance (ft):	<b>.0</b>
Structural Grade:	<b>0</b>
O&M Grade:	<b>0</b>
Clock Start/From:	
Clock To:	
1st Value:	
2nd Value:	
Value Percent:	<b>5.000</b>
Continuous Index:	
Within 8" of Joint:	<b>NO</b>
Remarks:

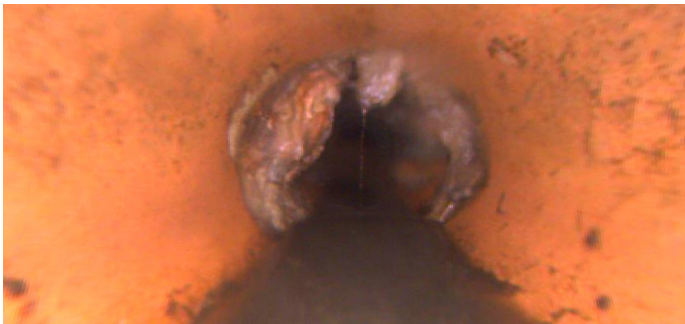
Code:	<b>DAE</b>
Description:	<b>Deposits Attached Encrustation</b>

Distance (ft):	<b>8.9</b>
Structural Grade:	<b>0</b>
O&M Grade:	<b>4</b>
Clock Start/From:	<b>8</b>
Clock To:	<b>4</b>
1st Value:	
2nd Value:	
Value Percent:	<b>30.000</b>
Continuous Index:	
Within 8" of Joint:	<b>YES</b>
Remarks:
