Profile/Photo Observation Report

Street:	Delaware St.	Flow Control:	Not Controlled
City:	Hobart, IN	Year Renewed:	
Location:	Light Highway	Tape/Media #:	
Purpose:	Routine Assessment	Dia/Height:	12"
Use:	Sanitary	Material:	VCP
Drain Area:	NA	Lining:	
Category:	NA		
Comment:

Location Details:		Direction of Survey:	Downstream
US MH:	M-507-003	DS MH:	M-507-004
		Total Length Surveyed (ft):	10.3

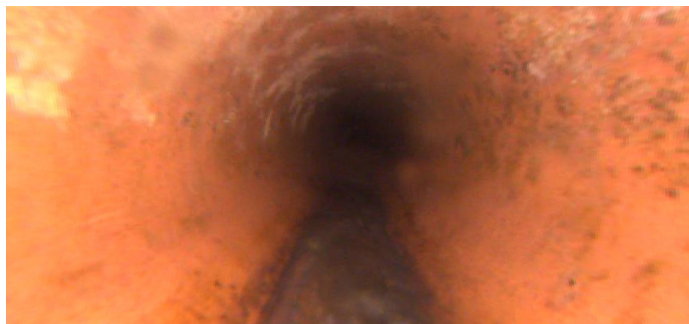
Code: **AMH**
Description: **Manhole**

Distance (ft): **.0**
Structural Grade: **0**
O&M Grade: **0**
Clock Start/From:
Clock To:
1st Value:
2nd Value:
Value Percent:
Continuous Index:
Within 8" of Joint: **NO**
Remarks: **M-507-003**

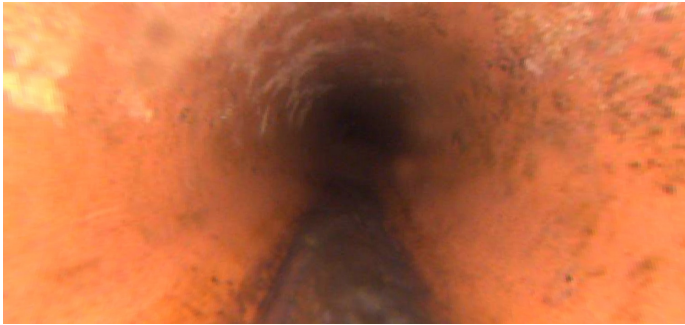
Code:	MWL
Description:	Water Level

Distance (ft):	.0
Structural Grade:	0
O&M Grade:	0
Clock Start/From:	
Clock To:	
1st Value:	
2nd Value:	
Value Percent:	5.000
Continuous Index:	
Within 8" of Joint:	NO
Remarks:

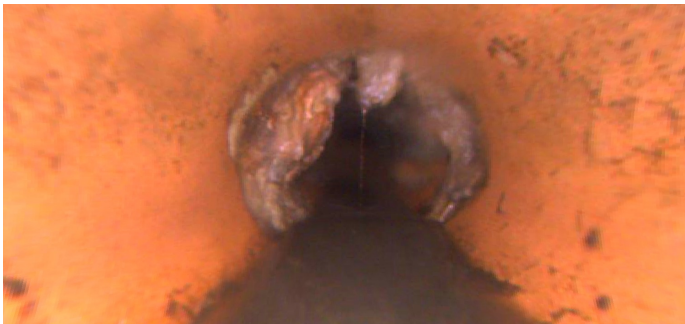
Code:	DAE
Description:	Deposits Attached Encrustation

Distance (ft):	8.9
Structural Grade:	0
O&M Grade:	4
Clock Start/From:	8
Clock To:	4
1st Value:	
2nd Value:	
Value Percent:	30.000
Continuous Index:	
Within 8" of Joint:	YES
Remarks:
