Profile/Photo Observation Report

Date:	01/29/2025	Weather:		Coding:	PACP 7.0
Pipe Length (ft):		Owner:	City of Hobart	Pre Clean:	No Pre-Cleaning
P.O.#:	YES502259	Surveyor:	S. Bucklin	PSR:	M-507-004-M-507-004.1
Customer:	City of Hobart	Clean Date:		Shape:	C

Street:	Delaware St.	Flow Control:	Not Controlled
City:	Hobart, IN	Year Renewed:	
Location:	Easement/Right of Way	Tape/Media #:	
Purpose:	Sewer System Evaluation Survey (SS	Dia/Height:	15"
Use:	Sanitary Sewage Pipe	Material:	VCP
Drain Area:		Lining:	None
Category:	NA		
Comment:			
Location Details:		Direction of Survey:	Downstream
US MH:	M-507-004	DS MH:	M-507-004.1
		Total Length Surveyed (ft):	24.6

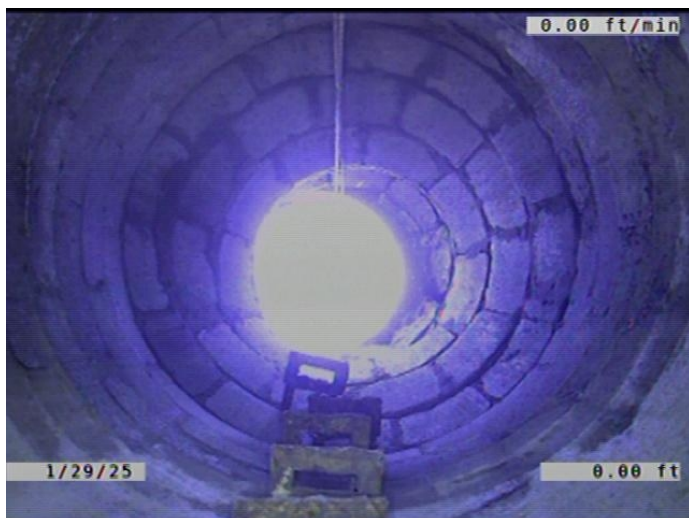
Code: **AMH**
Description: **Manhole**

Distance (ft): **.0**
Structural Grade: **0**
O&M Grade: **0**
Clock Start/From:
Clock To:
1st Value:
2nd Value:
Value Percent:
Continuous Index:
Within 8" of Joint: **NO**
Remarks: **M-507-004**

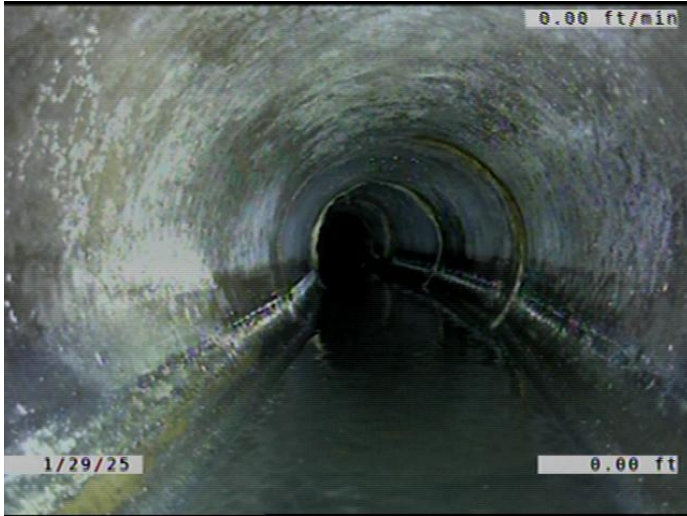
Code: **MWL**
Description: **Miscellaneous Water Level**

Distance (ft): **.0**
Structural Grade: **0**
O&M Grade: **0**
Clock Start/From:
Clock To:
1st Value:
2nd Value:
Value Percent: **15.000**
Continuous Index:
Within 8" of Joint: **NO**
Remarks:

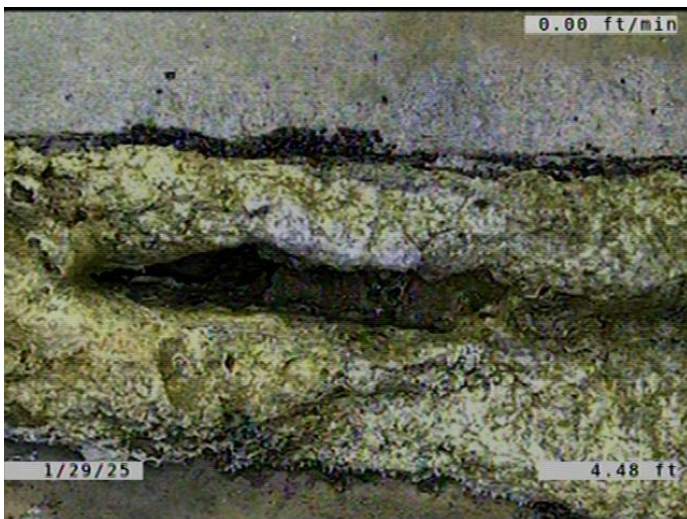
Code: **DAE**
Description: **Deposits Attached Encrustation**

Distance (ft): **4.5**
Structural Grade: **0**
O&M Grade: **2**
Clock Start/From: **7**
Clock To: **5**
1st Value:
2nd Value:
Value Percent: **5.000**
Continuous Index: **S01**
Within 8" of Joint: **YES**
Remarks:

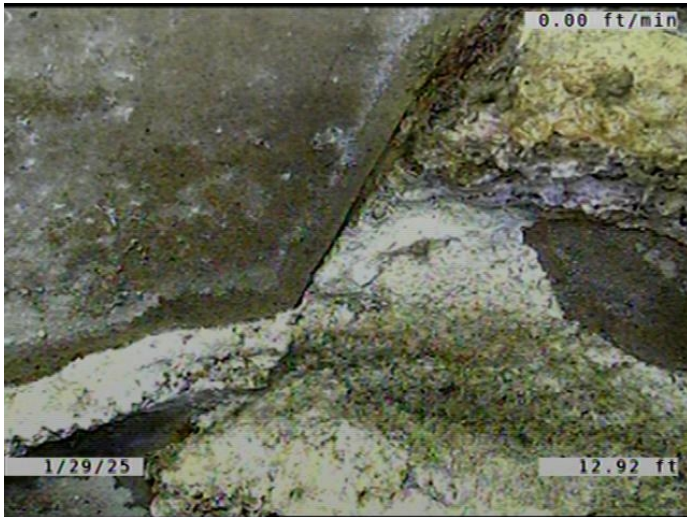
Code: **FM**
Description: **Fracture Multiple**

Distance (ft): **12.9**
Structural Grade: **4**
O&M Grade: **0**
Clock Start/From: **11**
Clock To: **3**
1st Value:
2nd Value:
Value Percent:
Continuous Index:
Within 8" of Joint: **YES**
Remarks:

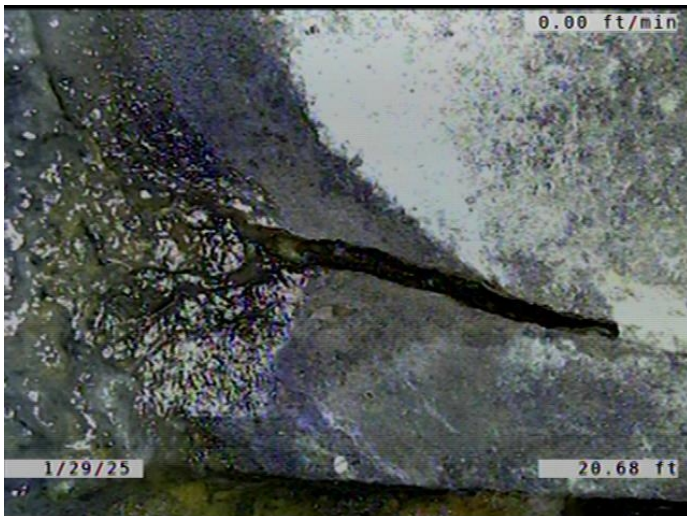
Code: **B**
Description: **Broken**

Distance (ft): **20.7**
Structural Grade: **4**
O&M Grade: **0**
Clock Start/From: **3**
Clock To: **6**
1st Value:
2nd Value:
Value Percent:
Continuous Index:
Within 8" of Joint: **YES**
Remarks:

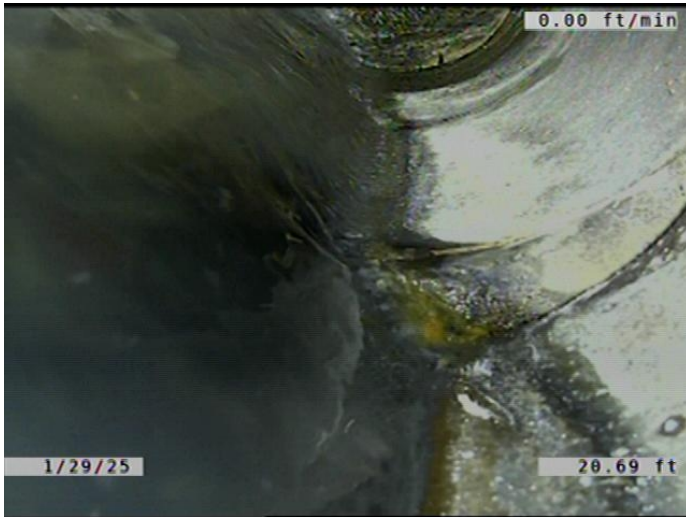
Code: **JOMD**
Description: **Joint Offset Medium Defective**

Distance (ft): **20.7**
Structural Grade: **3**
O&M Grade: **0**
Clock Start/From:
Clock To:
1st Value:
2nd Value:
Value Percent:
Continuous Index:
Within 8" of Joint: **NO**
Remarks:

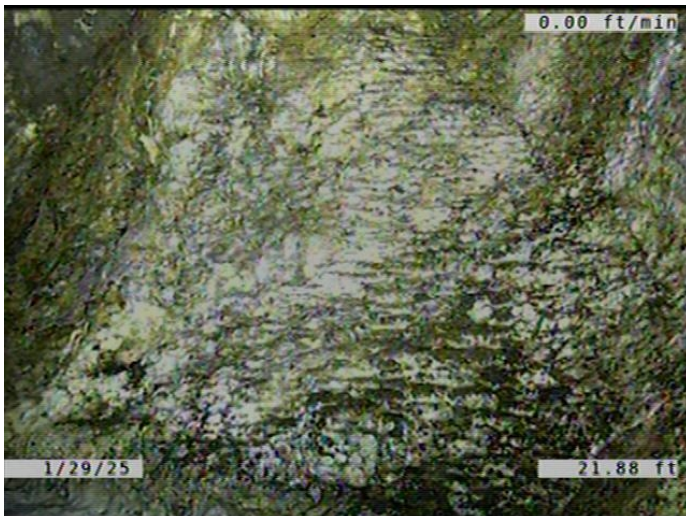
Code: **DAE**
Description: **Deposits Attached Encrustation**

Distance (ft): **21.9**
Structural Grade: **0**
O&M Grade: **2**
Clock Start/From: **7**
Clock To: **5**
1st Value:
2nd Value:
Value Percent: **5.000**
Continuous Index: **F01**
Within 8" of Joint: **YES**
Remarks:

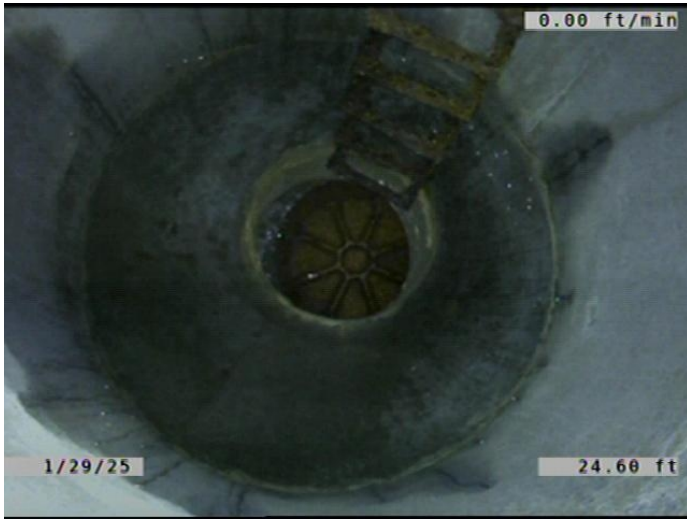
Code:	AMH
Description:	Manhole
Distance (ft):	24.6
Structural Grade:	0
O&M Grade:	0
Clock Start/From:	
Clock To:	
1st Value:	
2nd Value:	
Value Percent:	
Continuous Index:	
Within 8" of Joint:	NO
Remarks:	M-507-004.1
