## Profile/Photo Observation Report

Date:	<b>10/25/2021</b>	Weather:		Coding:	<b>PACP 6.0</b>
Pipe Length (ft):		Owner:	<b>Hobart, IN</b>	Pre Clean:	<b>Not Known</b>
P.O.#:	<b>1003_1</b>	Surveyor:	<b>M. Pielacha</b>	PSR:	<b>P-507-004-LS007</b>
Customer:	<b>Hobart, IN</b>	Clean Date:		Shape:	<b>C</b>

Street:	<b>Off 13th Place</b>	Flow Control:	<b>Not Controlled</b>
City:	<b>Hobart, IN</b>	Year Renewed:	
Location:	<b>Yard</b>	Tape/Media #:	<b>1003</b>
Purpose:	<b>Routine Assessment</b>	Dia/Height:	<b>12"</b>
Use:	<b>Sanitary</b>	Material:	<b>VCP</b>
Drain Area:		Lining:	
Category:	<b>NA</b>		
Comment:			
Location Details:		Direction of Survey:	<b>Upstream</b>
US MH:	<b>M-507-4Z</b>	DS MH:	<b>M-507-4</b>
		Total Length Surveyed (ft):	<b>.1</b>

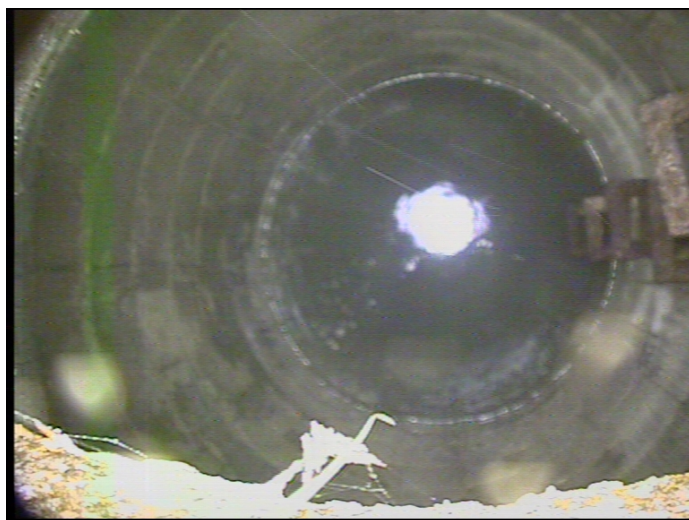
Code: **AMH**  
Description: **Manhole**

Distance (ft): **.0**  
Structural Grade: **0**  
O&M Grade: **0**  
Clock Start/From:  
Clock To:  
1st Value:  
2nd Value:  
Value Percent:  
Continuous Index:  
Within 8" of Joint: **NO**  
Remarks: **M-507-4**

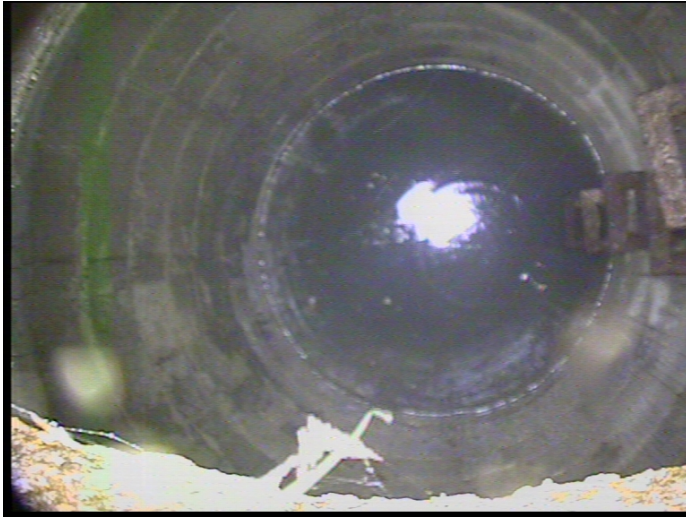
Code: **MWL**  
Description: **Water Level**

Distance (ft): **.0**  
Structural Grade: **0**  
O&M Grade: **0**  
Clock Start/From:  
Clock To:  
1st Value:  
2nd Value:  
Value Percent: **100.000**  
Continuous Index:  
Within 8" of Joint: **NO**  
Remarks:

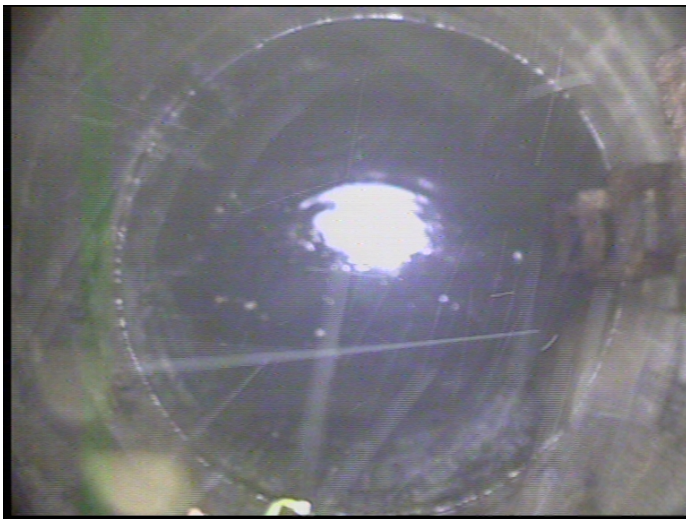
Code: **MSA**  
Description: **Abandoned Survey**

Distance (ft): **.0**  
Structural Grade: **0**  
O&M Grade: **0**  
Clock Start/From:  
Clock To:  
1st Value:  
2nd Value:  
Value Percent:  
Continuous Index:  
Within 8" of Joint: **NO**  
Remarks: **surcharged**
